Subject: Recertification of Environmental Condition of Property (ECP) for Parcels 060092 00045 and 060092 00047 on the Main Installation, Former Defense Depot Memphis Tennessee (DDMT)

Encl 1: ECP Visual Inspection Photolog

ENCLOSURE 1
Environmental Condition of Property Visual Inspection
Parcel 060092 00047
03/23/2020

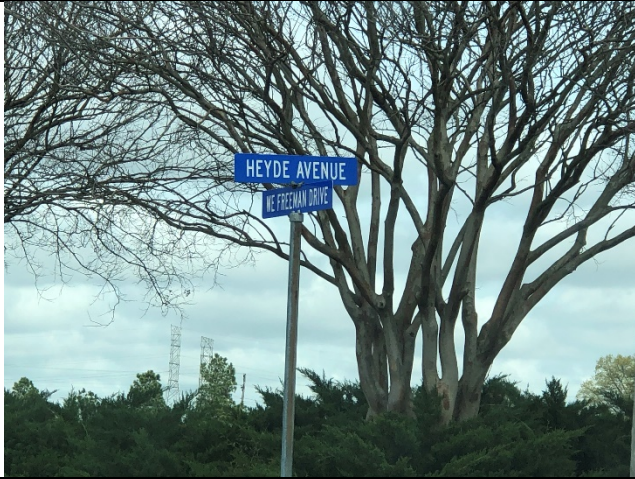
Southwest corner of parcel at corner of WE Freeman Drive running north to south and Heyde Avenue running east to west.

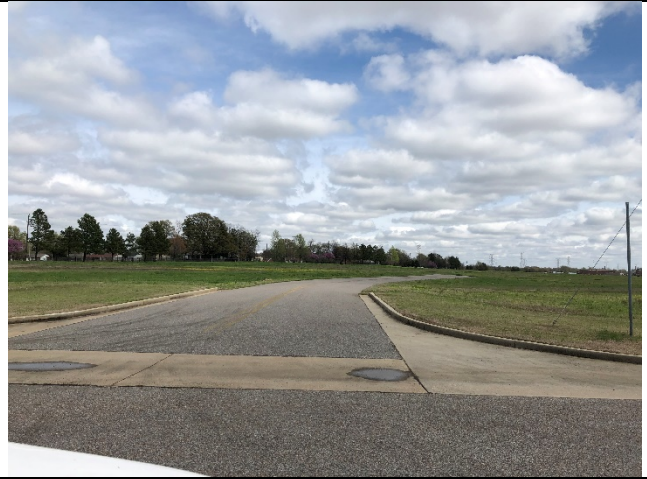
From WE Freeman Drive looking east along an unnamed paved road spur connected by a gravel road to a paved road on northern side of parcel.

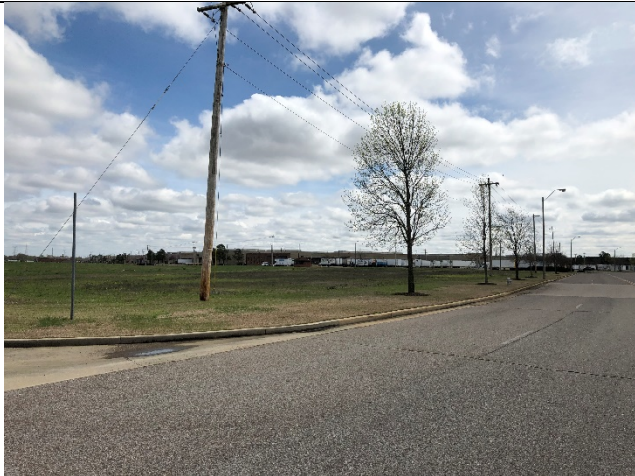
On WE Freeman Drive at road spur looking south along western edge of parcel.

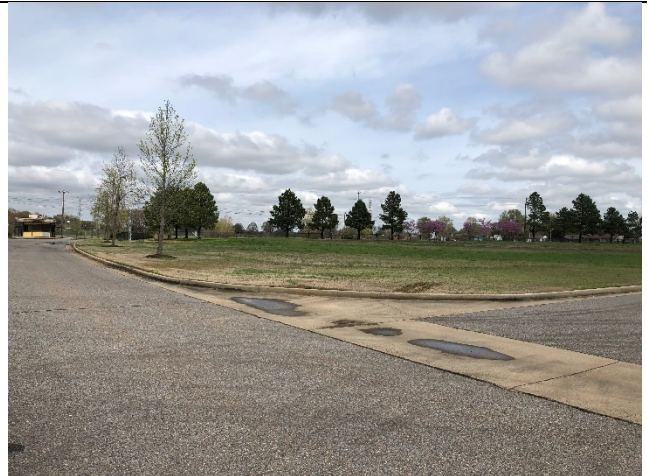
On WE Freeman Drive at road spur looking north.

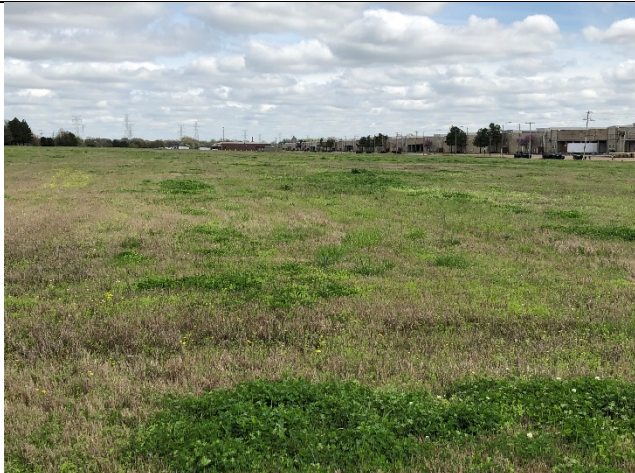
From end of road spur looking east. Typical warehouses on right. Building 210 shown in distance.

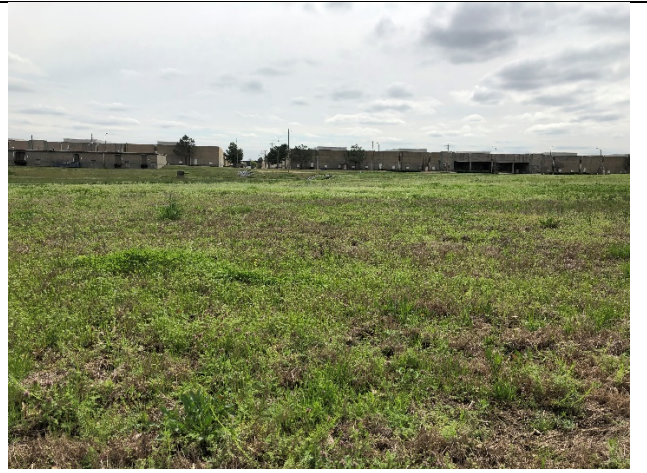
Northeast corner of parcel looking south. Edge of retention pond shown on left. The 1940-era typical warehouses shown in distance.

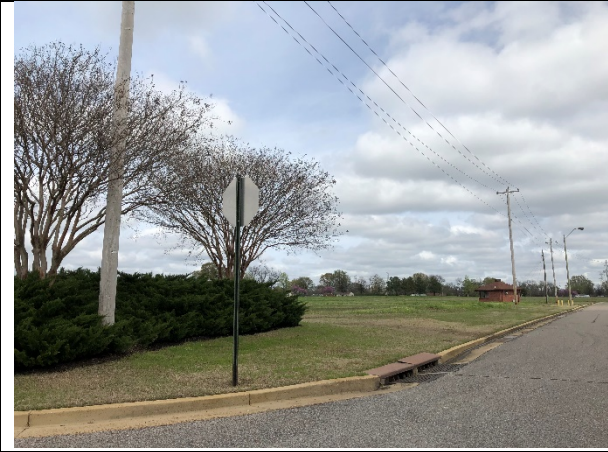
From corner of WE Freeman Drive and Heyde Drive looking east along southern parcel line. Building 727 shown in distance.

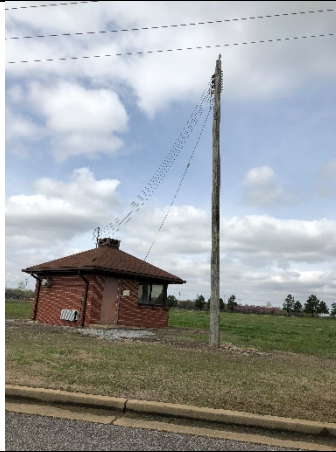
8. According to the EBS, Building 727 was constructed in 1994 as a sentry station. It was vacant during 1996 EBS visual inspections and was vacant during the 2020 visual inspection. The building is not used for hazardous substance or petroleum product storage, handling, spills or disposal.

Building 727 is not currently in use.

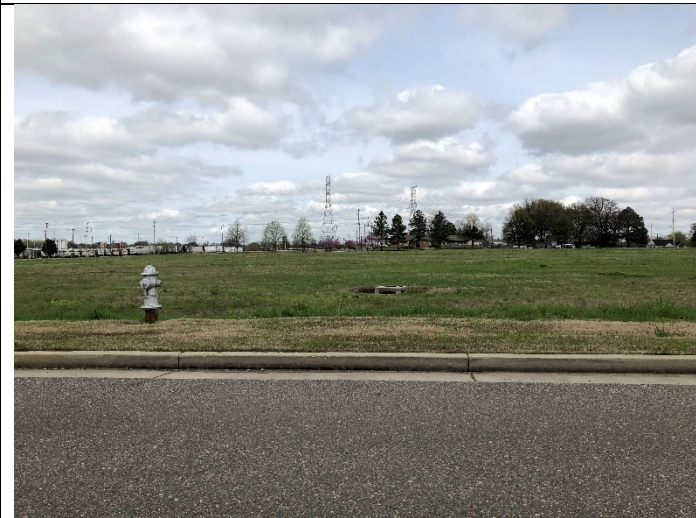
From Heyde Drive near southeastern corner of parcel looking north. Storm water drain and fire hydrant water line run parallel to Heyde Drive.

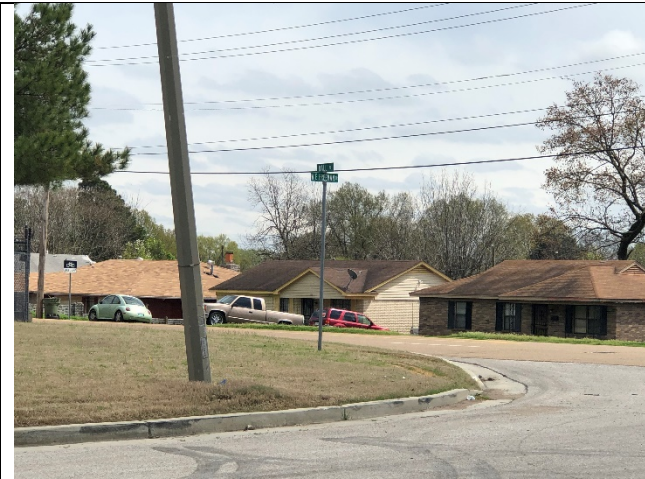
Parcel located near corner of WE Freeman Drive running north to south and Ball Road running east to west.

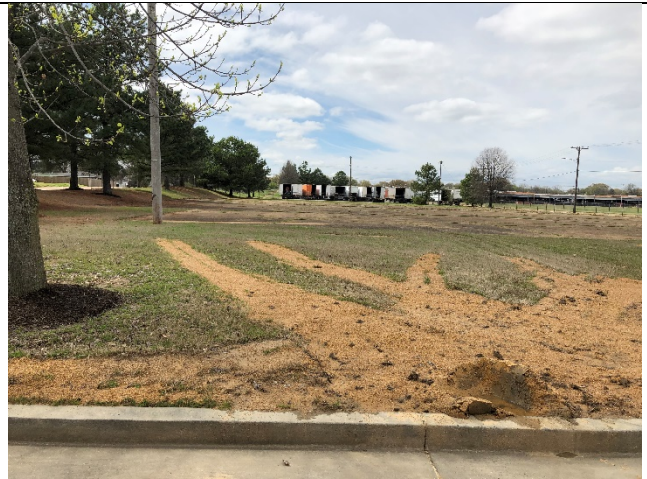
Southeast corner of parcel from WE Freeman Drive looking west.

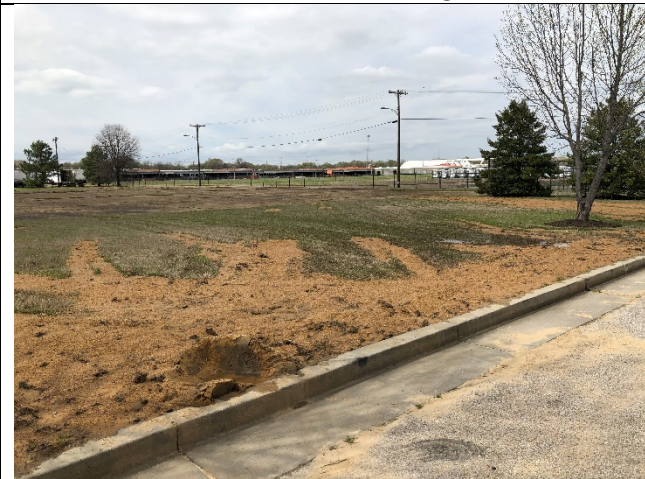
From WE Freeman Drive looking north at northeast corner of parcel.

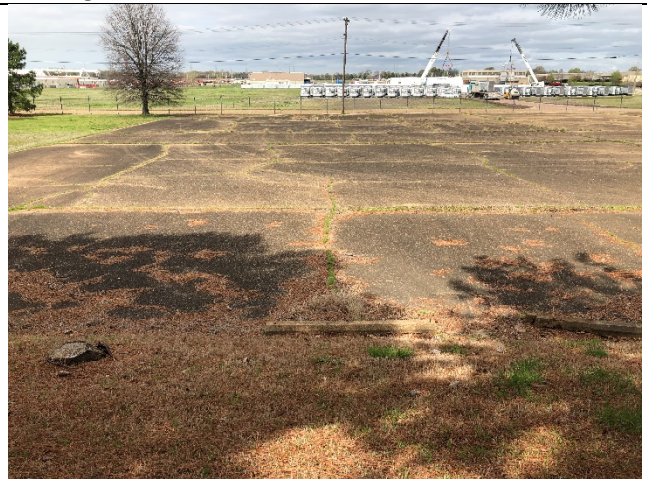
From southern boundary looking north towards Amido Avenue that runs east to west along the northern parcel line.

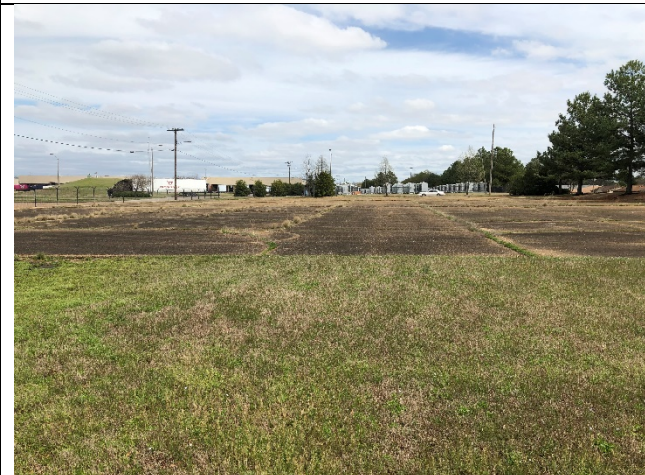
Looking east from the western parcel line.
