# THE MEMPHIS DEPOT TENNESSEE

## ADMINISTRATIVE RECORD COVER SHEET

RE: RCRA Facility Assessment (RFA) Findings  
DOD Defense Depot Memphis  
EPA I.D. No. TN4 210 020 570

APPENDIX B  
VSI Log Book

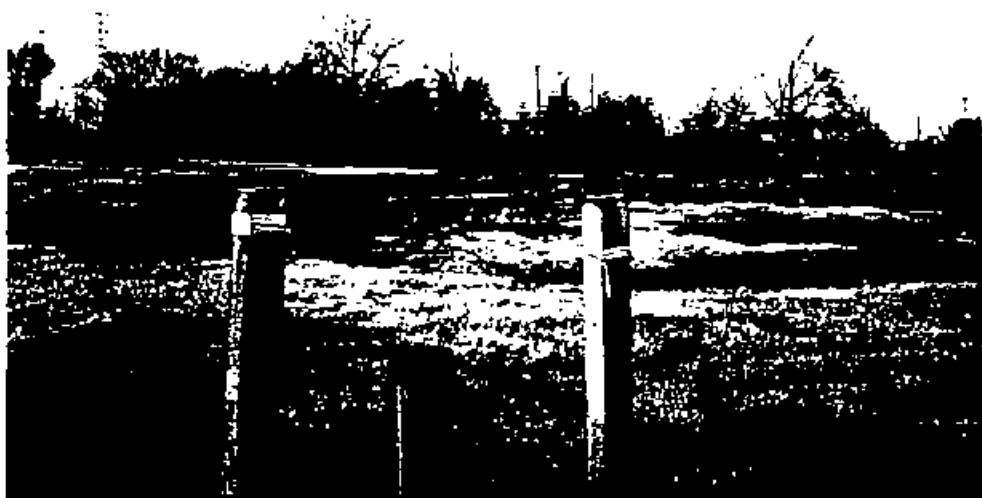
Photograph No. 1-4 Looking west at the Mixed Chemical Burial Site B (SWMU No. 13), the Municipal Waste Burial Site (SWMU No. 14), the Sodium Burial Sites (SWMU No. 15), the Unknown Acid Burial Site (SWMU No. 16), the Mixed Chemical Burial Site C (SWMU No. 17), and the Plane Crash Residue Burial Site (SWMU No. 18). Monitoring Well No. 4 in foreground. (Photograph taken December 6, 1989, by Jack Slechta of A.T. Kearney.)

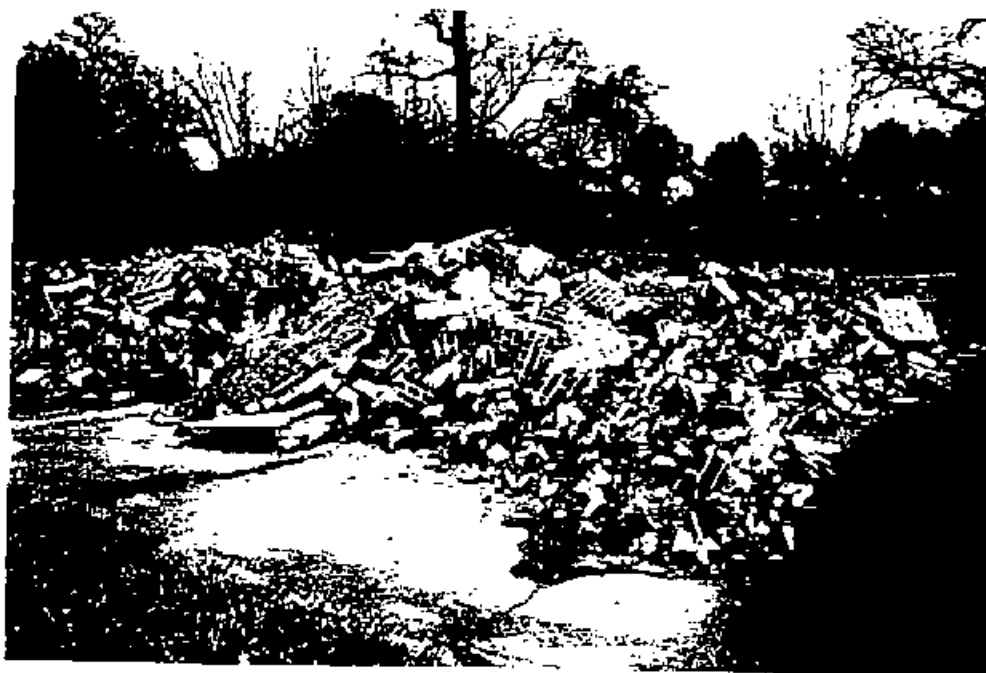
Photograph No. 1-7 Looking northeast at the building foundation for former possible storage of pesticides. (Photograph taken December 6, 1989, by Jack Slechta of A.T. Kearney.)

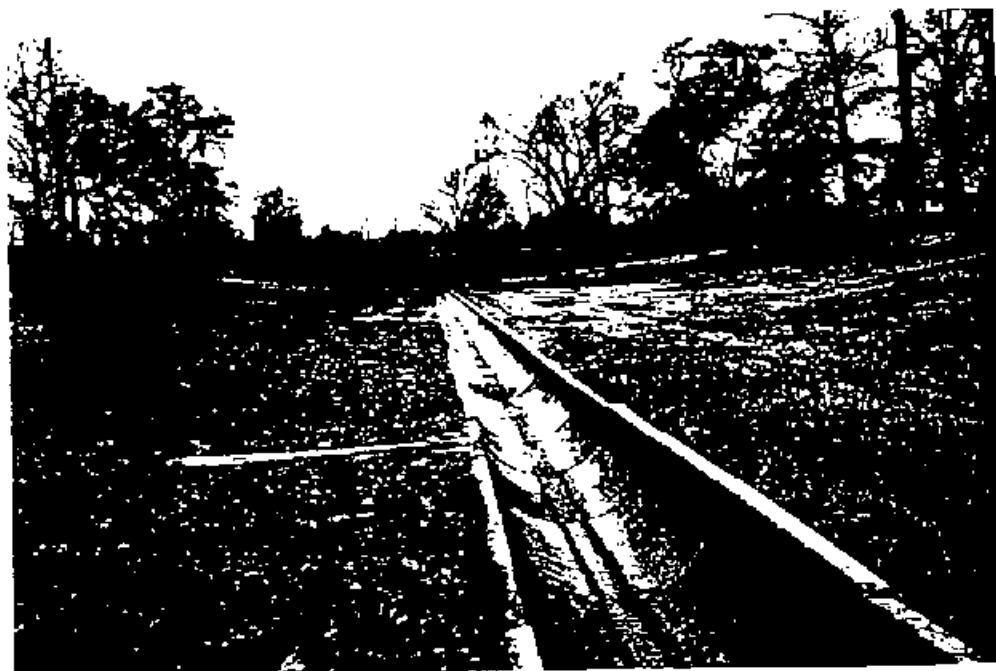
Photograph No. 1-10 Looking north along Dunn Field Drainage Ditch (AOC A) which is downslope from the XXCC-3 Probable Burial Site (SWMU No. 21) to the east and the pistol range to the west. (Photograph taken December 6, 1989, by Jack Slechta of A.T. Kearney.)

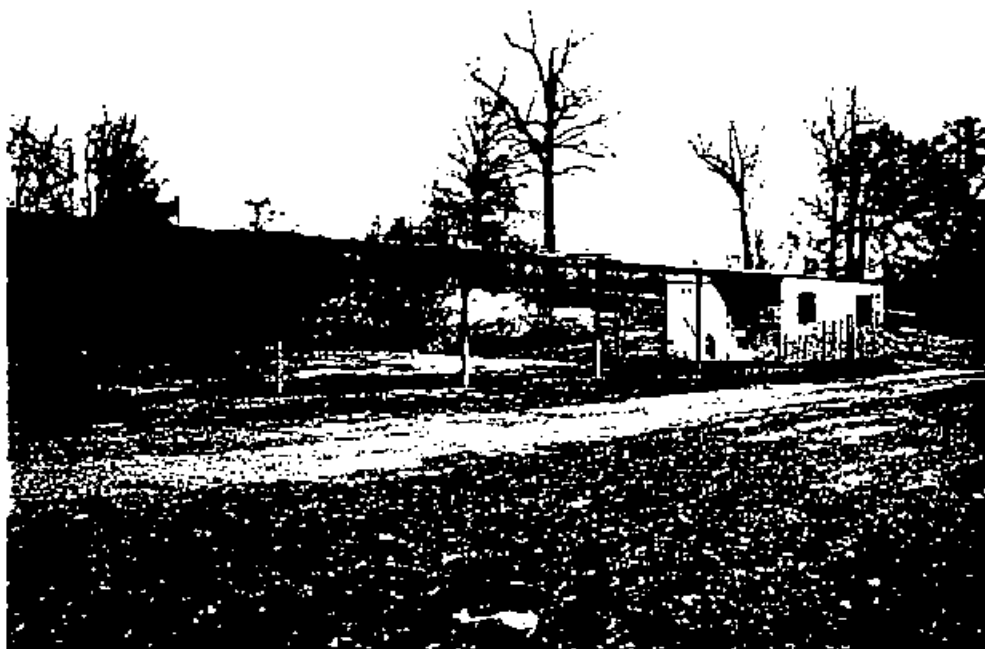
Photograph No. 1-12 Looking northwest at the pistol range and Building 1184 which is used to store pesticides prior to facility use. (Photograph taken December 6, 1989, by Jack Slechta of A.T. Kearney.)

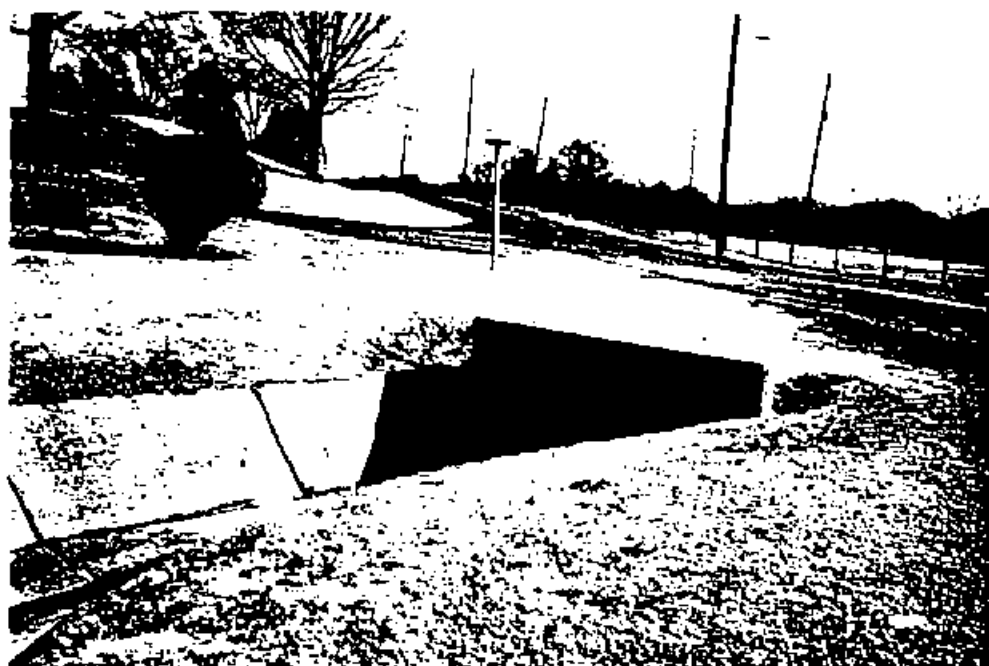
Photograph No. 1-19 Looking east at NPDES Outfall No. 004, which accepts drainage from Lake Danielson and the southern part of the main installation, located at southern boundary of facility. (Photograph taken December 6, 1989, by Jack Slechta of A.T. Kearney.)

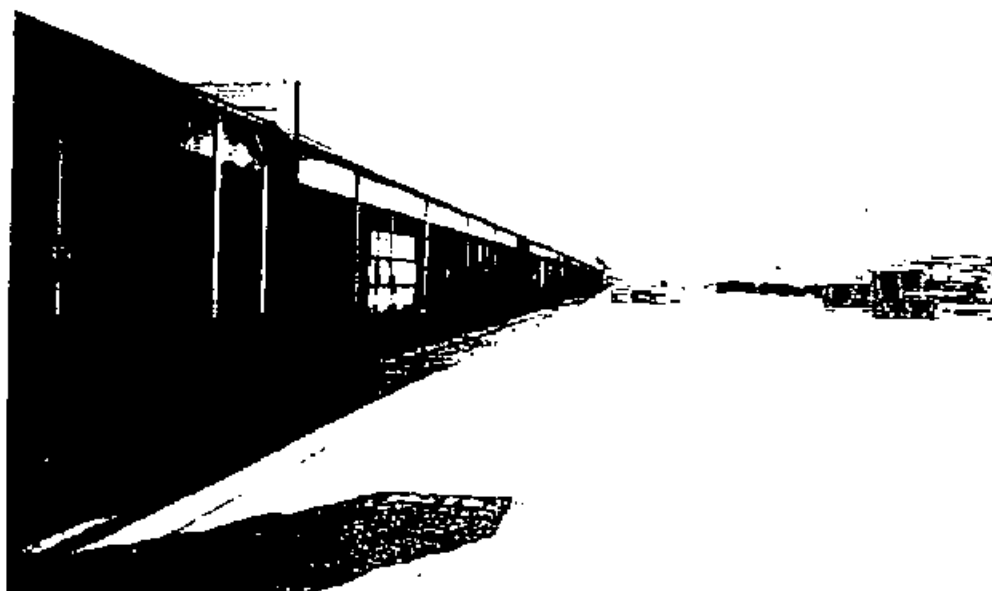
- c. SWMU No. 27 (Former Recoup Area). Aldrin, DDE and DDT have in the past been released into the soil of this area. Although contaminated soil has since been removed, the completeness of removal is uncertain. In addition, groundwater monitoring well MW-23, which may be down-gradient of this unit, showed water samples with concentrations of barium, cadmium, chromium, copper, lead, mercury, nickel and zinc above background levels.

Photograph No. 1-23 Looking north along the eastern side of Building 873 which was the location of the Former Recoup Area (SWMU No. 27). (Photograph taken December 6, 1989, by Jack Slechta of A.T. Kearney.)

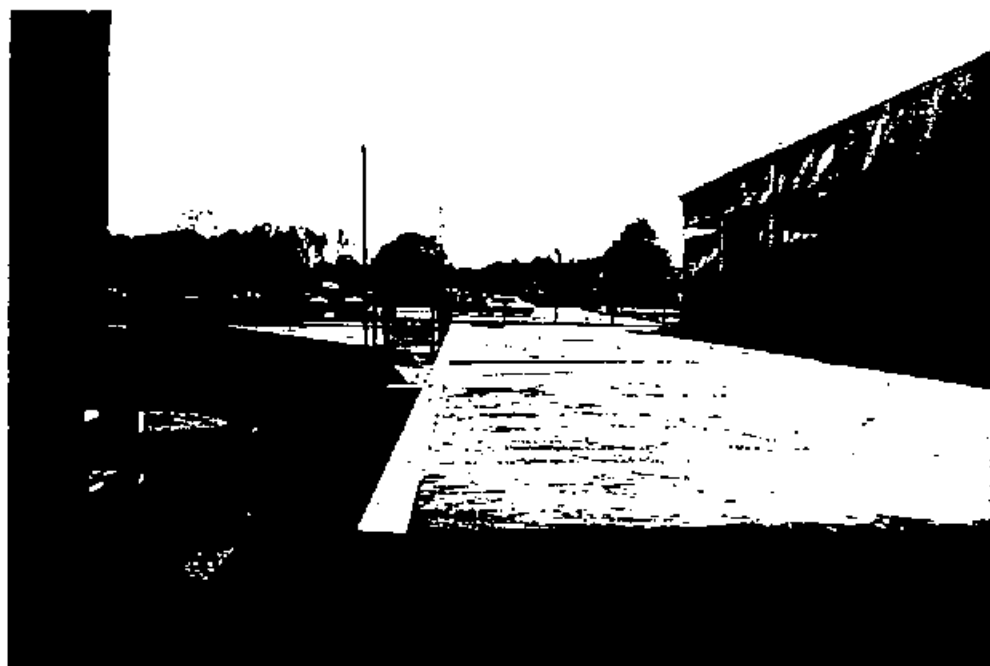
Photograph No. 1-24 Looking south along the eastern side of Building 873 which was the location of the Former Recoup Area (SWMU No. 27). (Photograph taken December 6, 1989, by Jack Slechta of A.T. Kearney.)

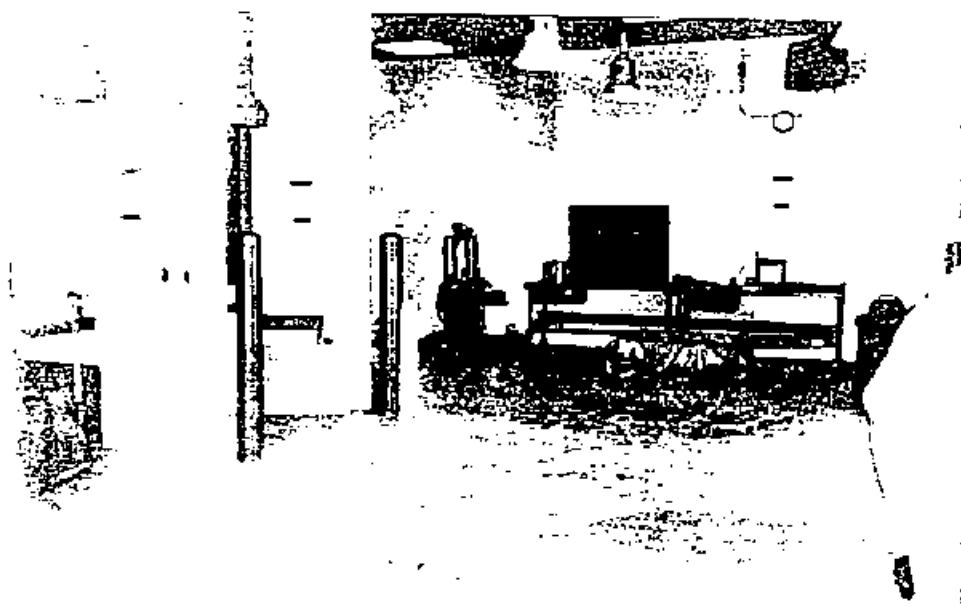
Photograph No. 1-26 Looking west at the work room in the Recoup Area Building (SWMU No. 28). This is the area where materials are transferred from damaged containers into new containers. Photograph taken December 6, 1989 by Jack Slechta of A.T. Kearney.

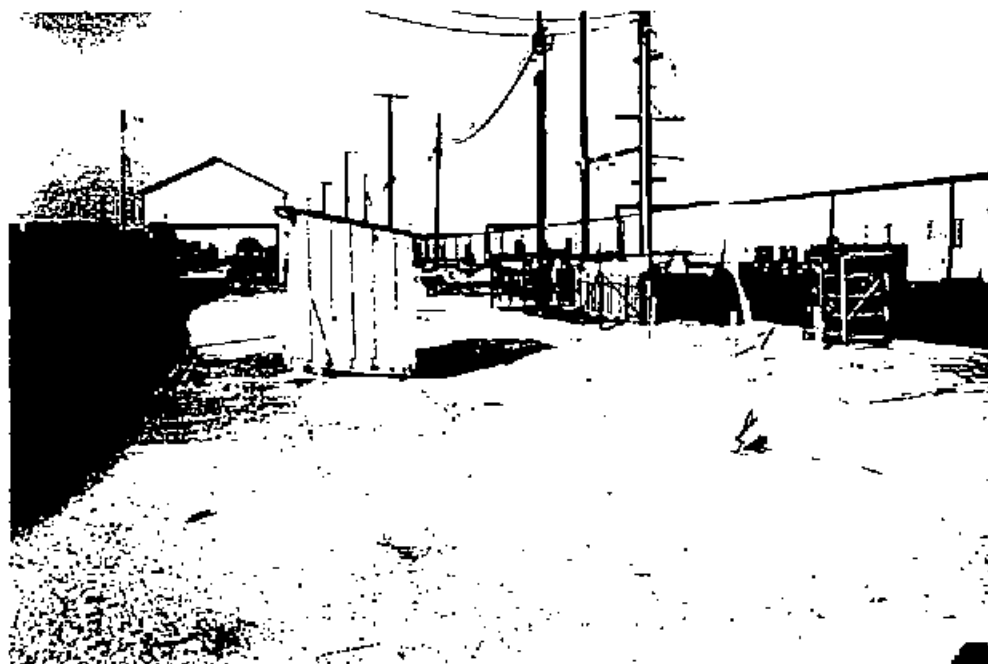
Photograph No. 1-28 Looking north at the Former Underground Waste Oil Storage Tank (SWMU No. 29). The unit is located just east of Building 1086. (Photograph taken December 6, 1989, by Jack Slechta of A.T. Kearney.)

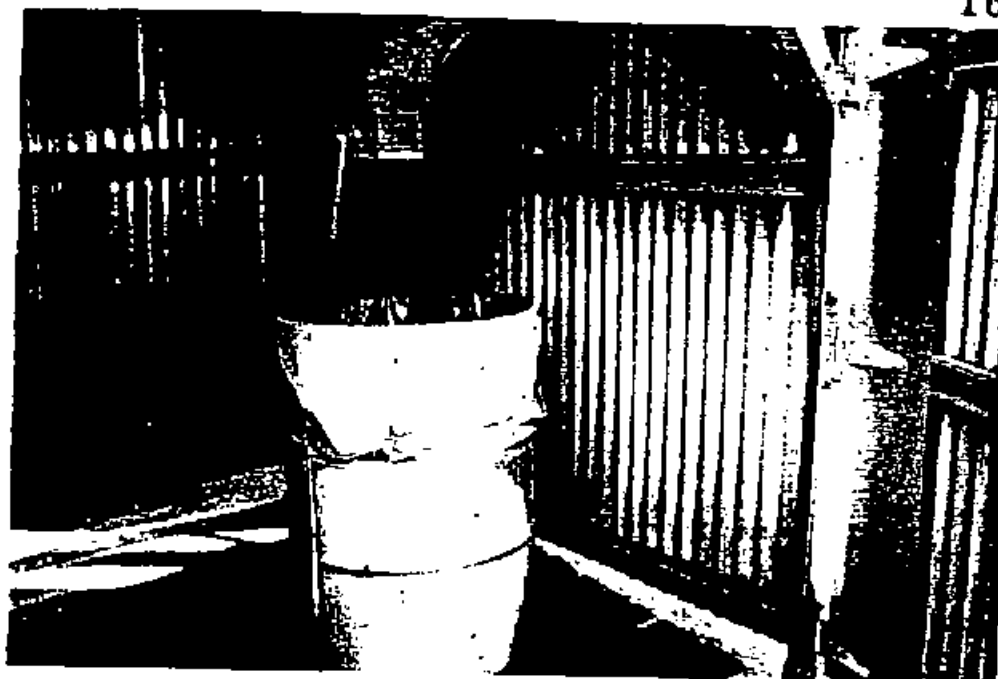
- d. SWMU No. 32 (Sandblasting Waste Accumulation Area). A soil sample taken below the drum area at Building 1088 exhibited elevated levels of heavy metals and pesticides. Surface soil samples taken near Building 1087 showed high levels of chromium (8680 mg/kg), lead (17,500 mg/kg), zinc (22,100 mg/kg) and pesticides/herbicides (7,400 mg/kg).

Photograph No. 1-31 Looking northwest at the Sandblasting Waste Accumulation Area (SWMU No. 32) located just south of Building 1088. (Photograph taken December 6, 1989, by Jack Slechta of A.T. Kearney.)

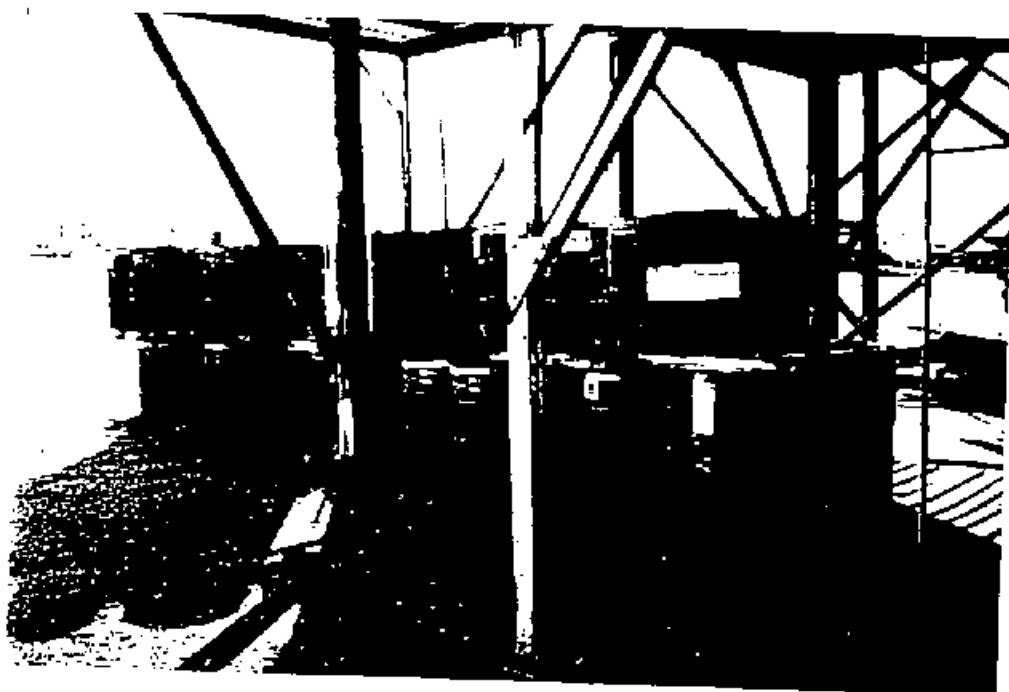
Photograph No. 1-32 Looking southwest at the Sandblasting Waste Drum Storage Area (SWMU No. 33), located just south of Building 1088. (Photograph taken December 6, 1989, by Jack Slechta of A.T. Kearney.)

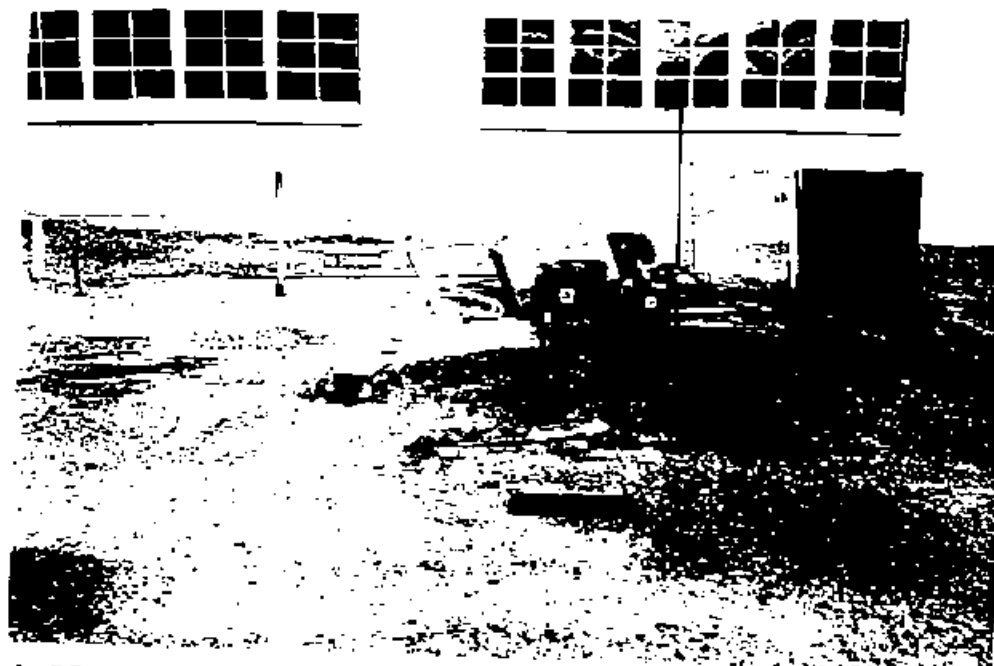
Photograph No. 1-33 Looking east at the Building 770 Underground Waste Oil Storage Tank Area (2) (SWMU No. 34). The unit is located on the west side of Building 770. (Photograph taken December 6, 1989, by Jack Slechta of A.T. Kearney.)

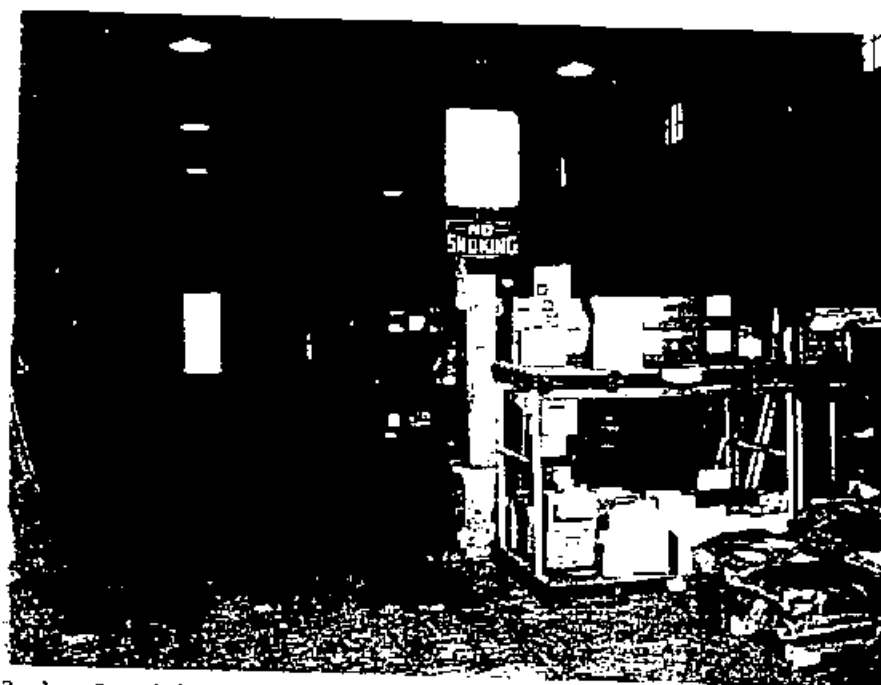
Photograph No. 2-1 Looking northeast at the DRMO Building T-308 Hazardous Waste Storage Area (SWMU No. 35). (Photograph Taken December 7, 1989 by Jack Slechta of A.T. Kearney.)

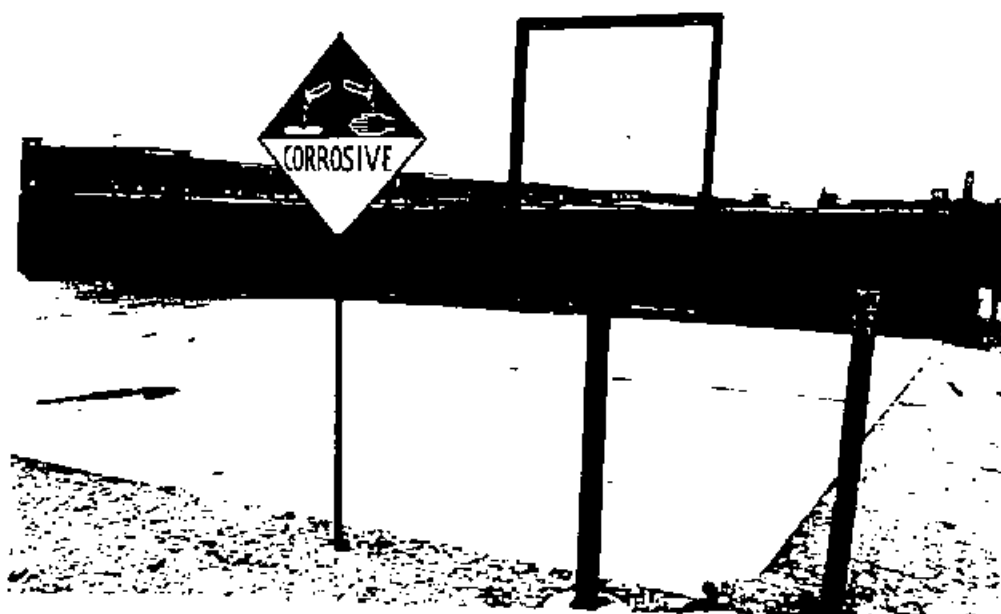
Photograph No. 2-2 Looking west at the DRMO Hazardous Waste Concrete Storage Pad (SWMU No. 36). (Photograph taken December 7, 1989, by Jack Slechta of A.T. Kearney.)

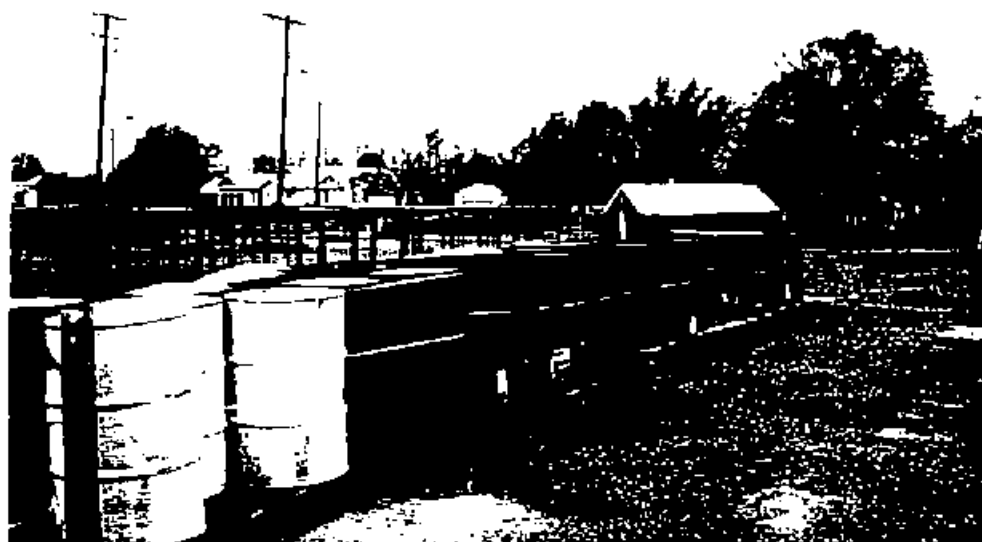
Photograph No. 2-4 Looking northwest at the DRMO Damaged and Empty Hazardous Materials Drum Area (SWMU No. 38). Note stains on the gravel in the foreground. (Photograph taken December 7, 1989, by Jack Slechta of A.T. Kearney.)

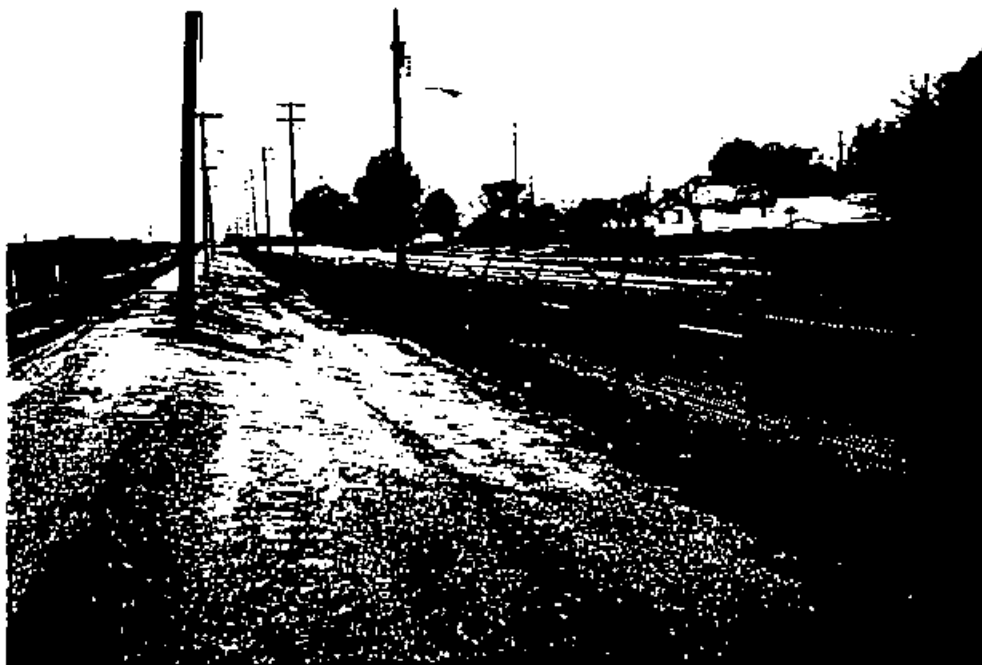
Photograph No. 2-10 Looking west along the northern boundary of the DRMO area at the North Run-off Area (AOC F). This area corresponds to NPDES discharge point No. 006. (Photograph taken December 7, 1989, by Jack Slechta of A.T. Kearney.)

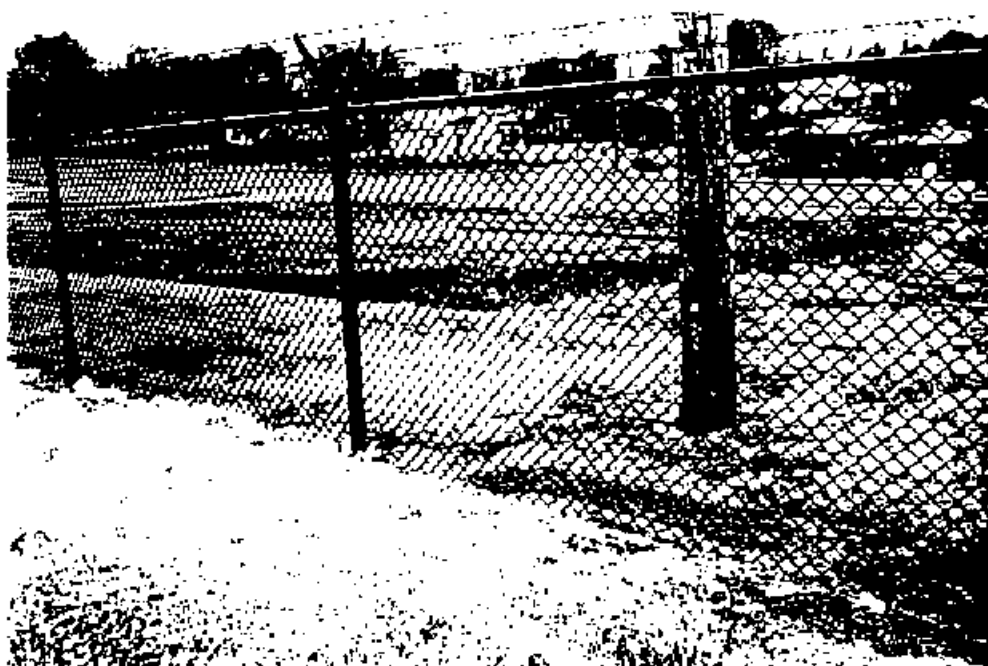
Photograph No. 2-11 Looking southwest at the NPDES discharge point No. 005, which is also the West Run-off Area (AOC G). (Photograph taken December 7, 1989, by Jack Slechta of A.T. Kearney.)

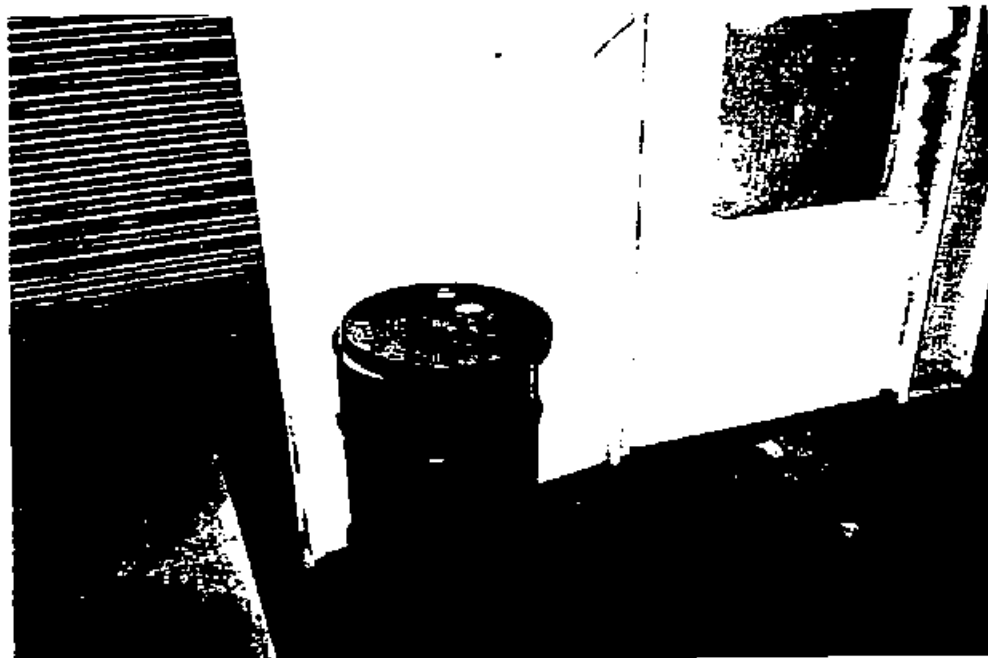
Photograph No. 2-14 Looking south at the thinner rag drum in the Satellite Drum Accumulation Area (SWMU No. 41) in the Paint Spray Booth (SWMU No. 30) located in Building 770. (Photograph taken December 7, 1989, by Jack Slechta of A.T. Kearney.)

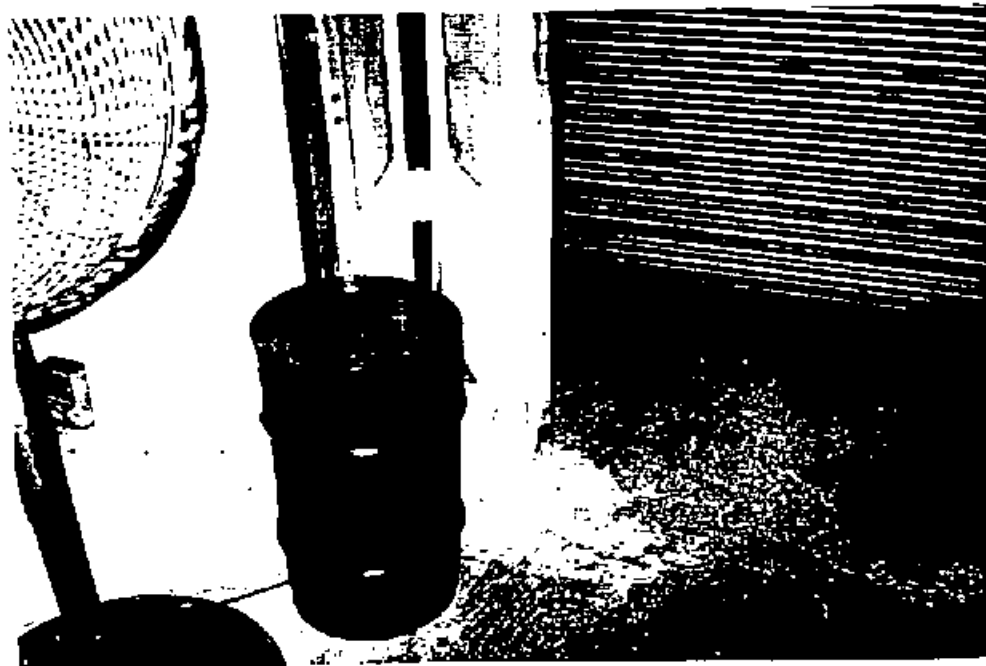
Photograph No. 2-15 Looking south at the thinner solvent drum in the Satellite Drum Accumulation Area (SWMU No. 41) in the Paint Spray Booth (SWMU No. 30) located in Building 770. (Photograph taken December 7, 1989, by Jack Slechta of A.T. Kearney.)

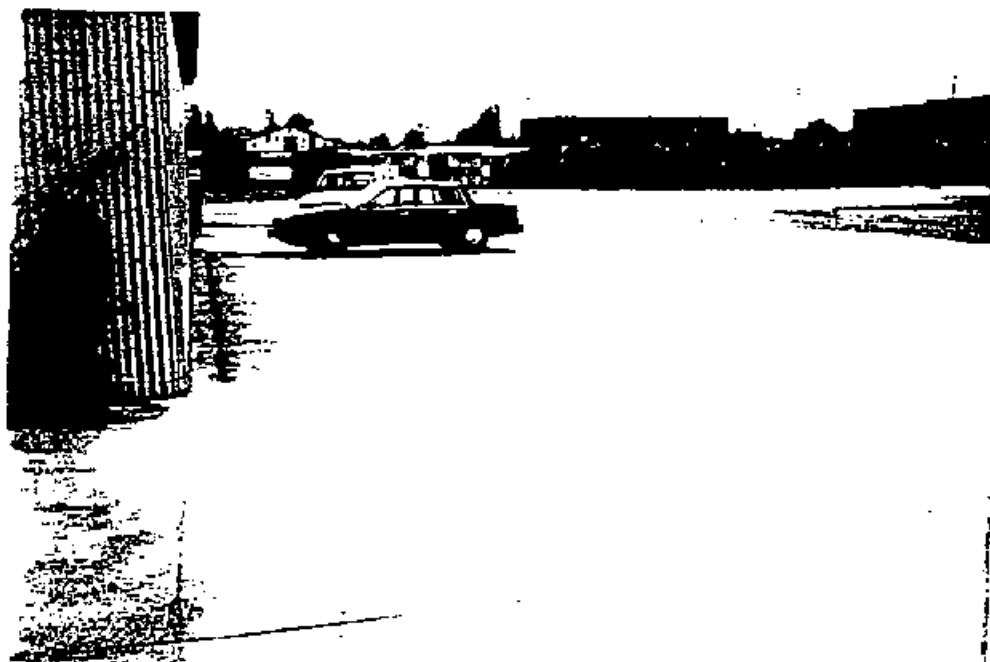
Photograph No. 2-17 Looking north at the Former PCP Dip Vat Area (SWMU No. 42). The unit was located near the middle of the photograph. (Photograph taken December 7, 1989, by Jack Slechta of A.T. Kearney.)
