LBP RISK ASSESSMENT AND SURVEY REPORTS

**LEAD-BASED PAINT SURVEY
REPORT FOR BUILDING 992 (Exterior Only)
RECREATION CENTER
FT. McCLELLAN, ALABAMA**

**LEAD-BASED PAINT SURVEY
REPORT FOR BUILDING NO. 1928, BOWLING ALLEY
FORT McCLELLAN, ALABAMA**

**LEAD-BASED PAINT SURVEY
REPORT FOR BUILDING NO. 3182, MILITARY POLICE MUSEUM
FORT McCLELLAN, ALABAMA**

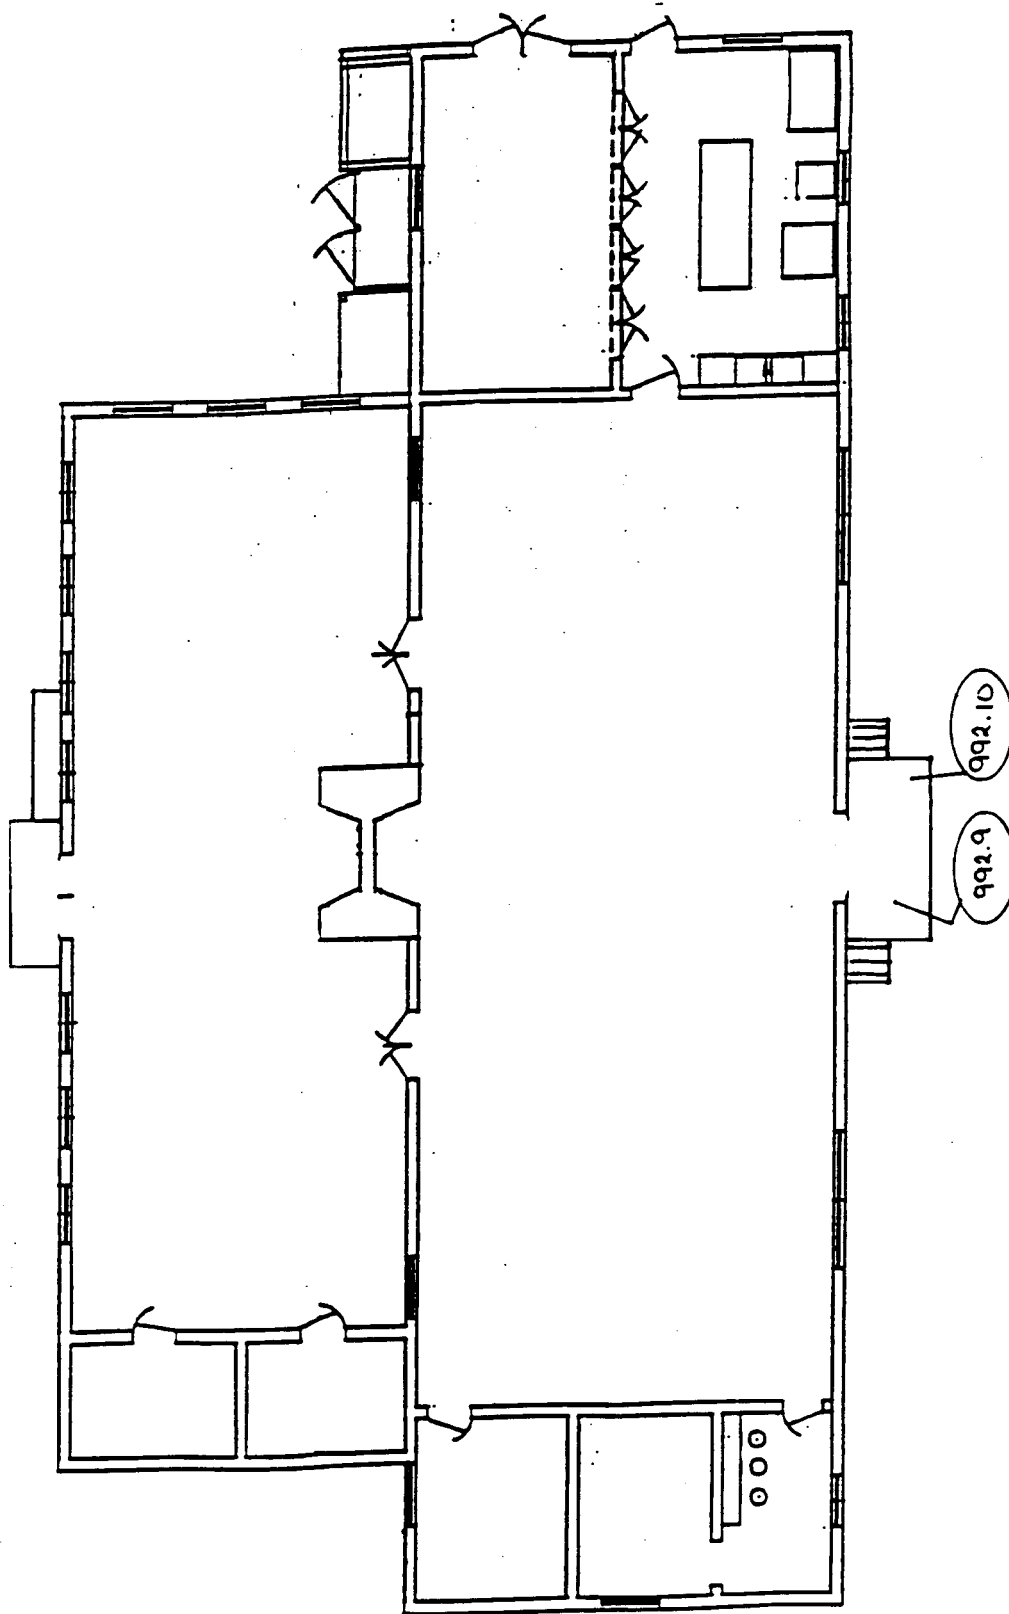
Plate No. 1

Only Locations of Positive XRF Readings (if any) Are Shown

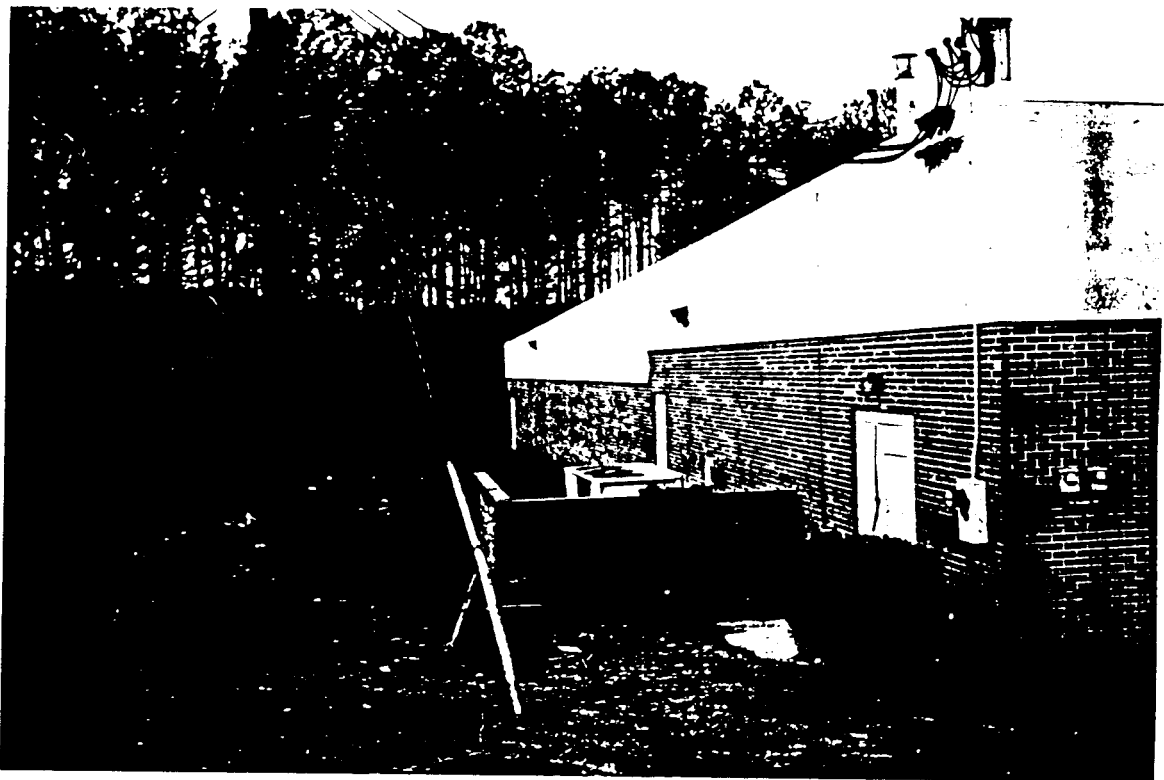
Figure 2. Rear view of Building No. 1928 (Bowling Alley)

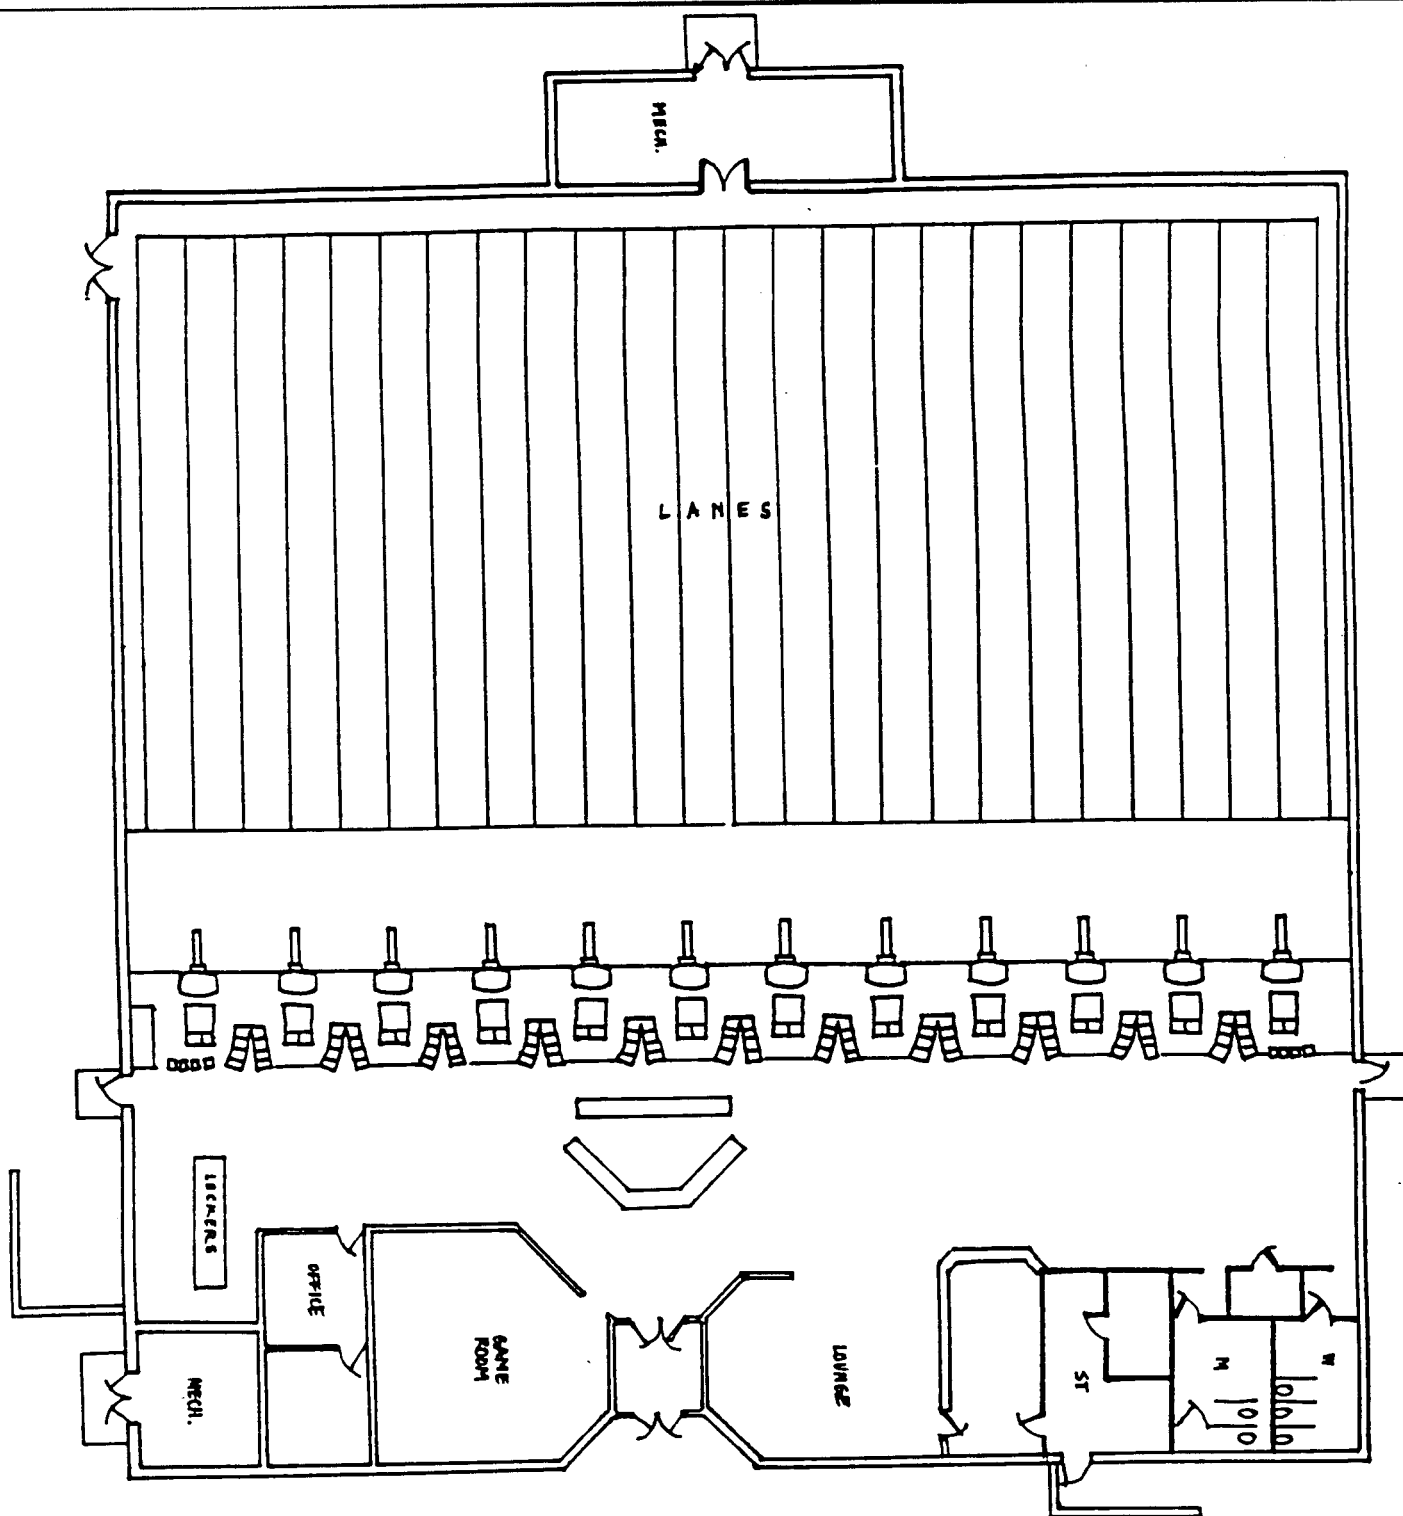
FORT MCCLELLAN, ALABAMA	
PLATE	<u>1</u>
BUILDING NUMBER	<u>1928</u>
LOCATION:	<u>21st Street</u>

NOTE: NO POSITIVE XRF READINGS

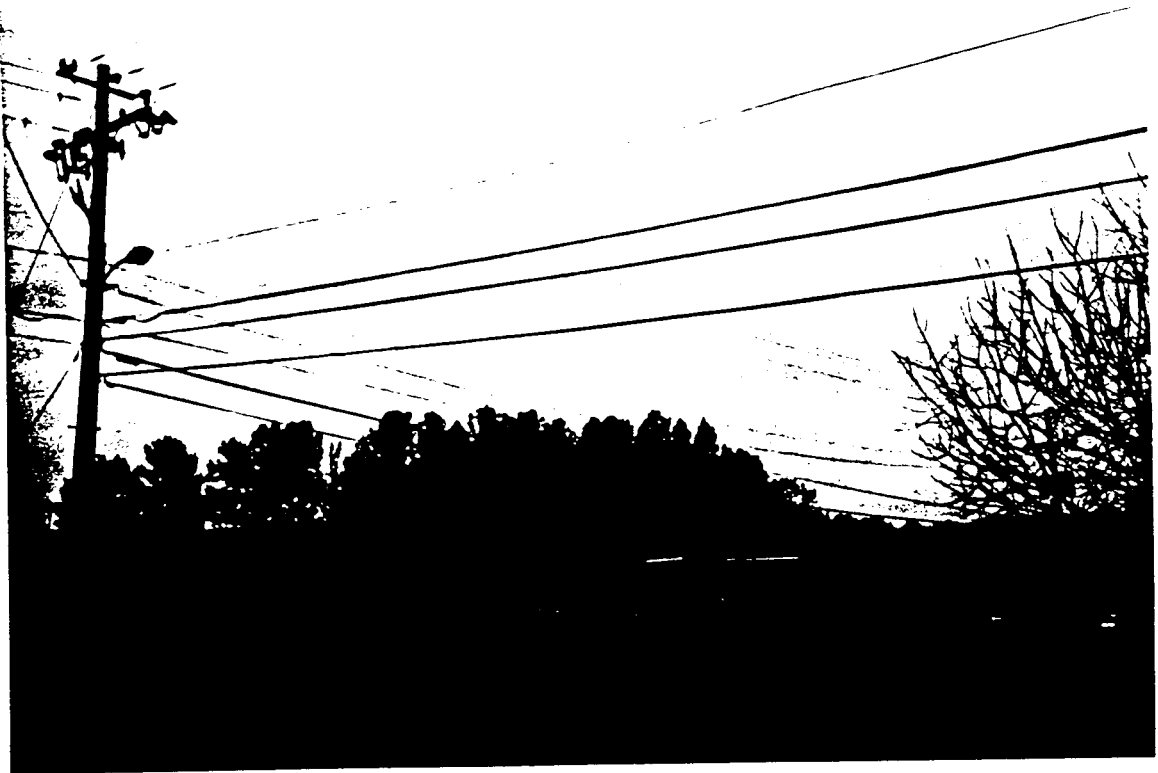
Figure 1. Front view of Building No. 3182 (Military Police Museum) at Fort McClellan, Alabama.

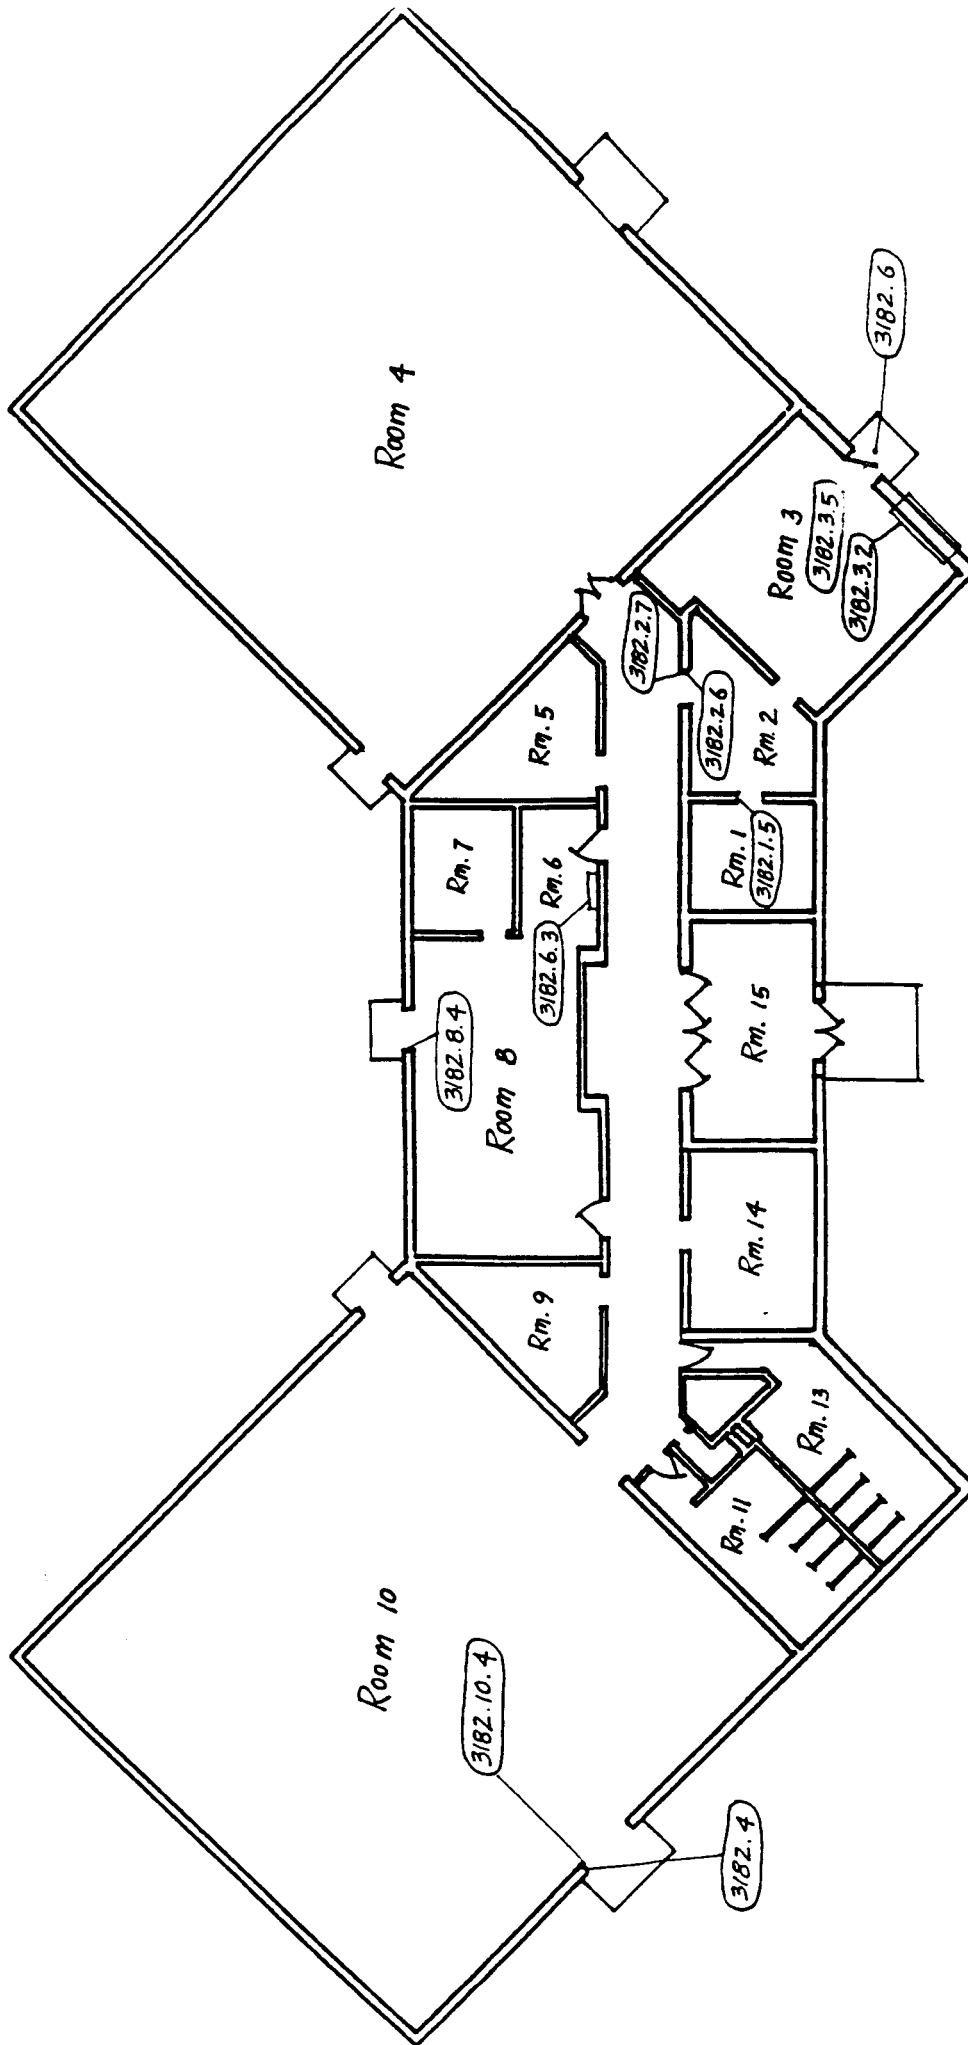
FORT MCCLELLAN, ALABAMA	
PLATE	1
BUILDING NUMBER	3182
LOCATION:	23rd Street

9. This building is an example of a unit where the XRF readings do not show any conclusive pattern. This is not unusual for an older structure where modifications and a random painting history are suspected. The interior doors, door components and metal windows should all be considered positive for leaded paint. The shelf in Room 6 (See Plate 1) next to the roll-up window also tested positive.

10. The exterior metal door frames with solid metal doors all should be considered positive for LBP. Because of the grating covering the windows, the survey team was not able to test the window frames on the exterior. Since the windows in the interior tested positive it would be reasonable to assume that they contain leaded paint on the exterior also. The brown metal awnings over the doorways also contain positive levels of LBP.

Only Locations of XRF Readings testing Positive Are Shown
