**Subject: Response to ADEMs Comments dated September 29, 2011 and Replacement Pages for the 2010 Land Use Control Effectiveness Report (LUCER) dated March 2, 2011**

# **Land Use Control Effectiveness Report - 2010**

## **McClellan Anniston, Alabama**

**March 2011**

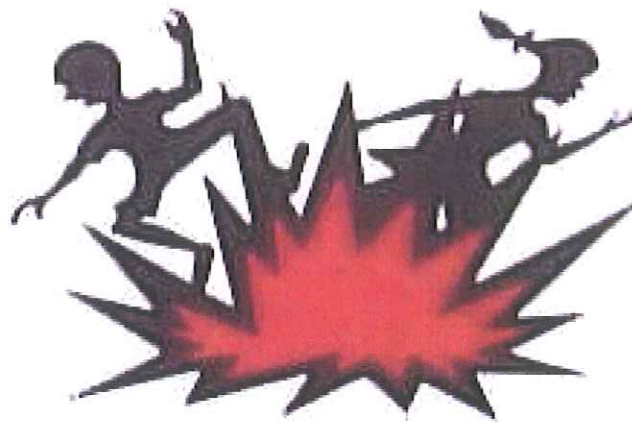
MEC warning signs (Figure 2) are installed around the perimeter of the Alpha Area and Bravo Area, and are inspected by MDA security officers on a weekly basis. Missing or damaged signs are replaced. The MDA coordinates the community outreach program with the Army. A training video explaining the dangers of MEC is mandatory for anyone performing work on McClellan. The MDA and Matrix brief all contractors conducting work in these areas at McClellan on the possibility of encountering MEC, and describe emergency procedures to implement should MEC be encountered.

Another LUC violation is warning sign theft. Warning signs are inspected by MDA security officers on a weekly basis. Missing or damaged signs are replaced.
