Appendix B

Landfill Cap Inspection Checklist Items for Landfill 1, Landfill 2, Landfill 4, and Garbage Dump and Fill Area East of Reilly

Specific Site Identification: Ft McClellan Landfill 1 Date: October 21, 2010

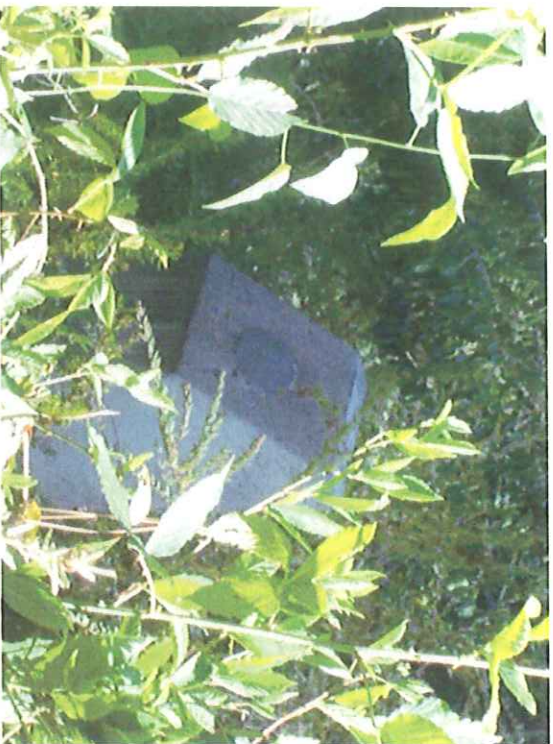
- ☒ Monument 1, Comments: Good Condition, no damage.
- ☒ Monument 2, Comments: Good Condition, no damage..
- ☒ Monument 3, Comments: Good Condition, no damage.
- ☒ Monument 4, Comments: Good Condition, no damage.
- ☒ Monument 5, Comments: Good Condition, no damage.
- ☒ Monument 6, Comments: Good Condition, no damage.
- ☒ Monument 7, Comments: Monument is rotated 180° from proper orientation.
- ☒ Monument 8, Comments: Good Condition, no damage.

The monuments showed no signs of damage or vandalism.

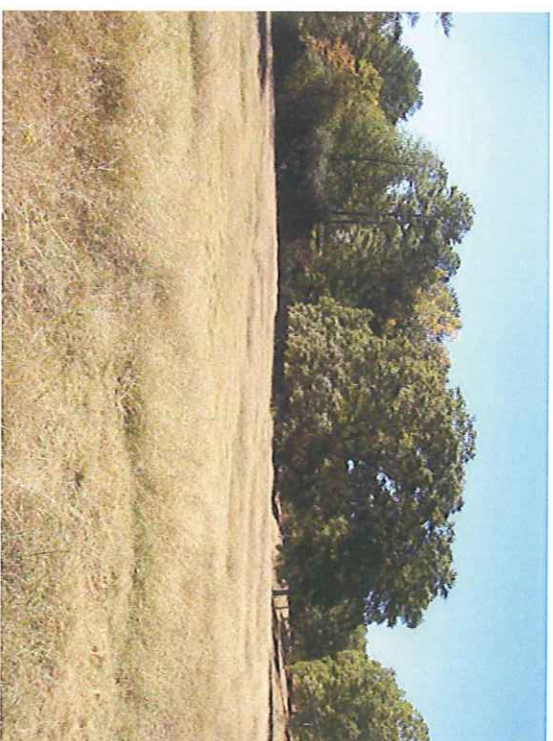
Vegetation cover across the landfill was thick and healthy. No areas of abnormal growth were observed. No patches of uncovered soil were observed during the inspection.

Vegetation covered the landfill cap surface.

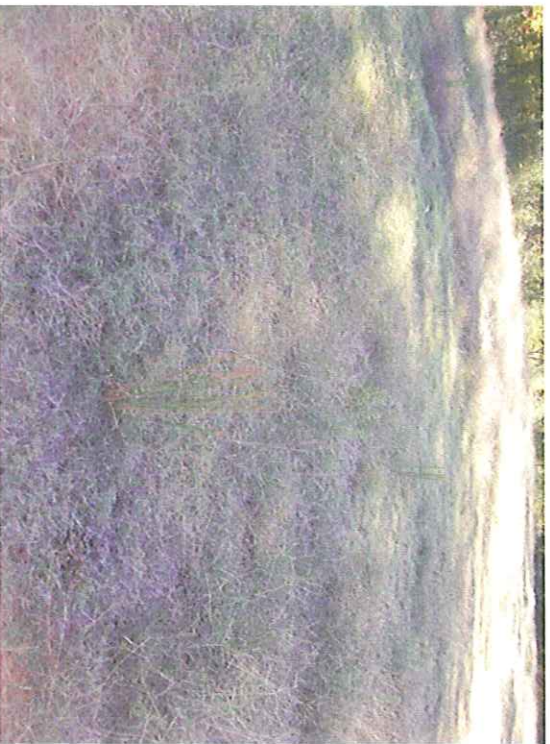
No patches of abnormal growth were observed.

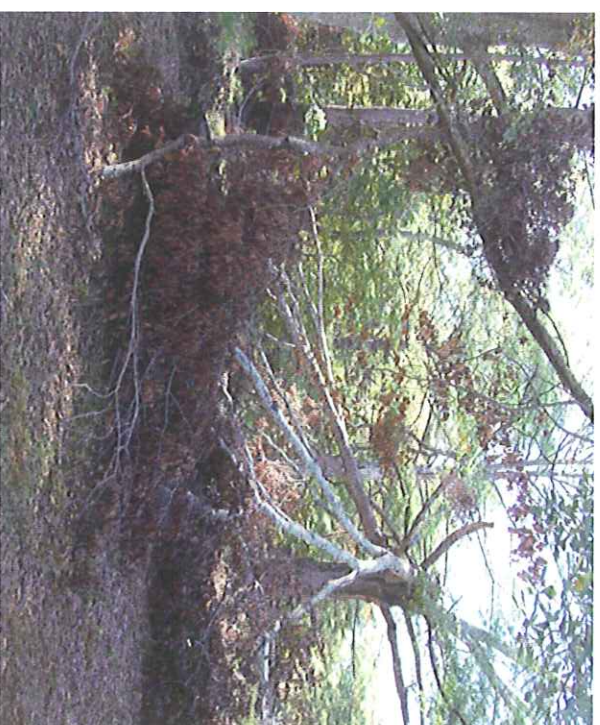
No visible signs of erosion or exposed debris were observed during the cap inspection. An oak tree in the center of the landfill had died and had been topped by the wind. (See photo log). The rootball was not exposed and the fallen branches did not penetrate the cap surface.

An old oak tree in the center of Landfill 1 died and broke in half; root ball was not exposed and cap surface not damaged.

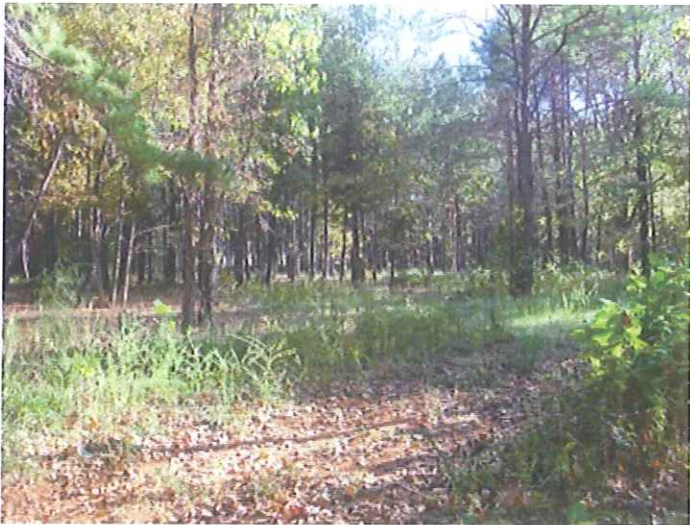
The cap surface is covered with vegetation and fallen leaves.

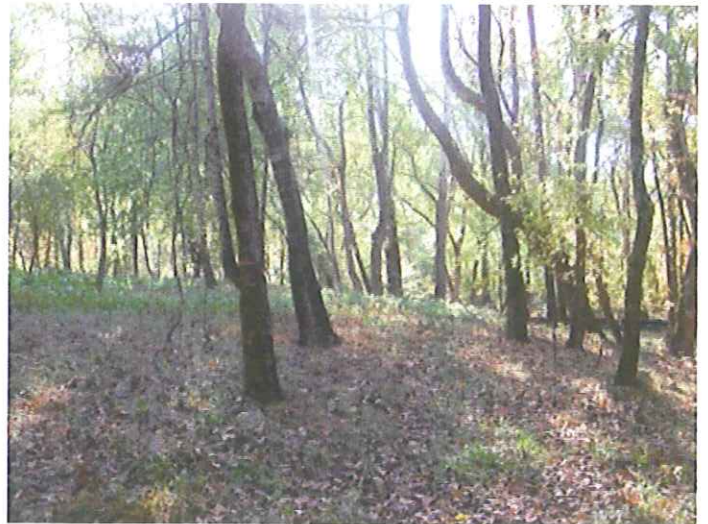
No signs of erosion were observed during the inspection.

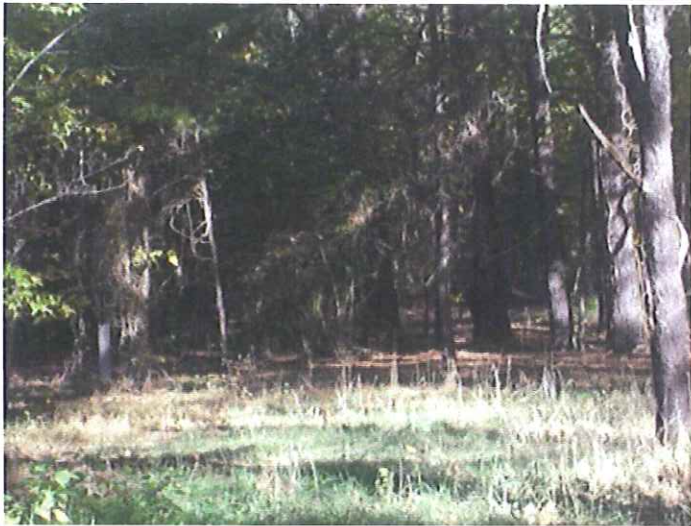
The cap appeared to be in good condition.

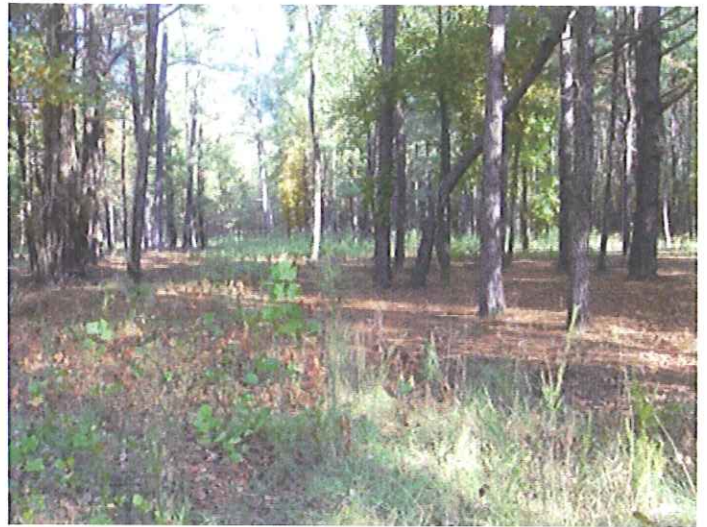
No signs of washout or erosion were observed.

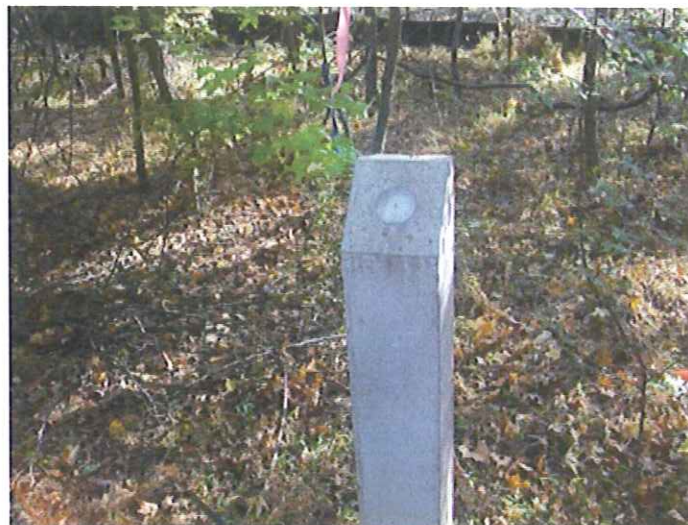
The boundary markers were in good condition.

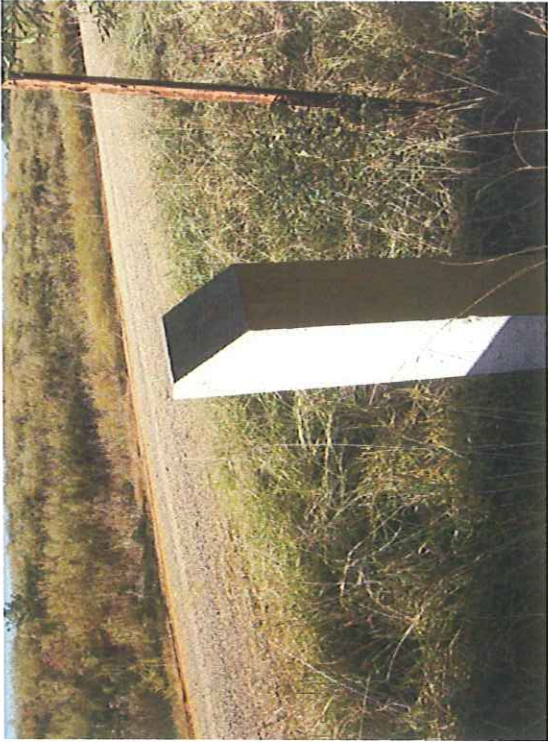
The monuments across the landfill were in good condition.

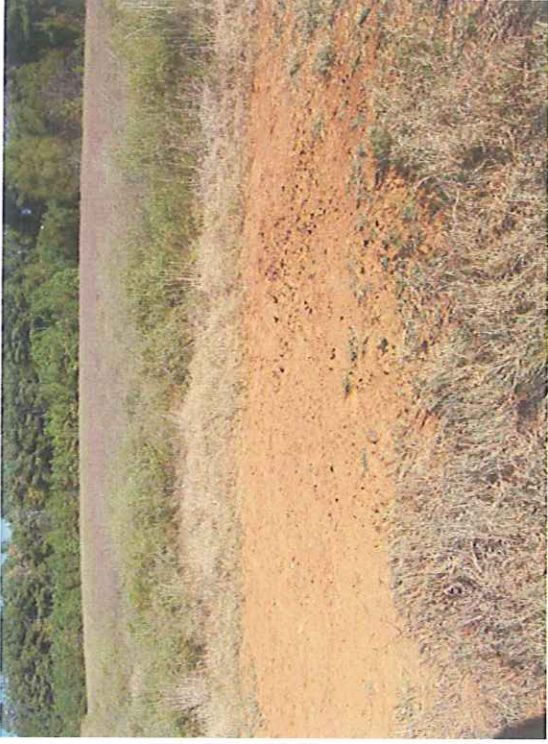
Two areas, both approximately 12-feet by 12-feet, were observed in the northeast corner of the landfill. (See attached photos and map.) The areas were void of vegetation and appeared to be covered with deer hoof prints. No abnormal growth of weeds was observed.

First area in the northeast corner of the landfill void of vegetation.

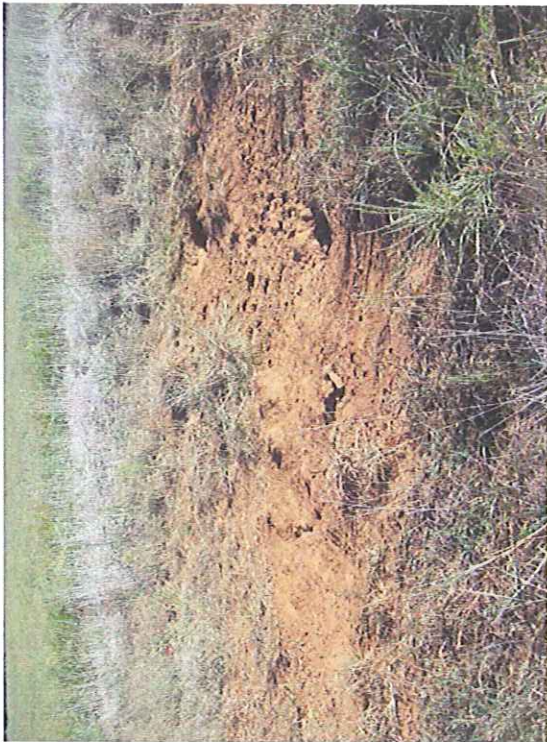
Second area in the northeast corner of the landfill void of vegetation and full of deer hoof prints.

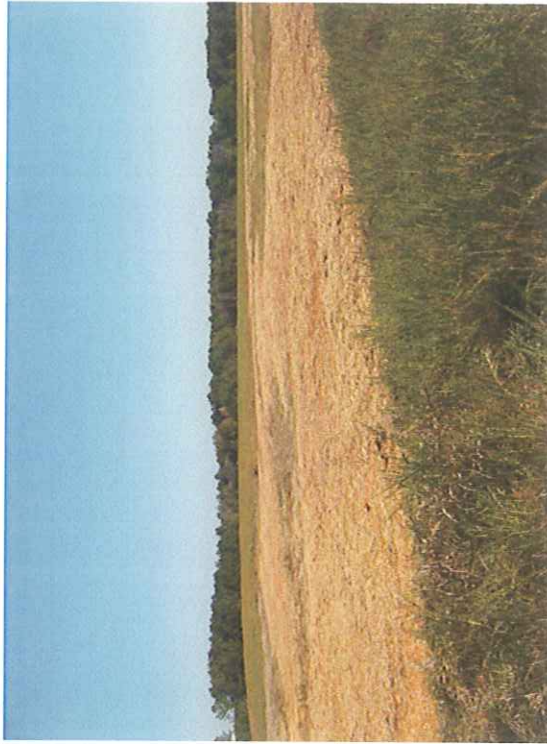
Area along the western perimeter of the landfill repaired, seeded, and mulched to allow for positive drainage.

Low areas along the western edge of the landfill were repaired in September 2010. Fill material was brought in from the Borrow Area to allow for positive drainage and the disturbed area was seeded and mulched.

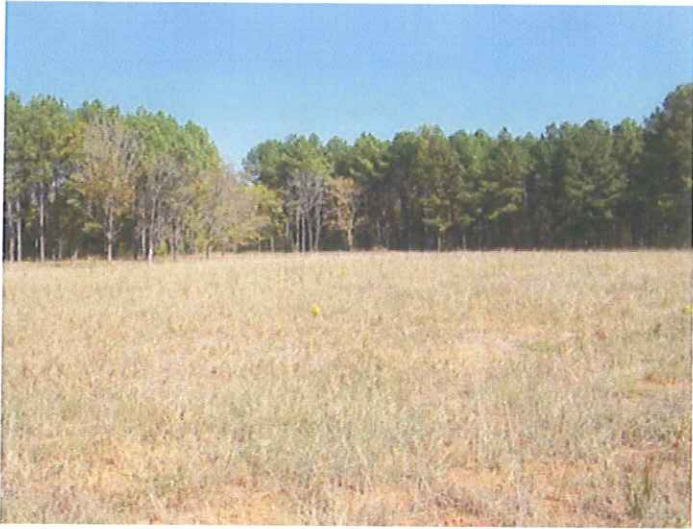
No abnormal growth of weeds or grasses were observed during the cap inspection.

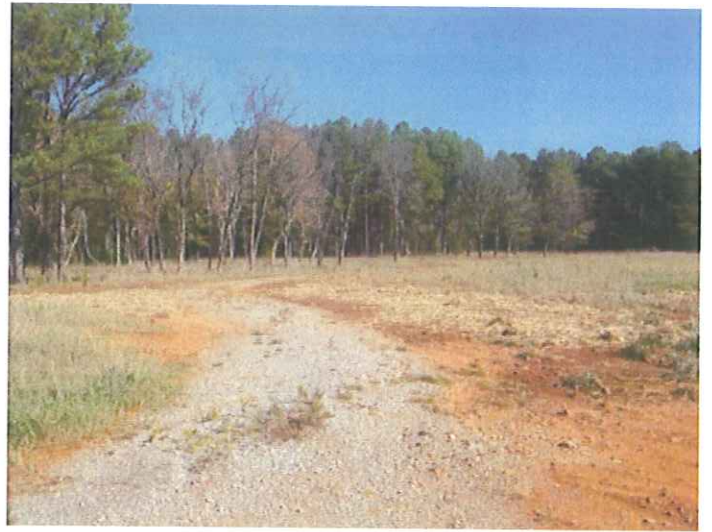
The area on the western edge, underneath the trees, with limited vegetation was seeded and mulched.

The areas with limited vegetation, located on the western perimeter near the entrance to the Garbage Dump, were covered with a layer of topsoil, seeded, and mulched with wheat straw. There were no areas of abnormal growth observed.

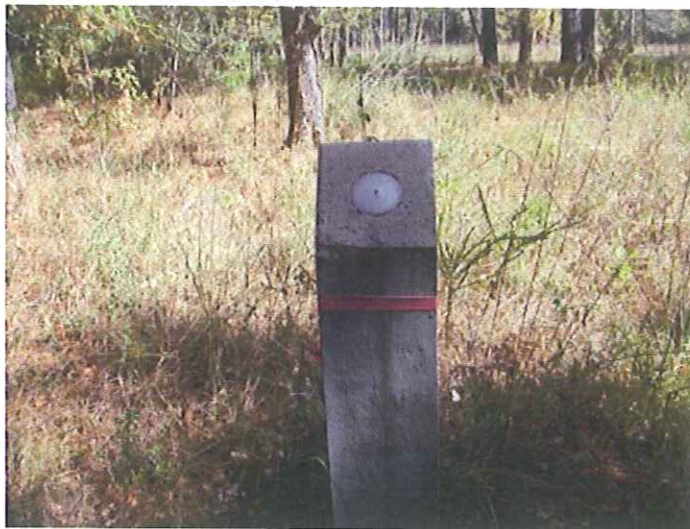
The boundary markers were all in good condition.
