August 3, 2020

SUBJECT: Amended Well Abandonment Report for Iron Mountain Road Ranges, Former
Fort McClellan, Anniston, Alabama

Subject: Abandonment of monitoring wells for the Iron Mountain Road Ranges (IMRRs), Parcels 69Q, 71Q, and 75Q, soil remediation site - Amended

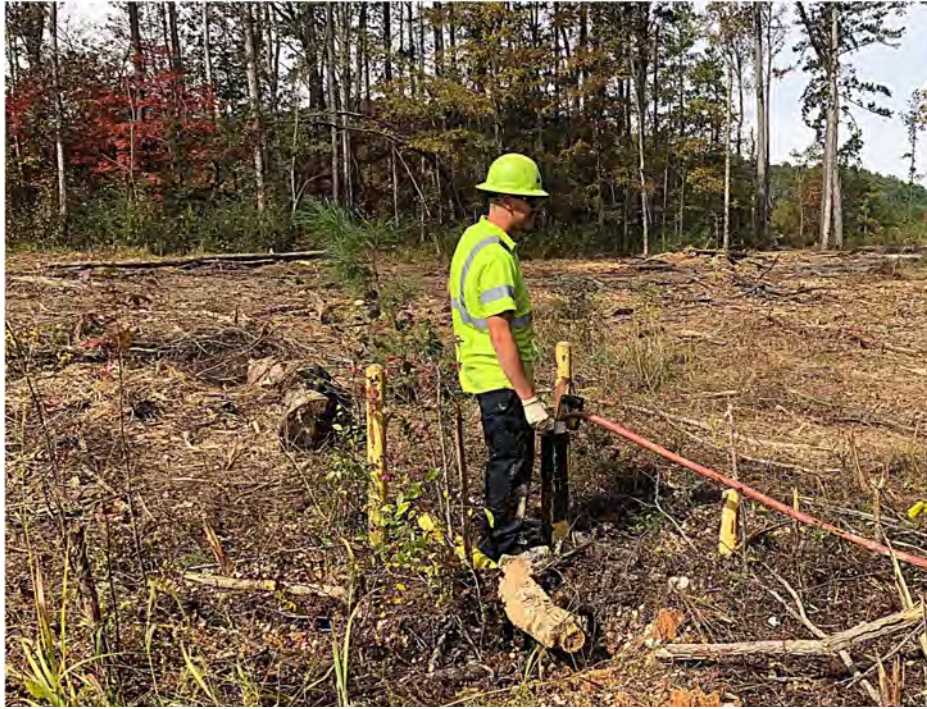
Photograph 1 - Monitoring well HR-69Q-MW01 being grouted in-place from the bottom to top via the positive displacement method (tremie grouting).

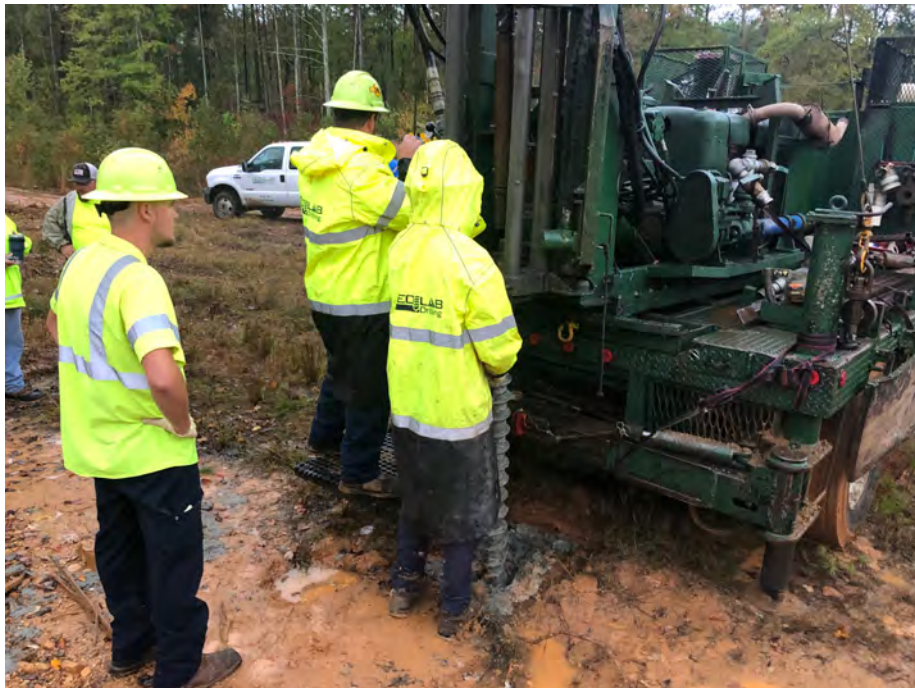
Photograph 2 - Monitoring well HR-69Q-MW01 being over-drilled using hollow stem augers to the full depth of the well to remove well screen and casing

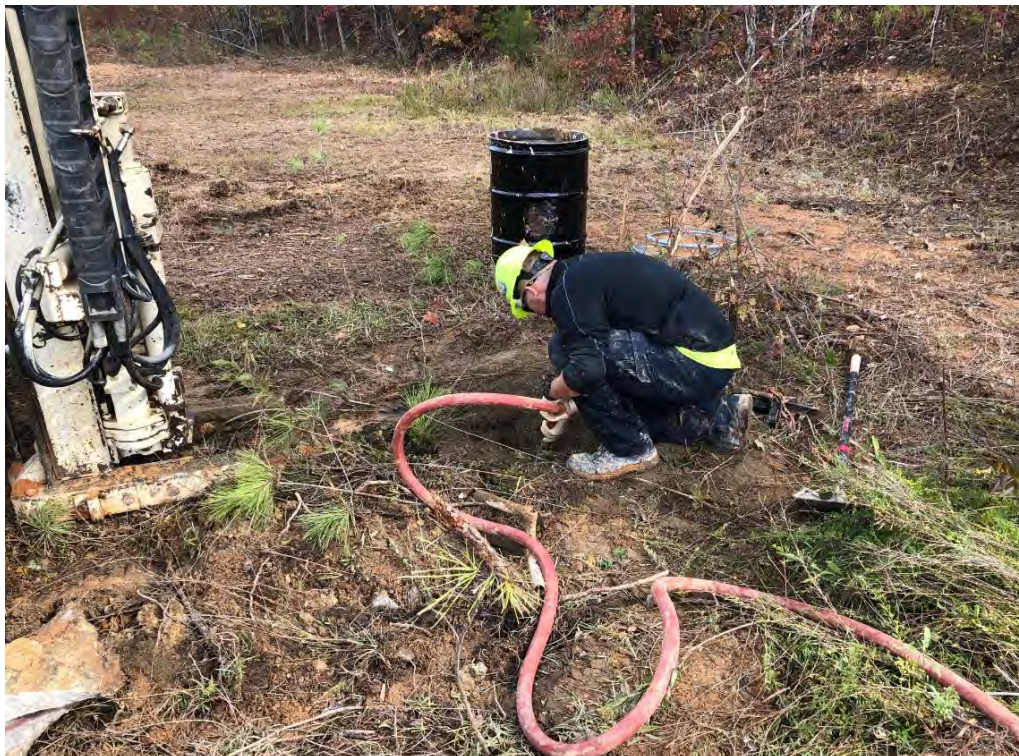
Photograph 3 - View of well being grouted to surface after overdrilling.

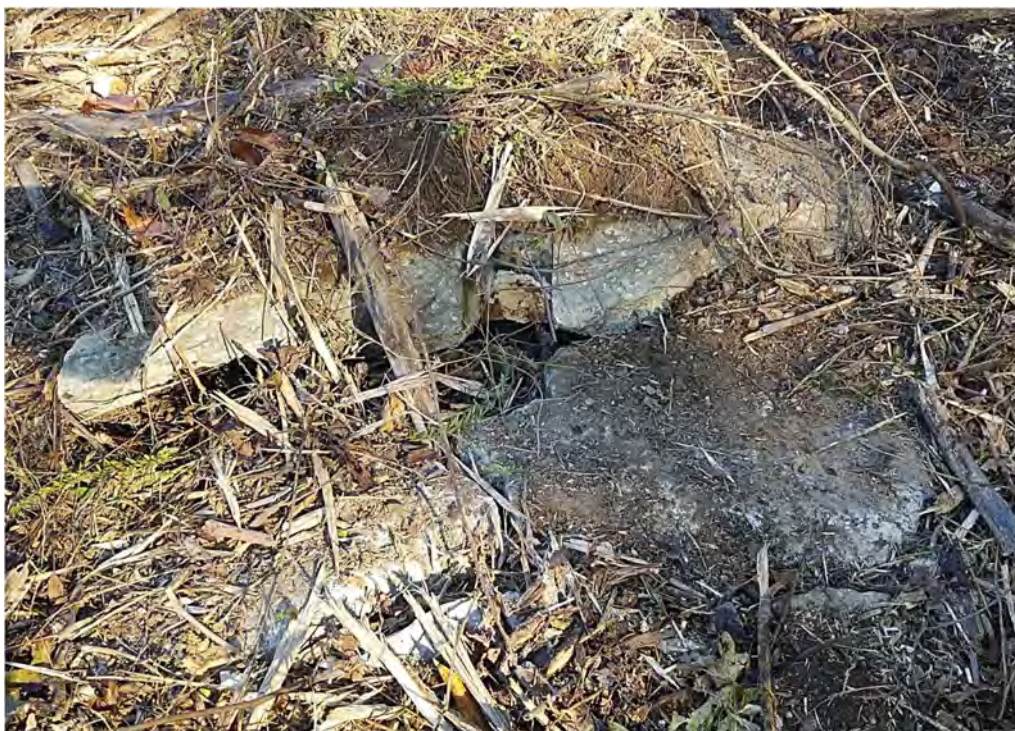
The sixth well, bedrock well HR-69Q-MW02, was destroyed by others prior to abandonment. The stick-up casing and bollards were missing. The well pad was broken and buried. In October 2019, the buried concrete pad and steel casing was excavated to expose the well remnants. During this initial attempt at abandonment, it was observed that the steel casing was damaged and the well was blocked so that the hollow stem auger could not be advanced within the steel casing more than a few feet, so the steel well casing was cut off and removed to approximately four feet below ground surface and the top foot of the well was sealed with cement/bentonite.

Photograph 4 - Condition of deep bedrock well HR-69Q-MW02 prior to abandonment activity (destroyed by others prior to abandonment).

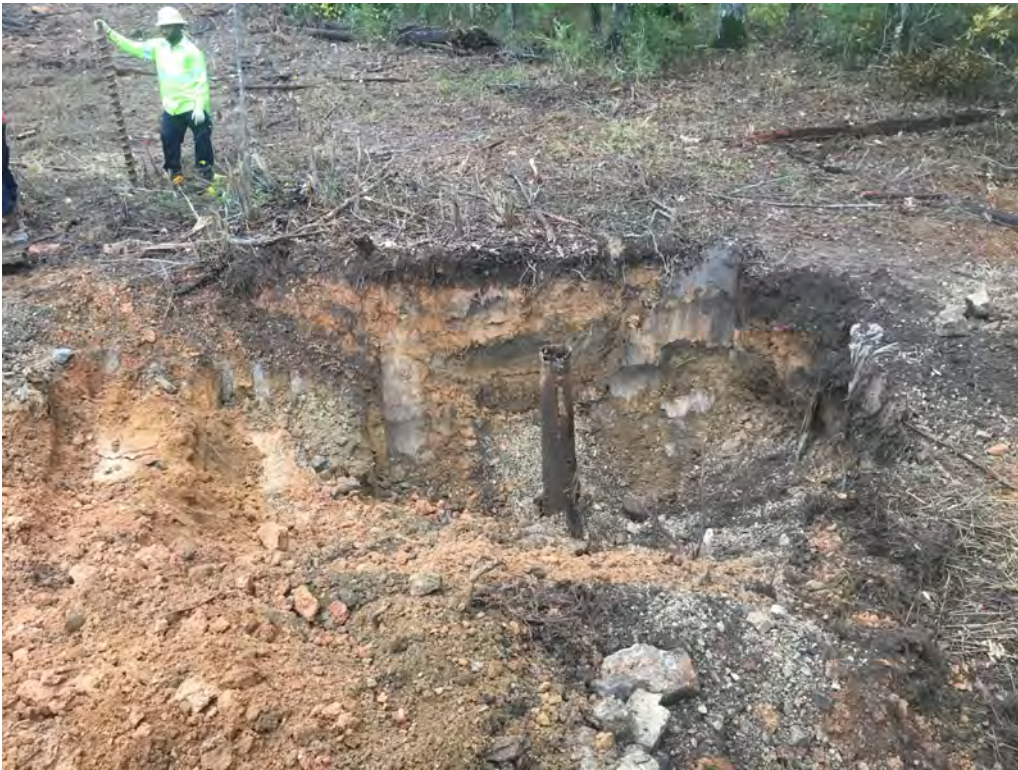
Photograph 5 - First attempt to abandon HR-69Q-MW02. Inner casing plugged to greater than 4.5 feet below ground surface.

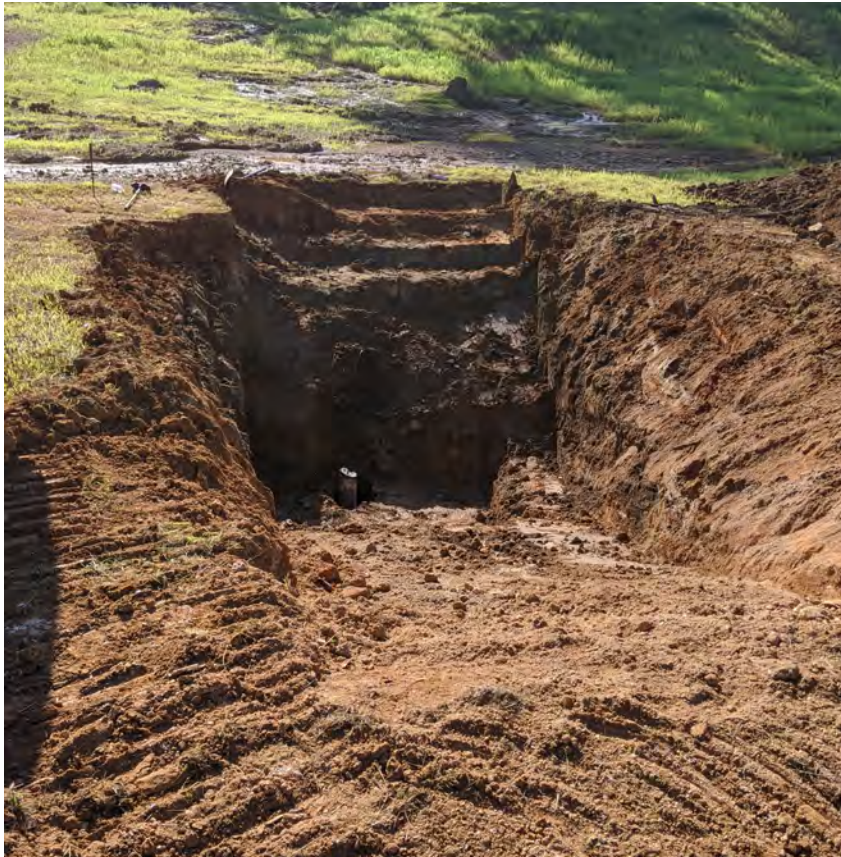
The area around the bedrock well HR-69Q-MW02 was excavated to a depth approximately eight feet below ground surface (bgs) to expose the top four feet of the remnants of the steel casing and previously placed cement/bentonite plug. The excavation was benched and sloped to allow workers to safely enter the excavation to perform abandonment activities. The cement/bentonite plug previously placed on the well in October 2019 was removed and the steel casing was cut off with a torch and removed. The well was then unplugged of mud and debris manually and confirmed to be clear to depth. Bentonite chips were then gravity fed into the well followed by fresh clean water. After a period of time to allow the bentonite chips to absorb the water, a 20% solids pumpable bentonite grout (Quik-Grout®) was mixed and slowly gravity fed into the well, until the well was completely filled to the top. Additional Quik-Grout® was added as the level dropped until there was no more grout settlement. The top two feet of the well was sealed with cement/bentonite and the well area was backfilled and graded.

Photograph 6 - Second attempt to abandon HR-69Q-MW02. Outer casing cut off and inner casing cleared at about 9 feet below ground surface.

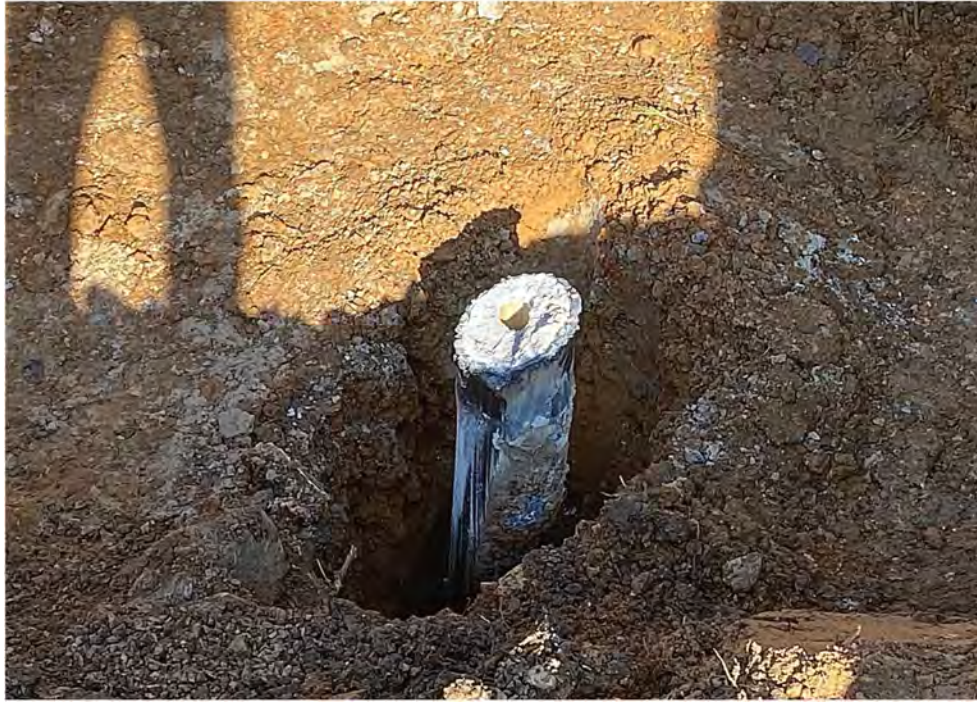
Photograph 7 - Bedrock well HR-69Q-MW02 after excavating, cutting casing, removal of mud and debris manually.

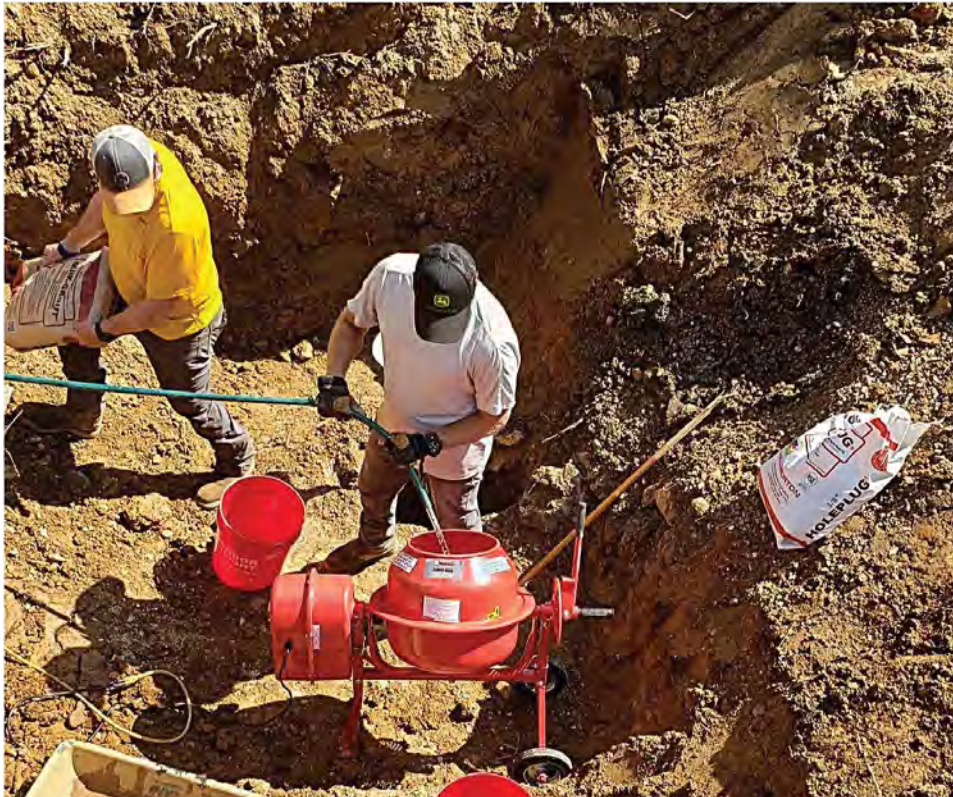
Photograph 8 - Preparing to Abandon bedrock well HR-69Q-MW02 with bentonite Quik Grout.

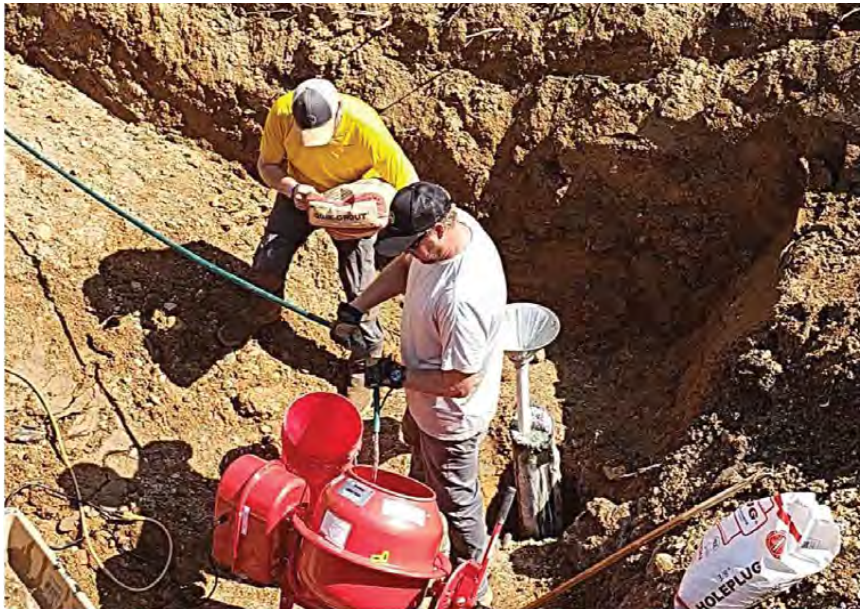
Photograph 9 - Gravity feeding well sealing materials into bedrock well HR-69Q-MW02.

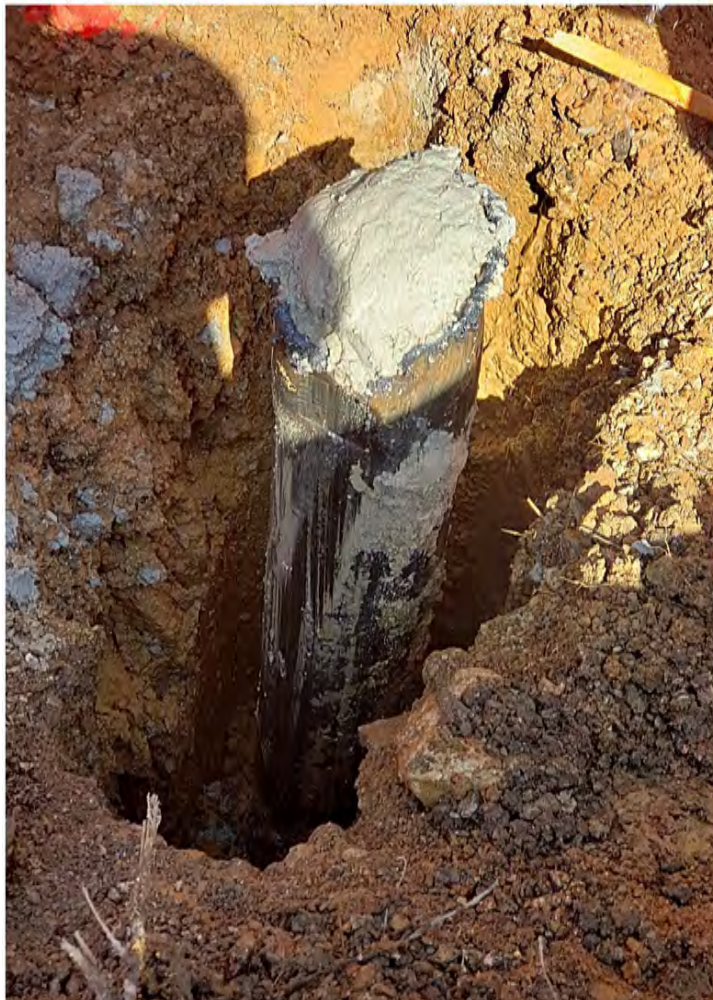
Photograph 10 - Bedrock well HR-69Q-MW02 after sealing with cement/bentonite.

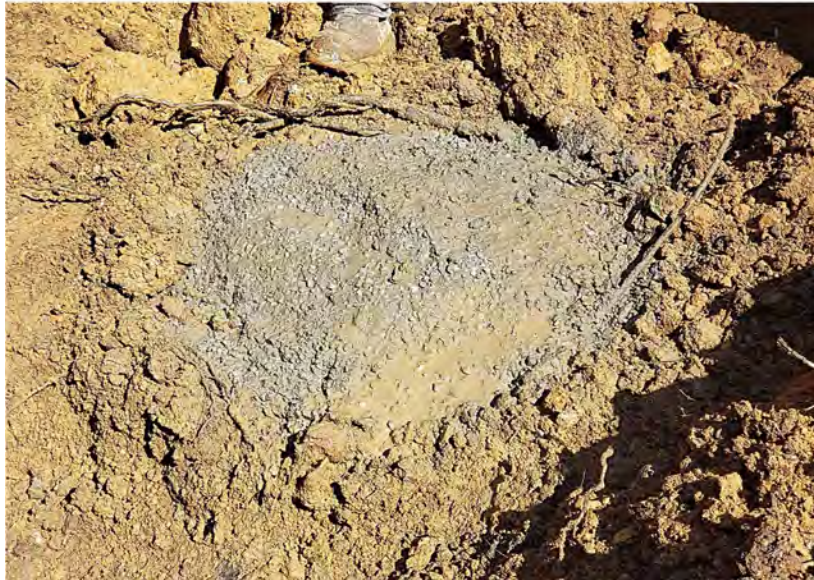
Photograph 11 - Bedrock well HR-69Q-MW02 finished by grouting flush to the ground surface with cement/bentonite.
