SUBJECT: Annual Landfill Cap Inspection Results
Landfill 1, Parcel 78(6)
Former Fort McClellan, Anniston, Alabama

ANNUAL LANDFILL CAP INSPECTION RESULTS

Site: McClellan Landfill 1, Parcel 78(6)

Date: December 13, 2007

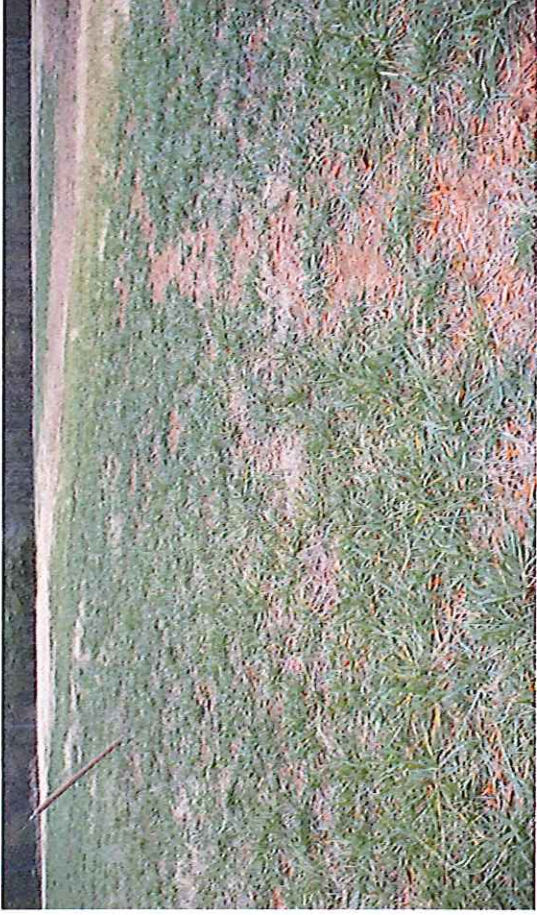
Picture 1 Repairs in area damaged during monument installation.

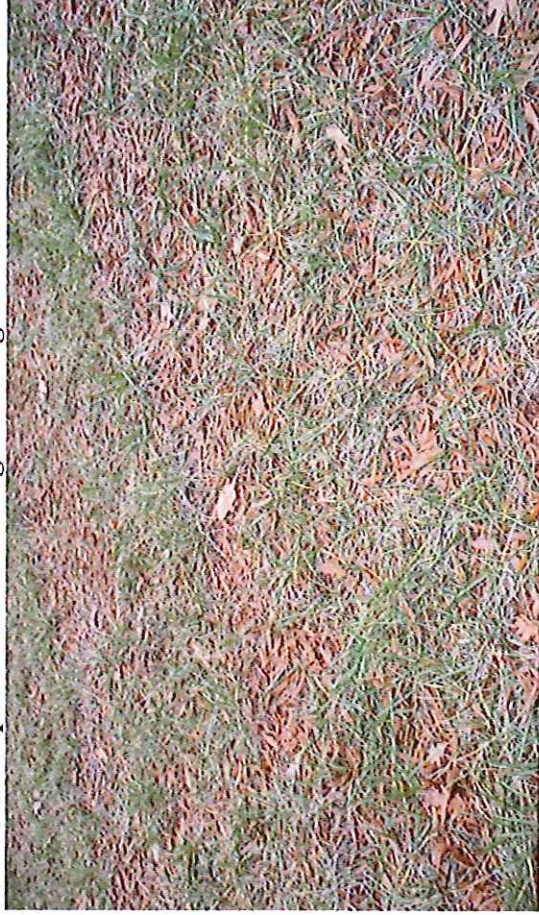
Picture 3. Close up of repaired area.

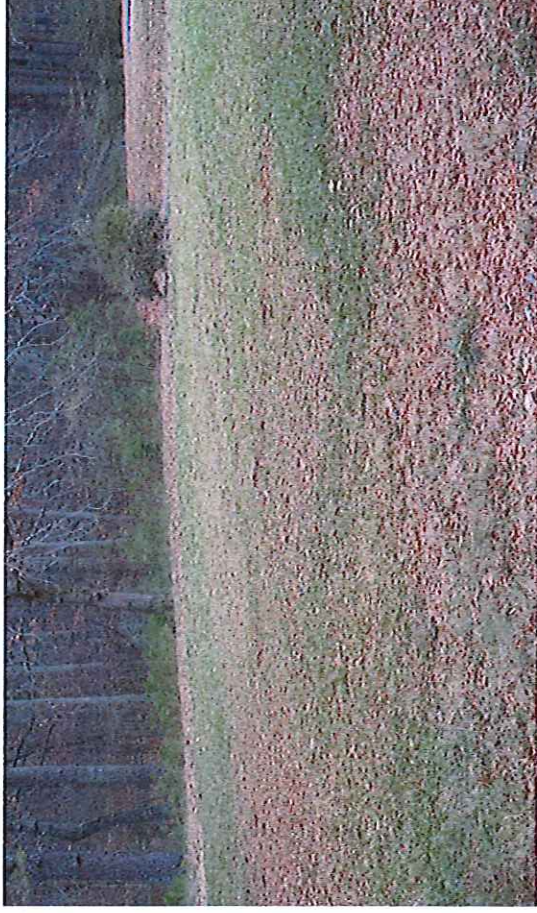
Picture 2 Growth after area repaired from installation.

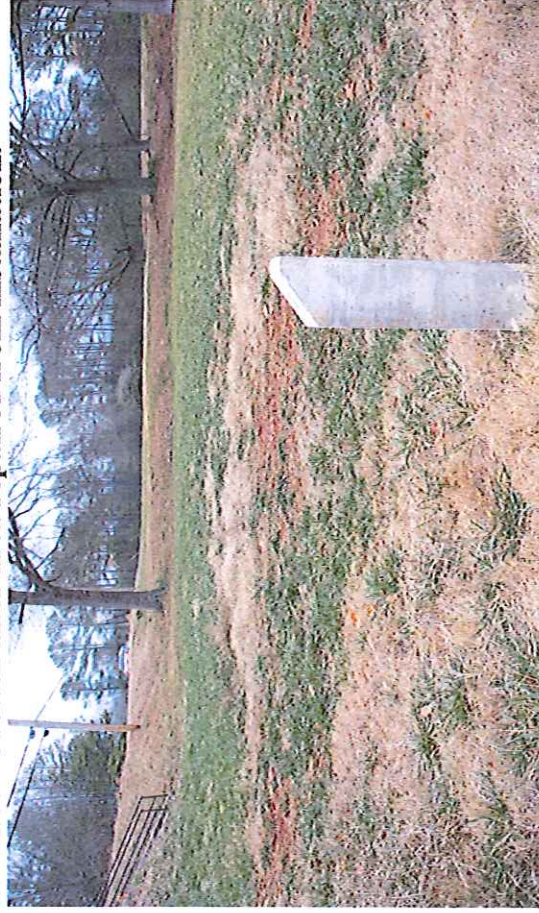
Picture 4 Looking at Monument 3.

Monument 3, Comments: Present and in good condition.

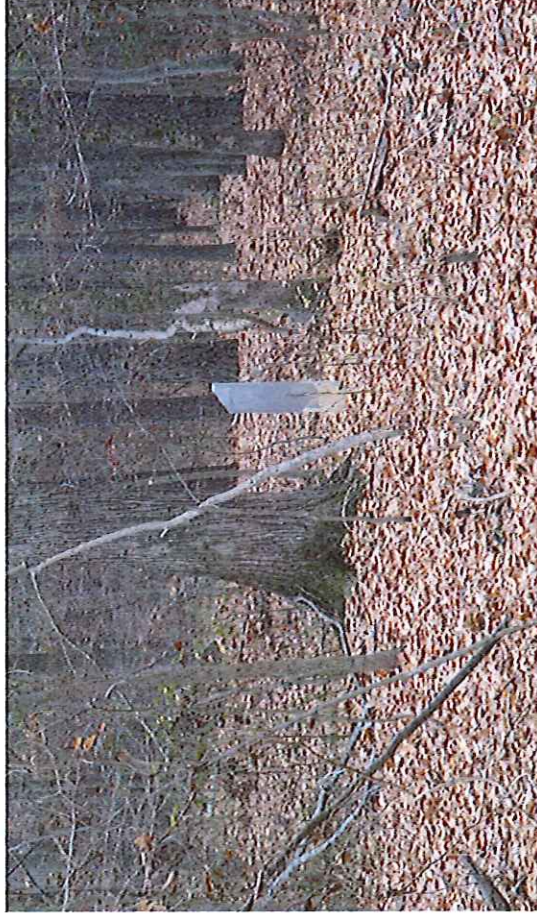
Picture 5. Monument 2.

Monument 2, Comments: Present and in good condition.

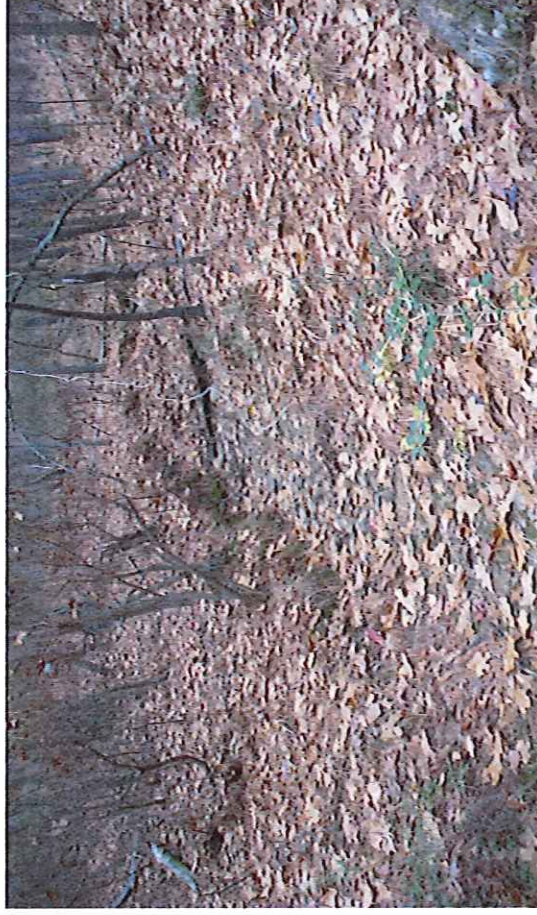
Picture 6. Drainage stream showing no sediment.

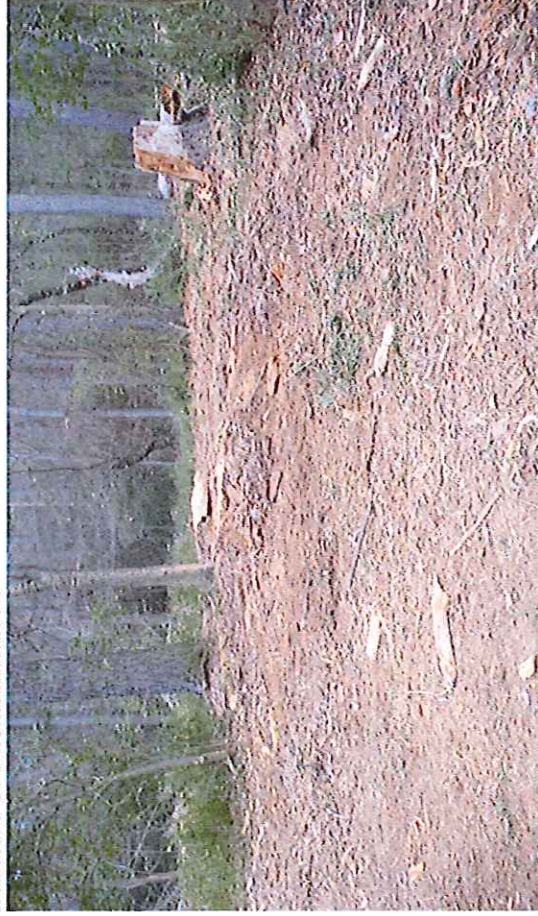
Picture 7. Dead Tree Removal Area.

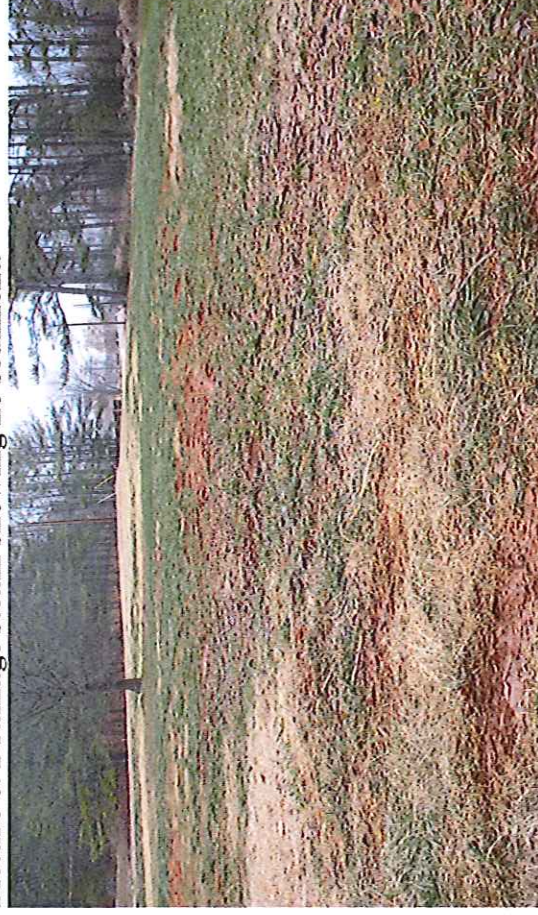
A small area on the northern eastern berm of the cap requires revegetation (see Photo Log section). The area was disturbed when dead trees were removed.

Picture 8. Area disturbed by tree removal activities.

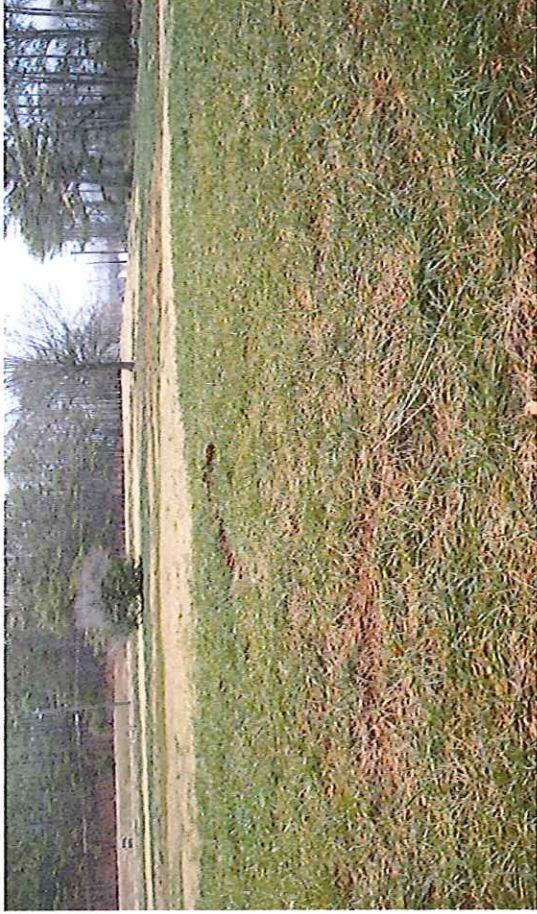
Picture 9. Overall area disturbed by tree removal.

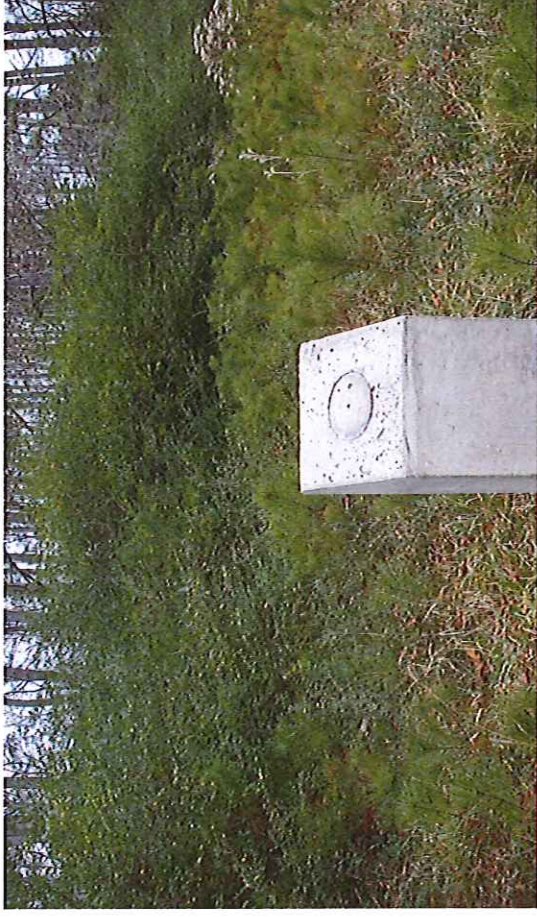
Picture 10. Monument 8 looking up slope.

Monument 8, Comments: Present and in good condition.

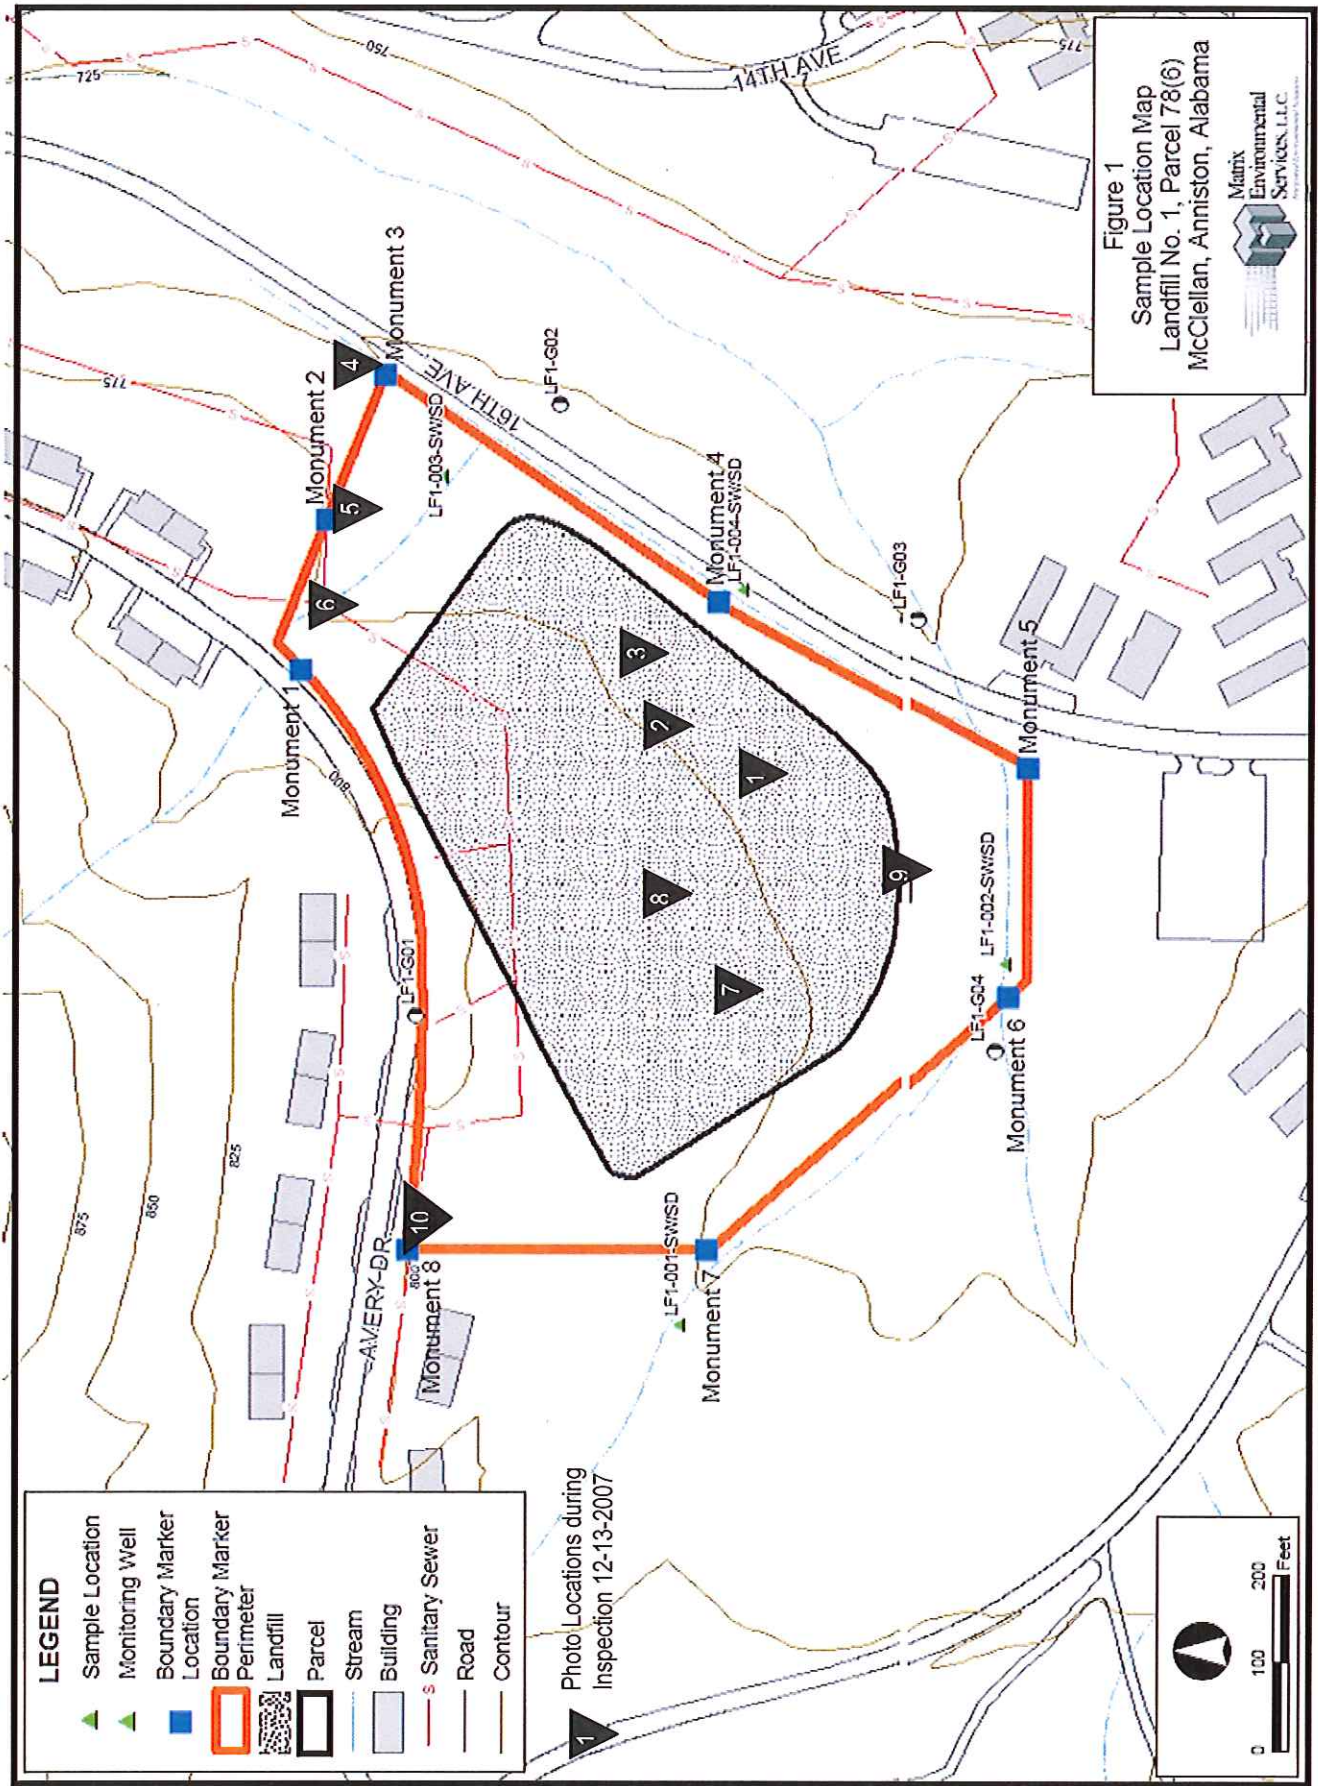
In February 2007, eight monuments were installed to mark the perimeter of Landfill 1 in the locations shown on figure 1.
