**FINAL
MAINTENANCE OF EROSION CONTROL FEATURES AND
VEGETATION LETTER REPORT OF ACTIVITIES,
YEAR 4, EVENT 1**

**FORMER 81MM MORTAR RANGE, BAINS GAP ROAD
RANGES, FORMER CHOCCOLOCCO CORRIDOR
RANGES, AND RANGES NEAR TRAINING AREA T-24A**

**ENVIRONMENTAL REMEDIATION SERVICES AT FOUR
SITES, FORT MCCLELLAN, ANNISTON, ALABAMA**

February 2019

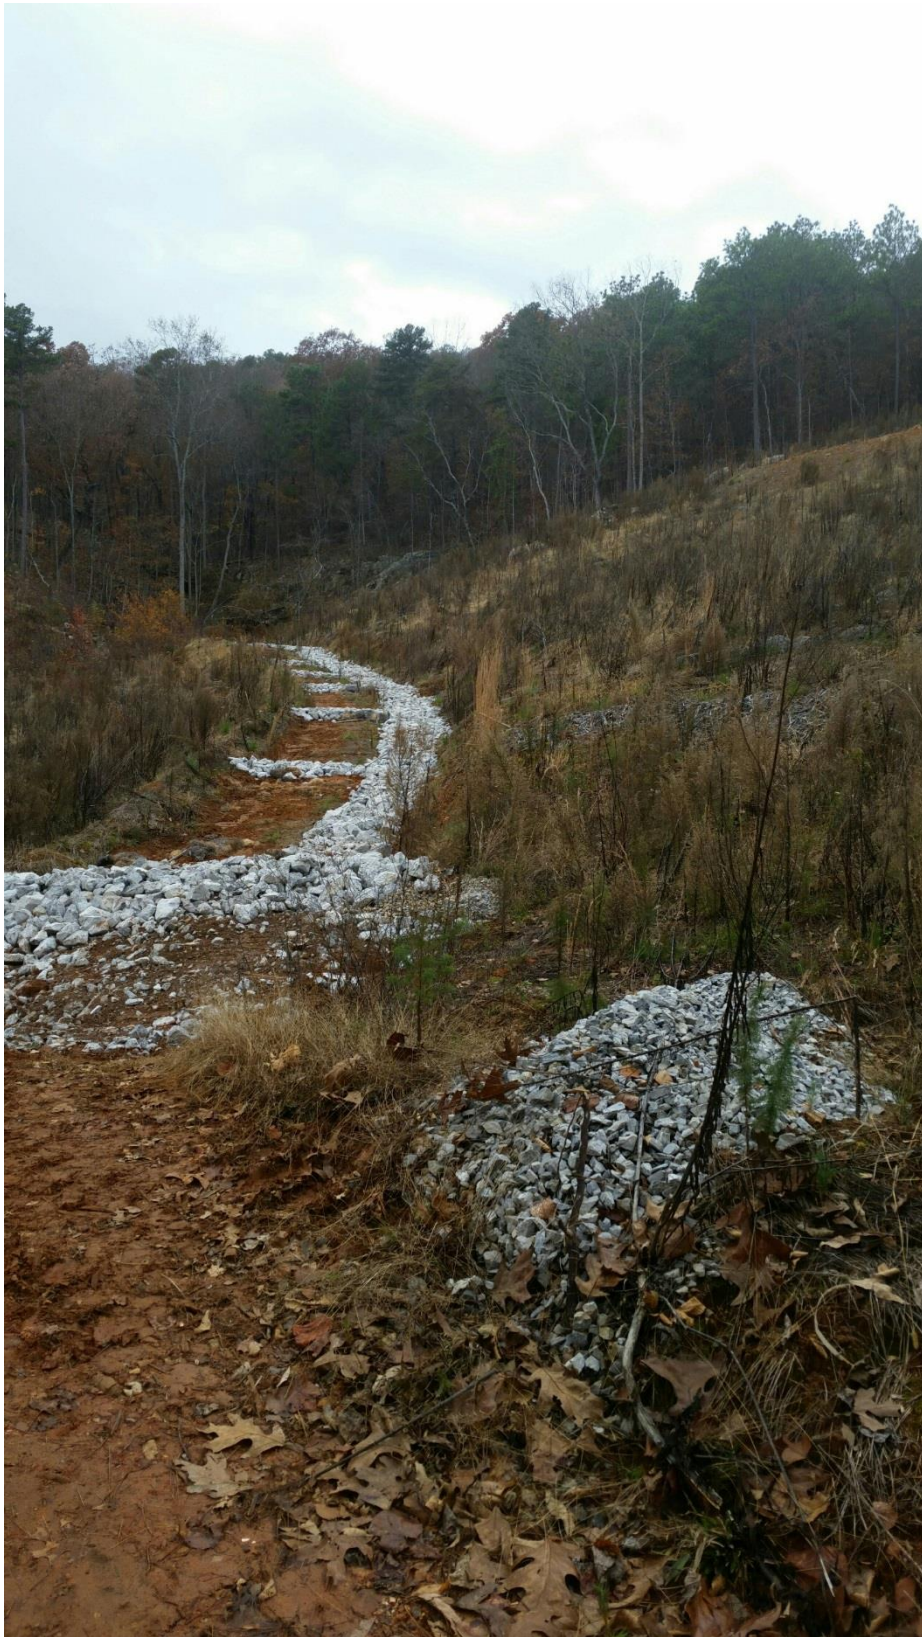
CCR – Repairs at Temporary Road Near Areas 1 and 2

- Repaired two areas of surface erosion along two abandoned temporary roads cut into Area 1/3 by rock armoring the existing gully, providing rock rows perpendicular to the flow at approximately 25-foot intervals, constructing a small rock wall at the bottom of the gully to trap sediment, and knocking down the existing berms to allow water kickout.

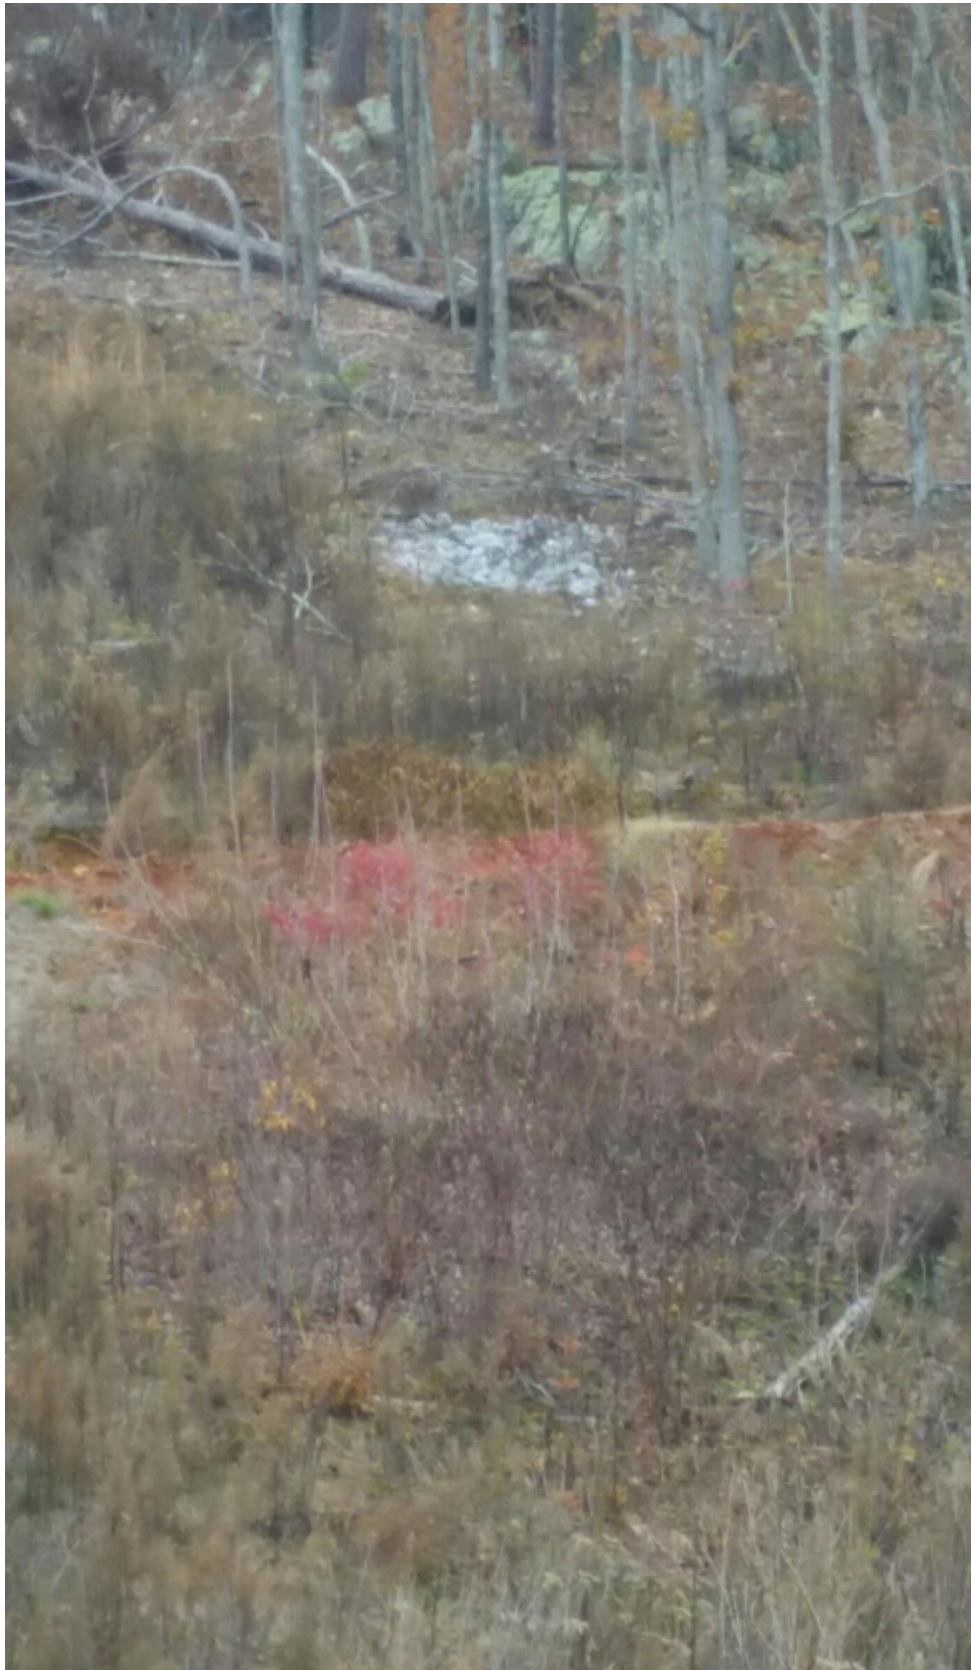
CCR – Riprap on Area 2 Slope

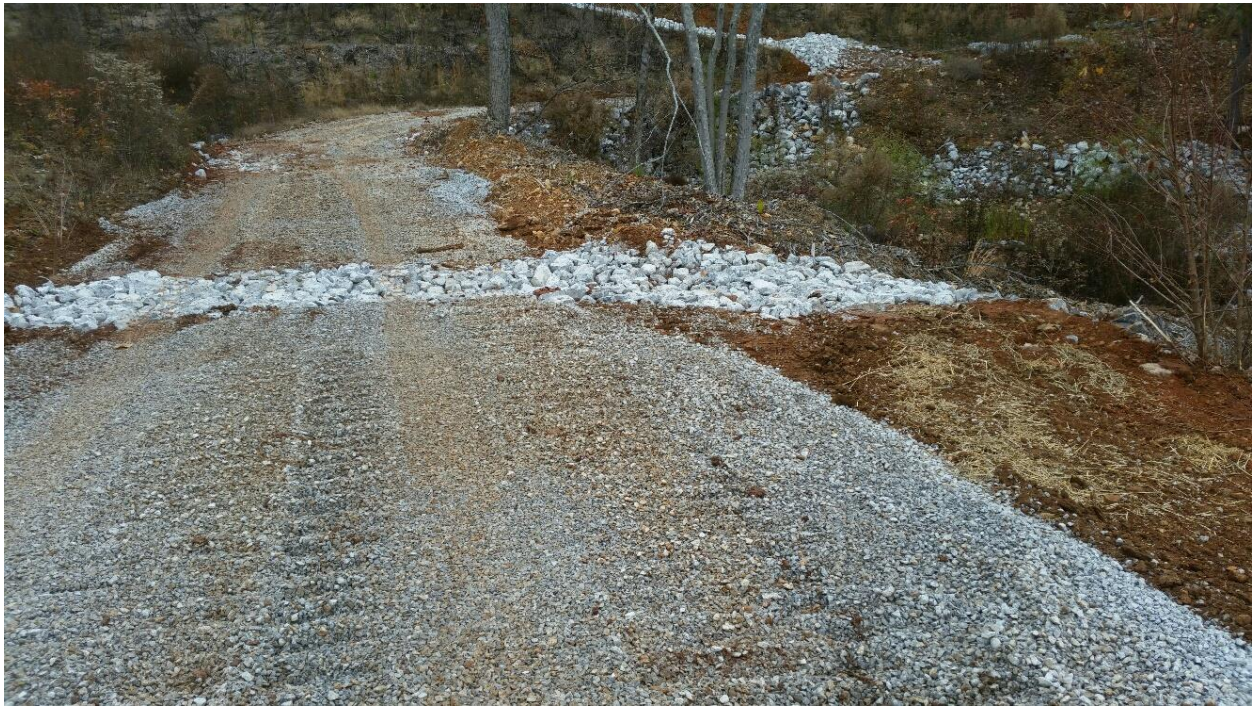
CCR – Repair of Haul Road Near Areas 1/3 and 2

- Repaired typical road erosion along the Upper Road adjacent to Areas 1/3 and 4/5 by reworking and track compacting the roads to provide a smooth surface and knocking down the berms along the east side of the Upper Road to allow down slope drainage off the roadway. The repairs extend approximately 1,200 feet along the Upper Road from Area 7 past the forebay/plunge pool adjacent to Area 1/3. Revitalization included the use of stone and riprap.

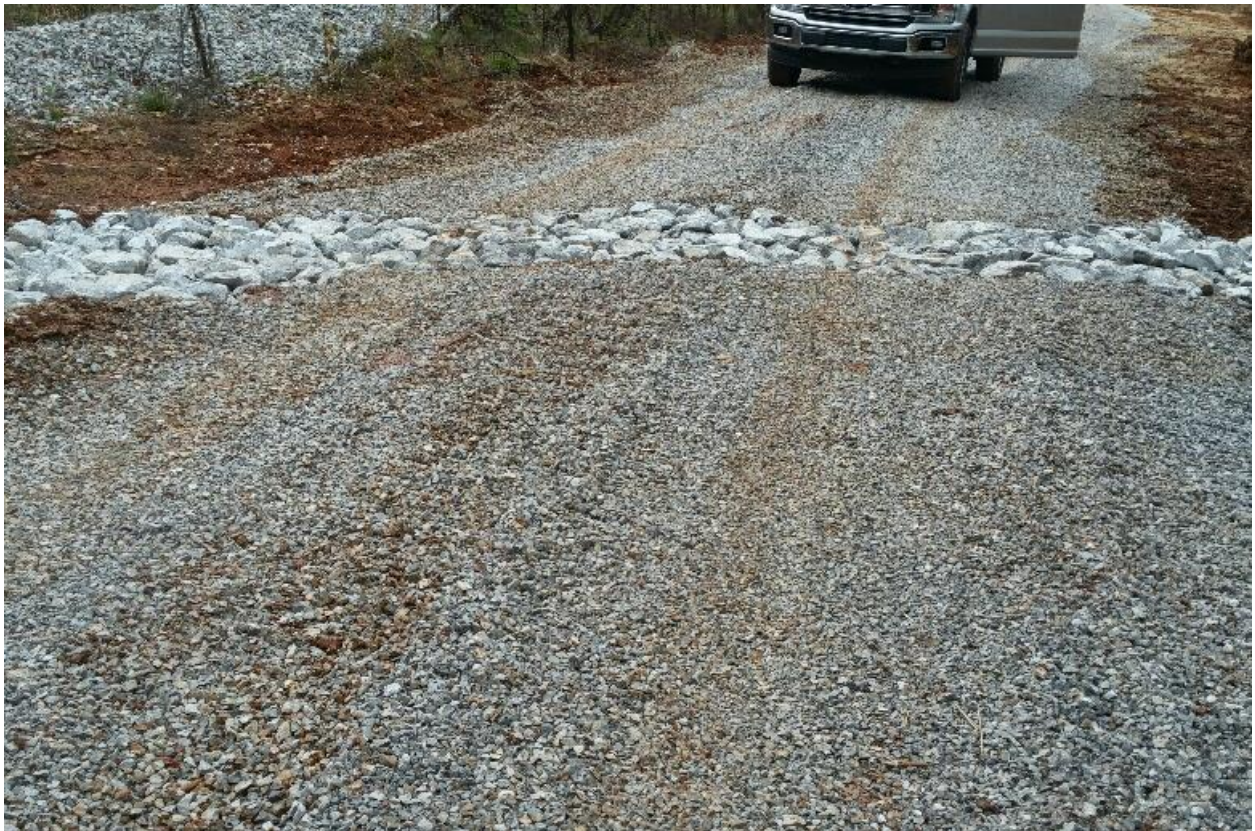
CCR – Repair of Haul Road Near Area 4 with Riprap Drain

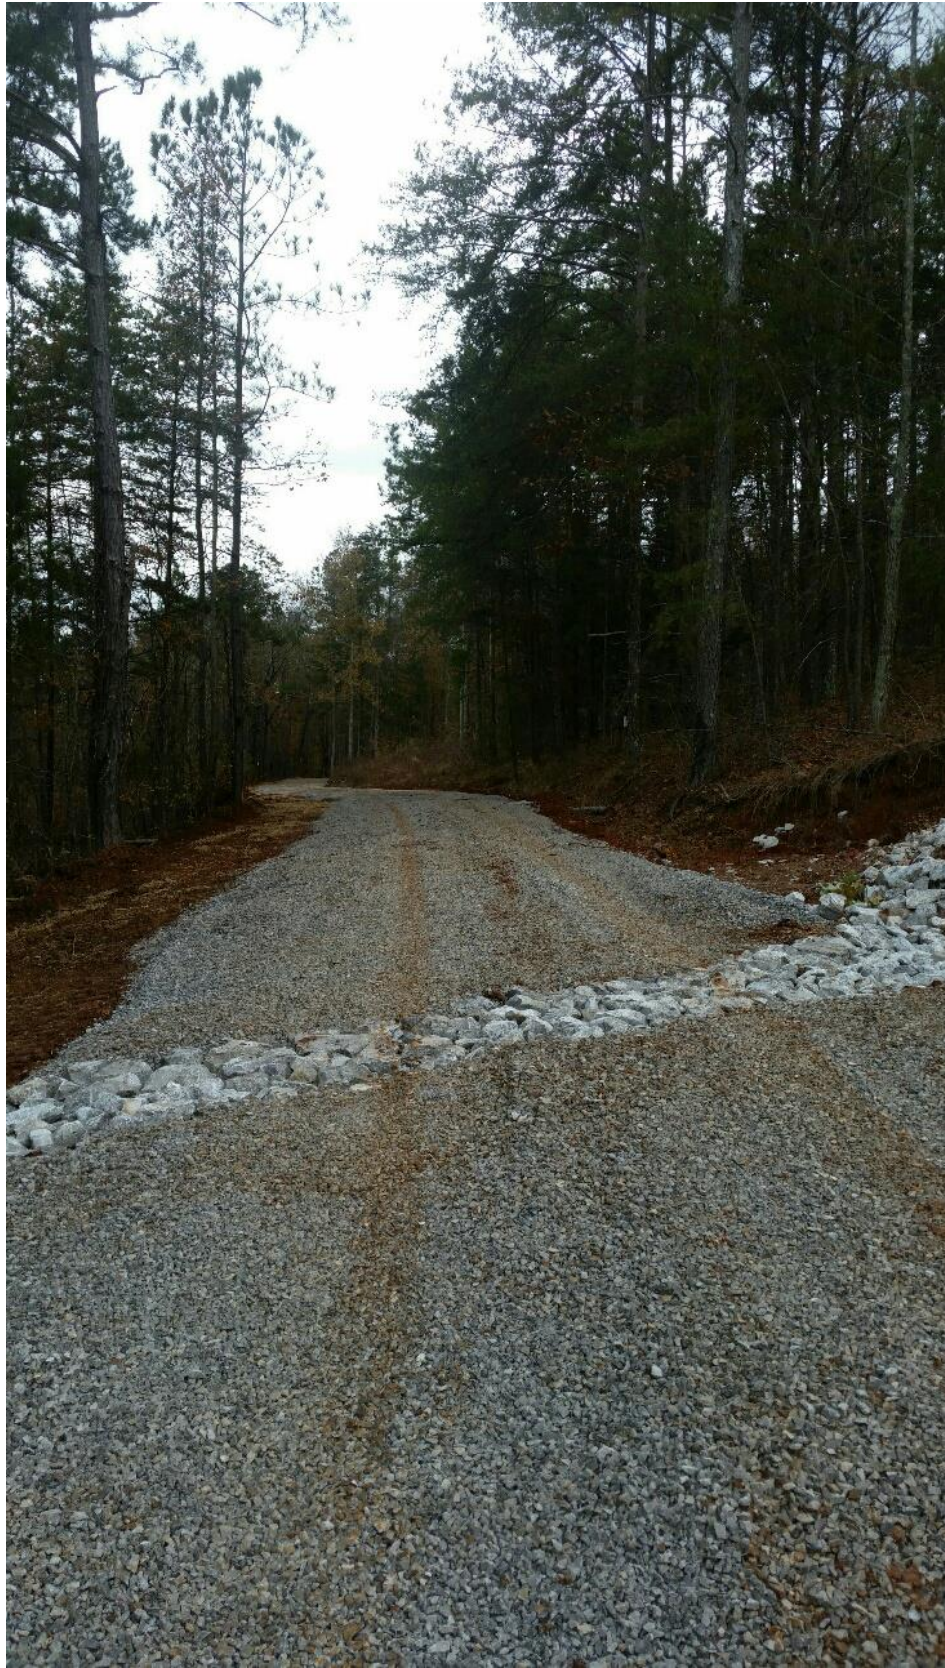
CCR – Haul Road from Area 4 to Areas 8/9/10 with Riprap Drain

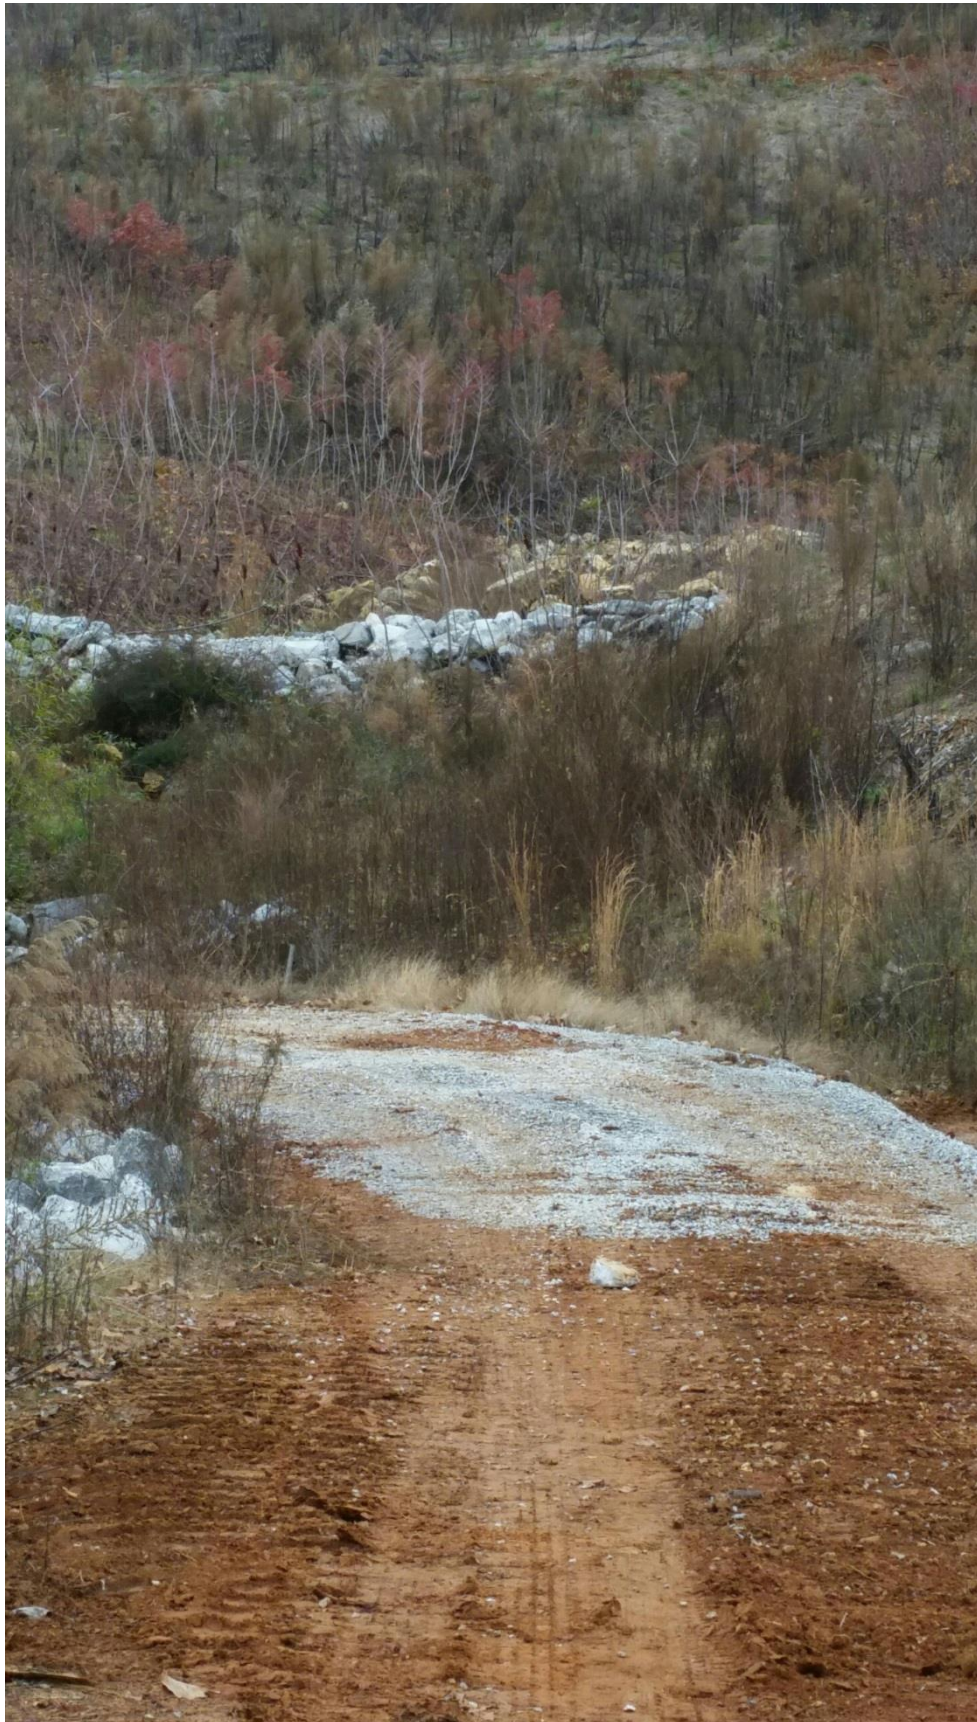
CCR – Repair of Temporary Roads at Areas 1/2 with Riprap Row at Gully

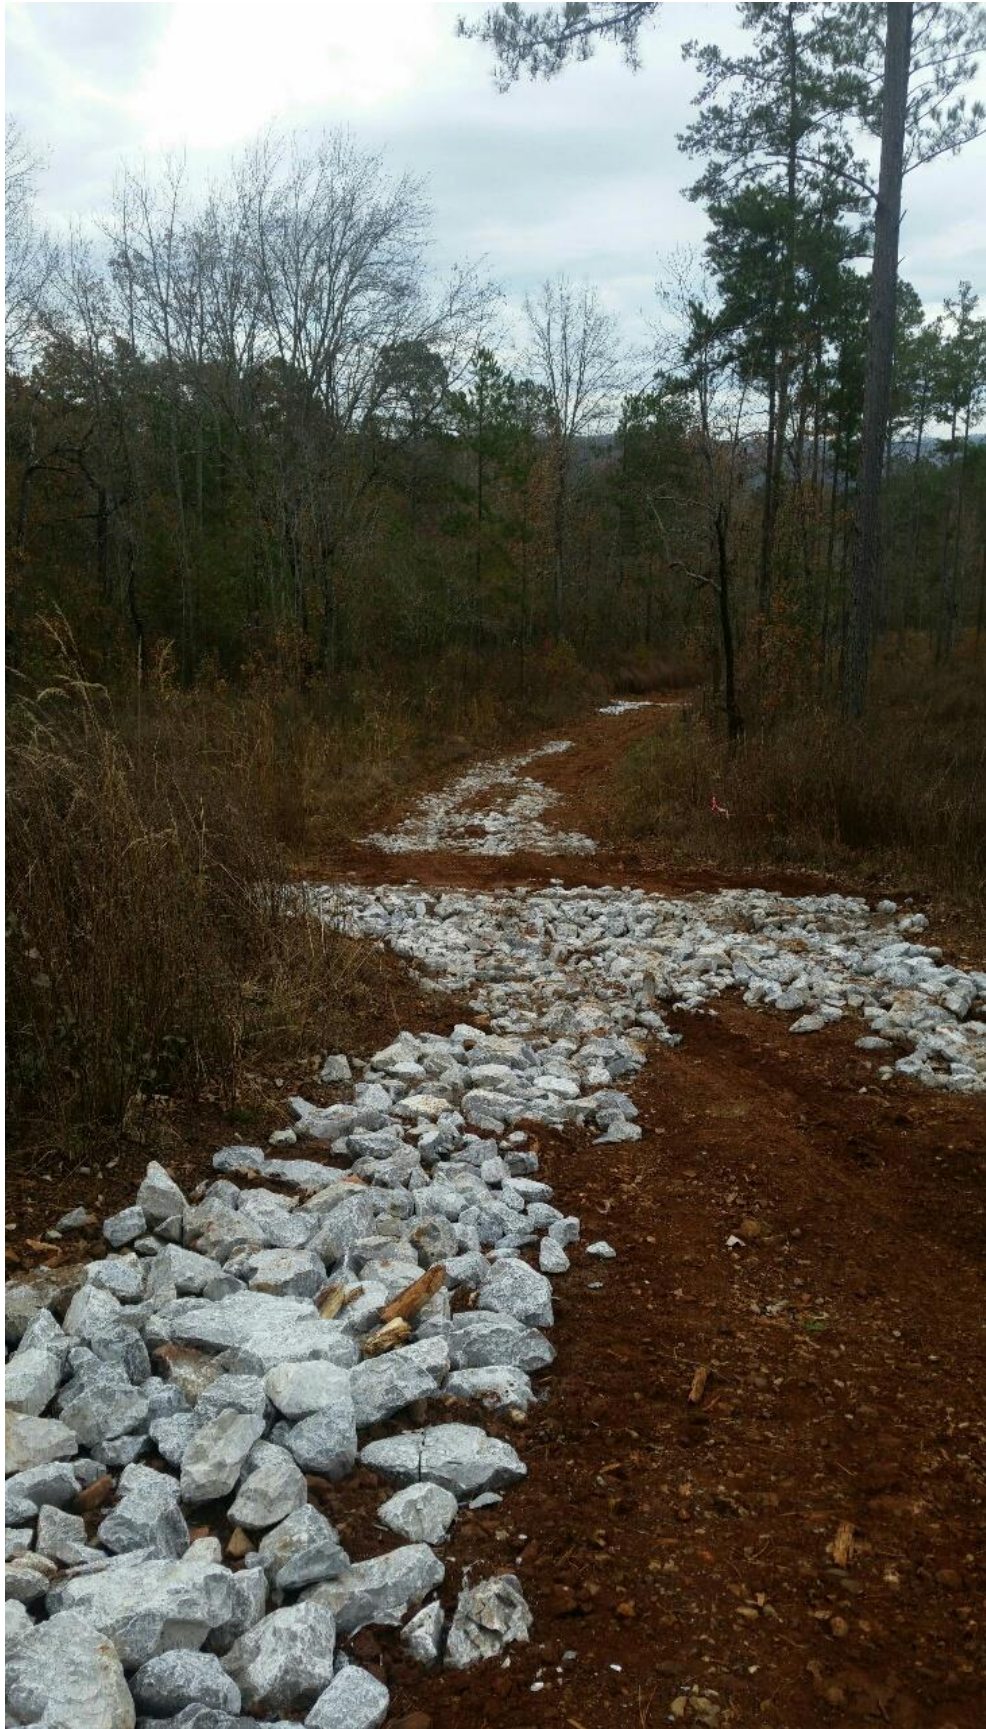
CCR – Repair of Central Road Downslope of Area 18

- Repaired an approximate 450-foot section of Central Road starting from Area 18 and extending eastward by compacting the road and revitalizing the road with riprap and stone.

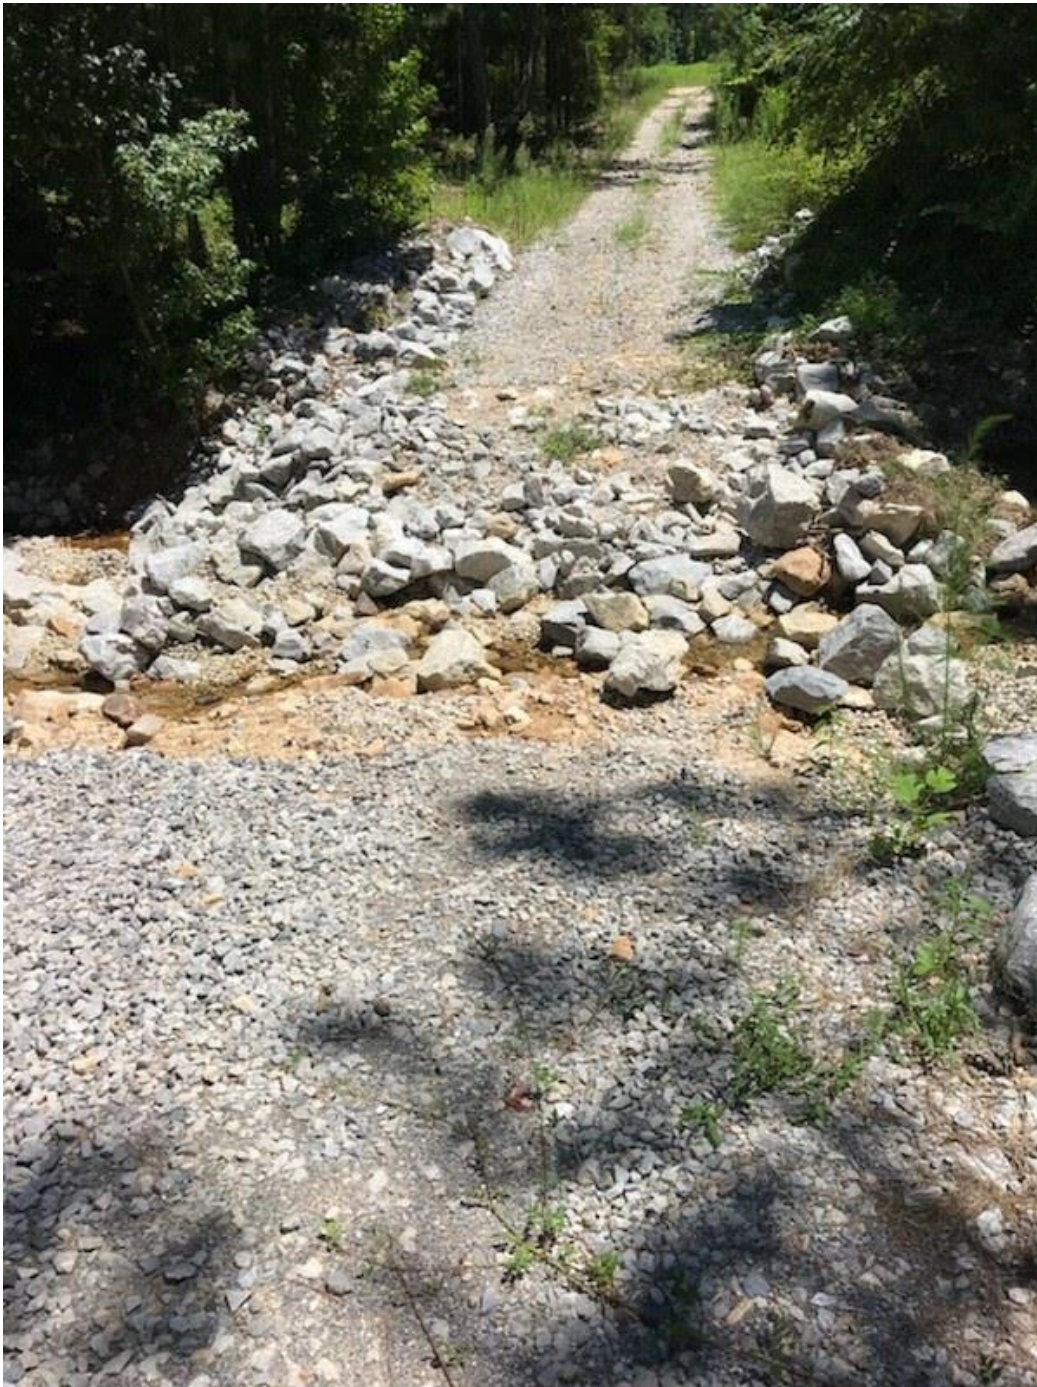
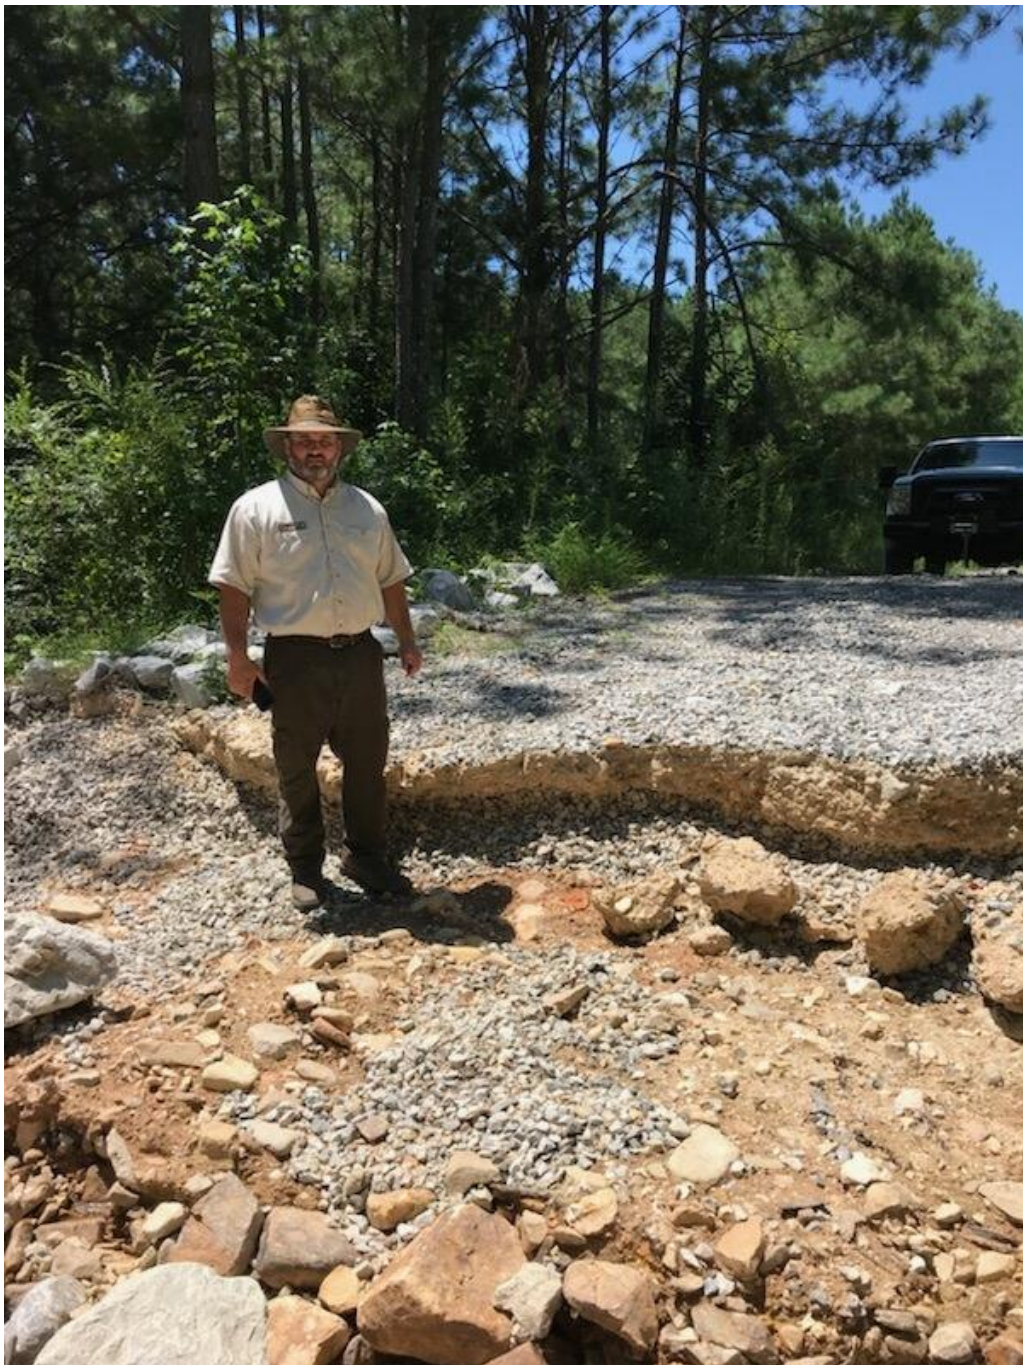
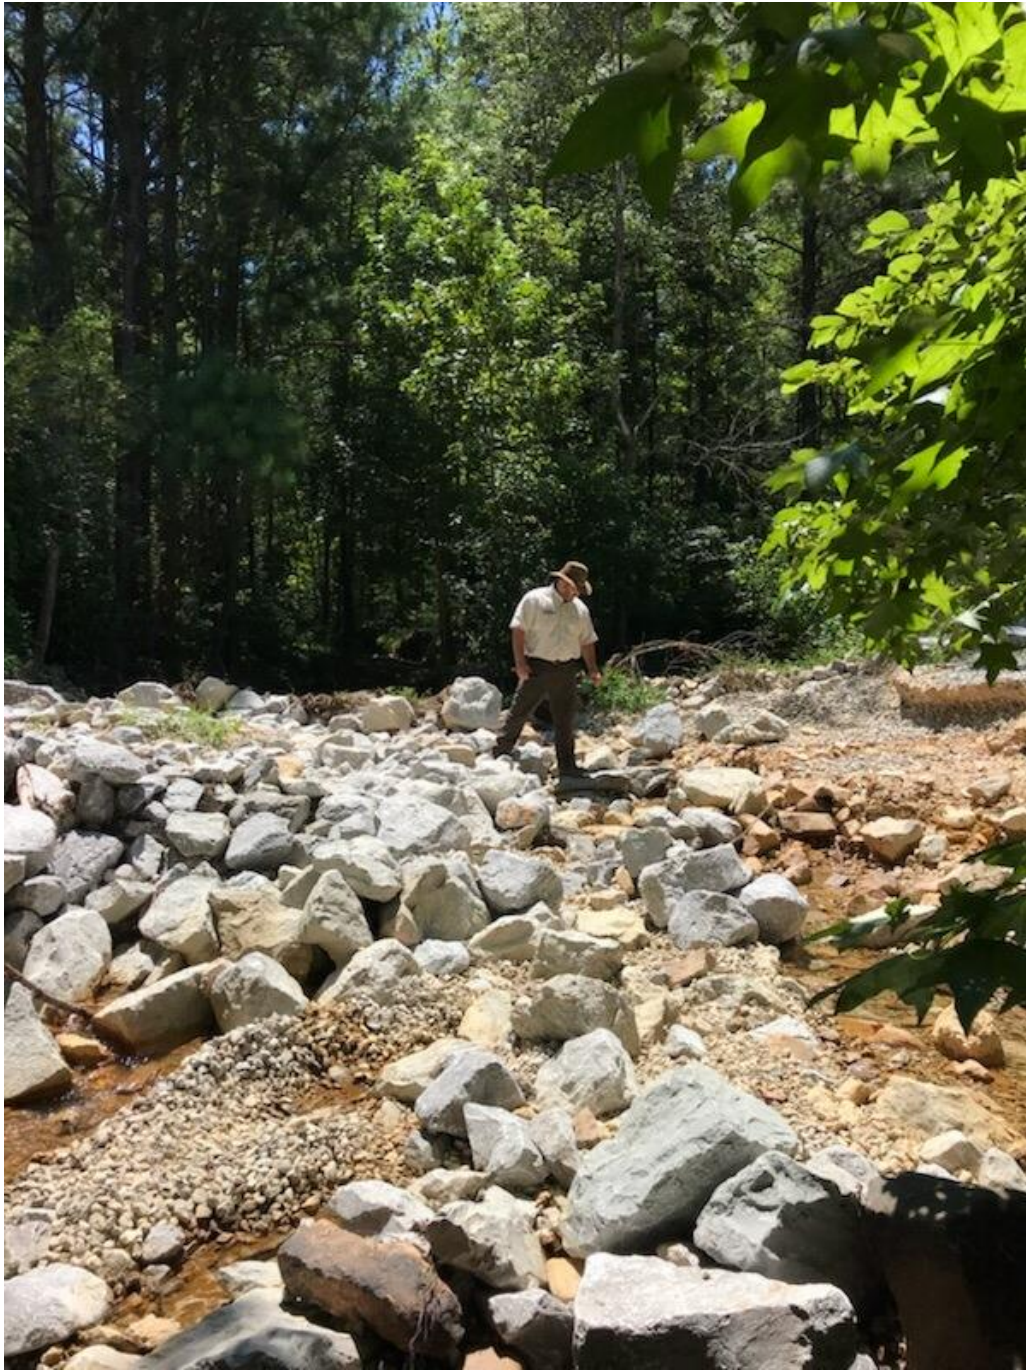
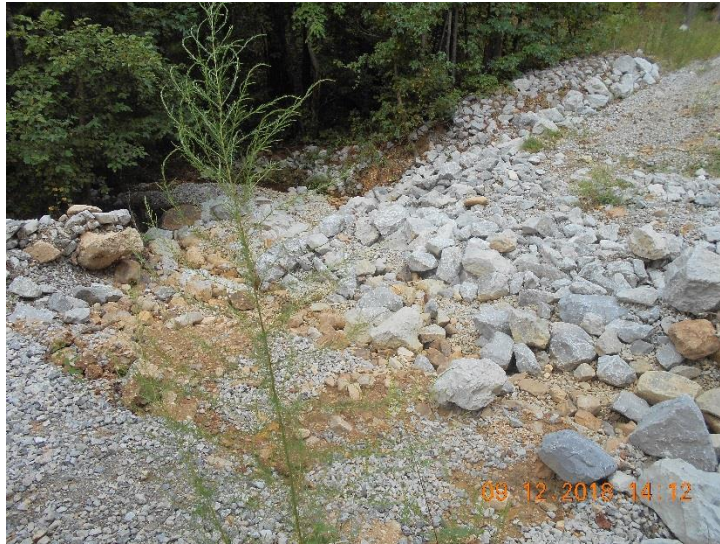
T24A - Washout of Original Low Water Crossing

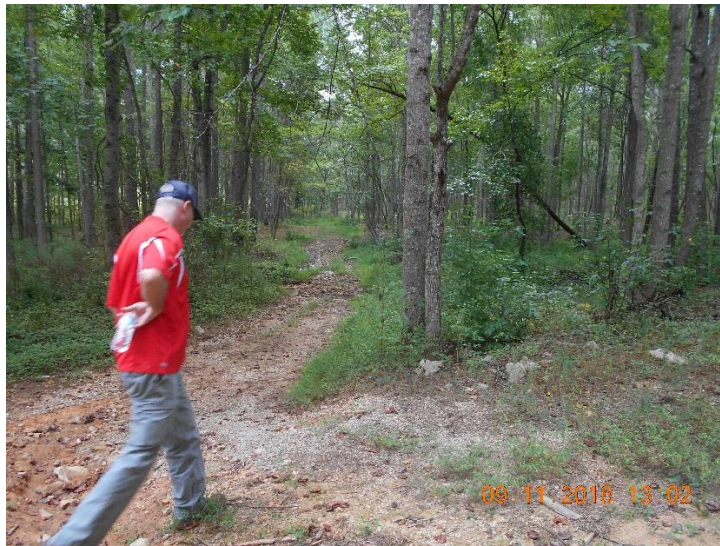
T24A - Inspection of Back Road to Alternate Low Water Crossing

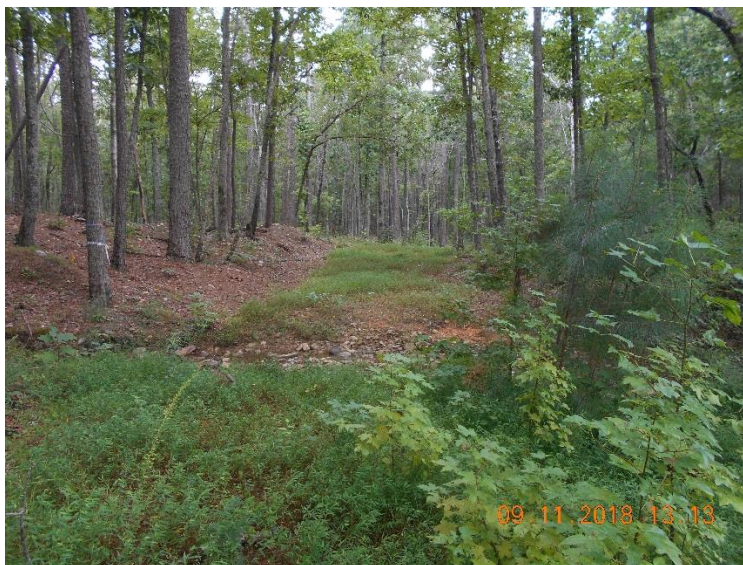
T24A - Inspection of Alternate Location for Low Water Crossing

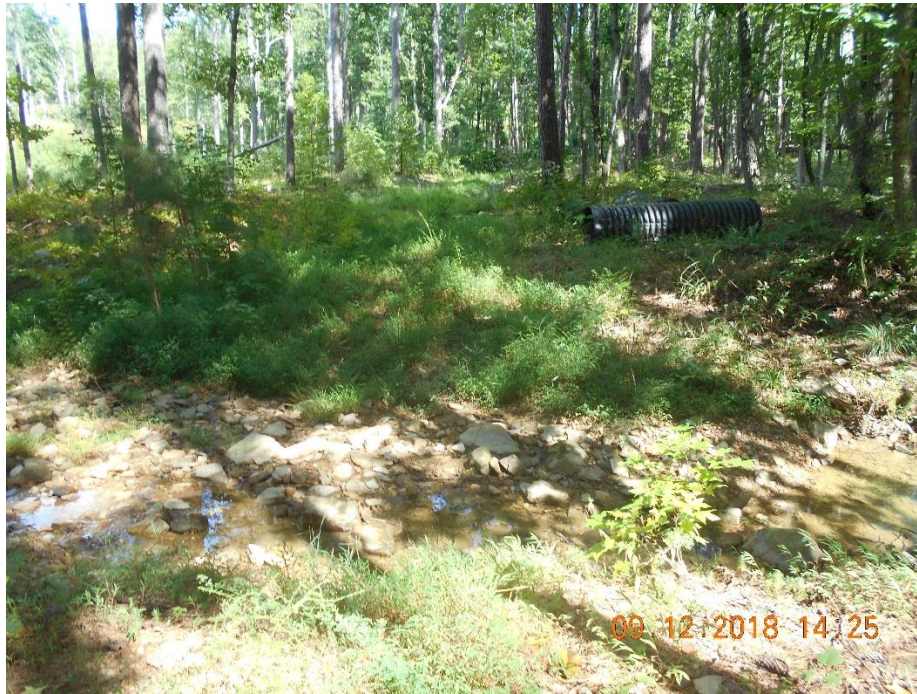
T24A – Inspection of Alternate Location for LWC

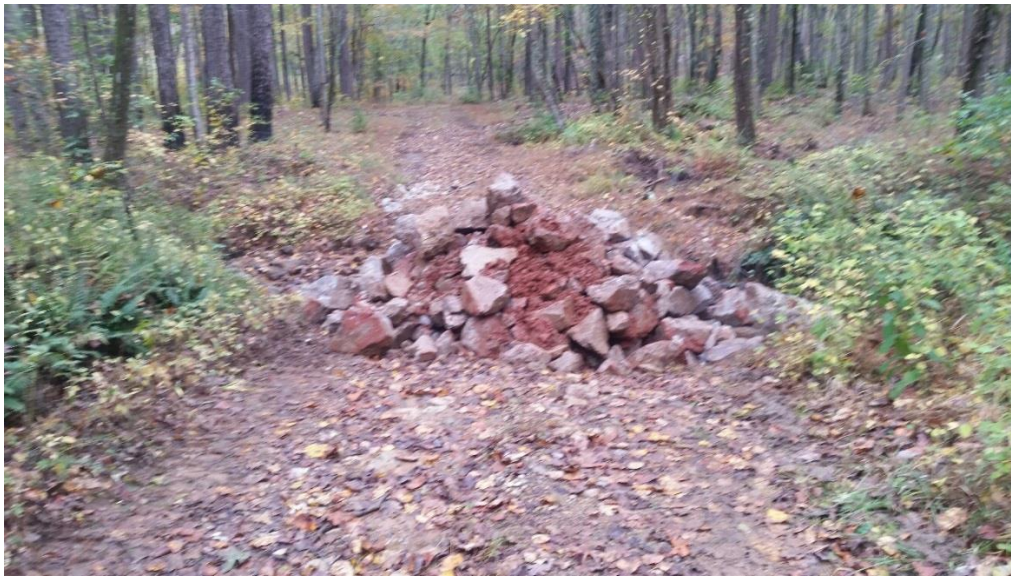
T24A – Clearing Debris from Original LWC

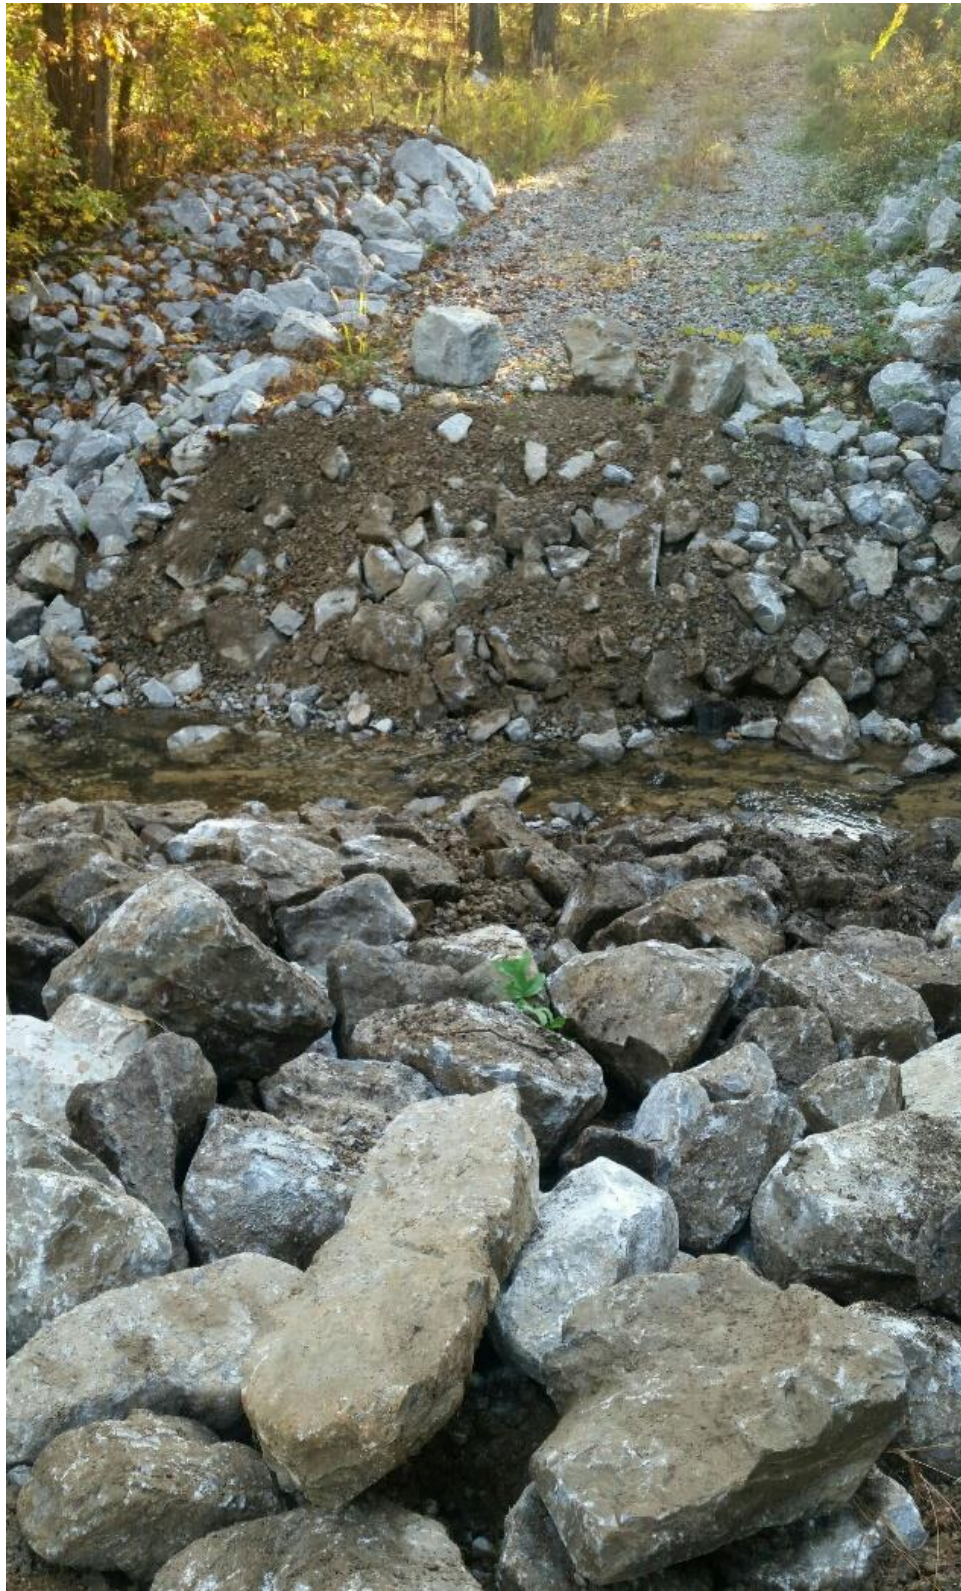
T24A – Clearing Original LWC

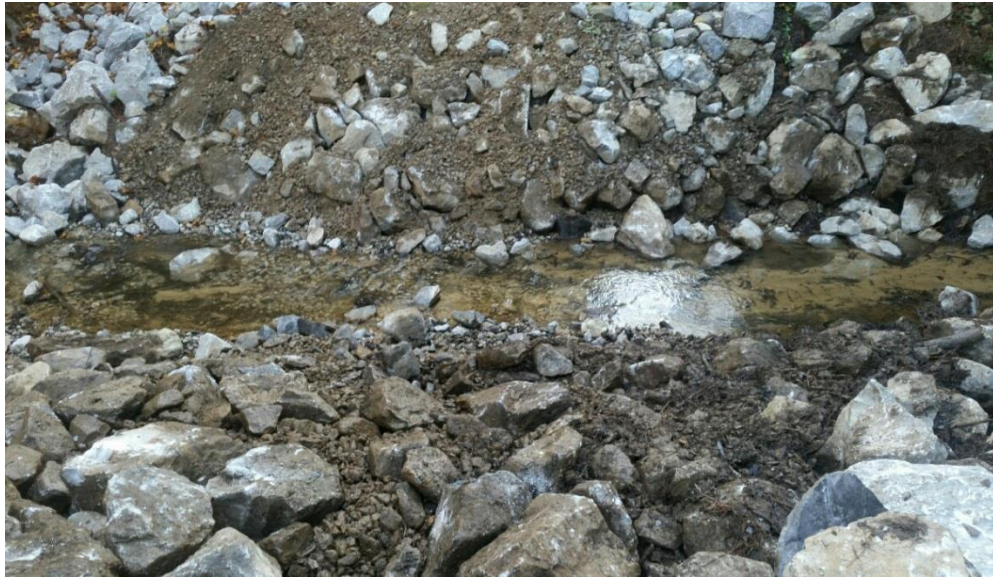
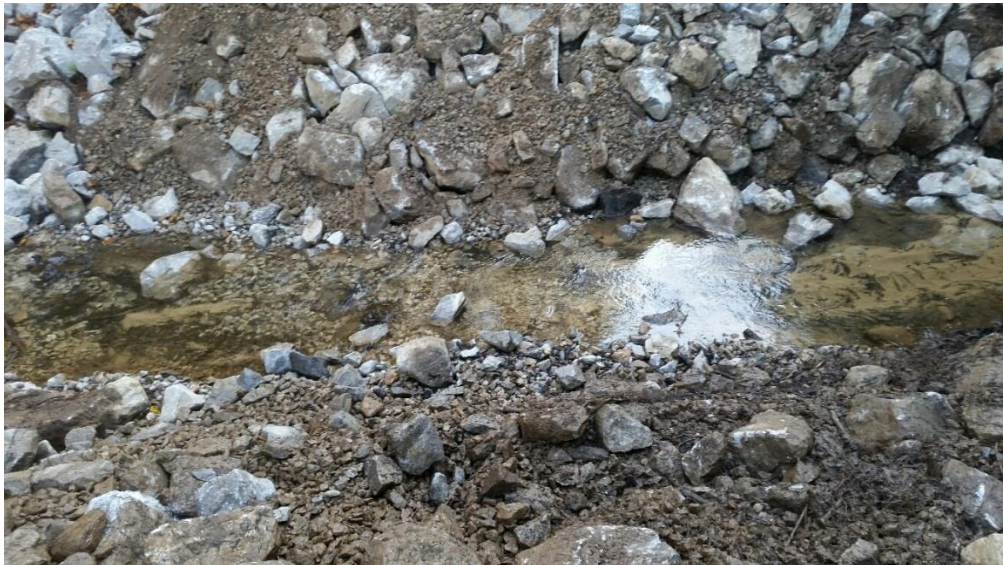
T24A – Cleared Original LWC

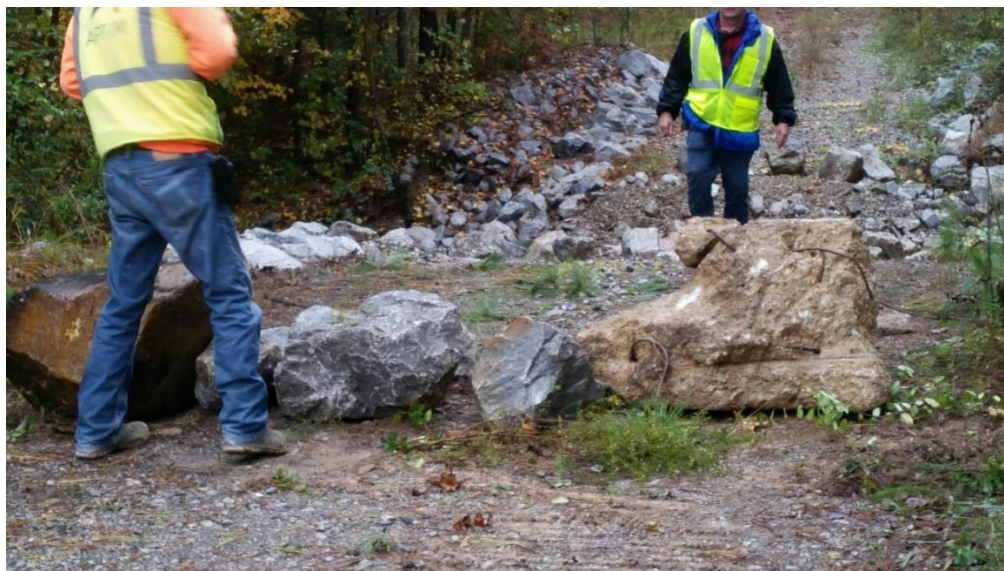
T24A – Placing Barriers at Original LWC

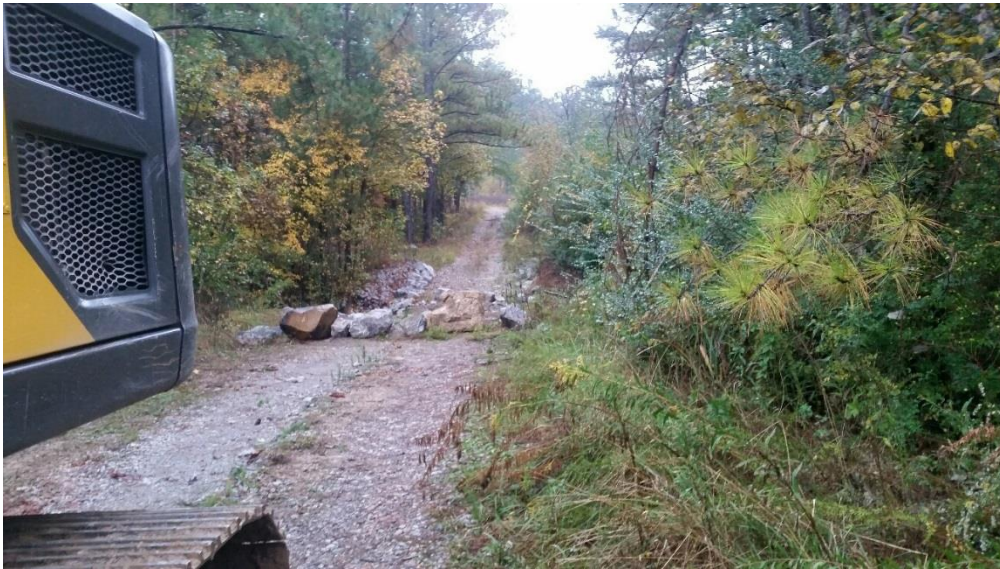
T24A – Barriers at Original LWC
