**FINAL
MAINTENANCE OF EROSION CONTROL FEATURES AND
VEGETATION LETTER REPORT OF ACTIVITIES,
YEAR 4, EVENT 1**

**FORMER 81MM MORTAR RANGE, BAINS GAP ROAD
RANGES, FORMER CHOCCOLOCCO CORRIDOR
RANGES, AND RANGES NEAR TRAINING AREA T-24A**

**ENVIRONMENTAL REMEDIATION SERVICES AT FOUR
SITES, FORT MCCLELLAN, ANNISTON, ALABAMA**

February 2019

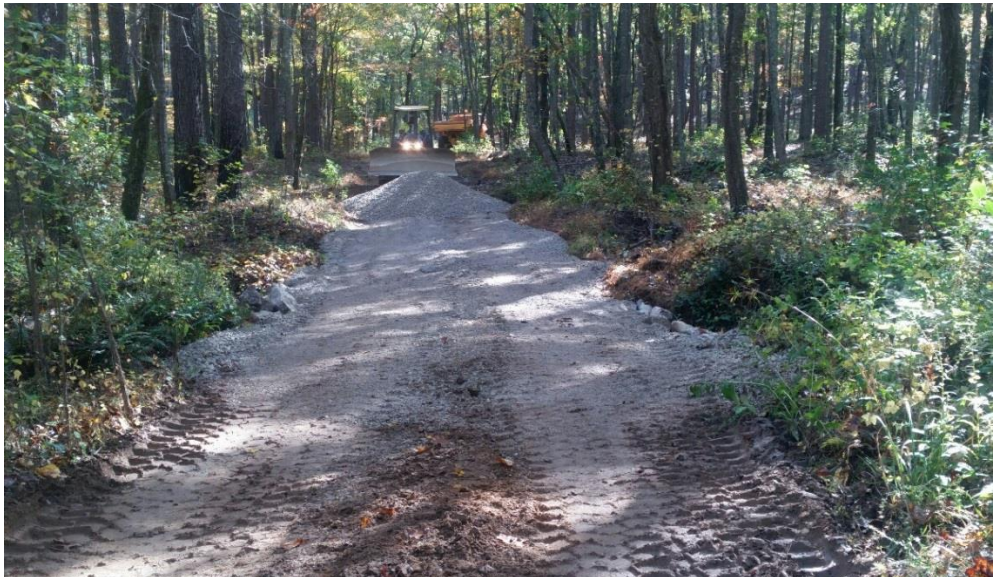
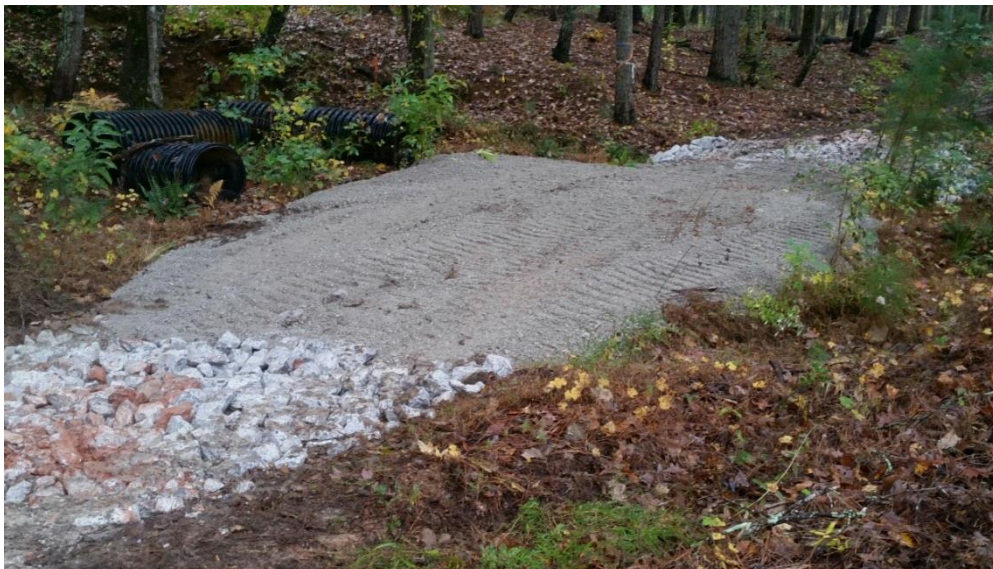
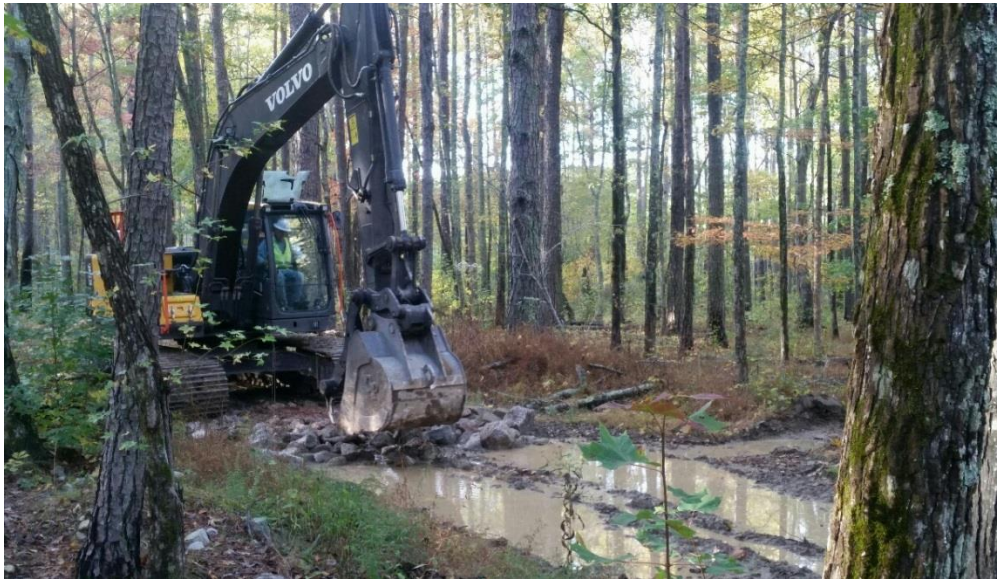
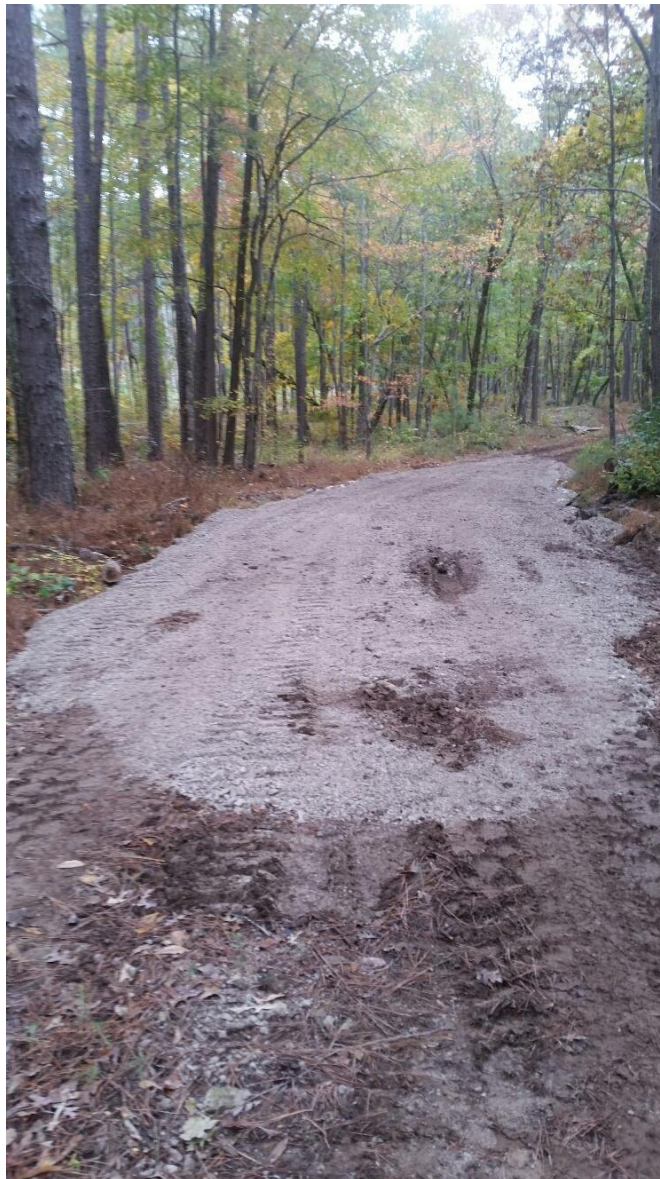
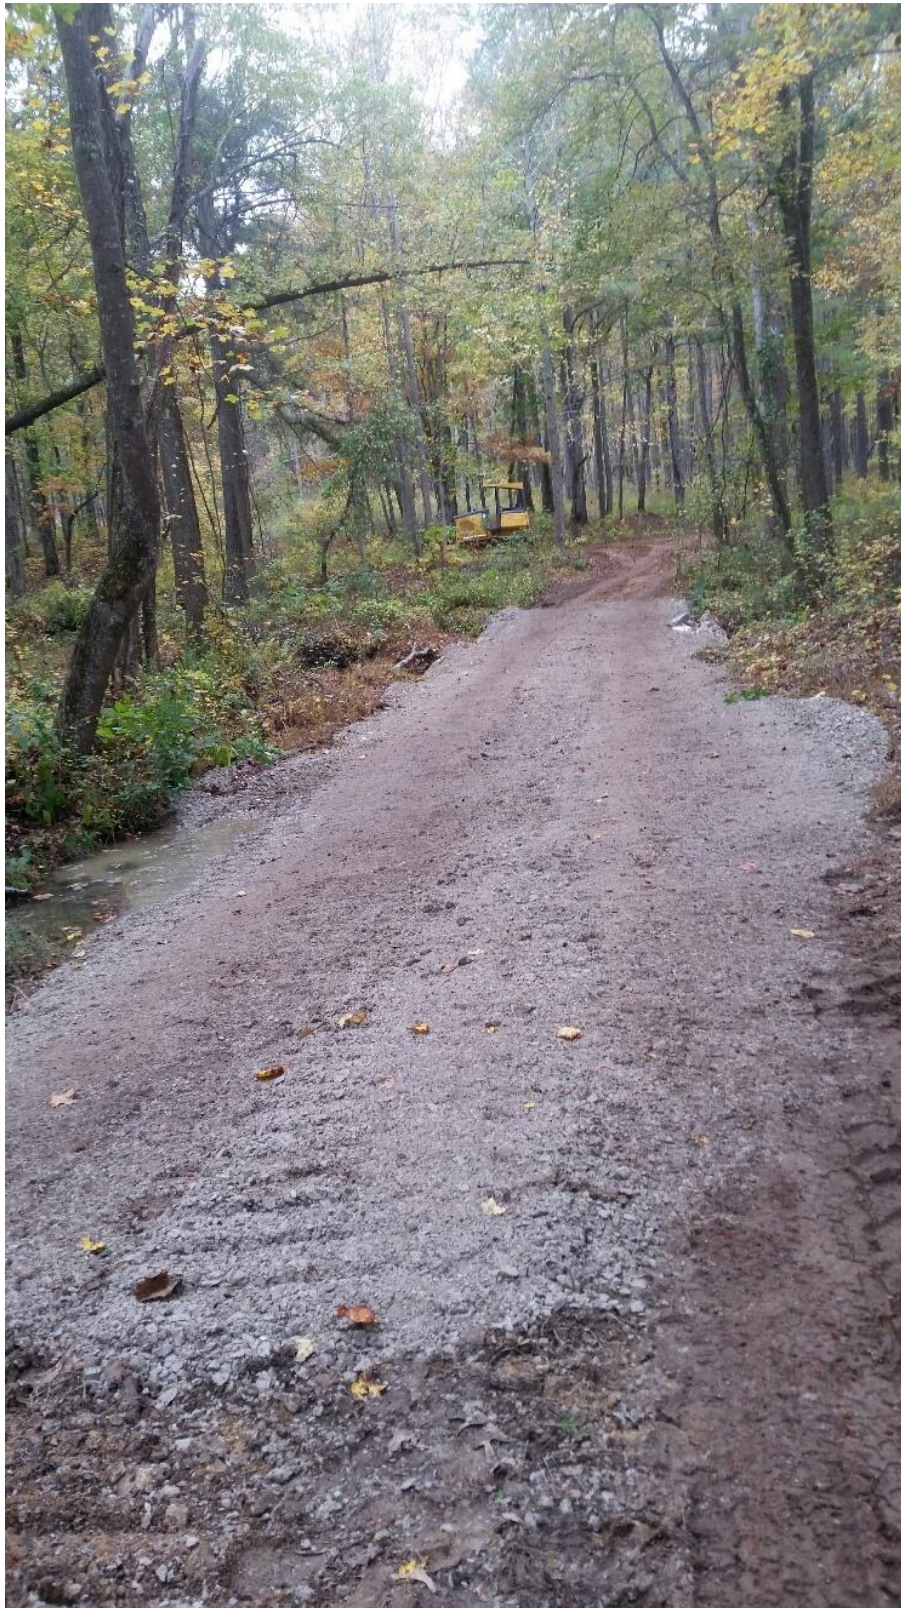
T24A – Clearing and Reinforcing Back Road to Alternate LWC

- Repaired/cleared approximately 1,300 feet of back road at the site to provide an access to the new low water crossings including clearing an area of dense native vegetation, removal of two large trees blocking the road, and navigation of a steep eroded slope.
- Utilized riprap, stone and crusher run to improve and repair the back road and create a road deck through the wet features, including two creeks, two seeps/springs, and an existing mudhole/wet area. Developed water bars on the back road to direct water off the back road.

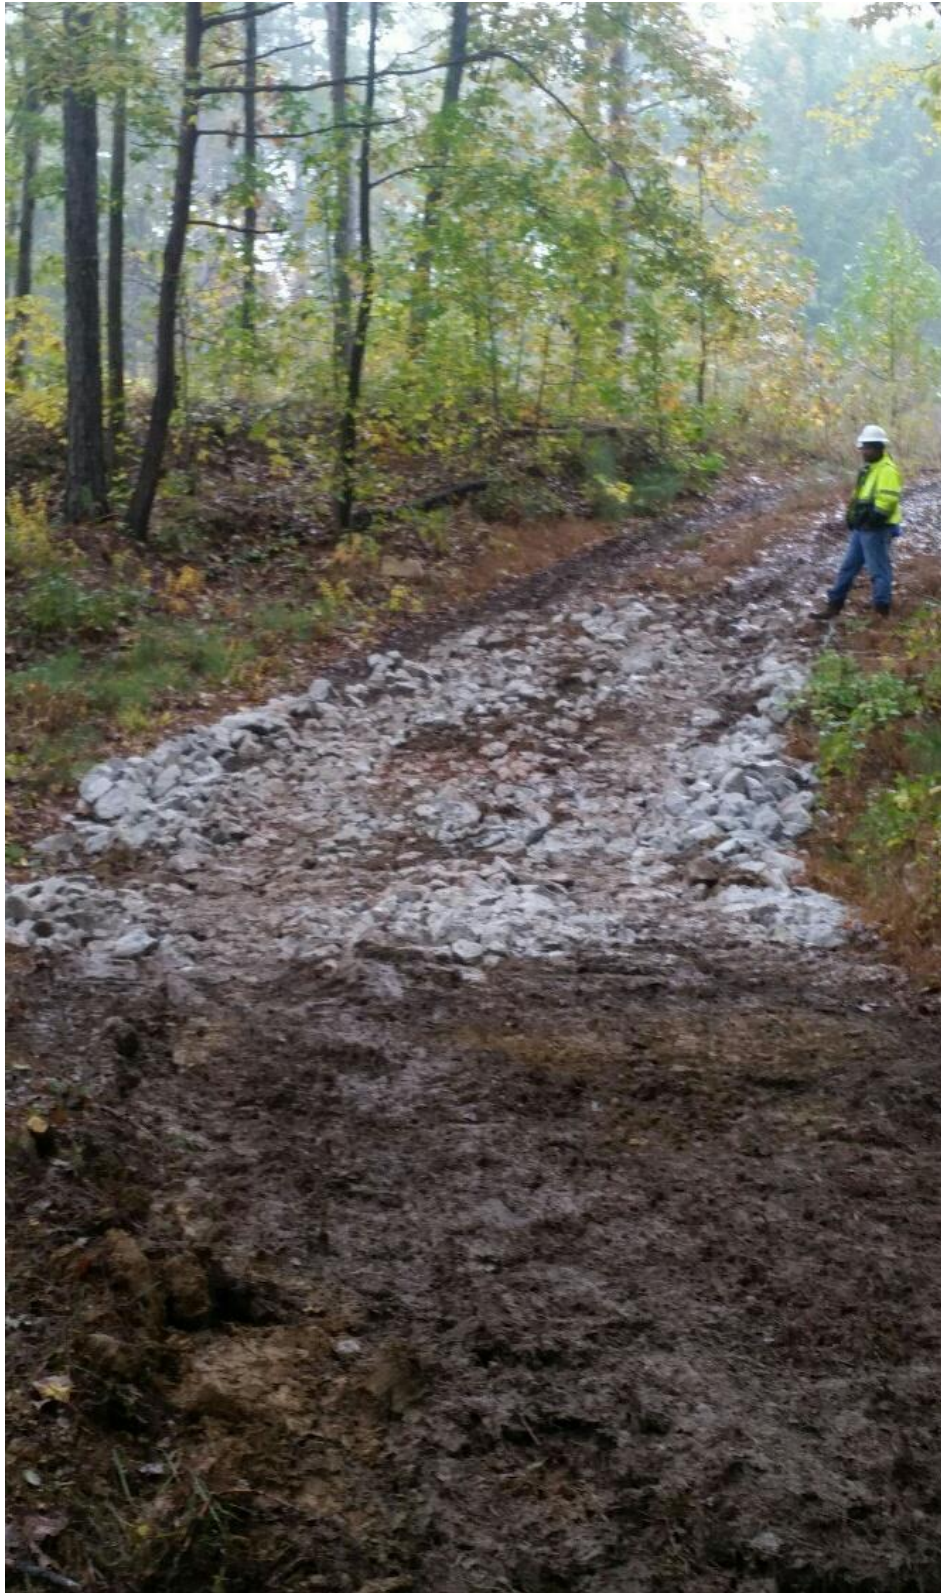
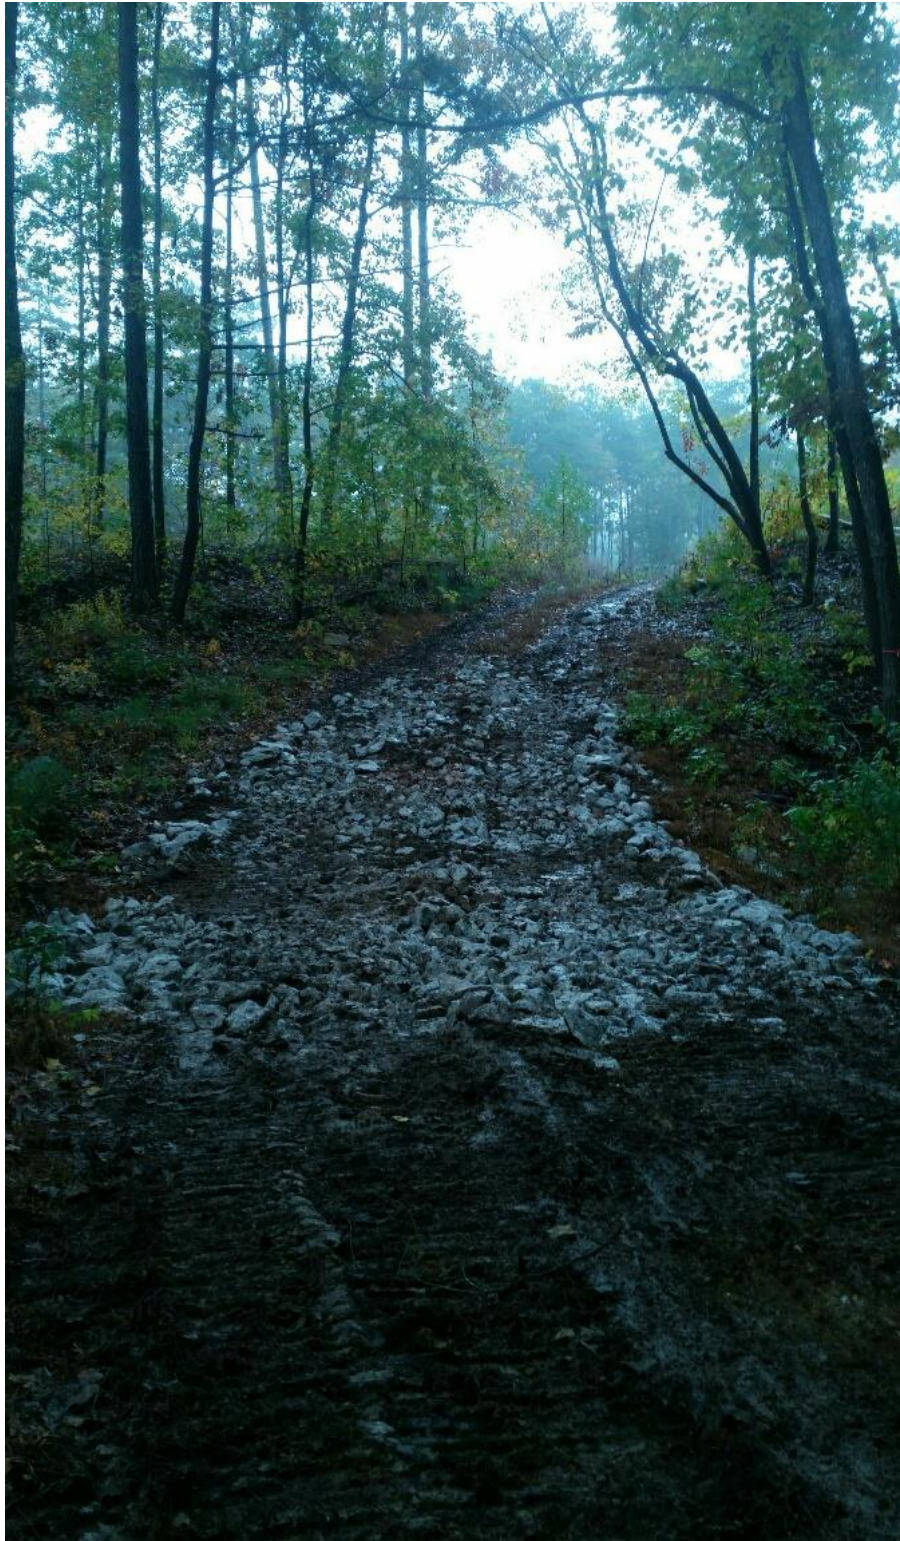
T24A - Reinforcing Steep Slope at Area 11 to Alternate LWC

- Utilized riprap to rock armor the steep slope into Area 11 along the back road and diverted stormwater from Area 11 off the steep slope.
- Constructed two new low water crossings by reworking and sloping the approaches to the creek to 1V:10H to accommodate vehicle traffic and prevent water damming, and preparing the crossings with a rock foundation and deck.
- Reshaped the original low water crossing to match the existing channel to provide uninterrupted flow and placed large stone on the main roadway to prevent vehicle access to the creek.

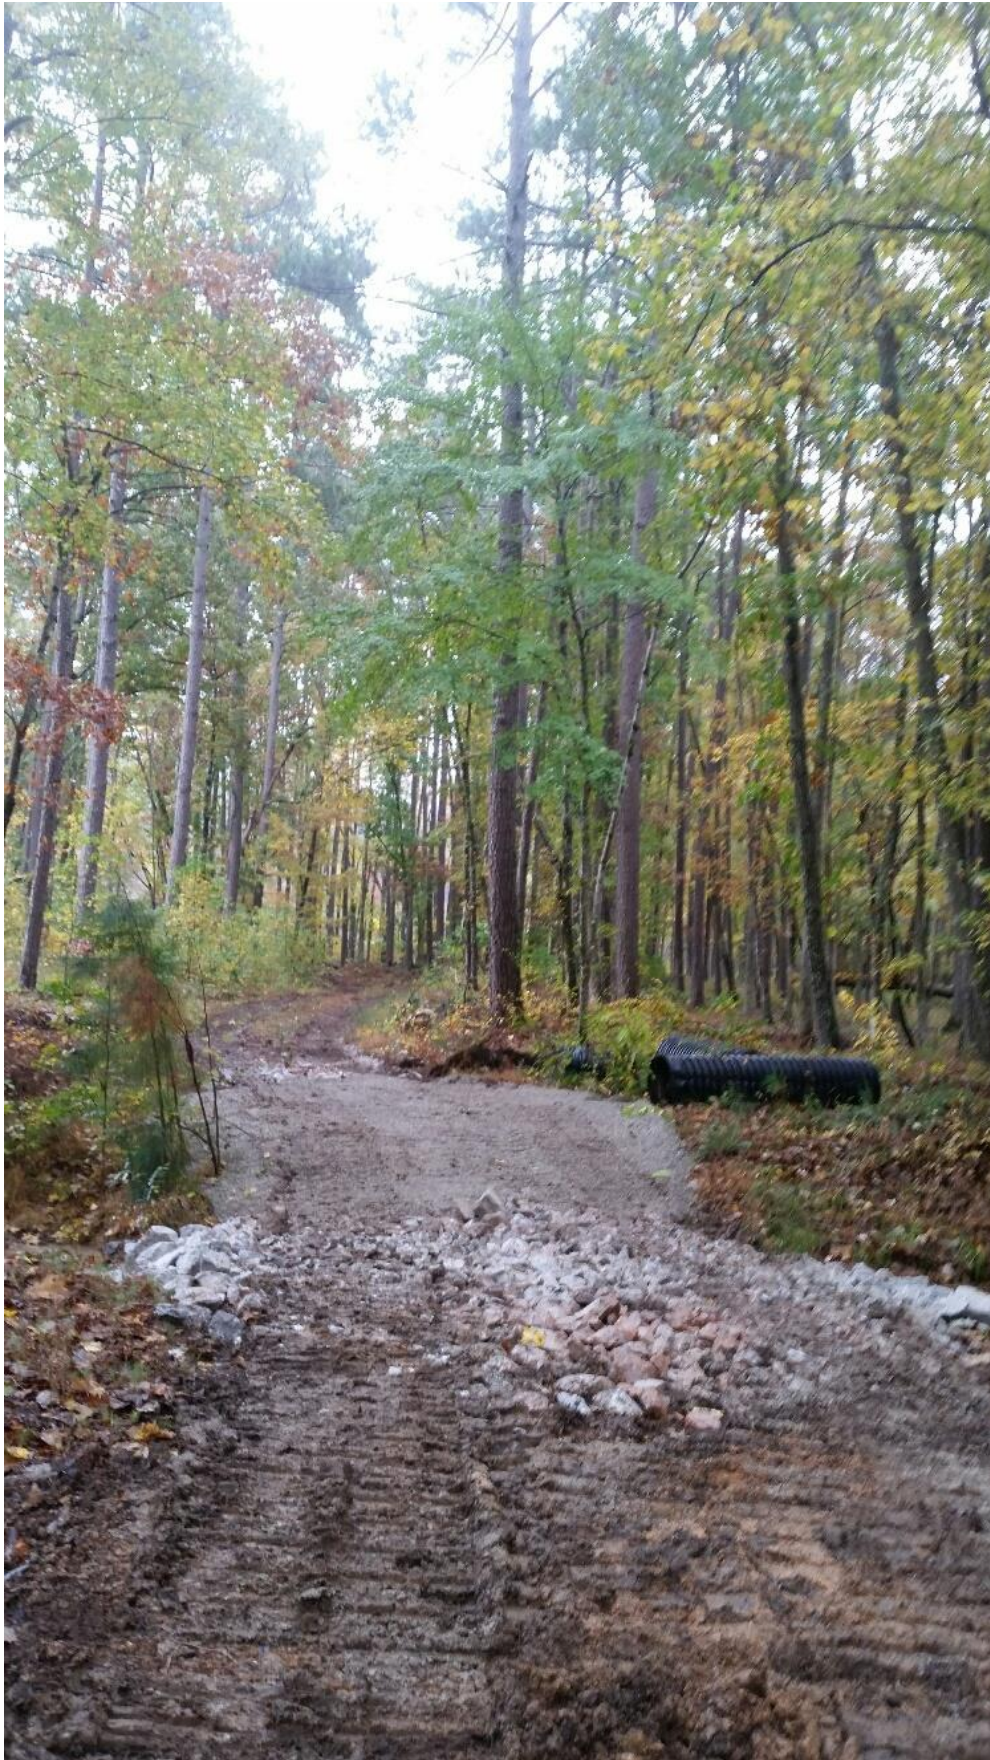
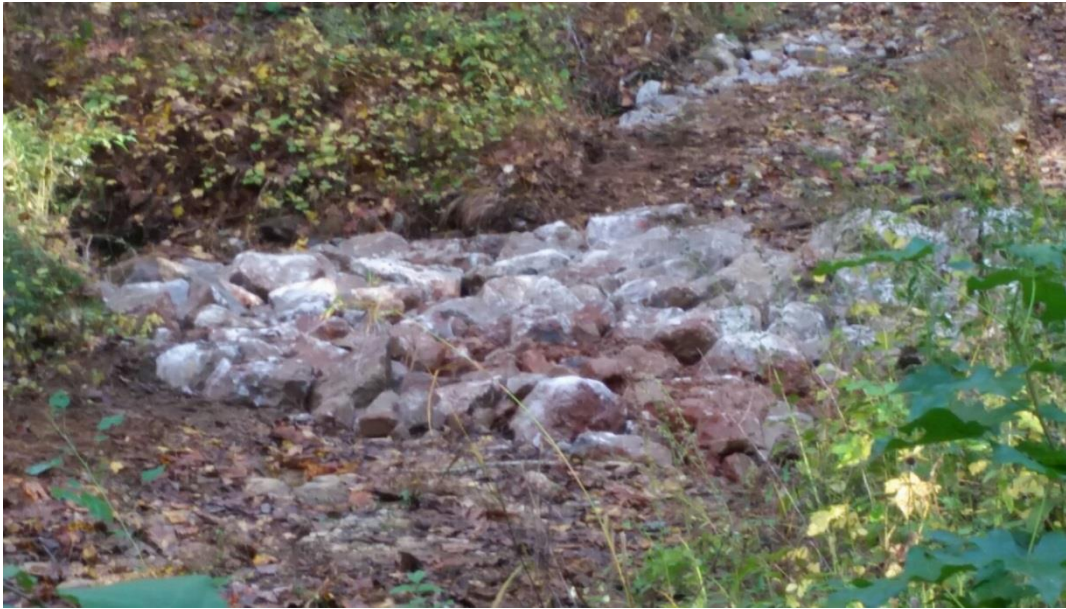
T24A - Constructing Alternate LWC

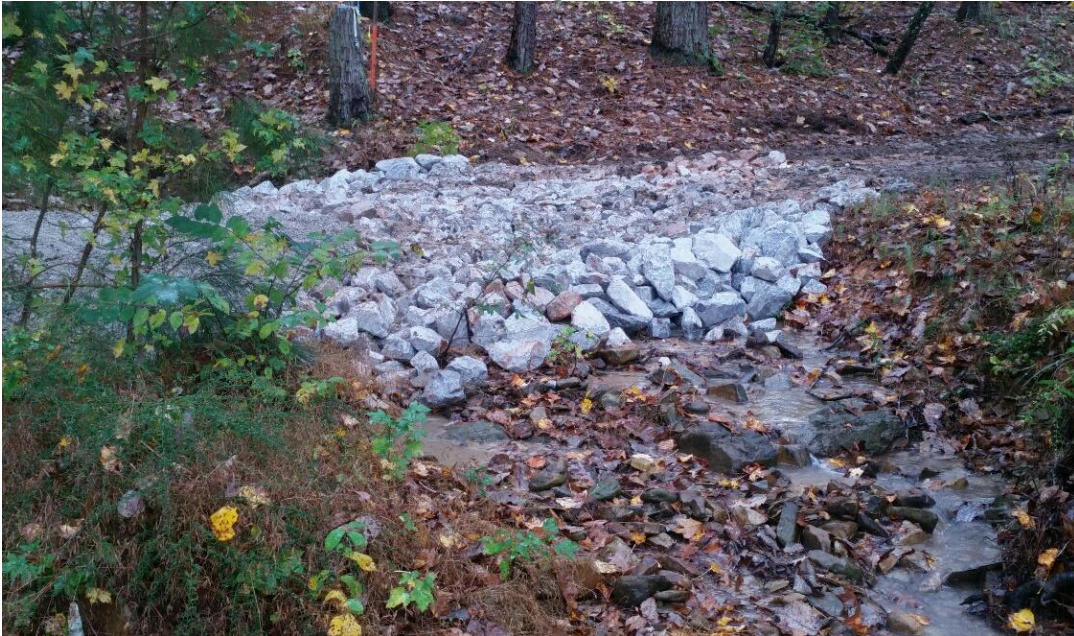
T24A - Alternate LWC
