Subject: Land Use Control Effectiveness Report – 2015

Land Use Control Effectiveness Report - 2015
McClellan, Anniston, Alabama

January 2016

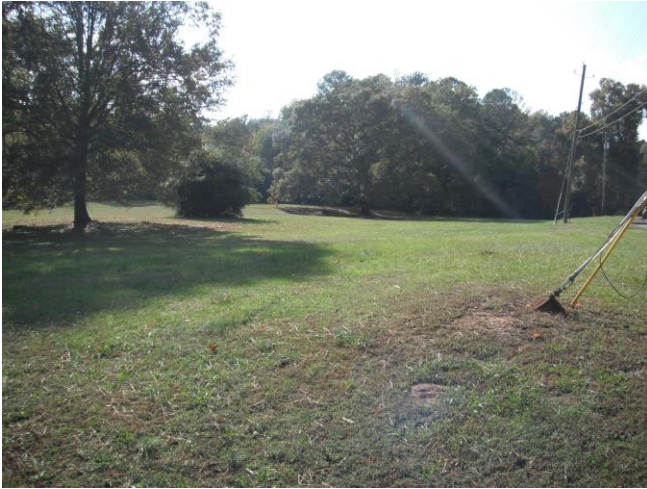
The vegetation across the cap surface appeared to be in good condition at the time of the inspection. No bare areas were observed.

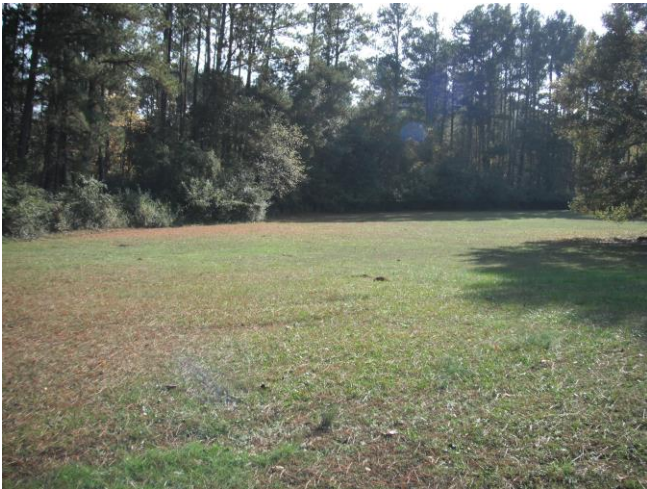
No signs of erosion such as rills or gullies were observed at the time of the inspection.

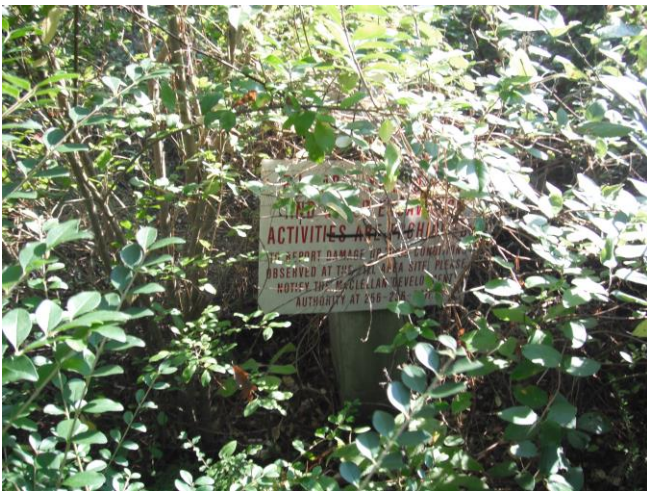
Some of the boundary monuments along the perimeter of Landfill 1 had become overgrown and were difficult to see. The vegetation had become very thick along the perimeter boundary. The vegetation was trimmed to allow the boundary monument and sign to be visible.

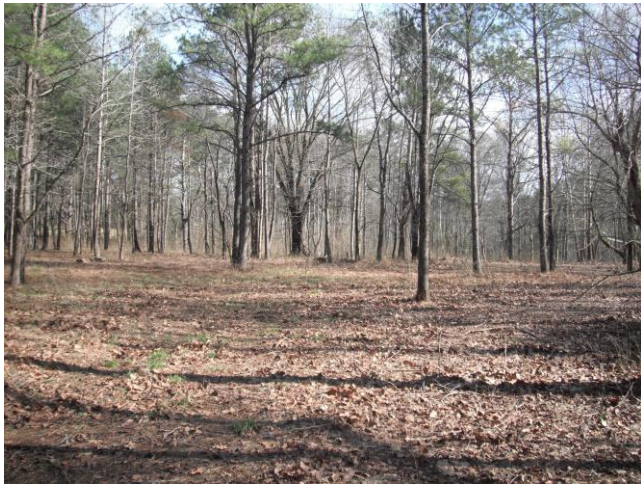
The vegetation across the landfill was observed to be in good condition at the time of the inspection. No bare areas were observed.

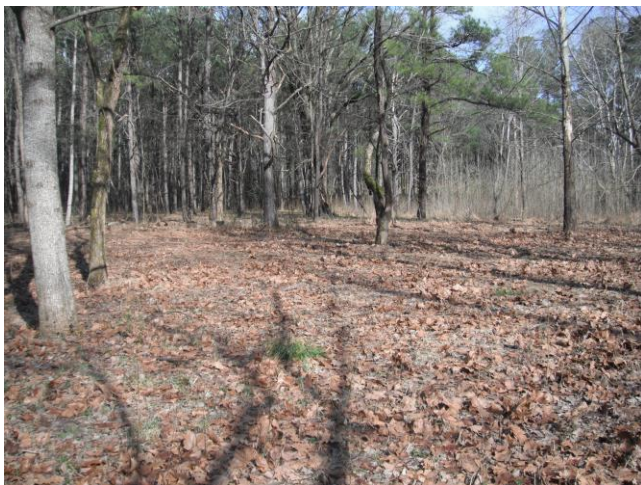
No erosion of the landfill cap was observed during the inspection. No low areas or exposed debris was observed.

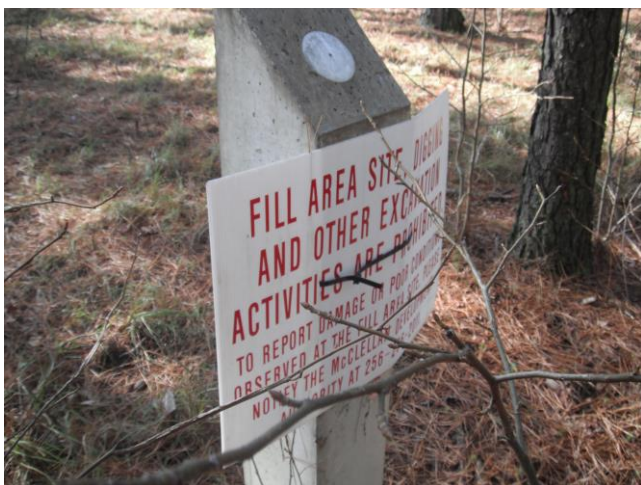
The landfill boundary monuments were in good condition with no visible signs of damage. The signs prohibiting digging on the landfill were all attached and in good condition.

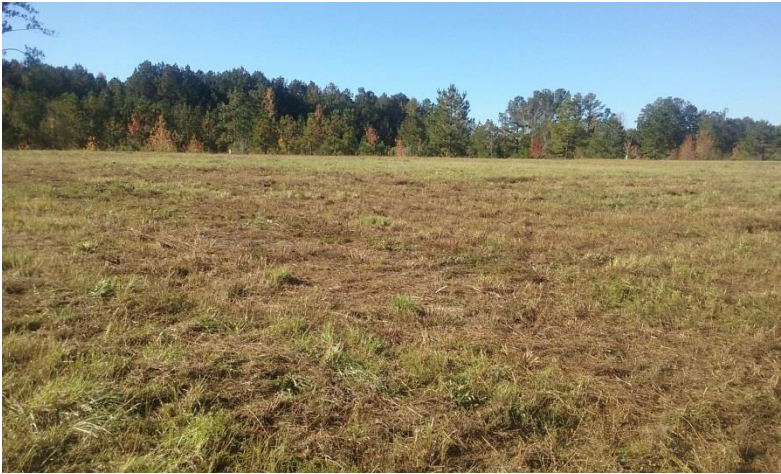
LF4-01: The vegetation across the landfill cap was observed to be in good condition during the inspection.

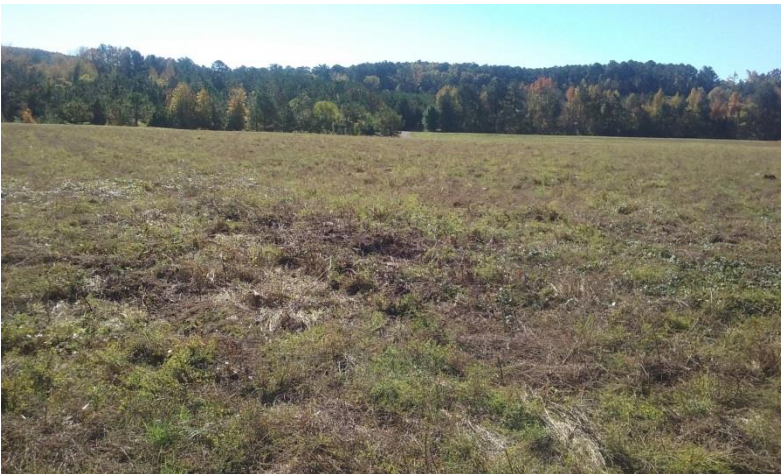
LF4-02: The landfill cap was mowed prior to the inspection. No bare areas were observed during the inspection.

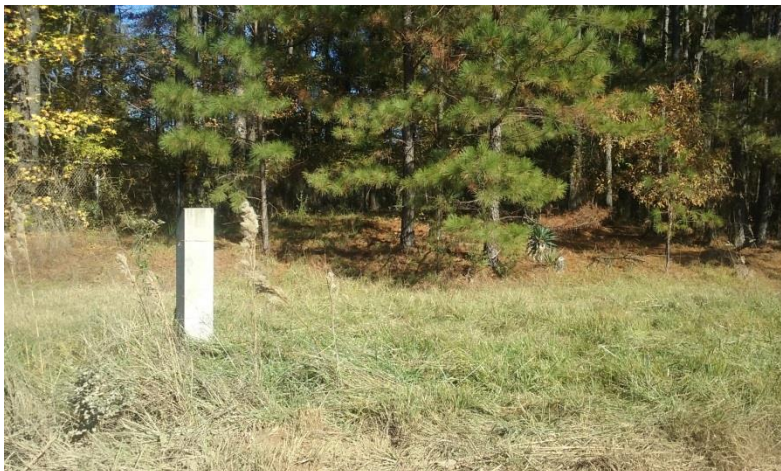
LF4-03: Boundary monuments were observed to be in good condition during the inspection; however, two of the no digging signs were knocked off when the vegetation was mowed. The signs were replaced after the inspection.

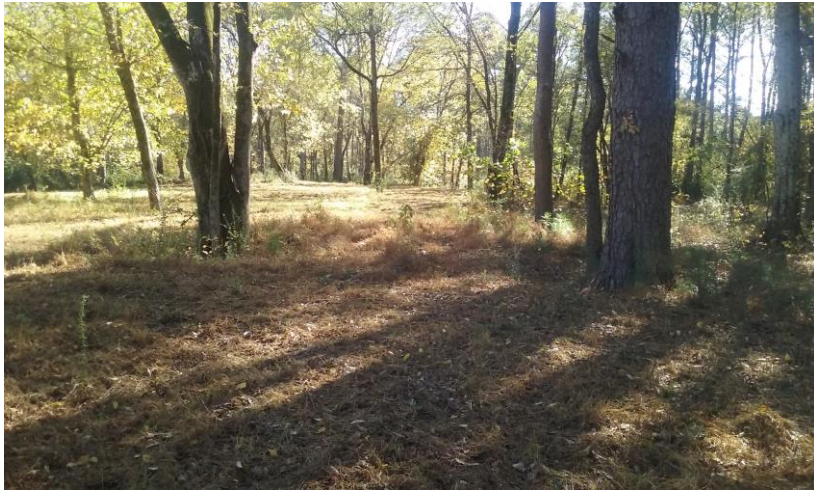
The vegetation across the landfill cap had been recently cut and the vegetation appeared to be in good condition during the inspection.

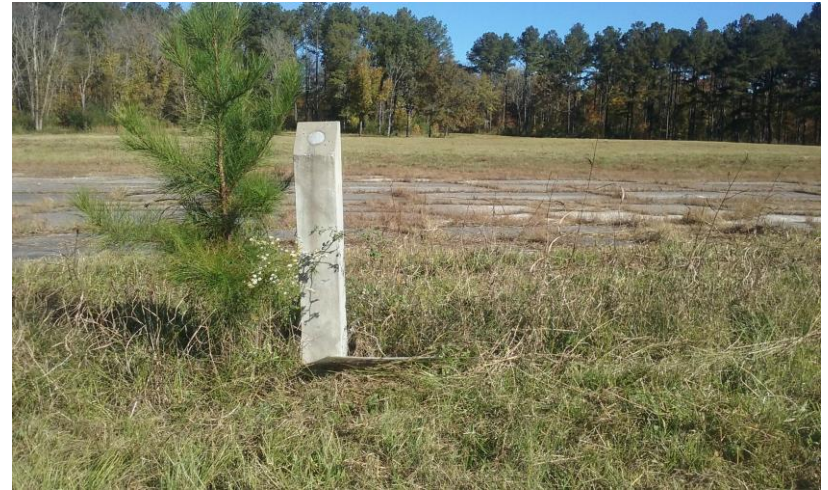
The no digging sign attached to Boundary Monument #4 had fallen and was reattached during the inspection.

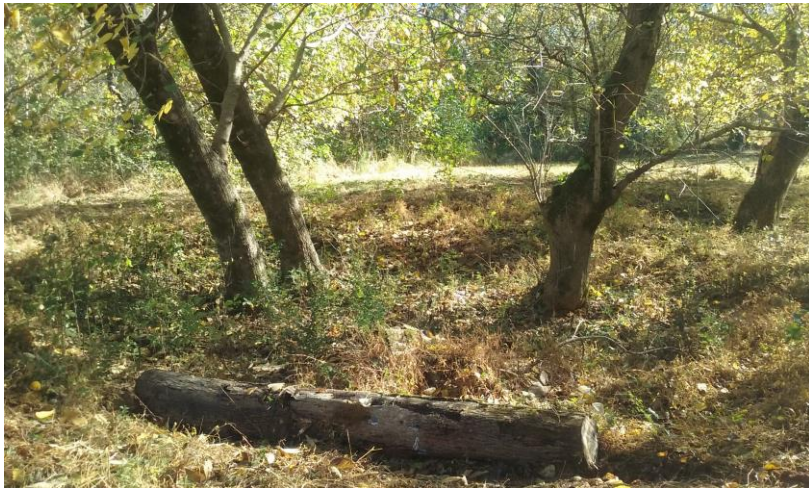
A tree in the northern area of the Garbage Dump had fallen a few years ago with no damage to the cap surface. The tree was left in place and allowed to decompose.

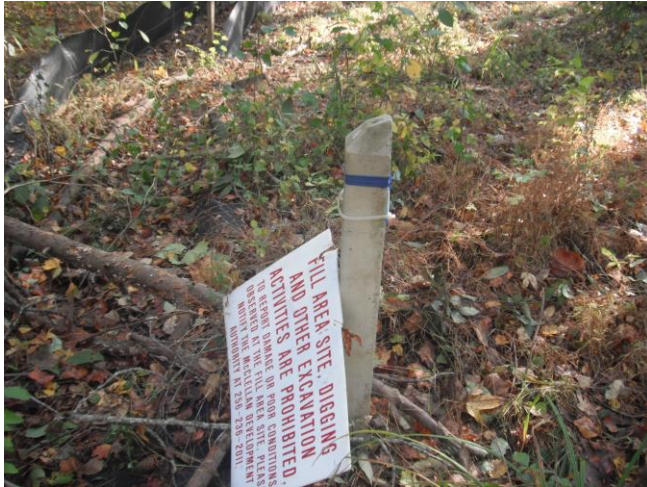
One of the no digging signs from the boundary monuments located along the perimeter had fallen and was reattached during the inspection.

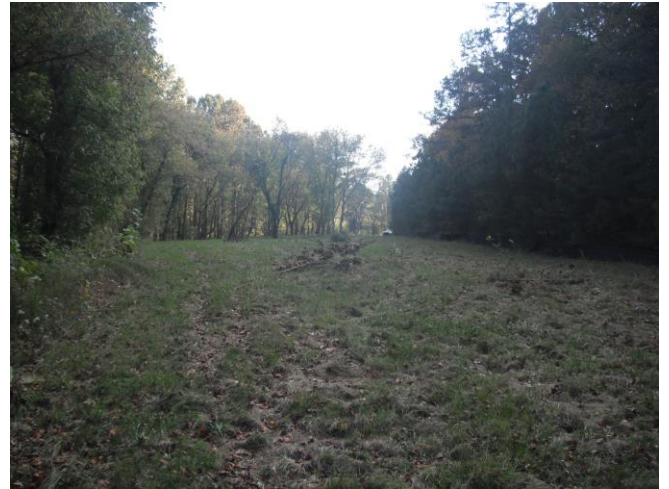
The vegetation across the cap appeared to be in good condition during the inspection.

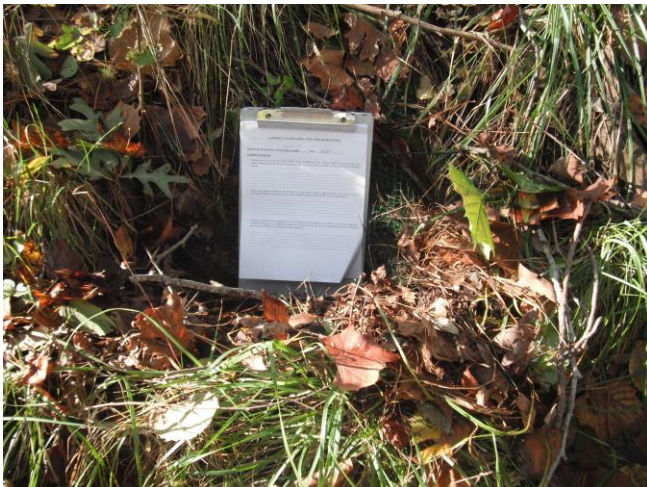
A cap inspection was conducted for the Fill Area North of Landfill 2 on October 8, 2015. The cap and vegetative cover appeared to be in good condition. However, a small hole in the cap surface was observed along the southeastern slope. The hole was repaired by filling it with gravel. No signs of subsidence, erosion, or exposed debris were observed. No monitoring wells are located at the Fill Area North of Landfill 2 and none were installed. The Landfill Cap inspection Checklist Items report for the cap inspection is provided in Appendix B.

A small hole was observed on the southeastern portion of the landfill, approximately three feet from the base of the slope. The hole was repaired by filling it with gravel.

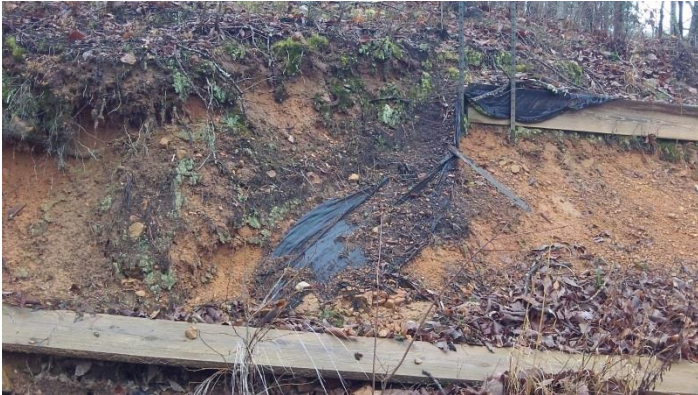
A deficiency in the BMPs was observed along the southern boundary of Range 12. The soil underneath the planks washed out and caused the silt fence and planks to fail.

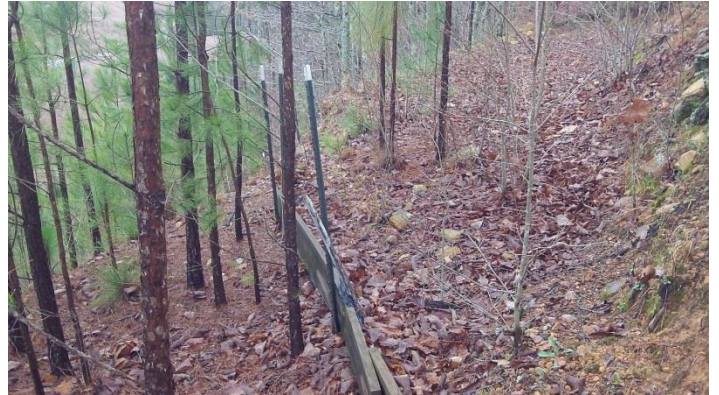
Pine trees grow beneath the area of erosion and help to stabilize the lower portion of the slope.

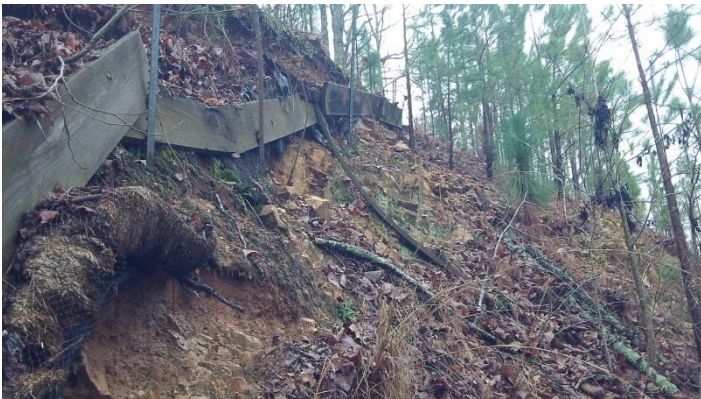
The vegetation growing on the slope of Range 12 is limited due to the steep, rocky slope.

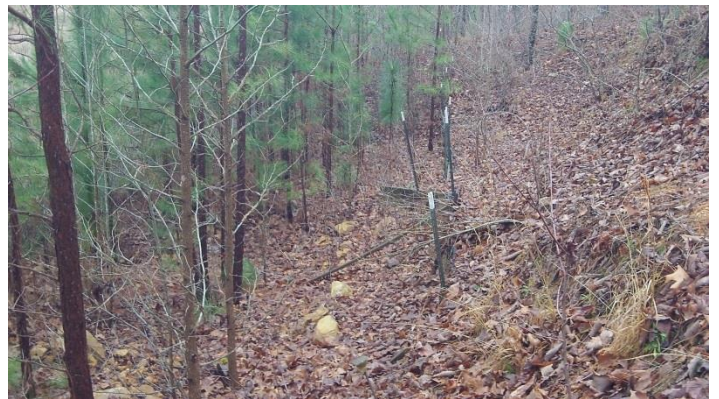
The ground surface at the base of the slope is covered with leaves and pine needles creating a natural mulch cover.

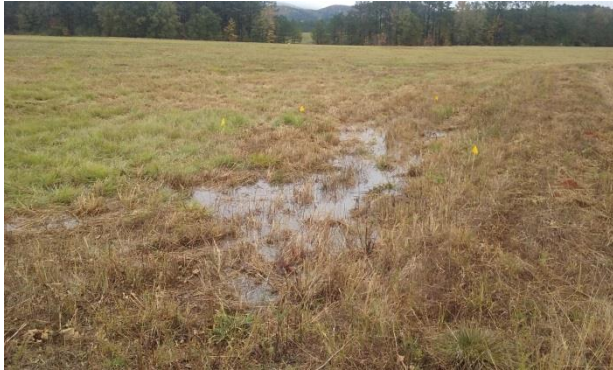
LF3_11.2.2015-001: The vegetation across the cap surface was in good condition at the time of the inspection. The picture is located in the west-central portion of the landfill looking to the south.

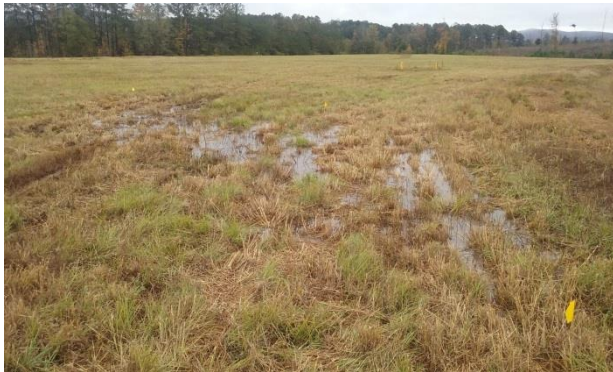
LF3_11.2.2015-002: Several areas were observed to be holding water after the rainfall event. The areas holding water were near the block and gravel inlets. This view is located in the west-central portion of the landfill looking to the south.

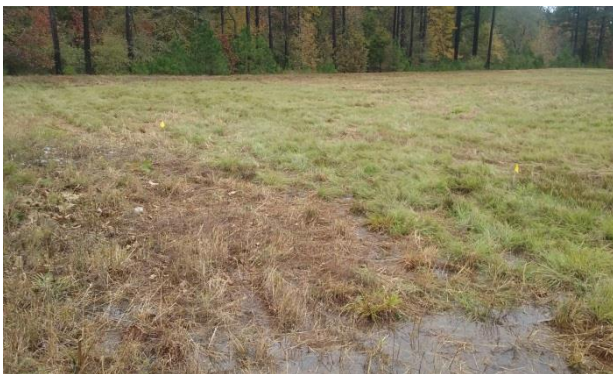
LF3_11.2.2015-003: No erosion or channeling was observed during the inspection. The photo is located in the west-central portion of the landfill looking to the west.
