Land Use Control Effectiveness Report - 2018

McClellan, Anniston, Alabama

January 2019

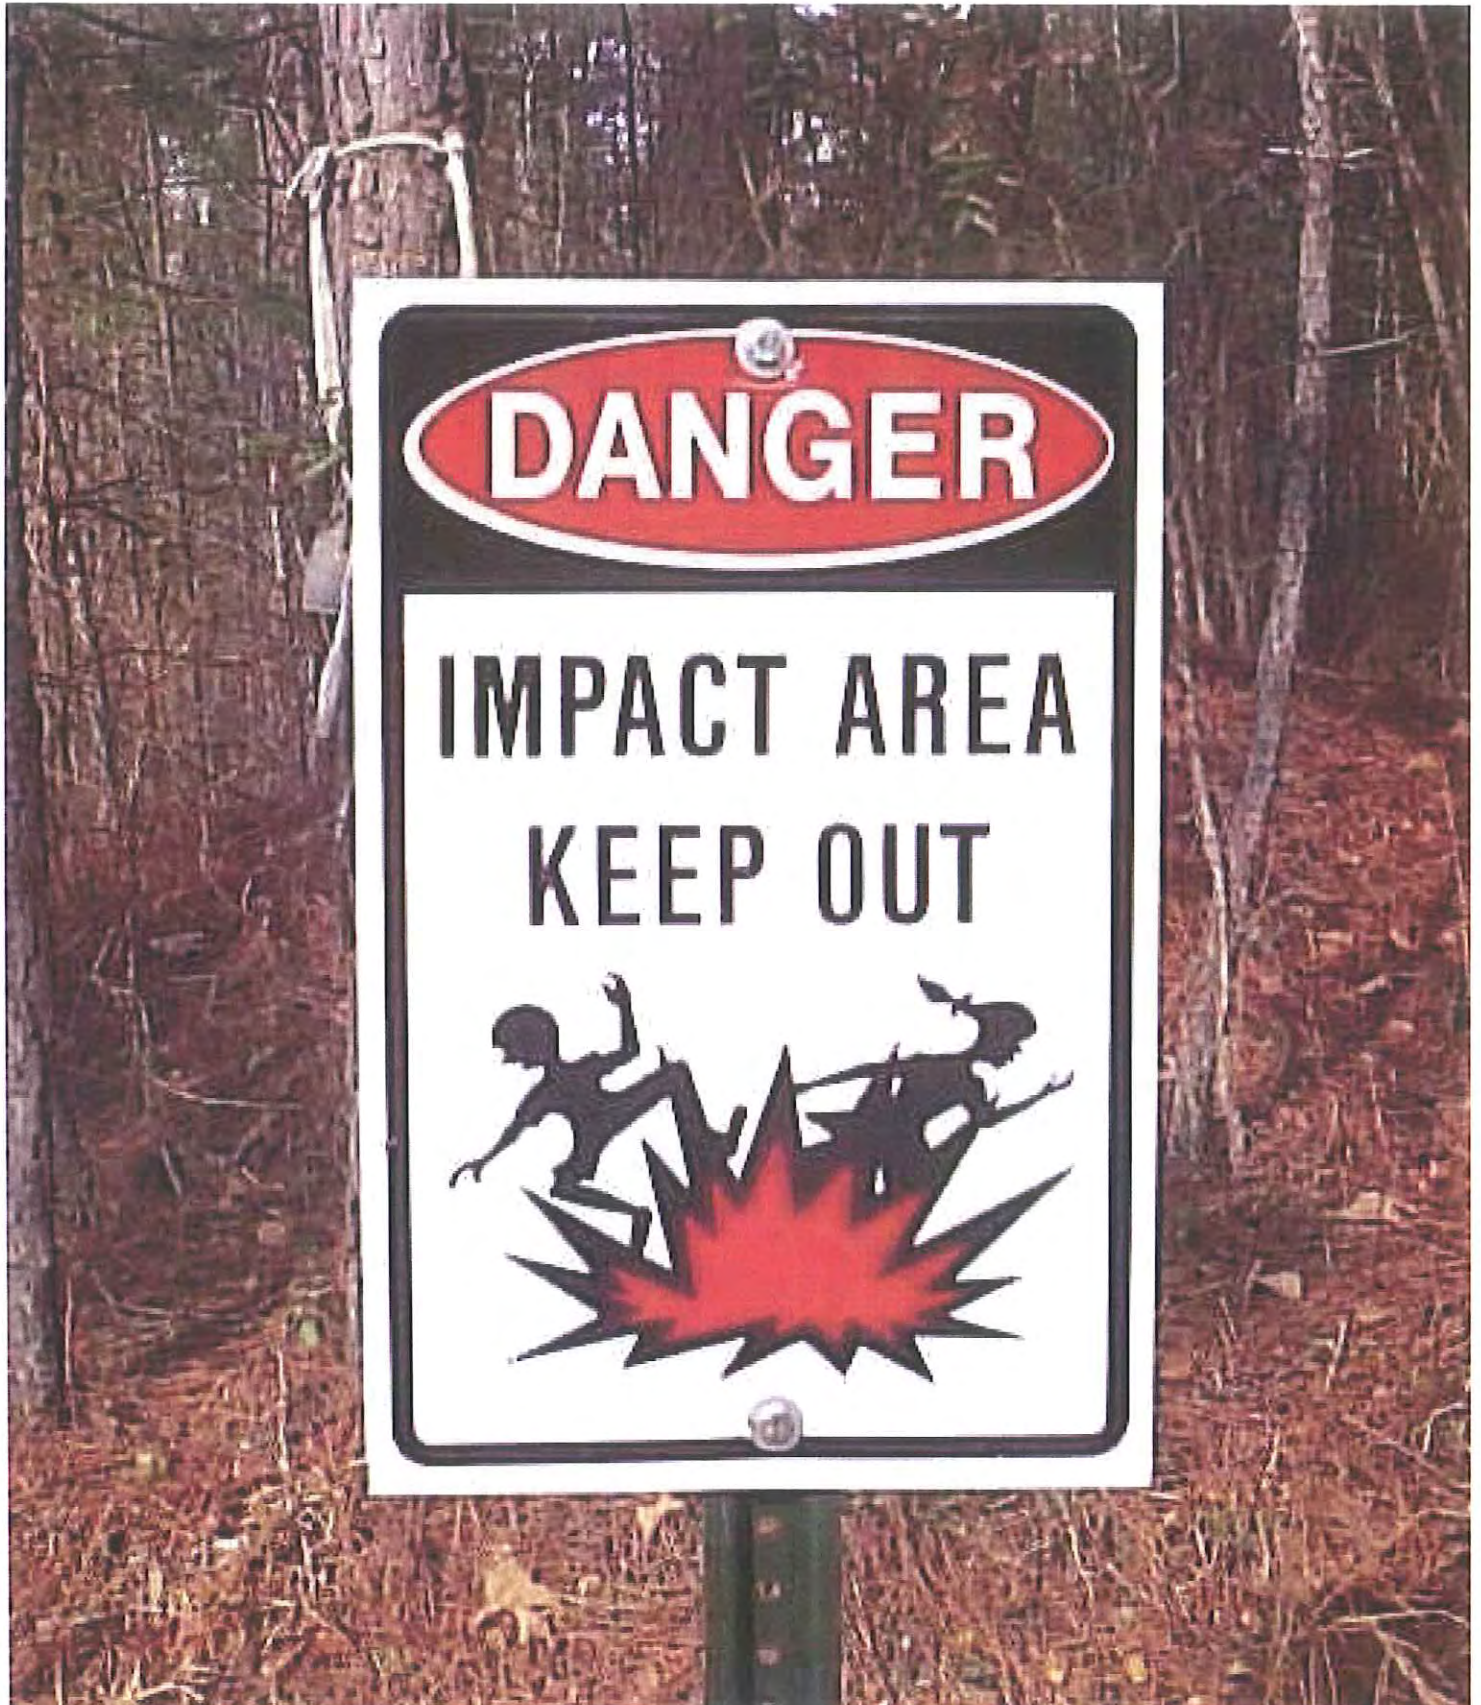
Figure 2

MEC warning signs (Figure 2) are installed around the perimeter of the Alpha MRA and Bravo MRA, and are inspected by Matrix on a bi-weekly basis. Missing or damaged signs are replaced as necessary. The MDA coordinates the community outreach program with the Army. A training video explaining the dangers of MEC is mandatory for anyone performing work on McClellan. The MDA and Matrix brief all contractors conducting work in these areas at McClellan on the possibility of encountering MEC, and describe procedures to implement should MEC happen to be encountered.

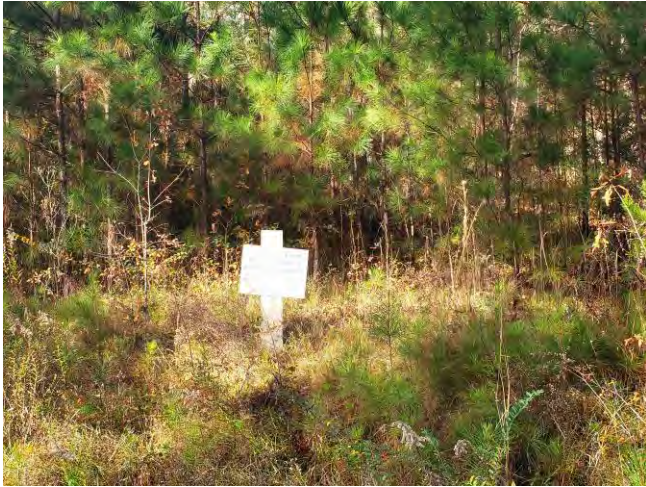
The boundary monuments were visible and in good condition during the inspection.

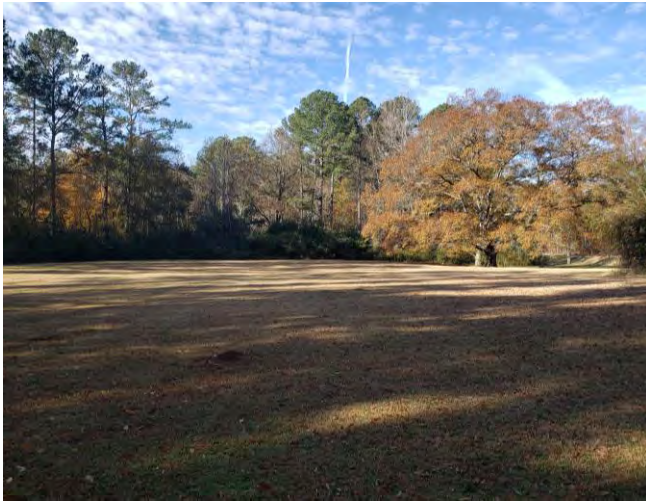
Vegetation was observed to be in good condition.

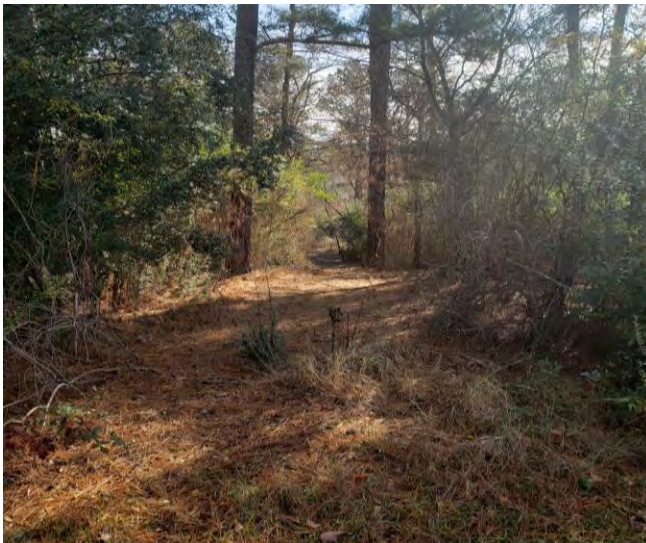
No erosion was observed during the inspection. The utility company has mowed the easement.

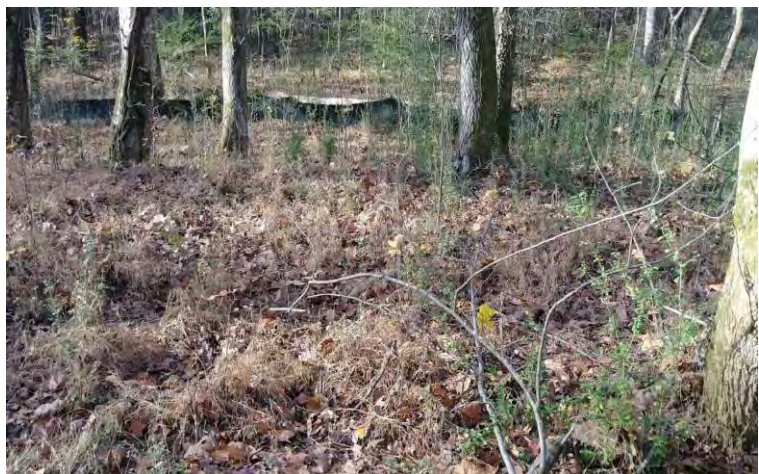
BMPs were in place and the vegetation was in good condition.

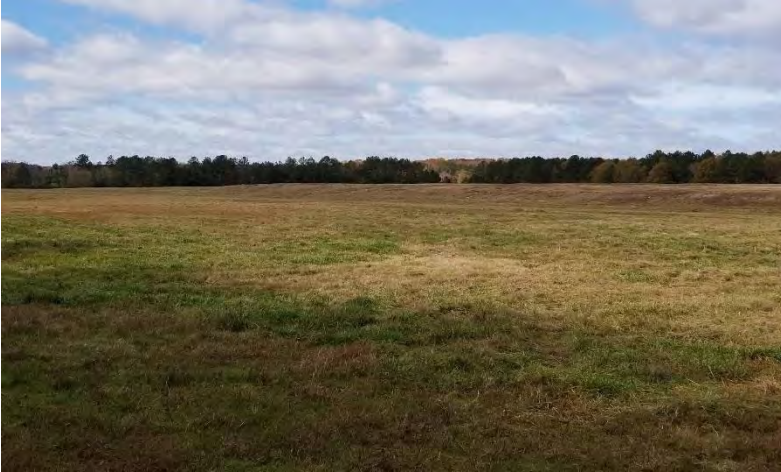
LF4-01: The landfill cap was mowed prior to the inspection. No bare areas were observed during the inspection.

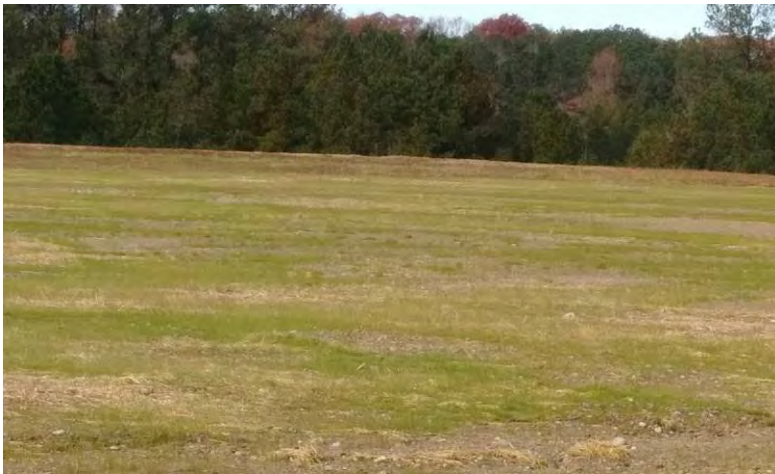
LF4-02: The vegetation across the landfill cap was observed to be in good condition during the inspection.

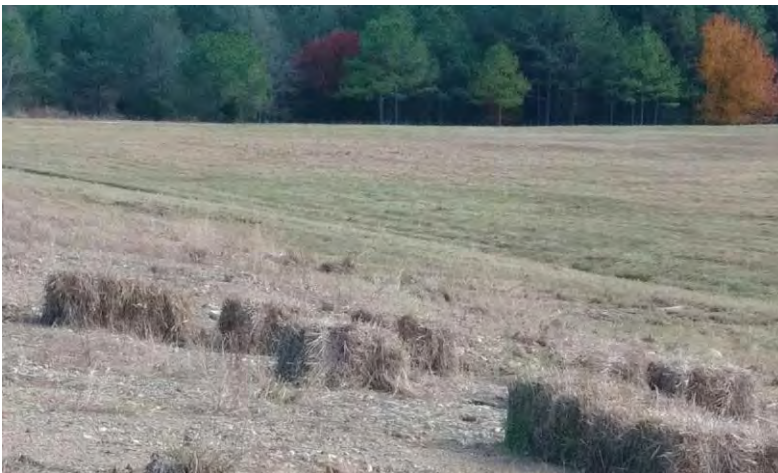
observed. No areas of subsidence, erosion, or exposed debris were noted. During the November 2017 inspection of the Butler Green Industrial Landfill several rills of various sizes were observed to be developing along the southern slope of the landfill. Matrix contracted Envirogrind, LLC to haul soil from a stockpile located near the Reilly Airfield and place the soil in the rills. Envirogrind then used a bulldozer to help pack the soils. After the soil was placed, Matrix personnel seeded and mulched the area to promote seed growth. The work was completed in March 2018. The Landfill Cap Inspection Checklist Items report for the cap inspection is provided in Appendix B.

LF4-03: BMPs were in place to fix rills noted in previous inspections and prevent erosion.

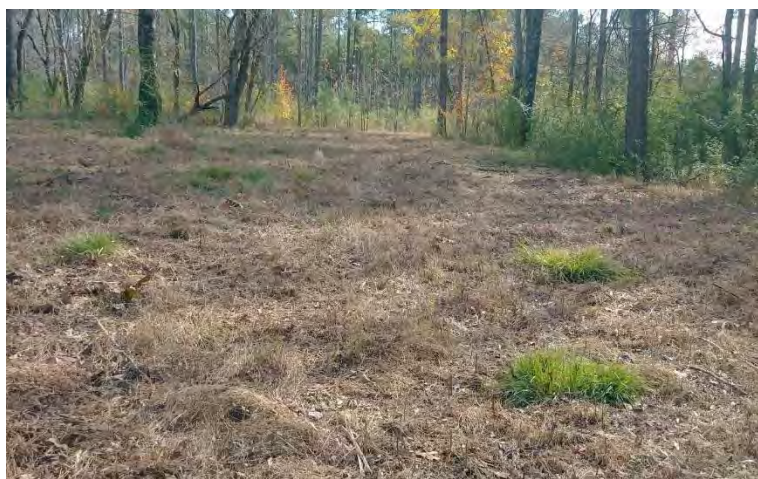
GD-01: The landfill cap was mowed prior to the inspection. No bare areas were observed during the inspection.

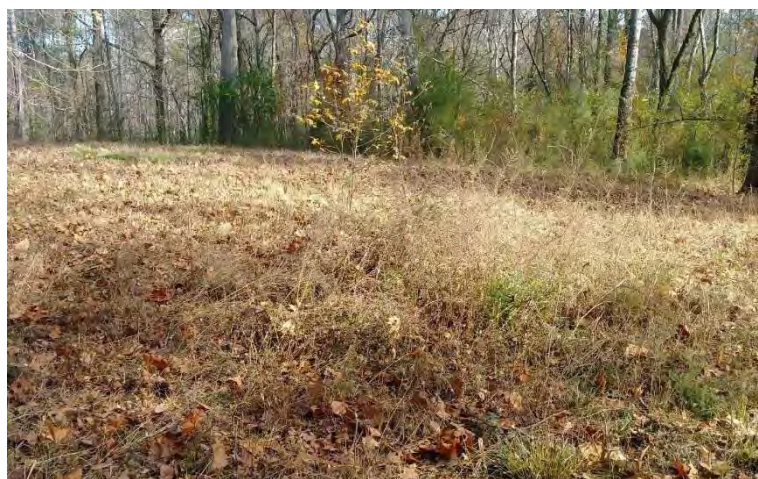
GD-02: The vegetation across the landfill cap was observed to be in good condition during the inspection.

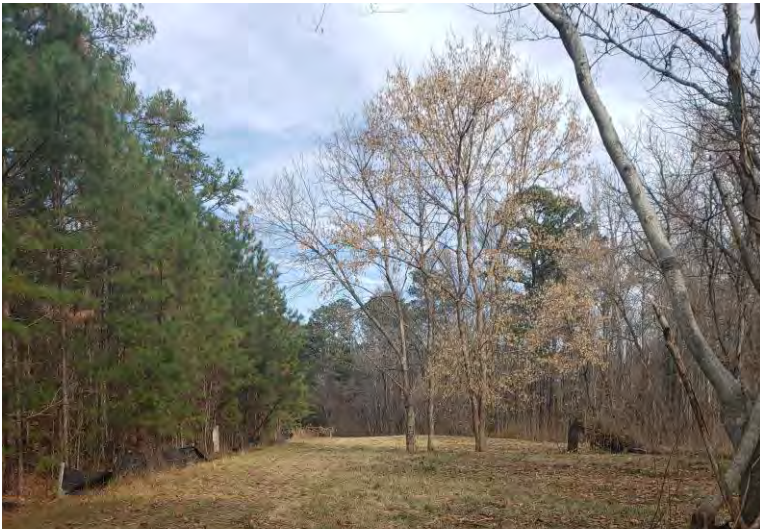
The vegetation across the cap appeared to be in good condition during the inspection.

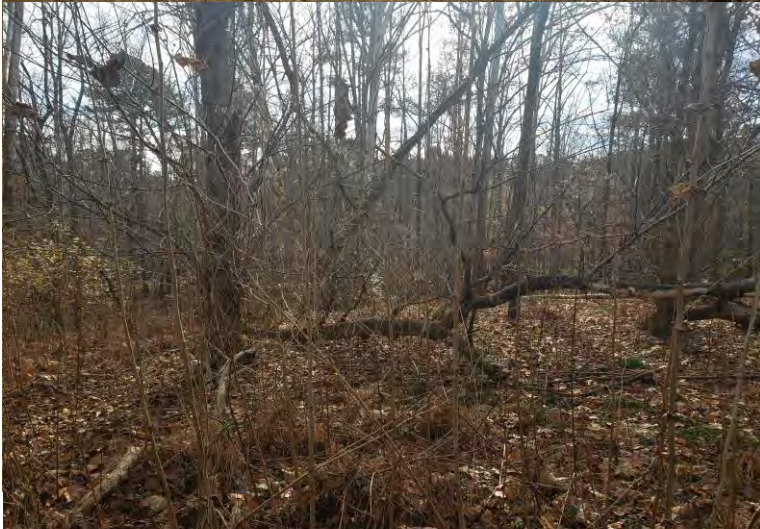
Several dead trees have fallen. No damage to the cap observed.

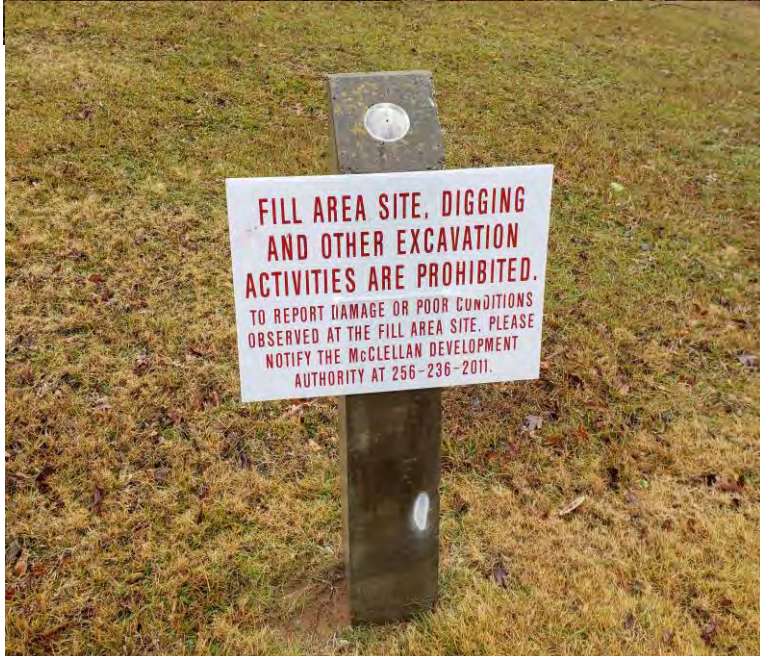
There was one No Digging Sign missing from the boundary monuments. It was replaced at the time of inspection.

A cap inspection was conducted for the Fill Area North of Landfill 2 on December 3, 2018. Monuments were in good condition. One no digging sign was reattached during the inspection. The cap and vegetative cover appeared to be in good condition during the inspection. No bare areas were observed. No signs of subsidence, erosion, or exposed debris were observed. No monitoring wells are located at the Fill Area North of Landfill 2 and none were installed. The Landfill Cap Inspection Checklist Items report for the cap inspection is provided in Appendix B.

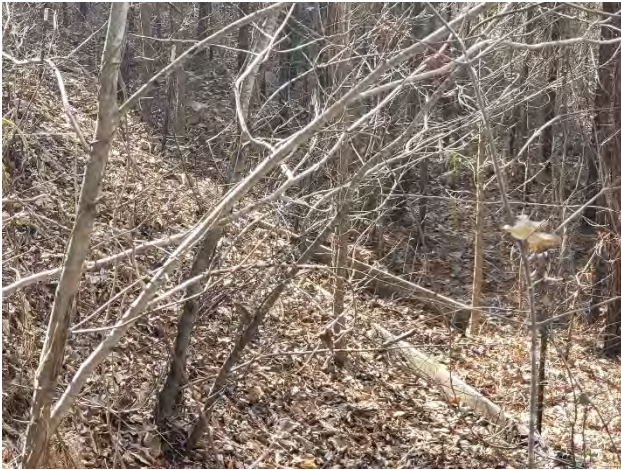
The BMPs repaired in March of 2015 were observed to be in place and in good condition.

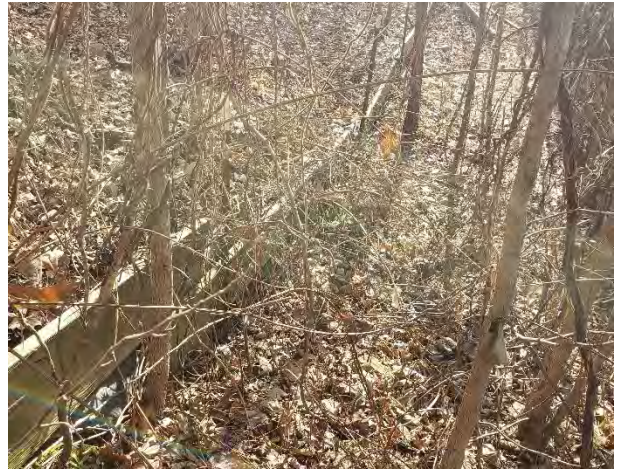
Vegetation is improving and continues to help limit erosion.

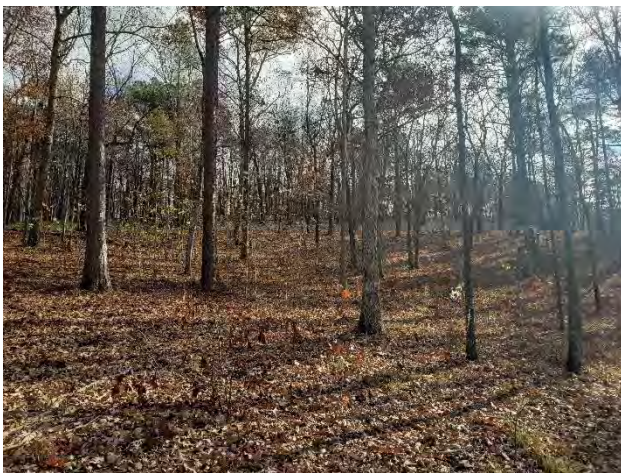
Vegetation on the slope of Range 12 is limited to small pine trees and other small woody stemmed plants.

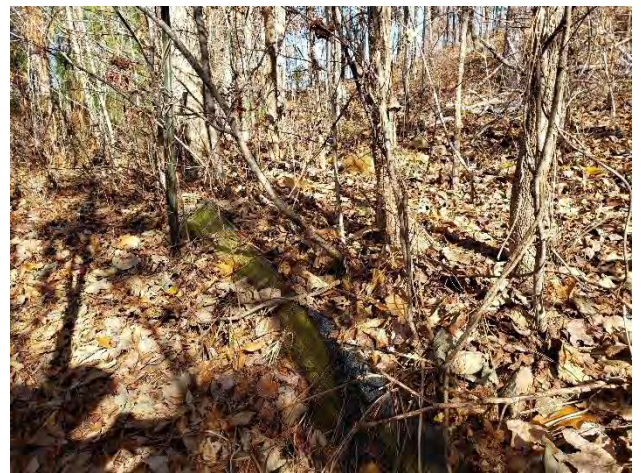
No erosion on the face of the slope was observed during the inspection. No soils were observed to have migrated offsite.

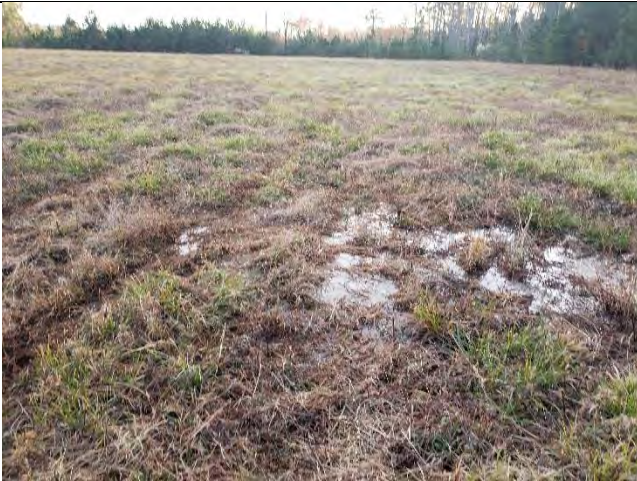
LF3: Some puddling was observed. Inspection was performed after 2 days of heavy rain.

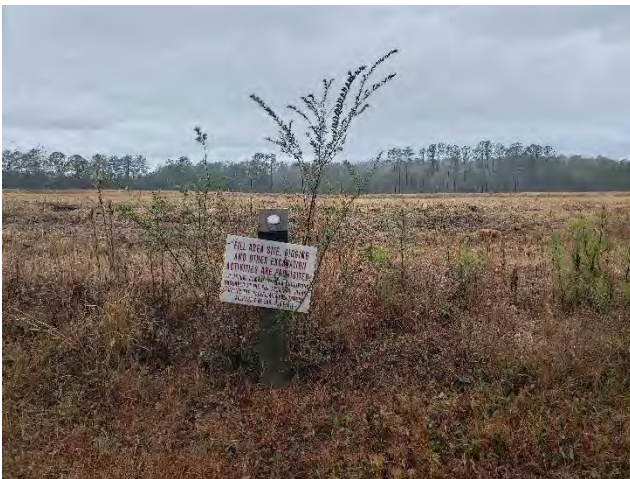
LF3: One sign was missing and was repaired at the time of inspection.

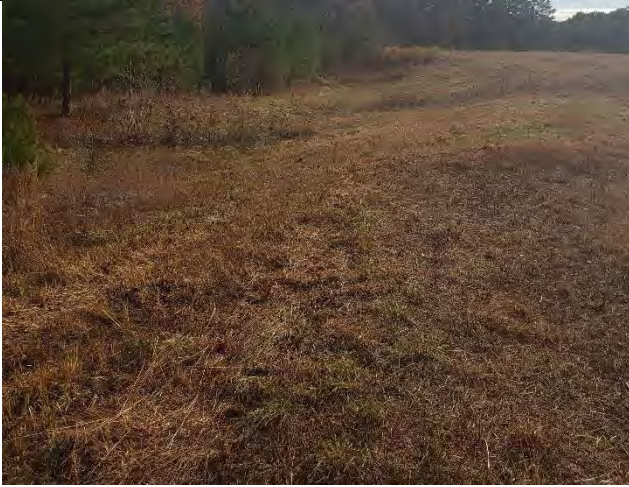
FANWR: The two rock chutes and vegetation of FANWR were observed to be in good condition at the time of inspection.

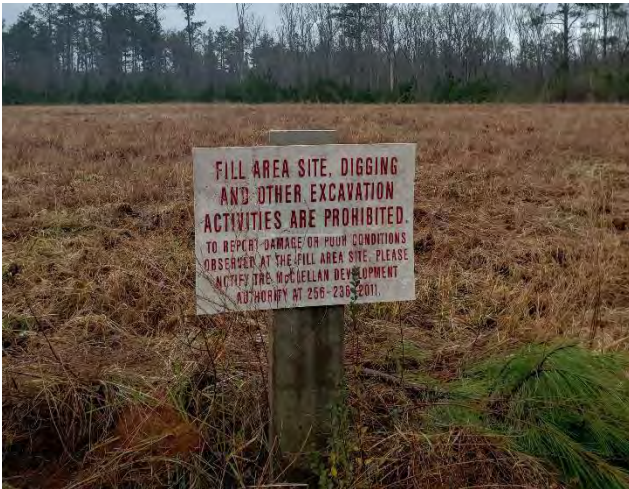
FANWR: All boundary monuments were in good condition. Two signs were missing and were replaced at the time of inspection.
