**Land Use Control Effectiveness Report - 2021**  
**McClellan, Anniston, Alabama**

**Matrix Environmental Services, LLC**  
**283 Rucker Street**  
**Anniston, Alabama 36205**

**January 2022**  
**Revised April 2022**

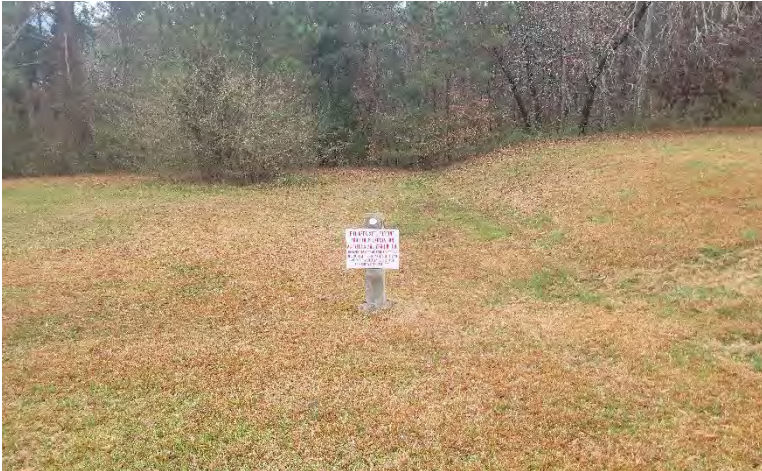
The #1 boundary monument sign was missing and was replaced at the time of inspection.

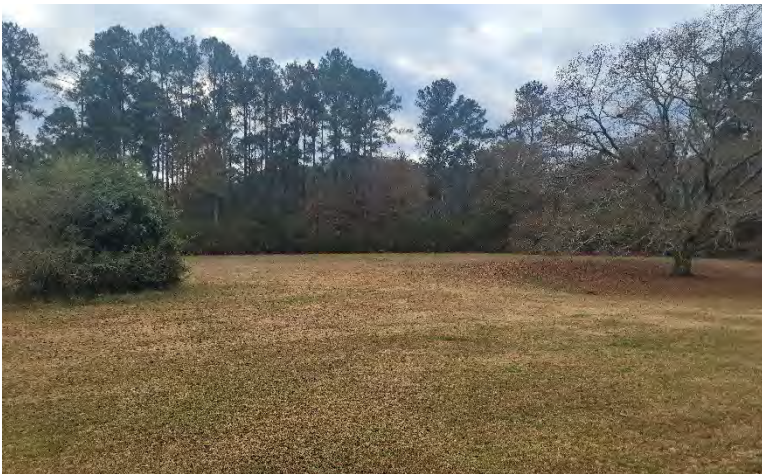
The cap was recently mowed. No erosion was observed.

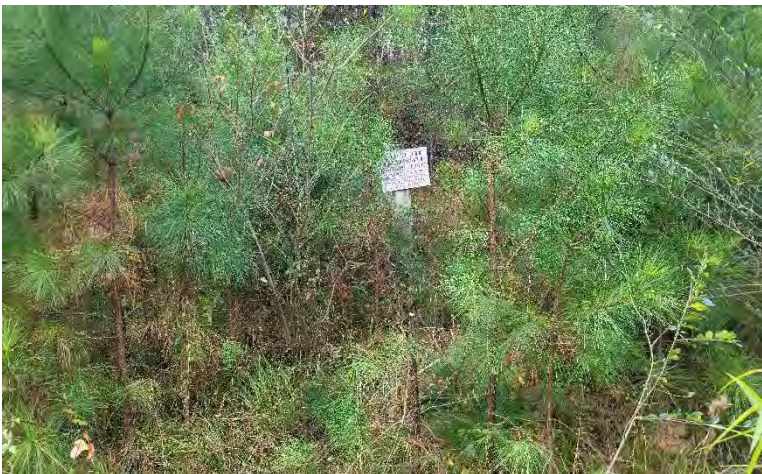
The #8 boundary monument sign was on the ground at the time of the inspection. It was repaired at the time of inspection.

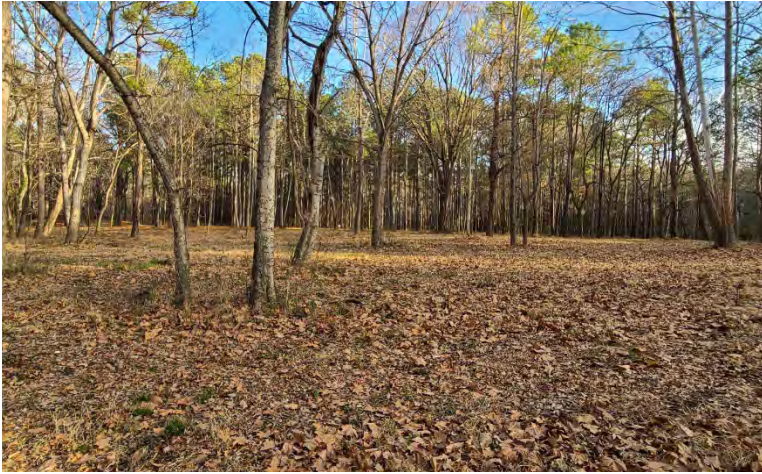
The vegetation across the cap appeared to be in good condition during the inspection.

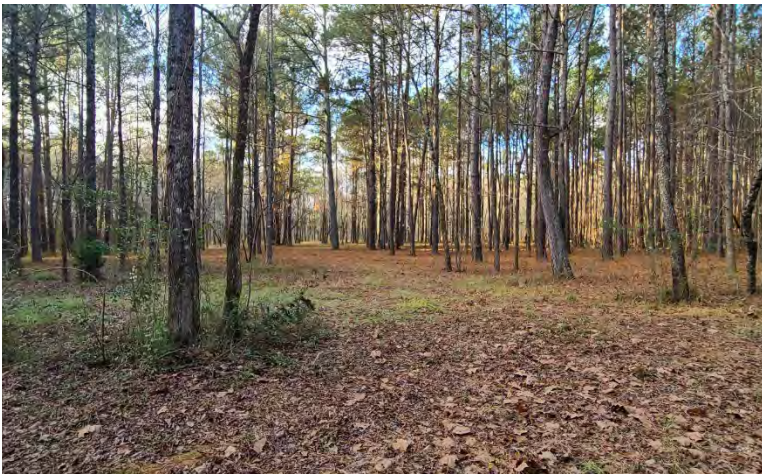
All deadfall from previous storms have been removed and overgrown areas have been reclaimed by mulching. No damage to the cap was found.

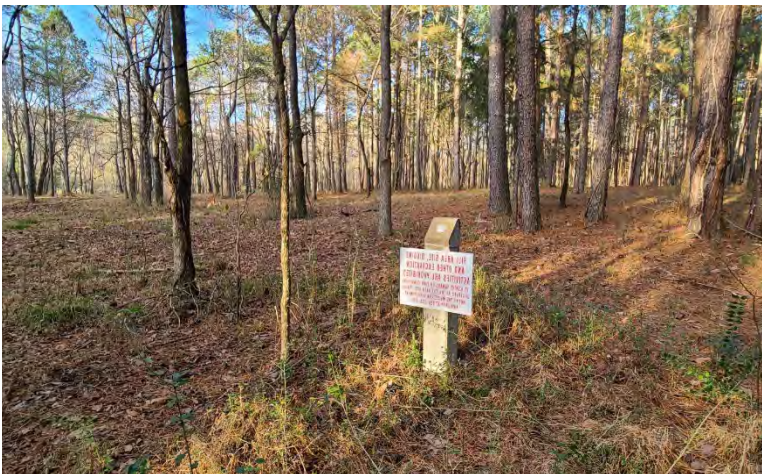
No Digging signs on monuments 1, 7, and 8 were attached, but were replaced due to deterioration.

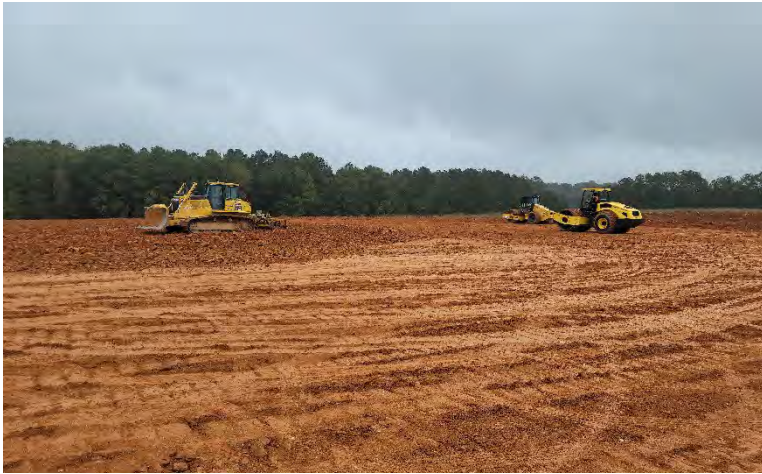
LF4-01: Landfill cap and closure activities are underway and should be completed by February 6, 2022.

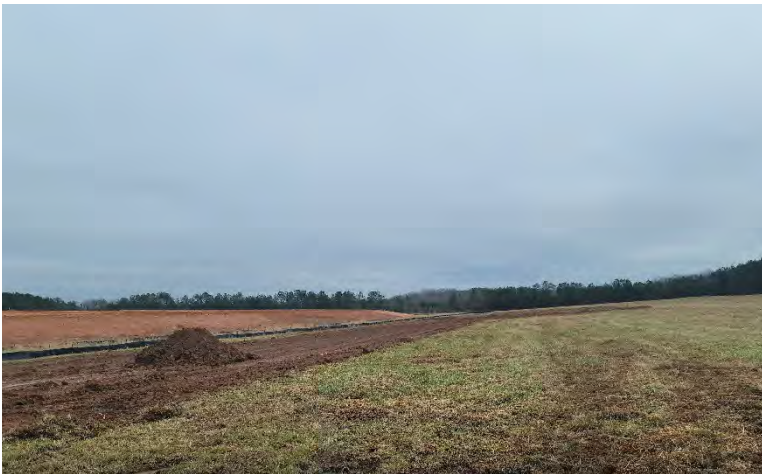
Some standing water was observed at the time of the inspection. The inspection was performed a couple of days after a heavy rain. Repairs are being addressed along with the cap and closure activities currently underway.

LF4-02: Some areas of subsidence were observed to be holding water. Repairs are being address during the cap and closure activities currently underway.

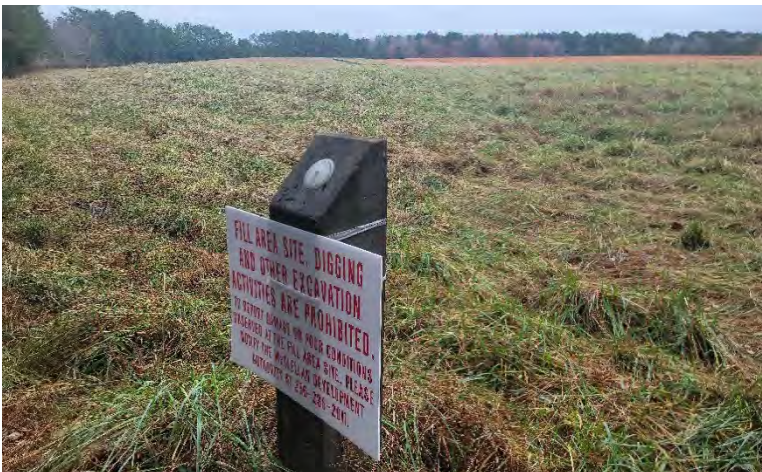
LF4-03: Three signs were missing and were repaired at the time of inspection. The vegetation across the landfill cap was observed to be in good condition with the exception of current cap and closure activities.

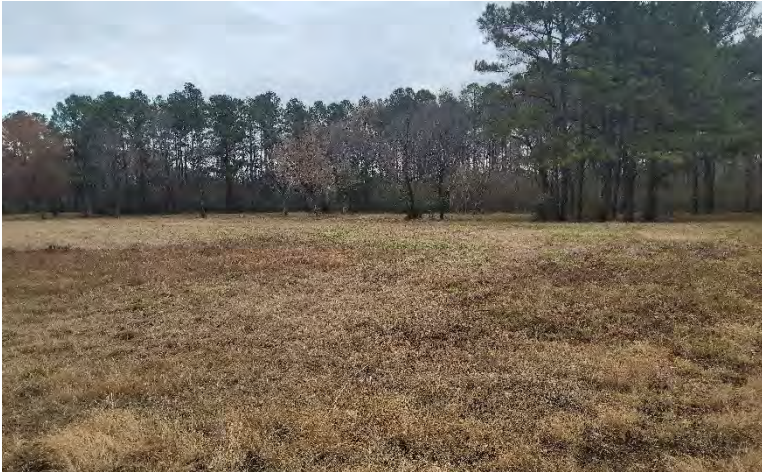
GD-01: No bare areas or damage to the cap were observed during the inspection.

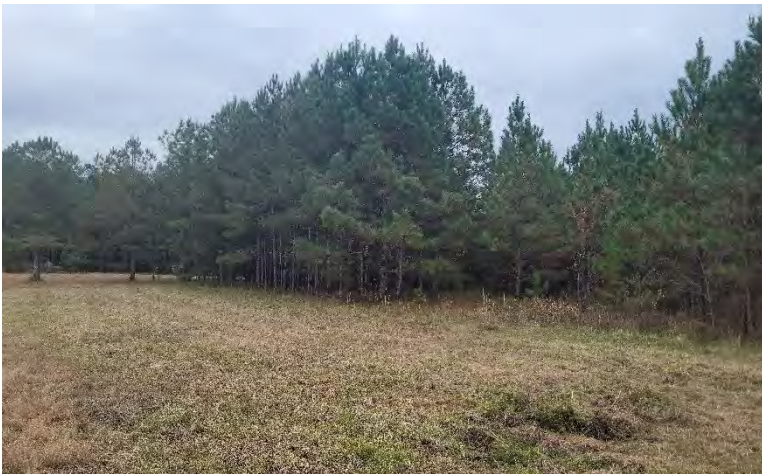
GD-02: The vegetation across the landfill cap was observed to be in good condition during the inspection.

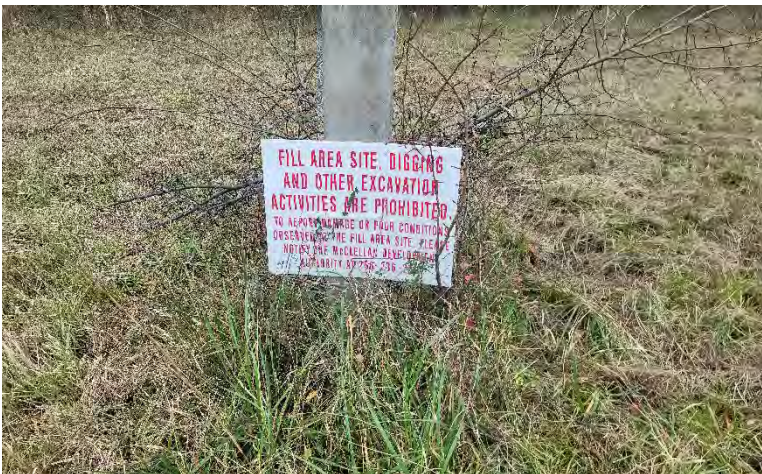
GD-03: The boundary monuments were in good condition and no signs were missing at the time of inspection.

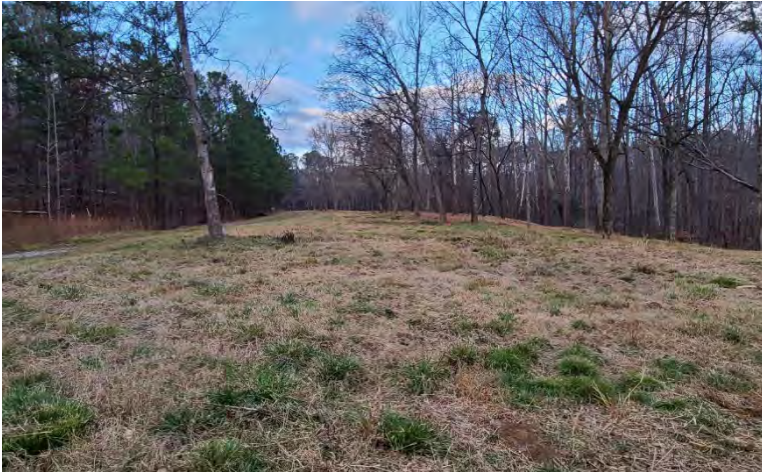
The vegetation across the cap appeared to be in good condition during the inspection.

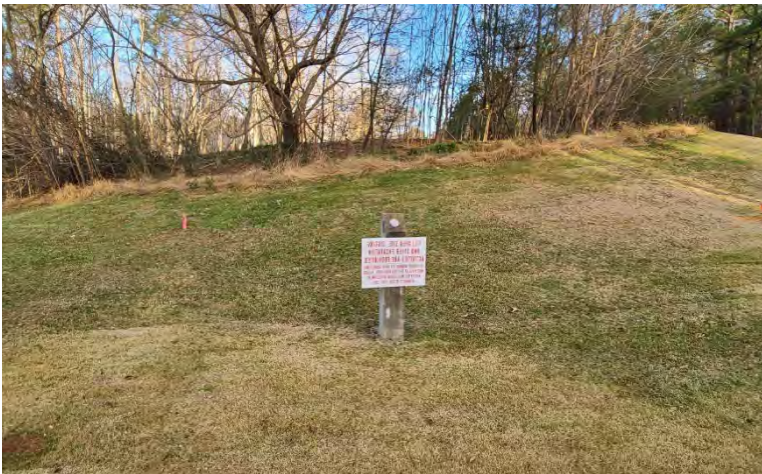
No Digging signs were replaced on monuments 2 and 4.

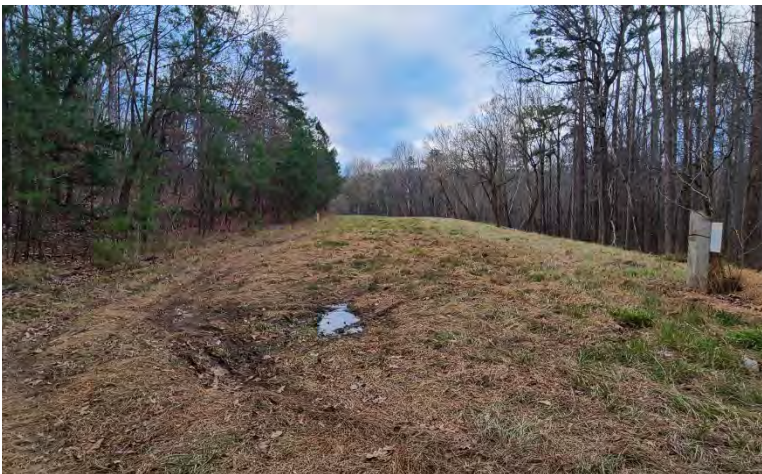
Several areas near monument 4 show signs of subsidence and are scheduled to be repaired in the spring of 2022.

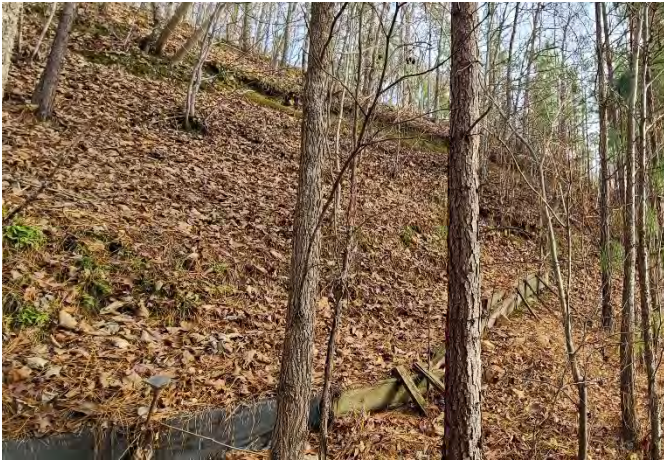
The BMPs repaired in March of 2015 were observed to be in place and in good condition.

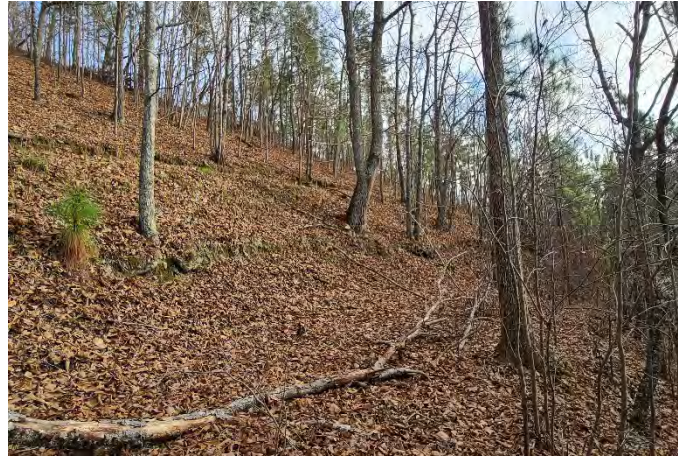
Vegetation is improving and continues to help limit erosion.

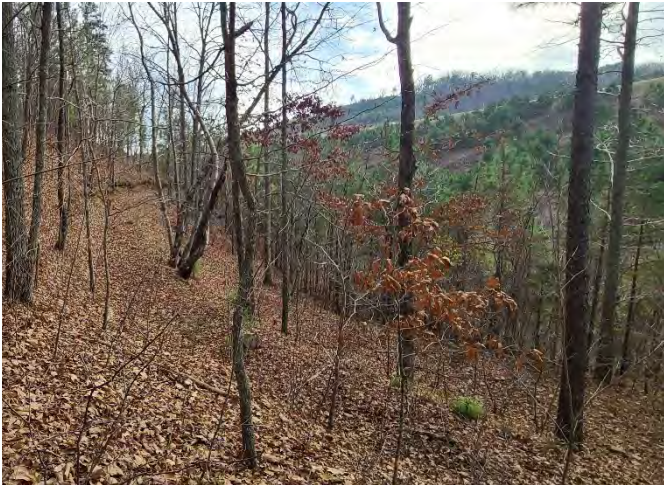
Vegetation on the slope of Range 12 is limited to small pine trees and other small woody stemmed plants.

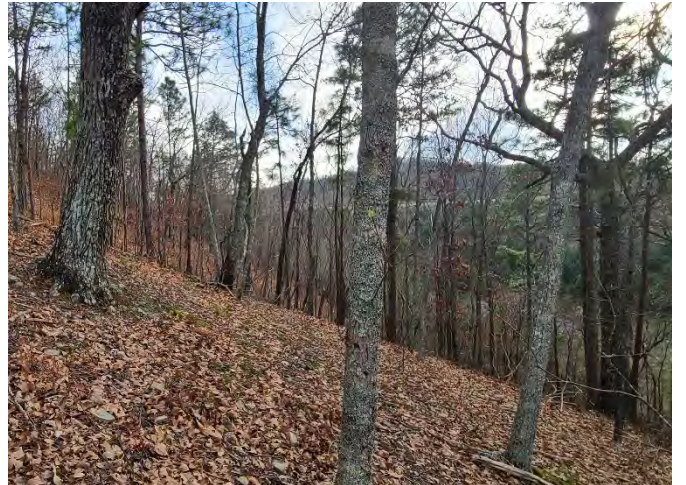
No erosion on the face of the slope was observed during the inspection. No soils were observed to have migrated offsite.

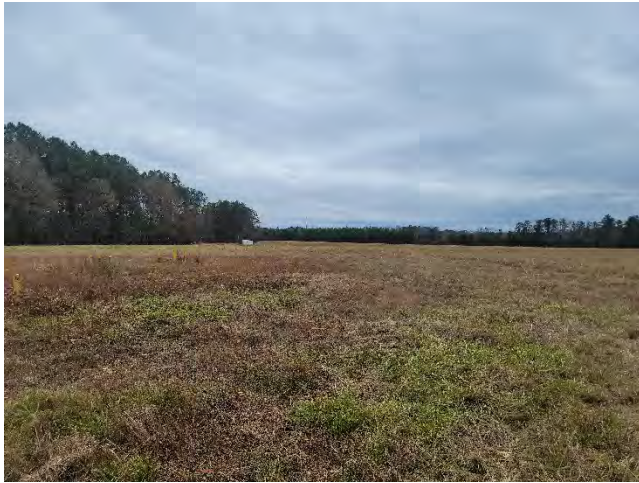
LF3: Vegetation was stable and in good condition. No standing water was observed at the time of inspection.

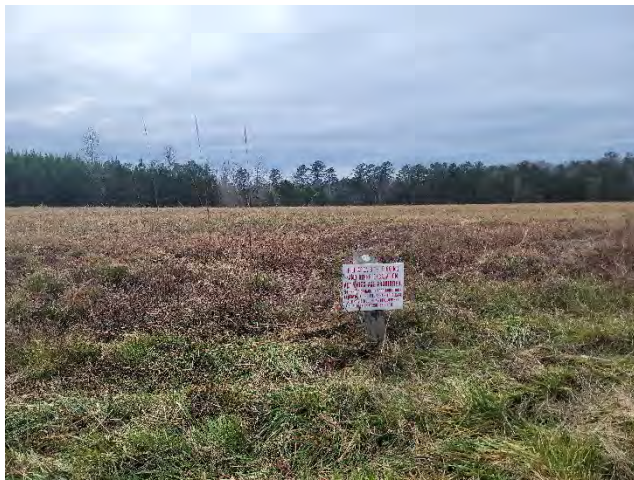
LF3: Six signs were damaged or missing and were replaced at the time of inspection.

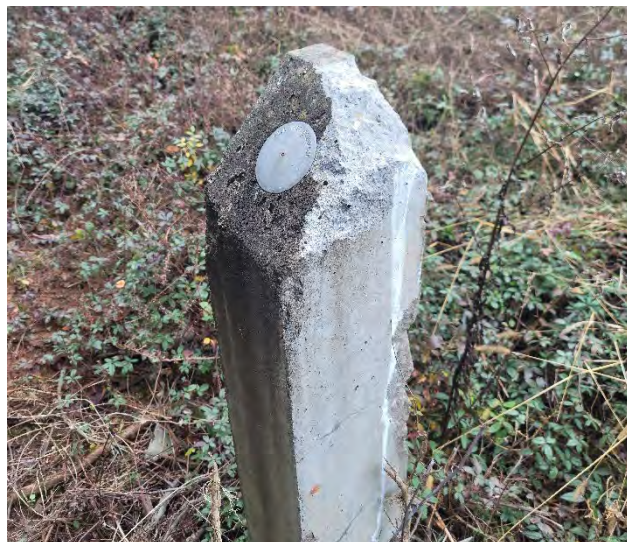
LF3: One monument on the south side of the landfill is chipped, but still in working order.

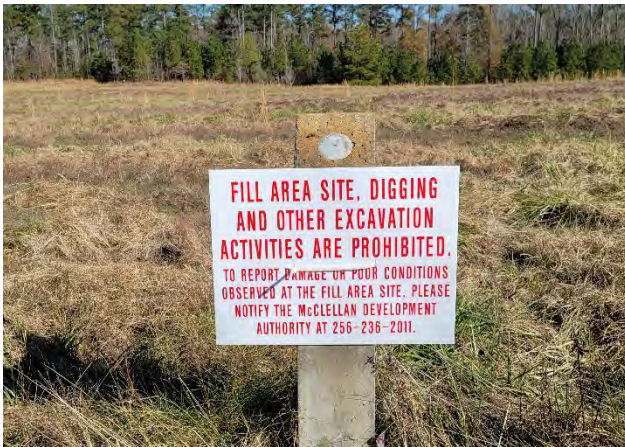
FANWR: All boundary monuments were in good condition. No Digging Signs were in good condition at the time of inspection.
