**Land Use Control Effectiveness Report - 2020**  
**McClellan, Anniston, Alabama**

**McClellan Development Authority**  
**McClellan, Anniston, Alabama**

**Matrix Environmental Services, LLC**  
**283 Rucker Street**  
**Anniston, Alabama 36205**

**January 2021**

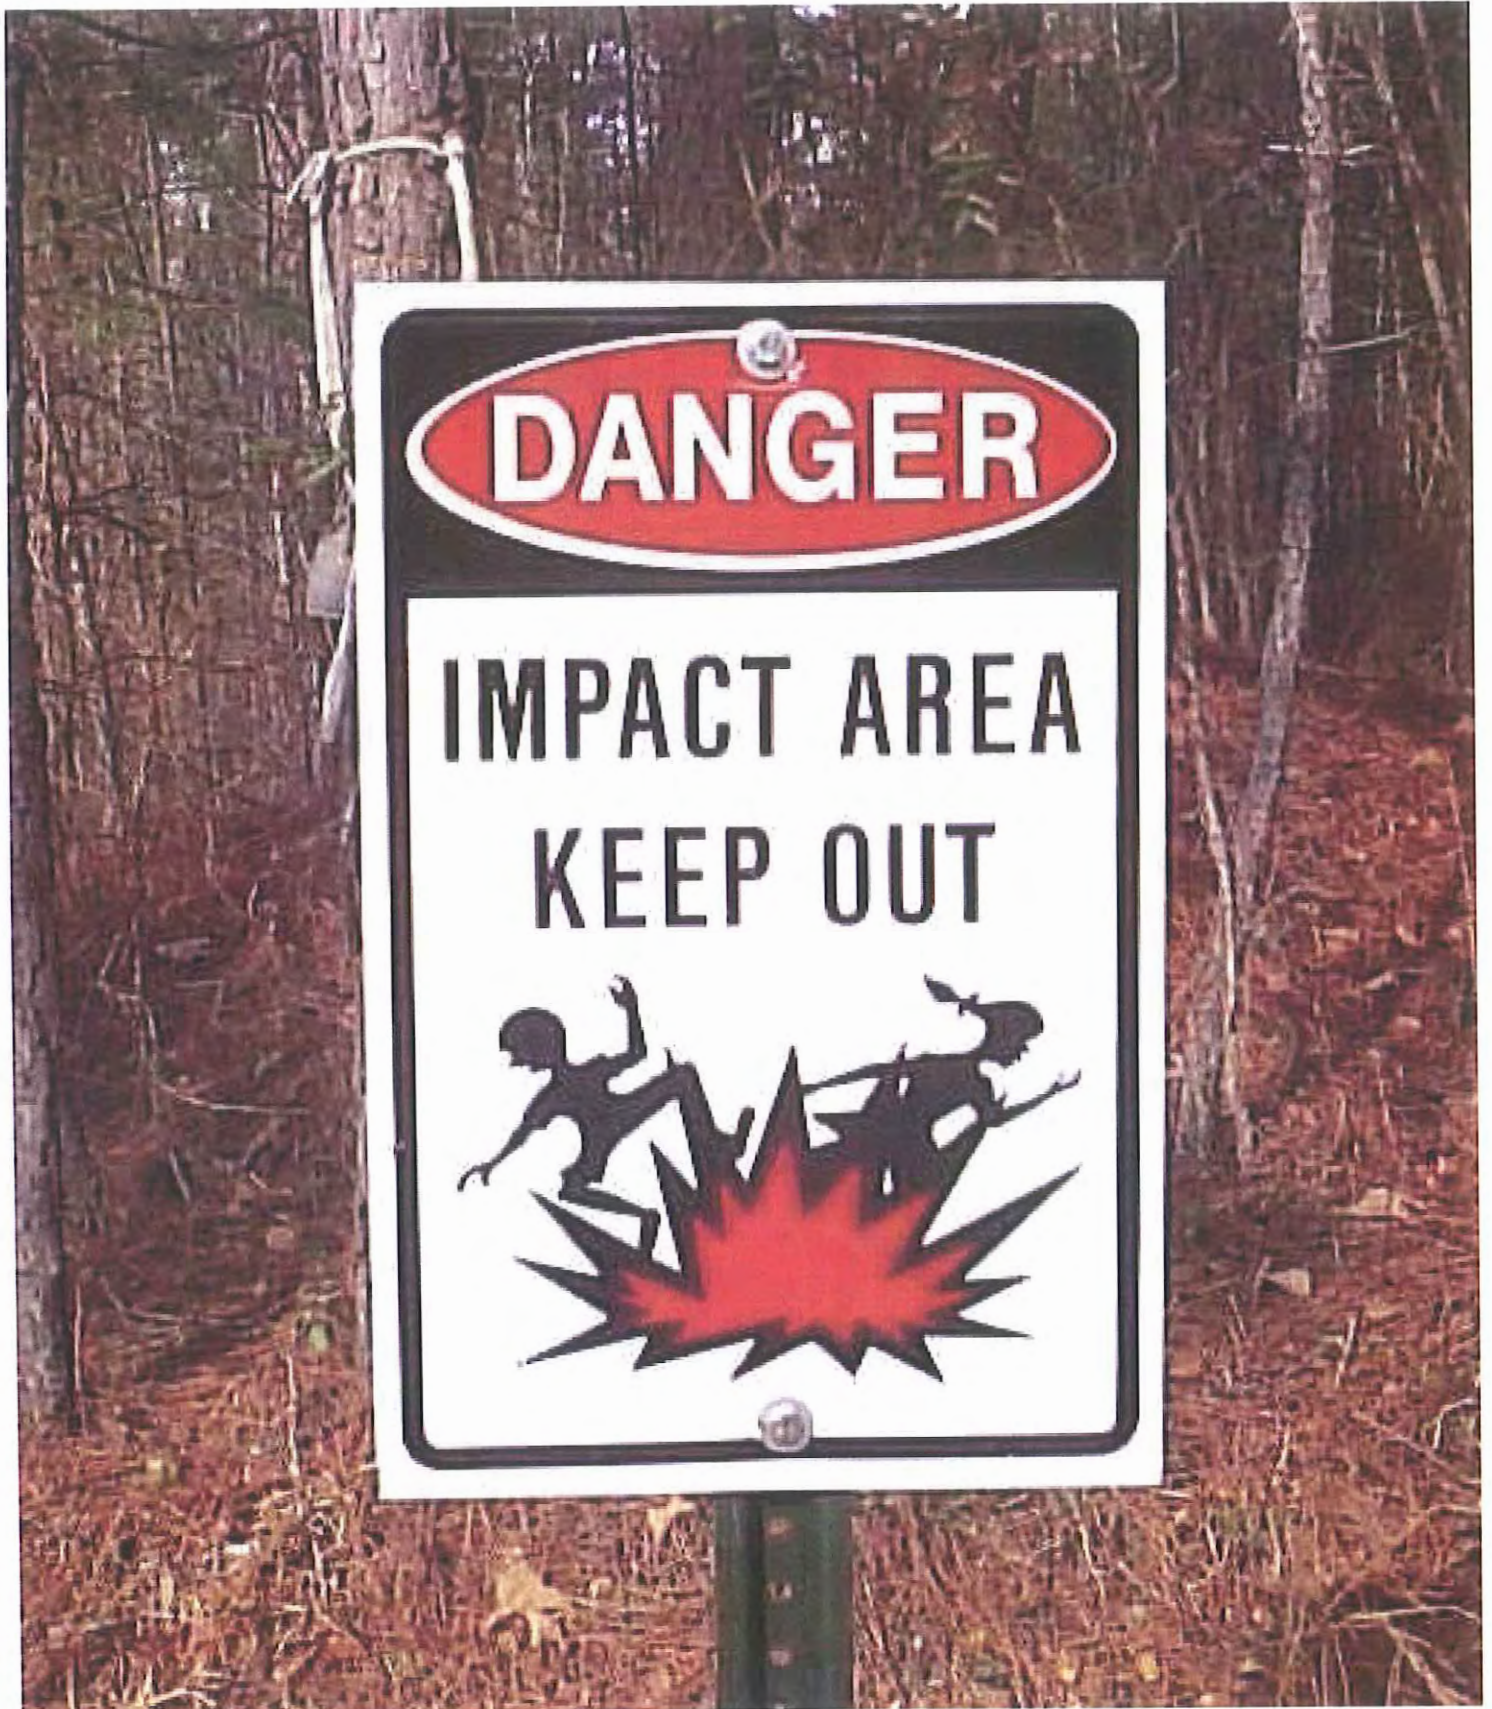
Figure 2

MEC warning signs (Figure 2) are installed around the perimeter of the Alpha MRA and Bravo MRA, and are inspected by Matrix on a semi-weekly basis. Missing or damaged signs are replaced as necessary. The MDA coordinates the community outreach program with the Army. A training video explaining the dangers of MEC is mandatory for anyone performing work on McClellan. The MDA and Matrix brief all contractors conducting work in these areas at McClellan on the possibility of encountering MEC, and describe procedures to implement should MEC happen to be encountered.

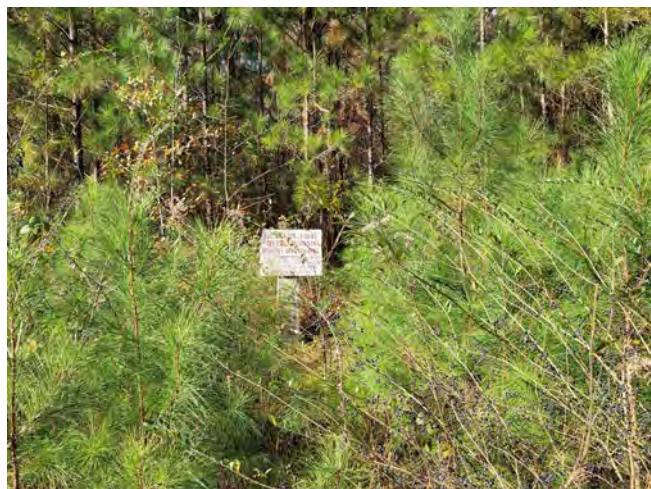
☒ Monument 8, Comments: Good condition, no damage. No digging sign was on the ground but was reattached during the inspection.

The #8 boundary monument sign was on the ground at the time of the inspection. It was repaired at the time of inspection.

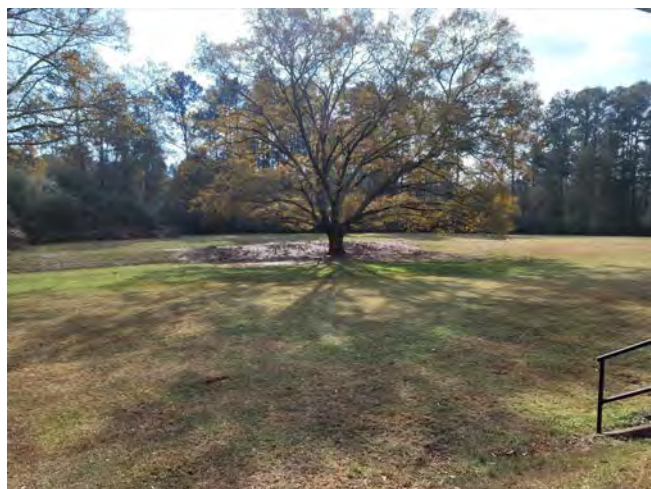
The cap was recently mowed. No erosion was observed.

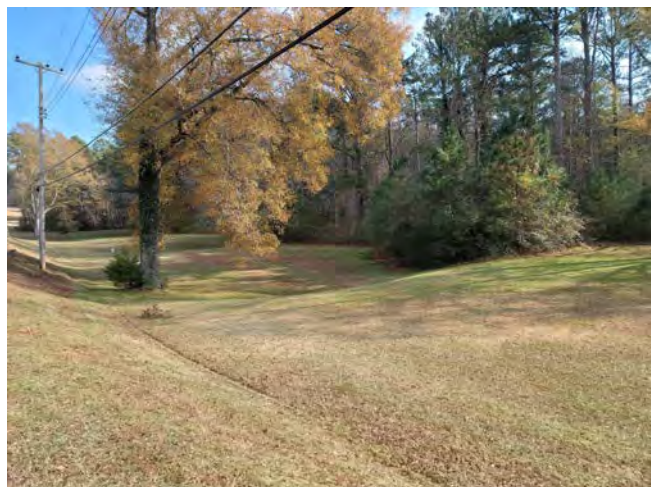
No erosion was observed during the inspection.

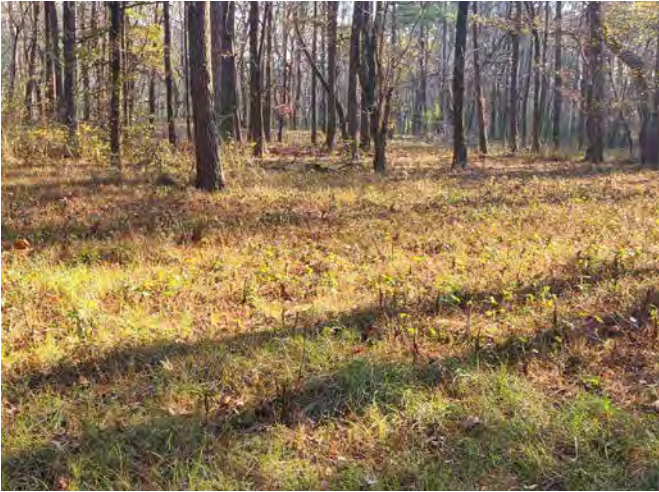
The vegetation across the cap appeared to be in good condition during the inspection.

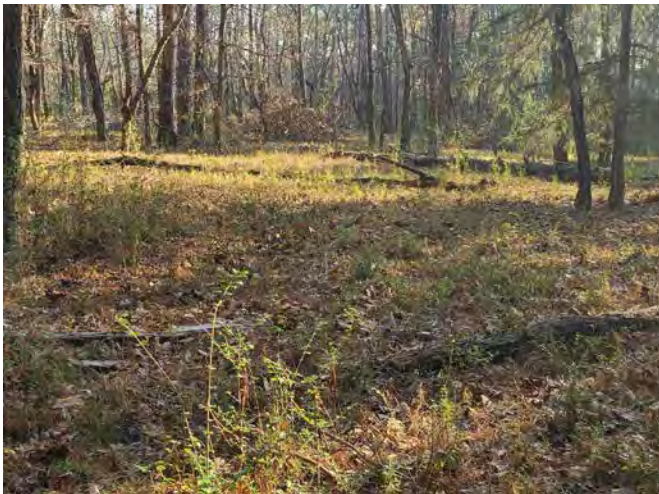
Storms with strong winds have created areas of with deadfall around the top of the cap. No damage to the cap was found.

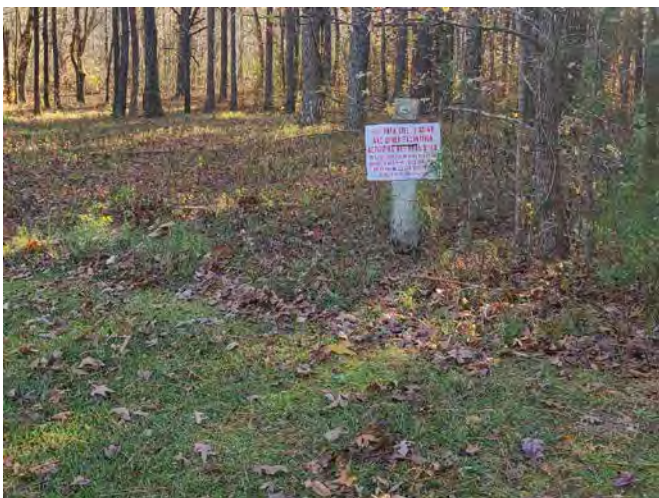
Monument 2 and attached no digging sign in good shape near the access point.

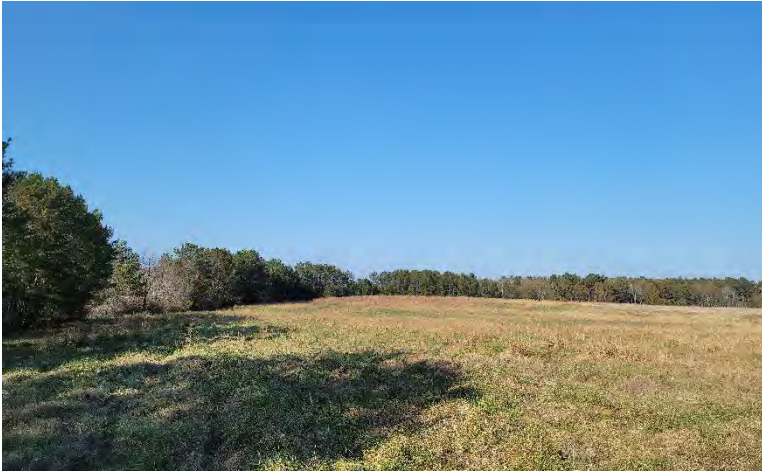
LF4-01: The landfill cap was mowed in August 2020. The vegetation across the landfill cap was observed to be in good condition during the inspection.

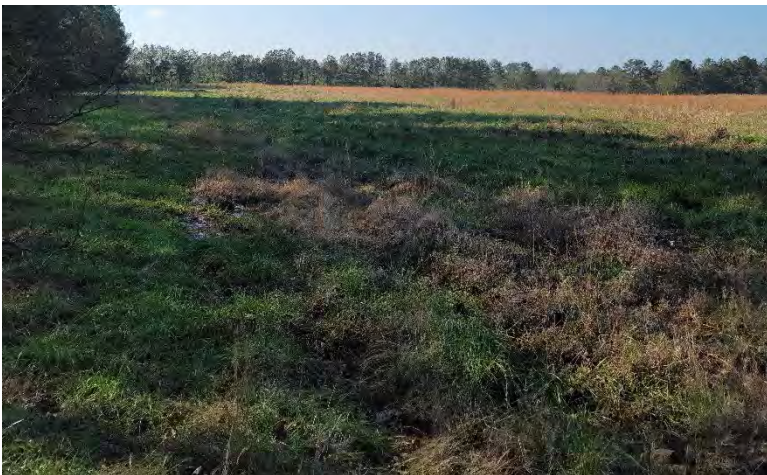
Some standing water was observed at the time of the inspection. The inspection was performed a couple of days after a heavy rain. Repairs are planned to occur when the final cap is installed.

LF4-02: Some areas of subsidence were observed to be holding water. Repairs are planned to occur when the final cap is installed.

Standing water was observed in a drainage ditch. Matrix performed repairs to the drainage ditch and additional mowing around the monitoring wells in September 2020. Final repairs are planned to occur when the final cap is installed. The Landfill Cap Inspection Checklist Items report for the Landfill 4 cap inspection is provided in Appendix B.

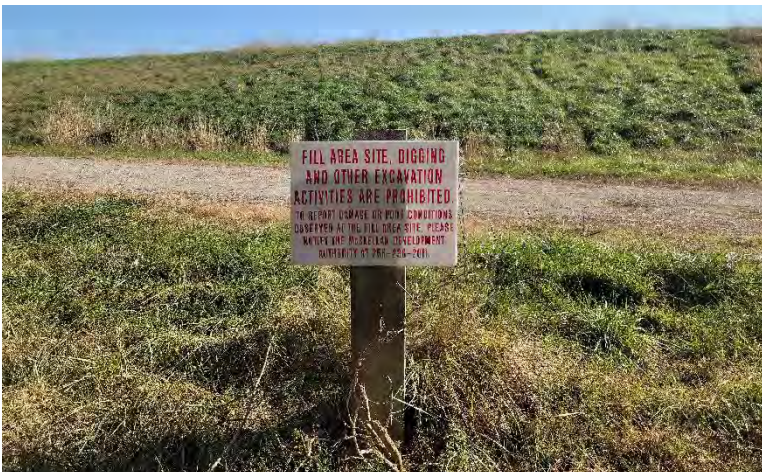
LF4-03: Seven signs were damaged or deteriorated and were repaired at the time of inspection.

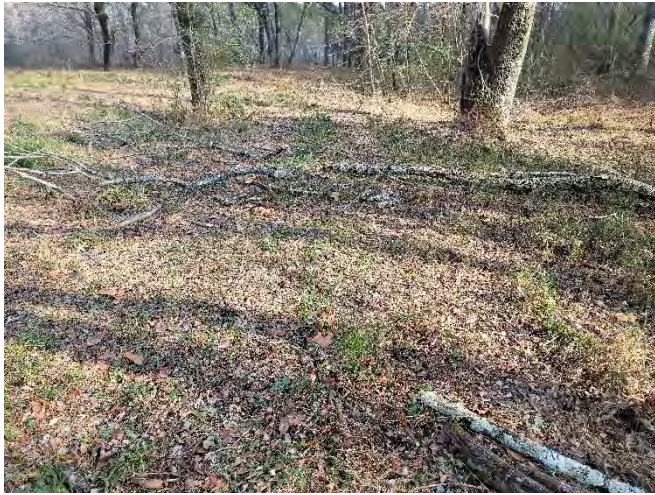
GD-01: Limbs and debris were on the cap. No bare areas or damage to the cap were observed during the inspection.

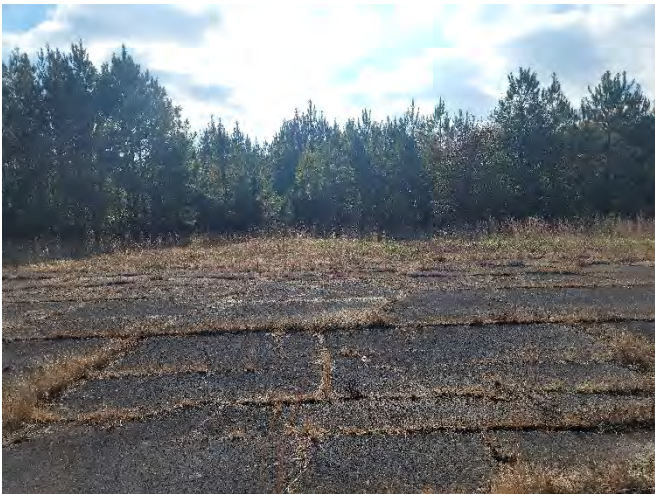
GD-02: The vegetation across the landfill cap was observed to be in good condition during the inspection.

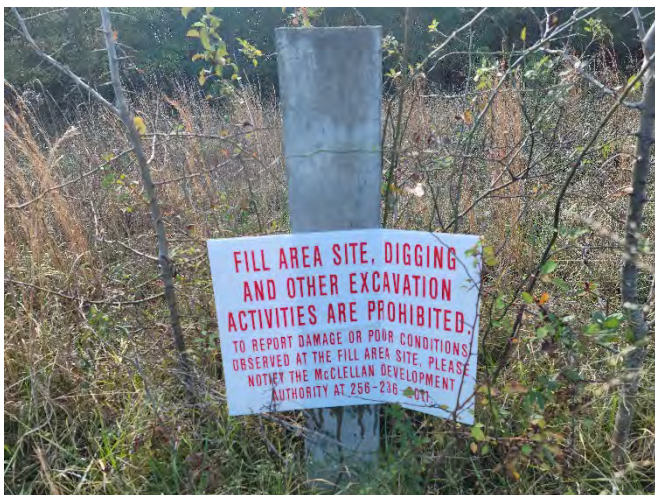
GD-03: The #2 boundary monument sign was on the ground at the time of the inspection. It was repaired at the time of inspection.

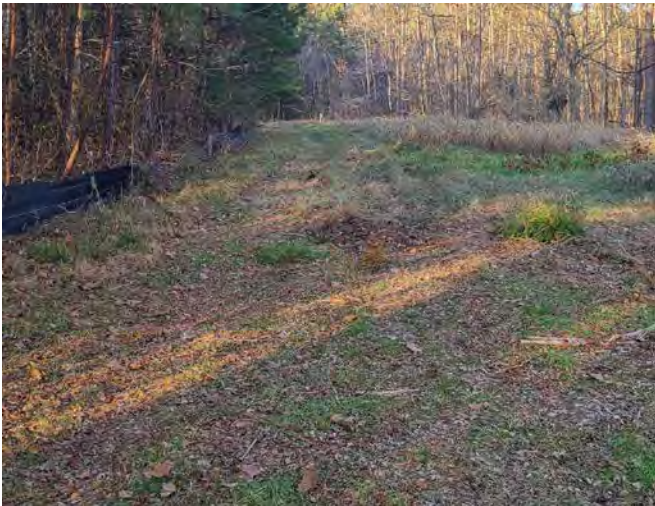
The vegetation across the cap appeared to be in good condition during the inspection.

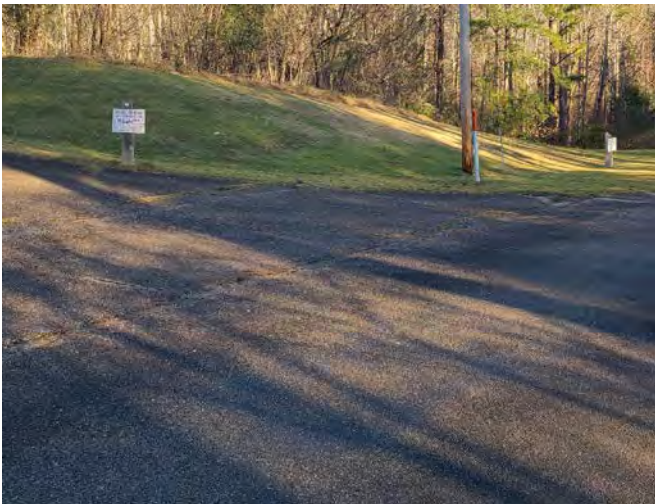
Monuments 5 and 6 by the main entrance are highly visible with no digging signs attached.

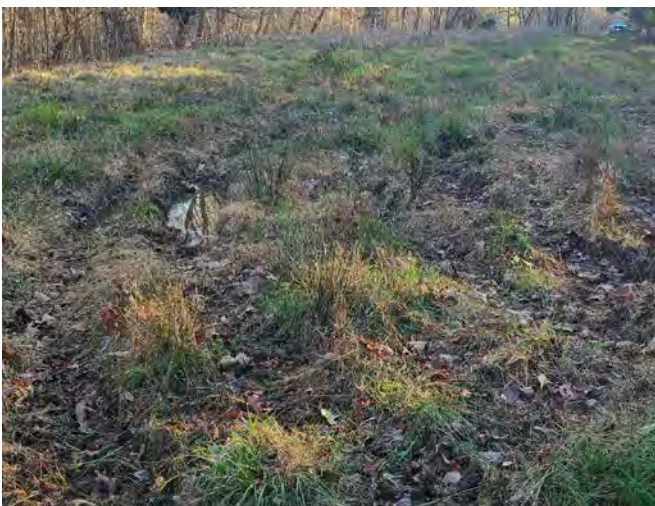
Small area of subsidence that will need to be addressed. Created by vehicular traffic and recent heavy rains.

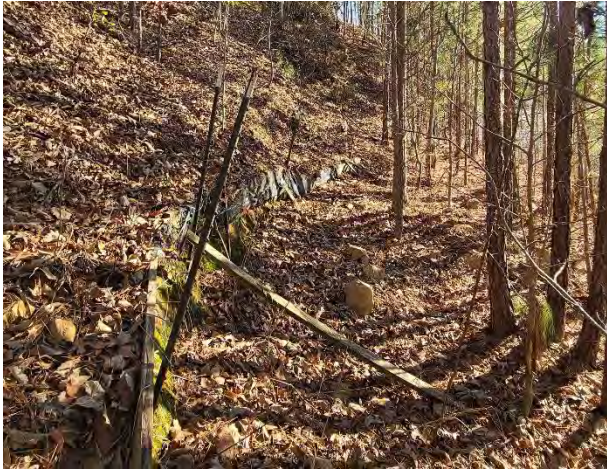
The BMPs repaired in March of 2015 were observed to be in place and in good condition.

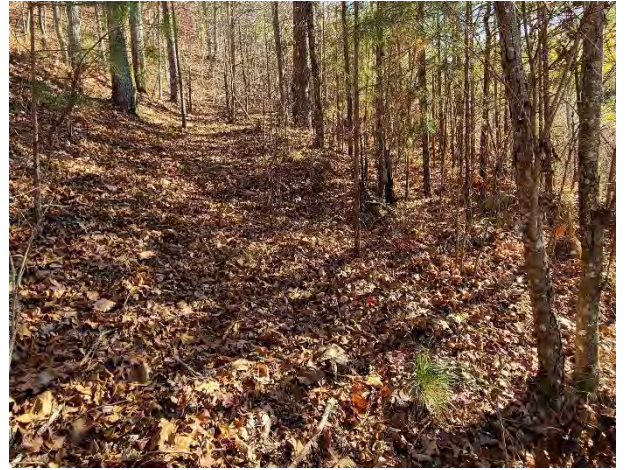
Vegetation is improving and continues to help limit erosion.

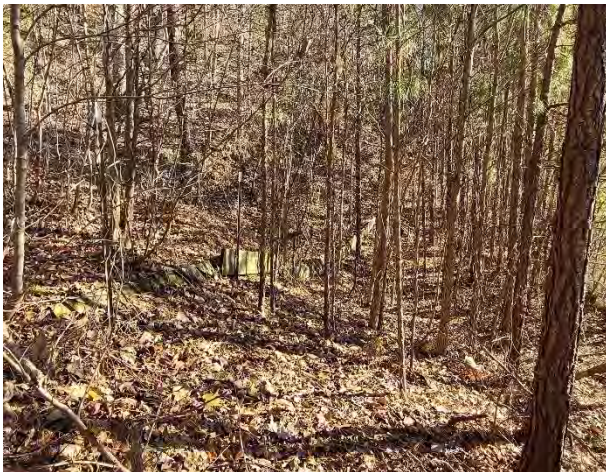
Vegetation on the slope of Range 12 is limited to small pine trees and other small woody stemmed plants.

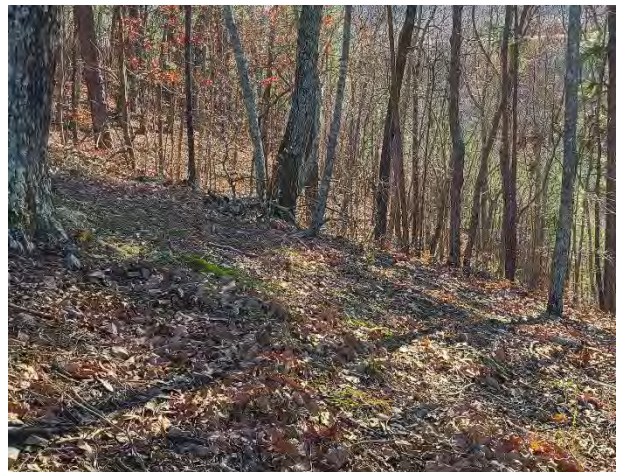
No erosion on the face of the slope was observed during the inspection. No soils were observed to have migrated offsite.

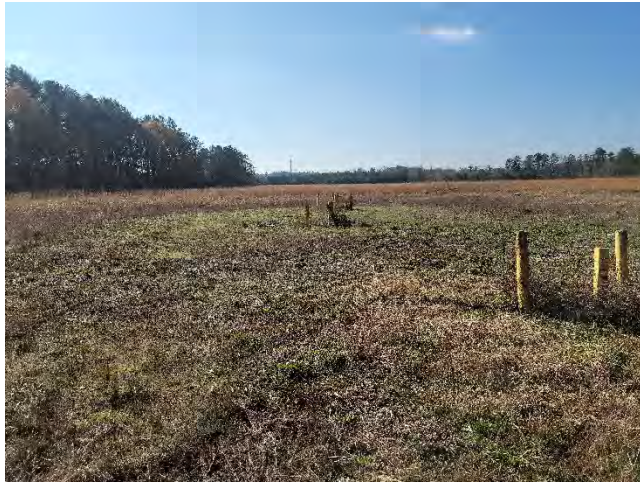
LF3: Vegetation was stable and in good condition. No standing water was observed at the time of inspection.

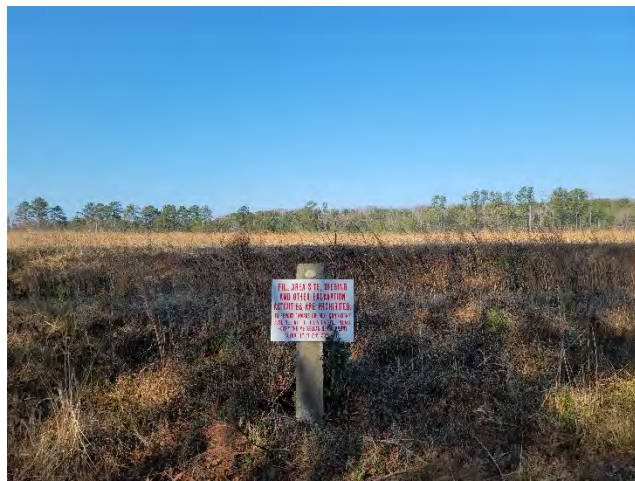
LF3: Five signs were damaged or deteriorated and were replaced at the time of inspection.

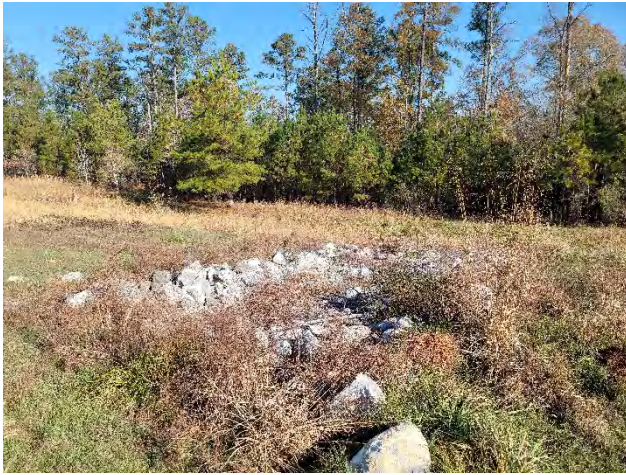
FANWR: The culvert and drainage ditch were in good condition. No sediment accumulation was observed during the inspection.

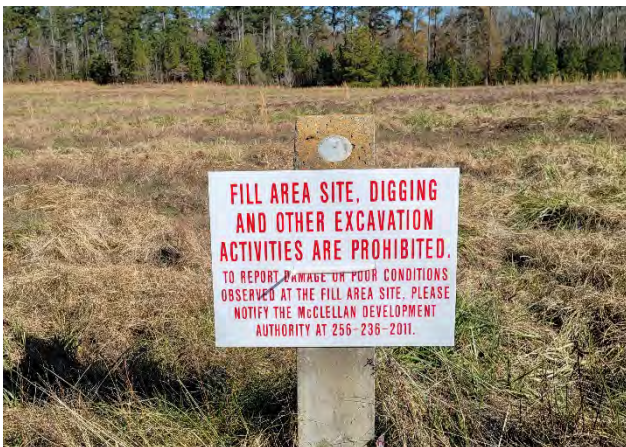
FANWR: All boundary monuments were in good condition. Six signs were damaged or deteriorated and were replaced at the time of inspection.
