Land Use Control Effectiveness Report - 2017
McClellan, Anniston, Alabama

MCCLELLAN
DEVELOPMENT AUTHORITY

Matrix Environmental Services, LLC
283 Rucker Street
Anniston, Alabama 36205

January 2018
Revised July 2018

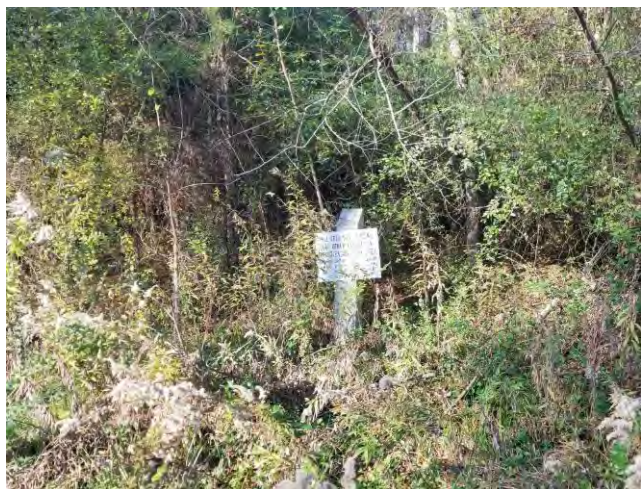
The boundary monuments were visible and in good condition during the inspection.

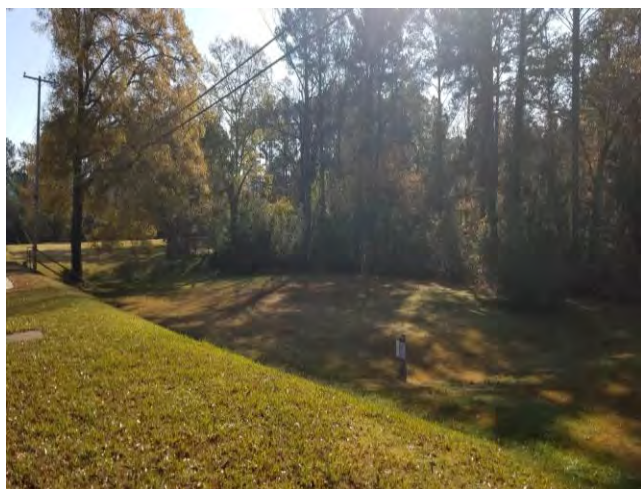
No erosion was observed during the inspection.

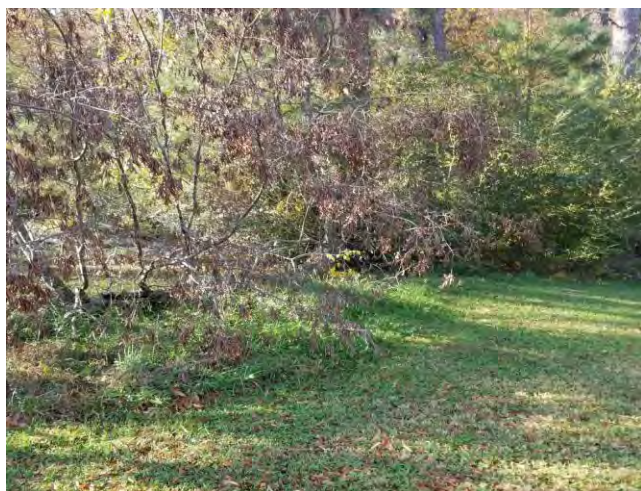
Vegetation was observed to be in good condition during the inspection.

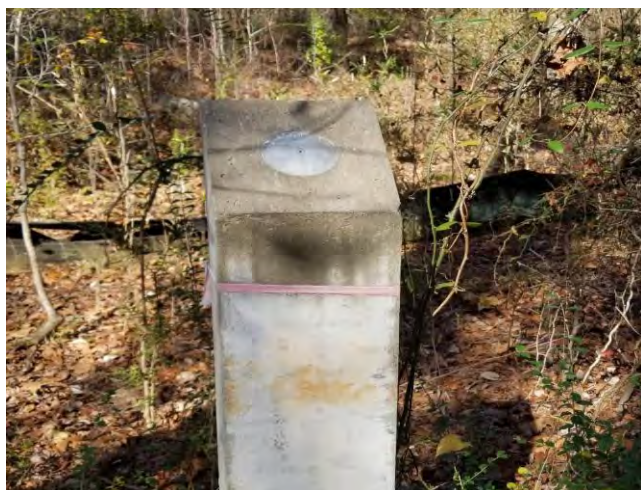
One boundary monument was missing a No Digging Sign. It was replaced at the time of inspection.

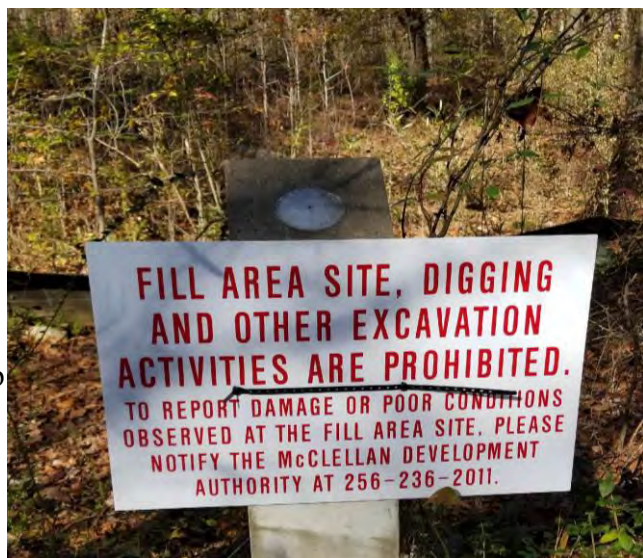
The no digging sign was replaced and secured to the boundary monument.

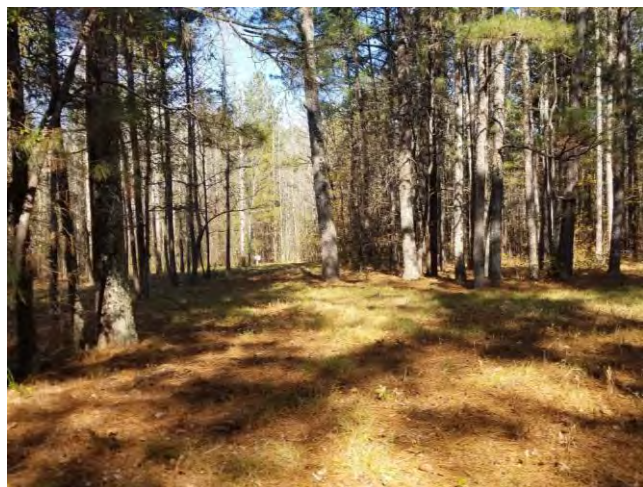
The vegetation across the landfill was observed to be in good condition at the time of the inspection. No bare areas were observed. No erosion of the landfill cap was observed during the inspection. No low areas or exposed debris was observed.

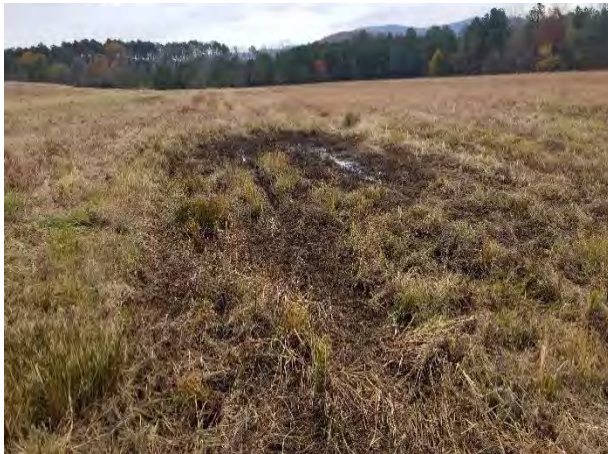
LF4-001: The cap surface appeared to be in good condition at the time of the inspection. The vegetation was in good condition except for the areas previously identified for repair.

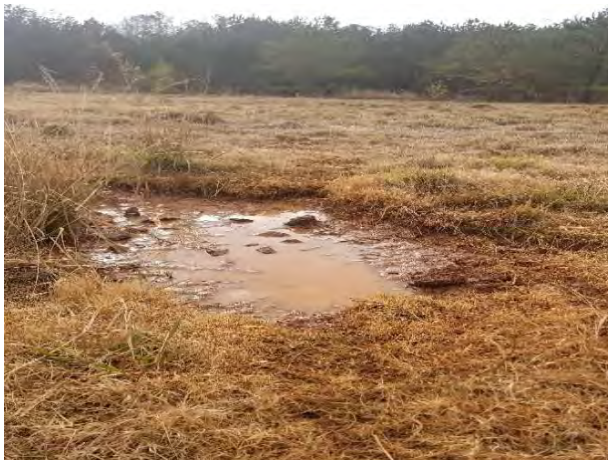
LF4-003: An area in the northeastern corner of the landfill (Area A on the attached figure) was observed to have been disturbed. This area is often frequented by deer.

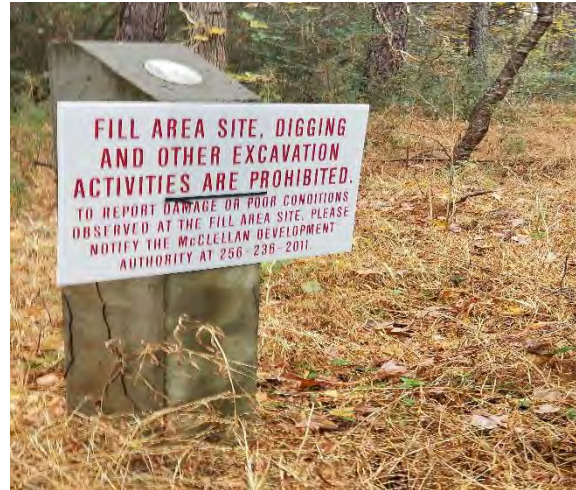
LF4-002: The boundary monuments were observed to be in good condition. Two No Digging signs were missing. They were replaced at the time of the inspection.

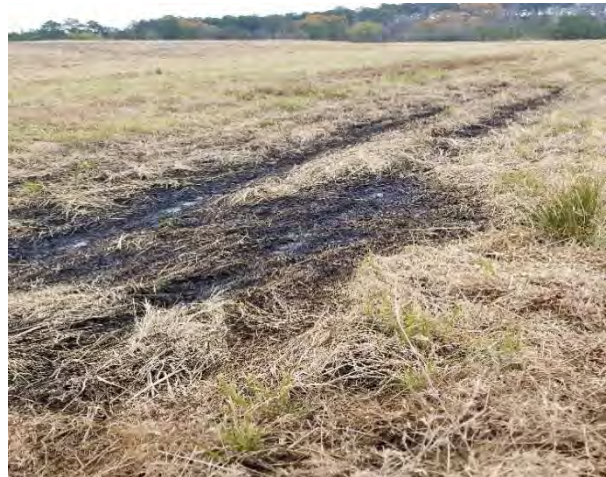
Four areas of minor subsidence were observed south of the centrally located drainage ditch. The approximate size and location of the areas was noted on the attached figure. One additional area of disturbance was observed in the northeastern section of the landfill. This is an area that has been repaired multiple times due to deer damaging the surface. Deer prints were observed in this area during the inspection. The areas of subsidence will be repaired during the final closure of the Industrial Landfill.

LF4-004: Four areas of minor subsidence were still visible. The areas of subsidence have been identified and are scheduled to be repaired during construction of the final landfill cap.

ditch. One additional area of disturbance was observed in the northeastern section of the landfill. The areas of subsidence will be repaired during the final closure of the Industrial Landfill. The Landfill Cap Inspection Checklist Items report for the cap inspection is provided in Appendix B.

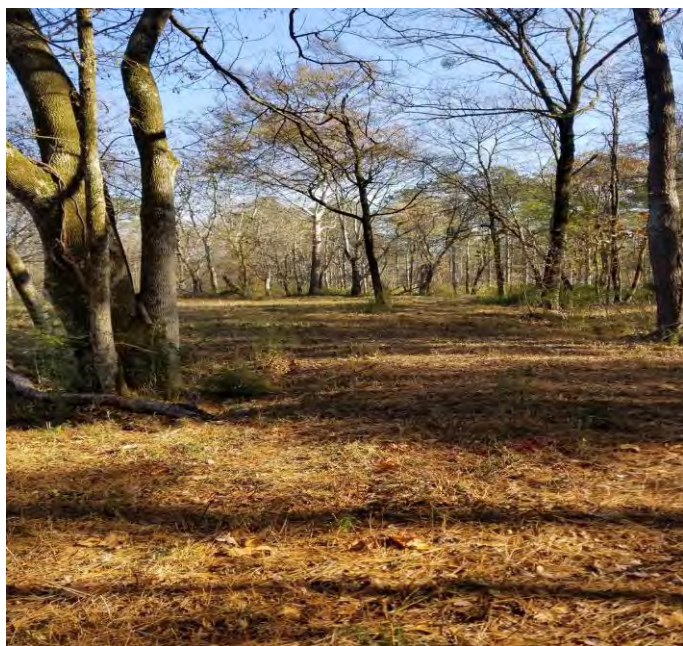
The vegetation appeared to be in good condition.

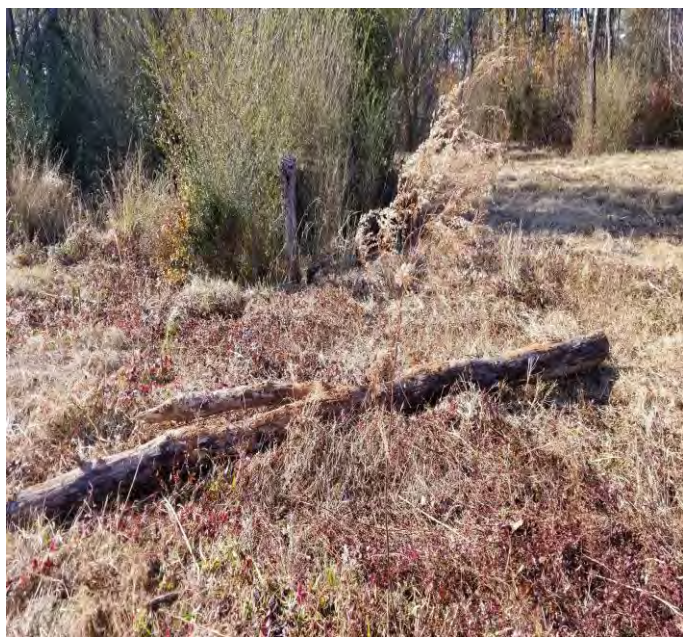
No erosion of the landfill cap was observed during the inspection.

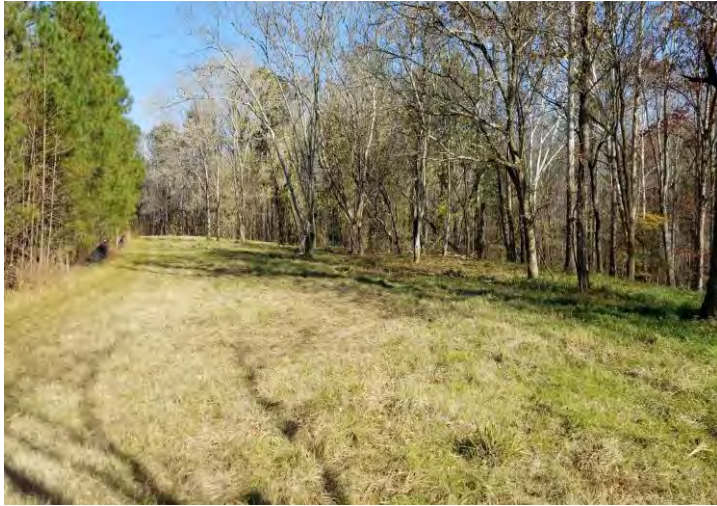
The vegetation across the cap appeared to be in good condition during the inspection.

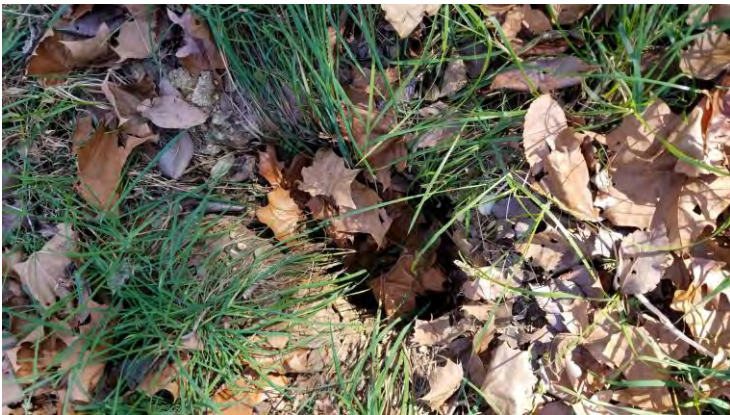
A small animal hole was observed on the cap surface; however, no exposed trash or debris was observed.

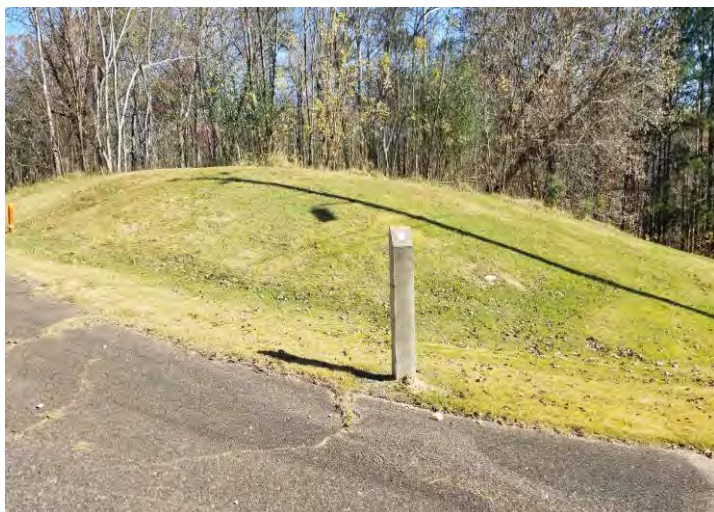
There were three No Digging Signs missing from the boundary monuments. All three were replaced at the time of inspection.

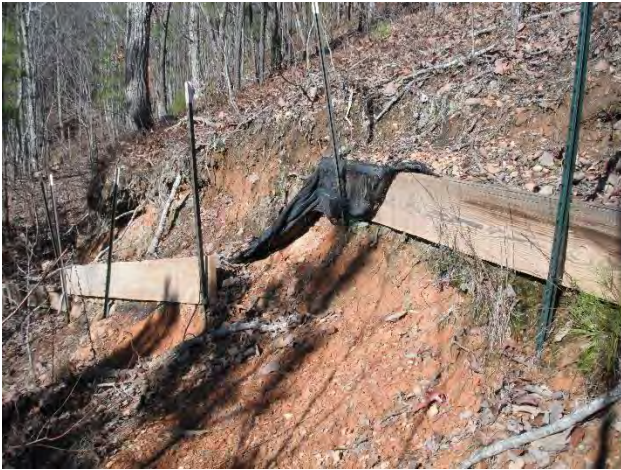
The BMPs repaired in March of 2015 were observed to be in place and in good condition.

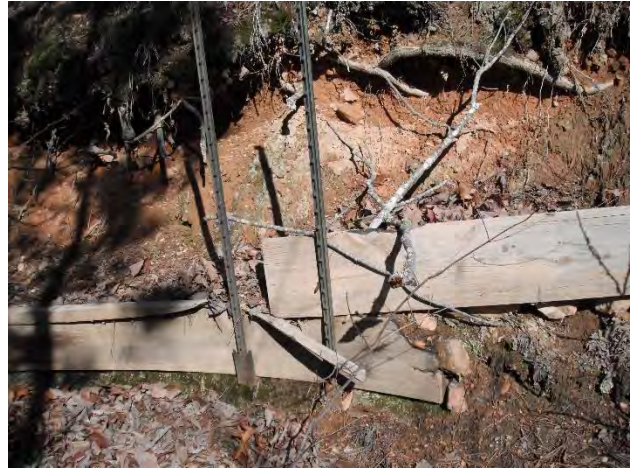
The t-posts located behind the wooden board helps to keep the board in place and helps limit erosion.

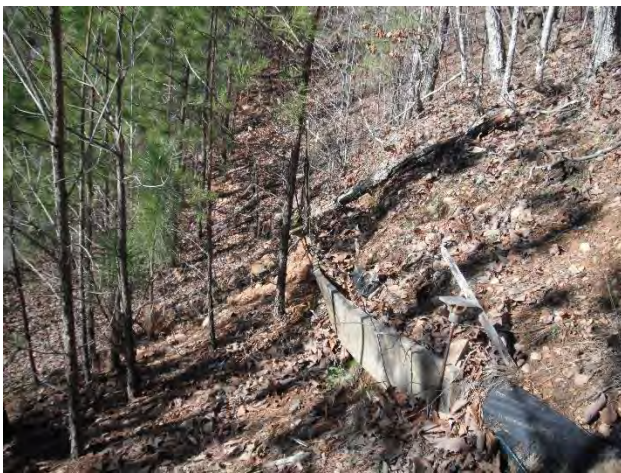
Vegetation on the slope of Range 12 is limited to small pine trees and other small woody stemmed plants.

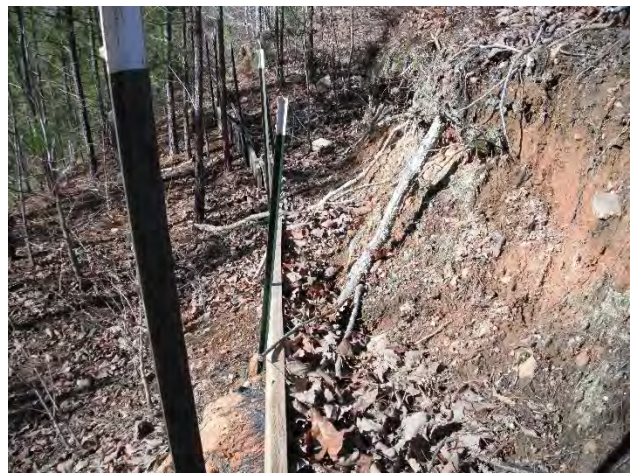
Due to the steepness of the slope, erosion on the face of the slope was observed during the inspection. No soils were observed to have migrated offsite.

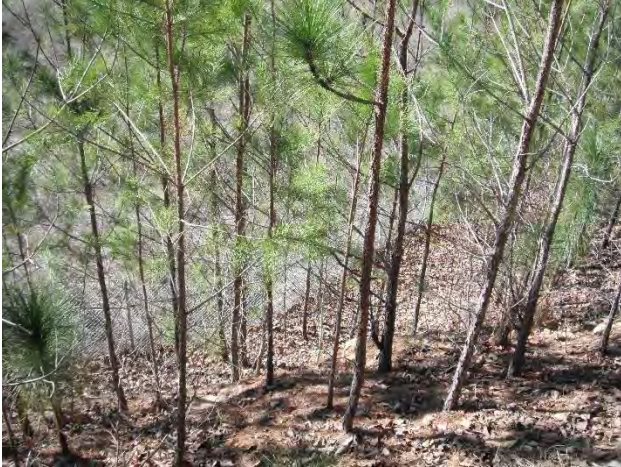
Pine trees at the base of the slope help to hold the soils in place and limit erosion.

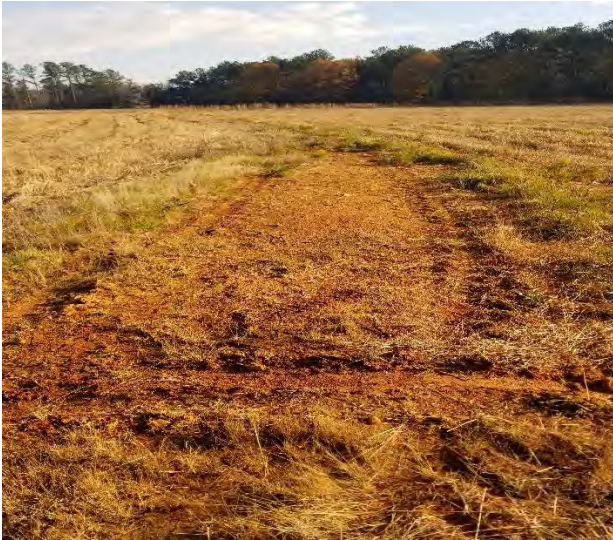
LF3: A small area located near the center of the landfill was observed to have patchy vegetation.

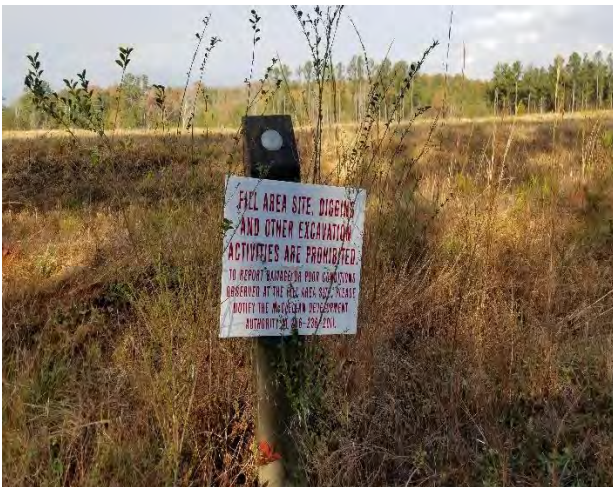
LF3: All monuments and signs were in place at the time of inspection.

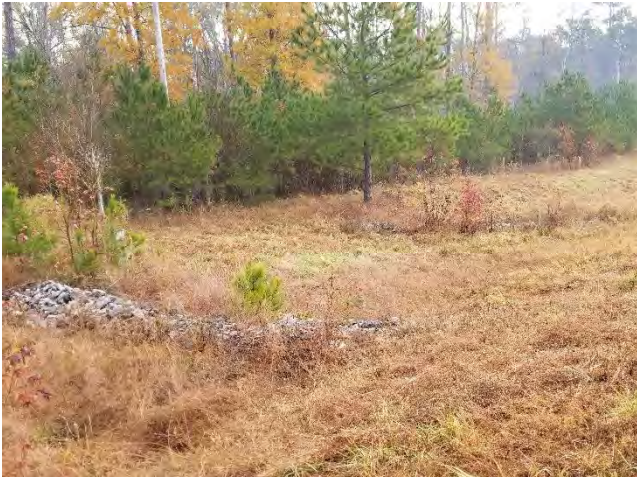
FANWR: The two rock chutes and vegetation of FANWR were observed to be in good condition at the time of inspection.

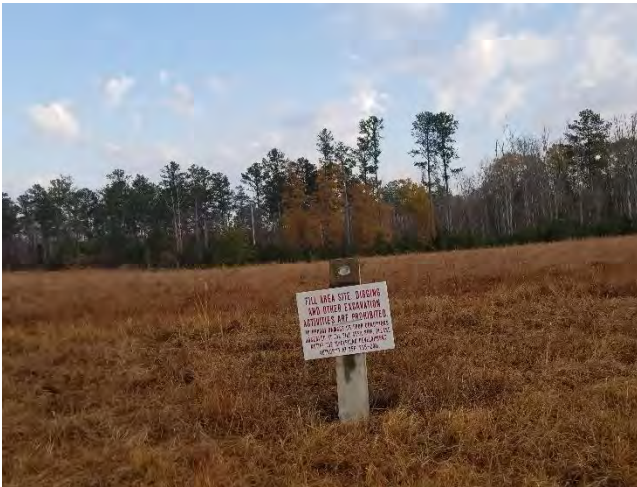
FANWR: All boundary monuments were in good condition. One sign was damaged and was replaced at the time of inspection.
