**Land Use Control Effectiveness Report - 2019**  
**McClellan, Anniston, Alabama**

**McClellan Development Authority**  
**McClellan, Anniston, Alabama**

**Matrix Environmental Services, LLC**  
**283 Rucker Street**  
**Anniston, Alabama 36205**

**January 2020**

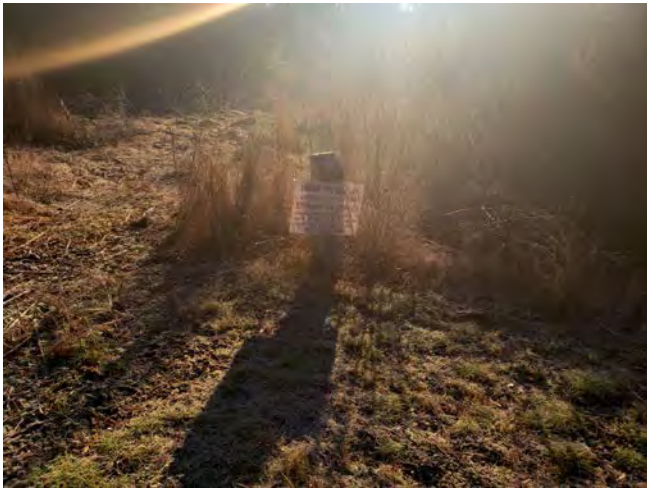
The #1 boundary monument sign was on the ground at the time of the inspection. It was repaired at the time of inspection.

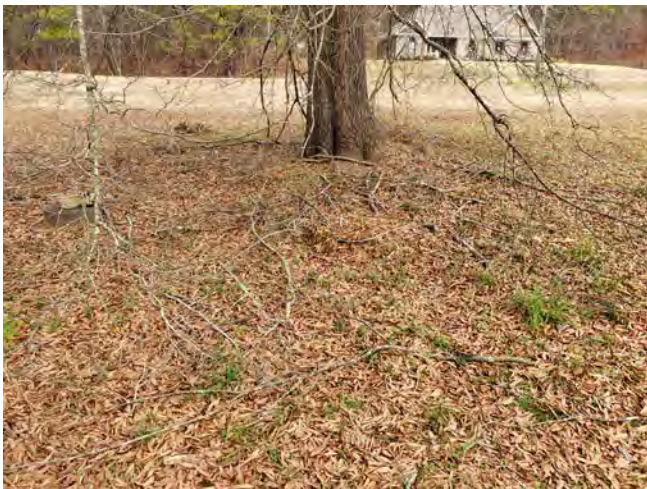
Small to medium branches have fallen from trees, but no damage was caused. Vegetation was observed to be in good condition.

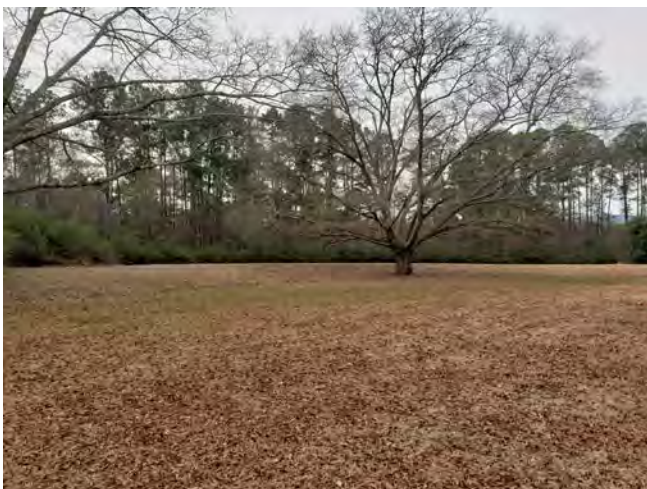
No erosion was observed during the inspection.

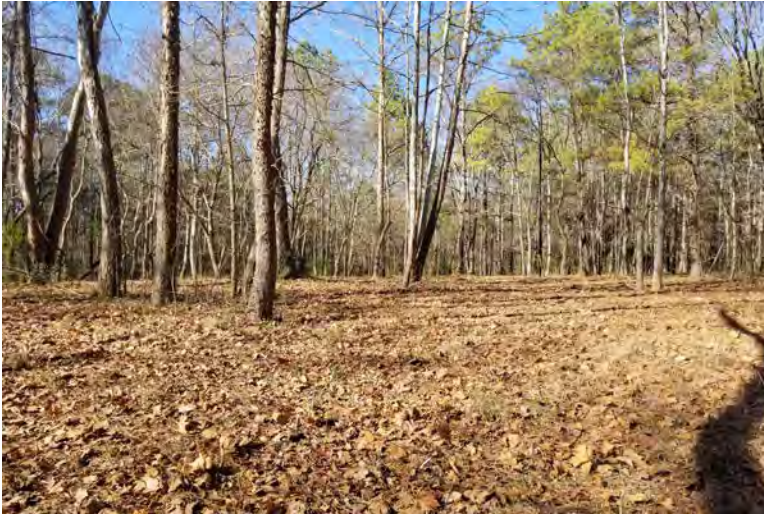
The vegetation across the cap appeared to be in good condition during the inspection.

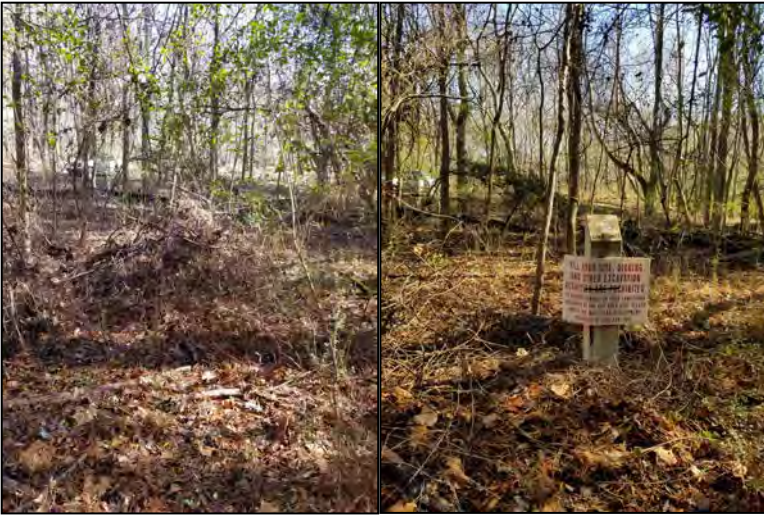
☒ Monument 7, Comments: Good condition, covered by deadfall, removed during inspection. No digging sign was attached.

Monument number 7 before deadfall removal and after with No Digging Sign still intact.

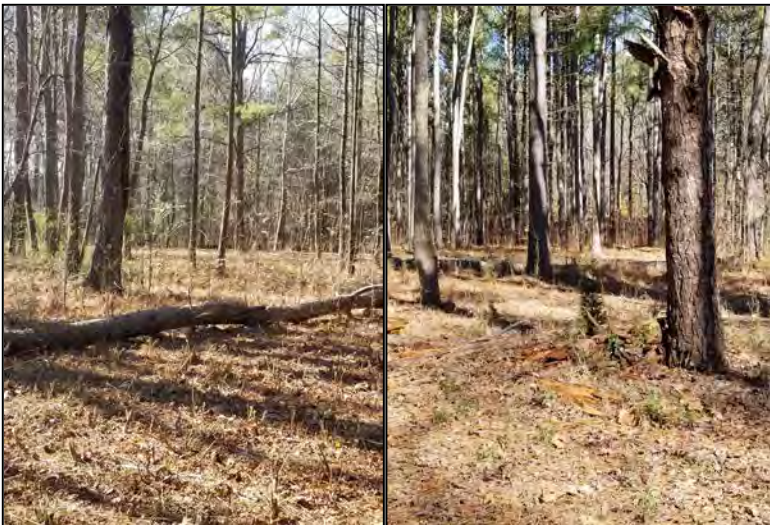
Several areas with deadfall observed. No damage to the cap was found during the inspection.

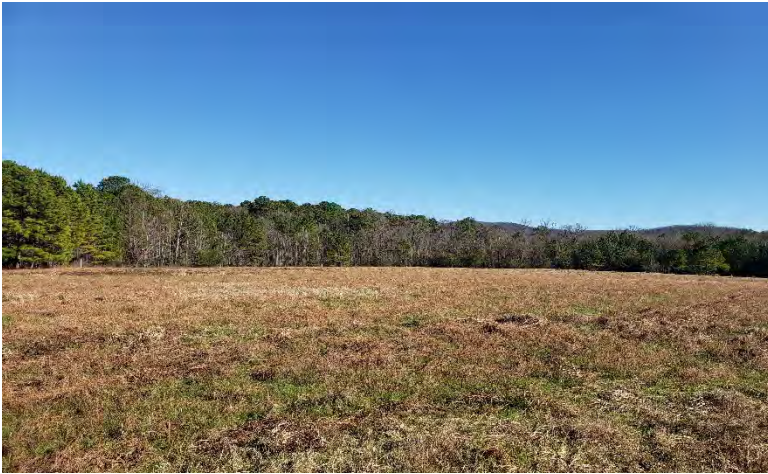
LF4-01: The landfill cap was mowed prior to the inspection. The vegetation across the landfill cap was observed to be in good condition during the inspection.

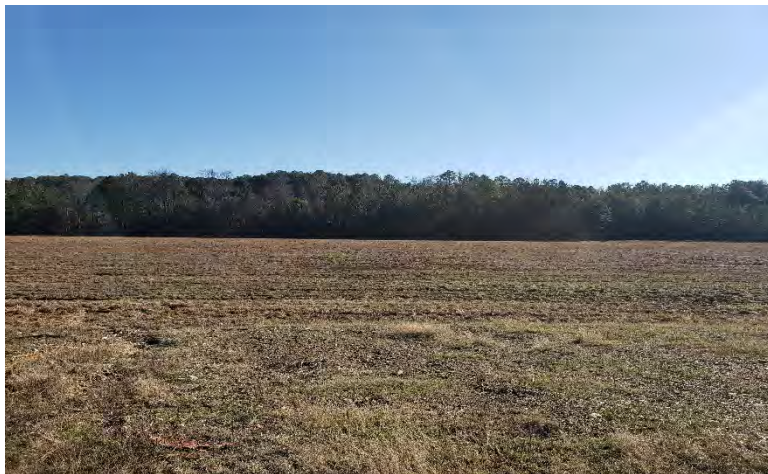
Some standing water was observed at the time of the inspection. The inspection was performed after one day of heavy rain. Repairs are planned to occur when the final cap is installed.

LF4-02: Some areas of subsidence were observed to be holding water. Repairs are planned to occur when the final cap is installed.

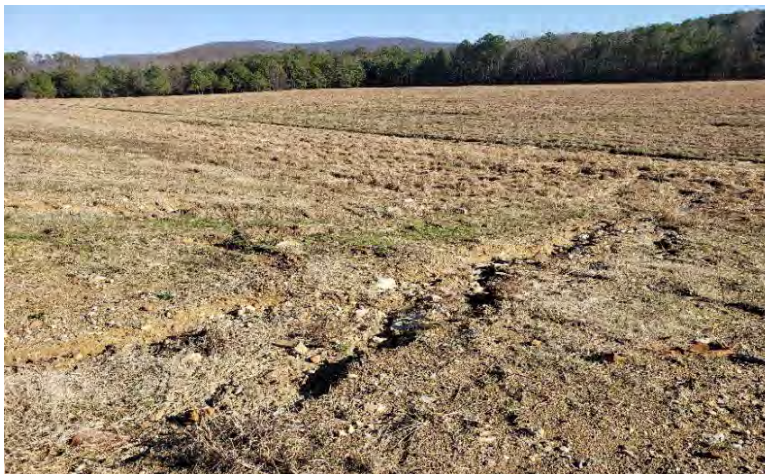
Rills were noted on the west slope. Repairs were completed and the areas were seeded after the inspection. No exposed debris was observed.

LF4-03: Rills were noted on the west slope. Repairs are underway.

Green Industrial Landfill by ADEM several rills of various sizes were observed to be developing along the slopes of the landfill. Matrix used a skid steer to move soil from the existing stockpile located near the former Reilly Airfield and place the soil in the rills. Matrix then used the skid steer to help pack the soils. After the soil was placed, Matrix personnel seeded and used BMPs in the area to help promote the seed growth. The work was completed in December 2019. Some standing water was observed at the time of the December 2019 inspection which was performed one day after heavy rain. Repairs are planned to occur when the final cap is installed. The Landfill Cap Inspection Checklist Items report for the cap inspection is provided in Appendix B.

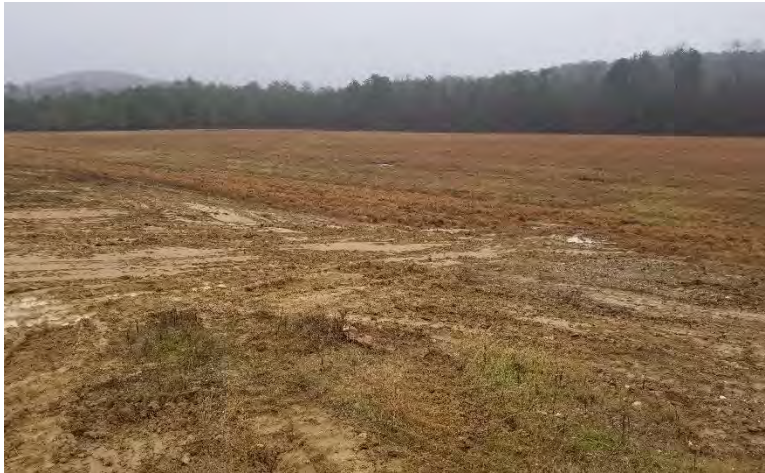
LF4-04: Rills were repaired after the cap inspection.

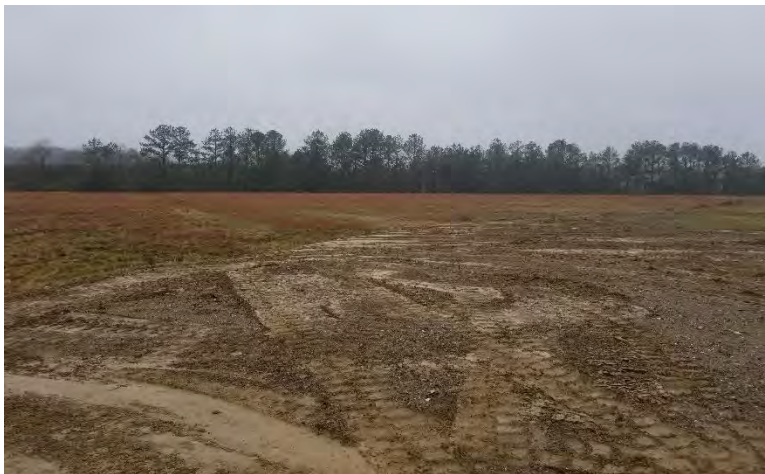
LF4-05: Rills on the west slope have been repaired.

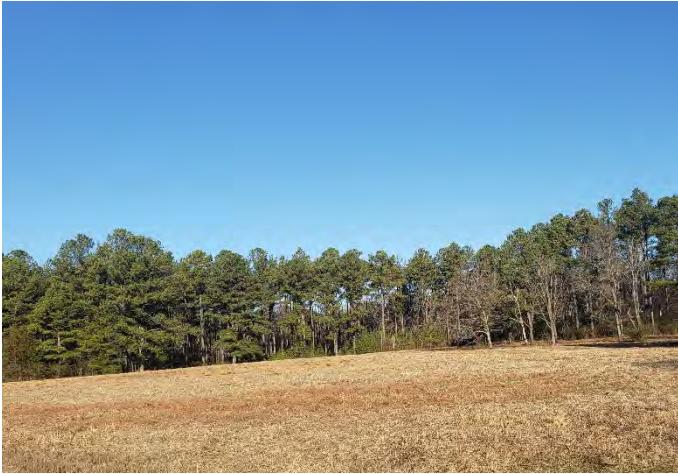
GD-01: The landfill cap was mowed prior to the inspection. No bare areas were observed during the inspection.

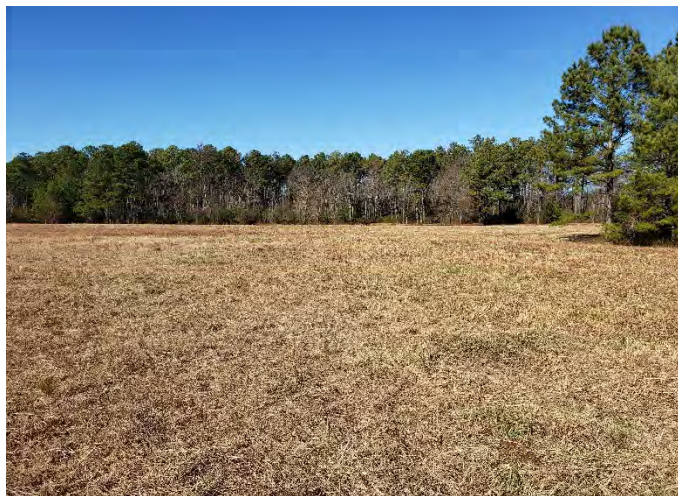
GD-02: The vegetation across the landfill cap was observed to be in good condition during the inspection.

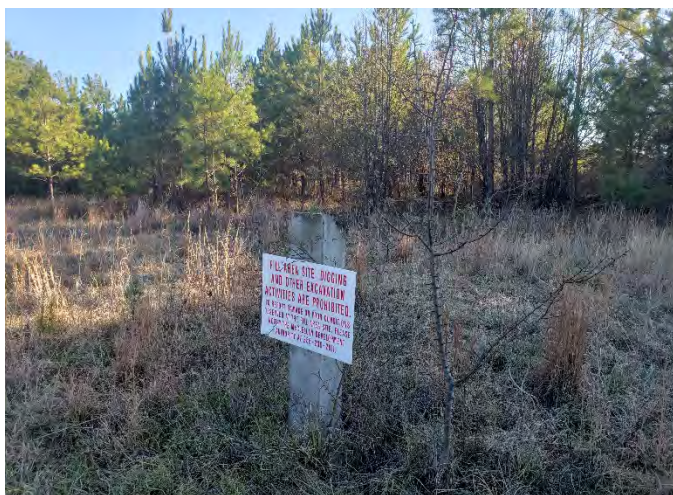
GD-03: The #1 boundary monument was on the ground at the time of the inspection. It was repaired at the time of inspection.

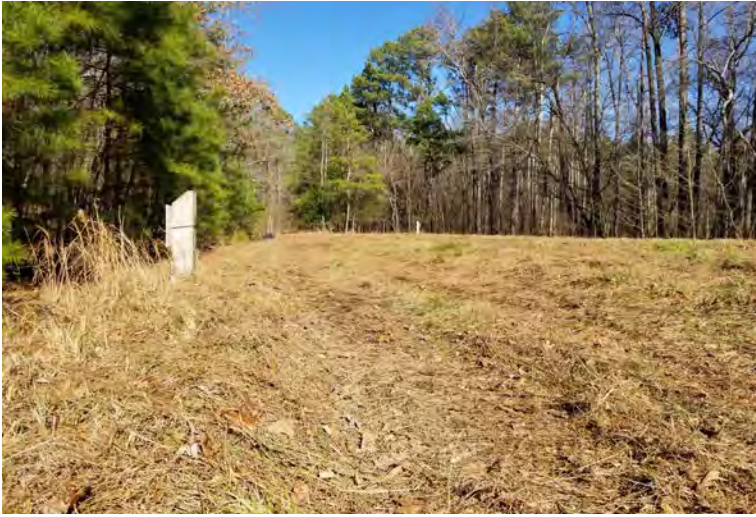
The vegetation across the cap appeared to be in good condition during the inspection. All No Digging Signs were in place and in good repair.

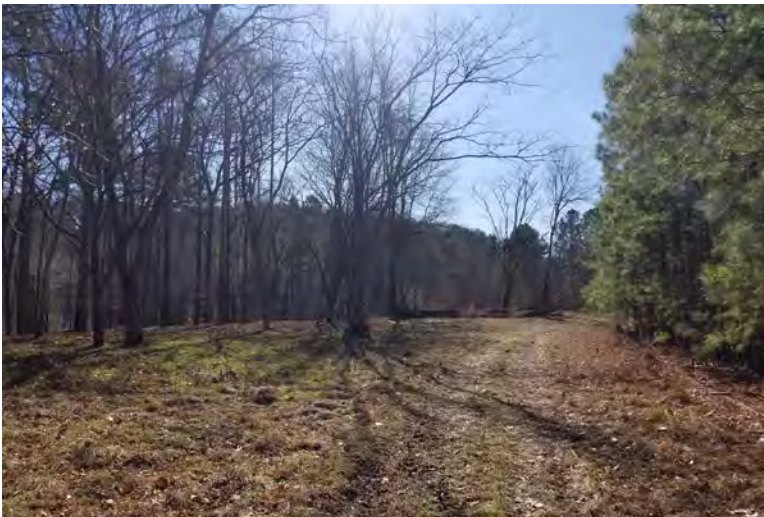
Several areas with dead fall were observed. No damage to the cap observed.

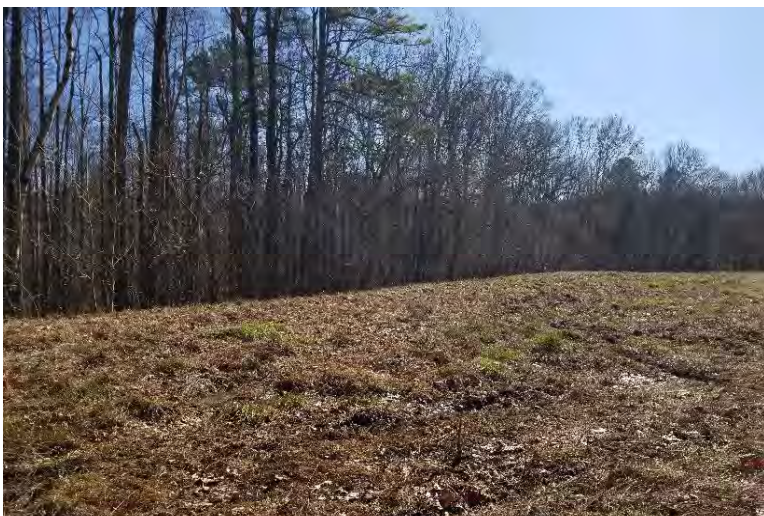
Small area of subsidence that will need to be addressed. Created by vehicular traffic and recent heavy rains.

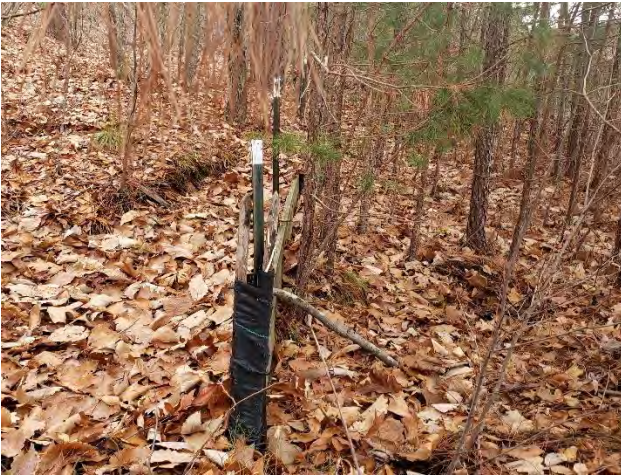
The BMPs repaired in March of 2015 were observed to be in place and in good condition.

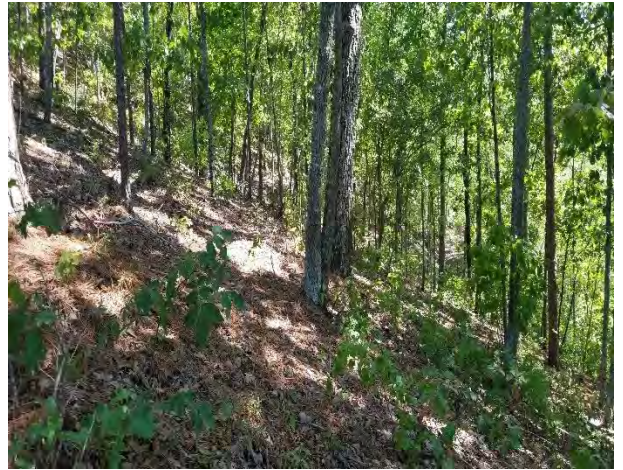
Vegetation is improving and continues to help limit erosion. Photo was taken on September 4, 2019 to represent live vegetation.

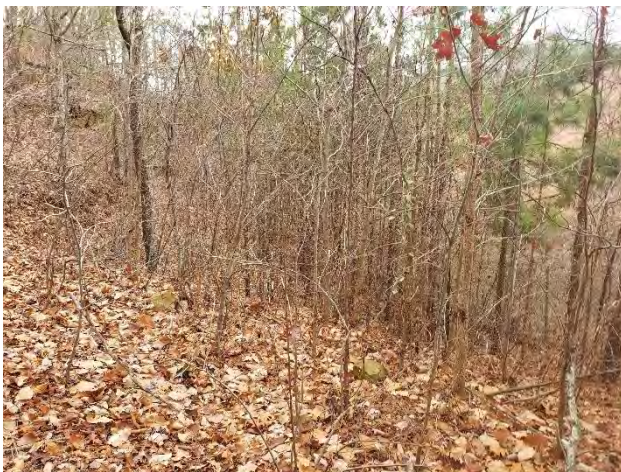
Vegetation on the slope of Range 12 is limited to small pine trees and other small woody stemmed plants.

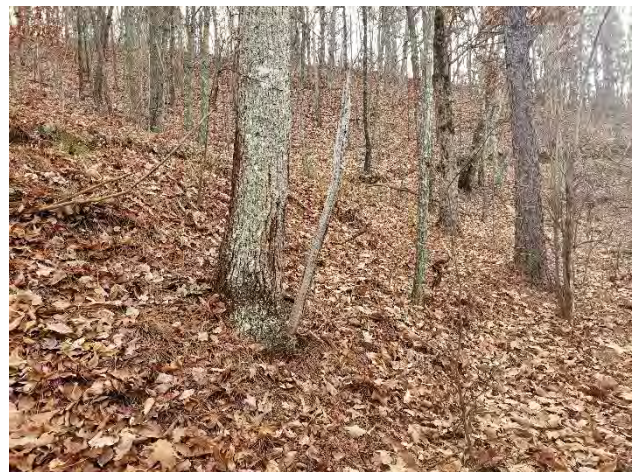
No erosion on the face of the slope was observed during the inspection. No soils were observed to have migrated offsite.

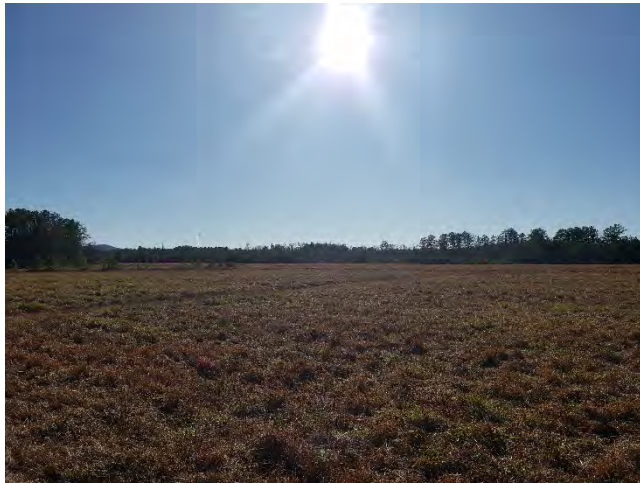
LF3: No standing water was observed at the time of inspection.

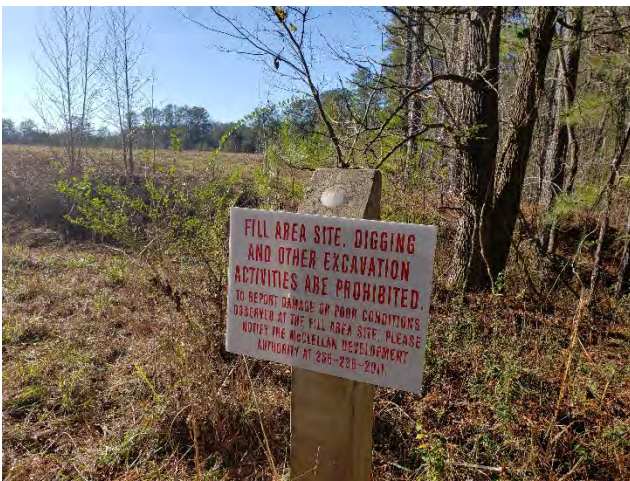
LF3: Two signs were damaged and were repaired at the time of inspection.

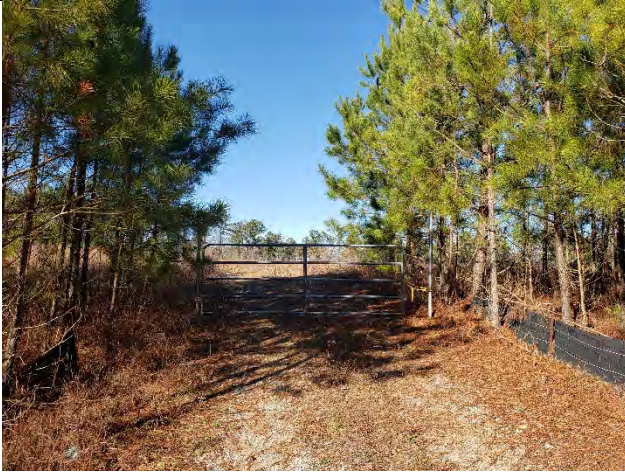
FANWR: A gate was installed at the southern boundary to control access from new road construction.

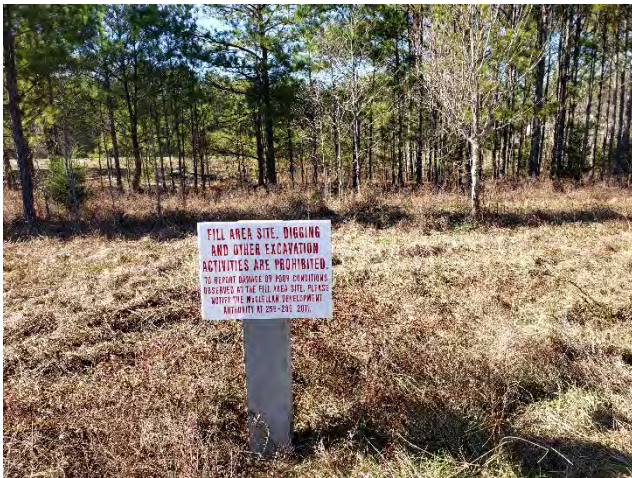
FANWR: All boundary monuments were in good condition. Five signs were damaged and were replaced at the time of inspection.
