Land Use Control Effectiveness Report - 2022
McClellan, Anniston, Alabama

MCCLELLAN
DEVELOPMENT AUTHORITY

Matrix Environmental Services, LLC
283 Rucker Street
Anniston, Alabama 36205

January 2023
Revised August 2023

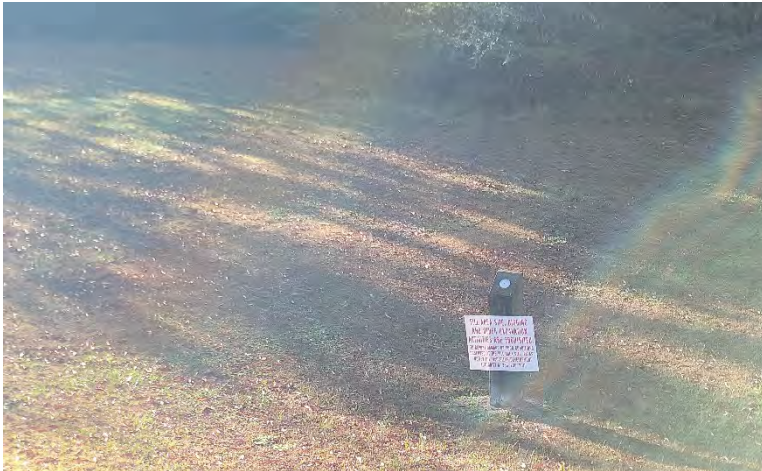
The #1 boundary monument signs were in place at the time of inspection.

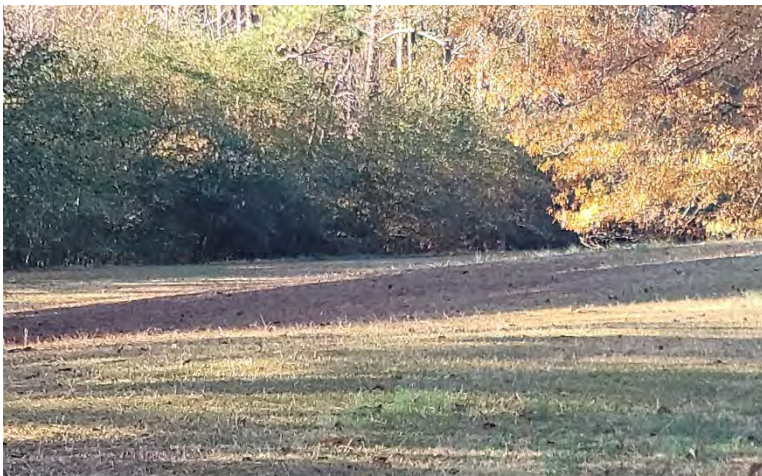
The cap was recently mowed. No erosion was observed.

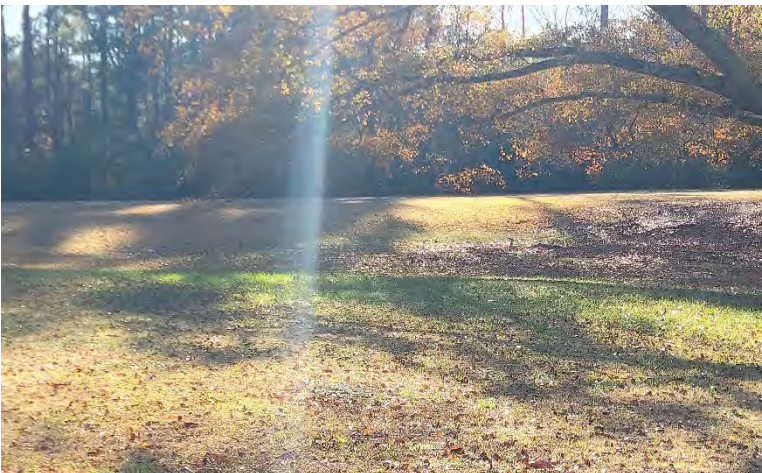
No erosion was observed at the time of inspection.

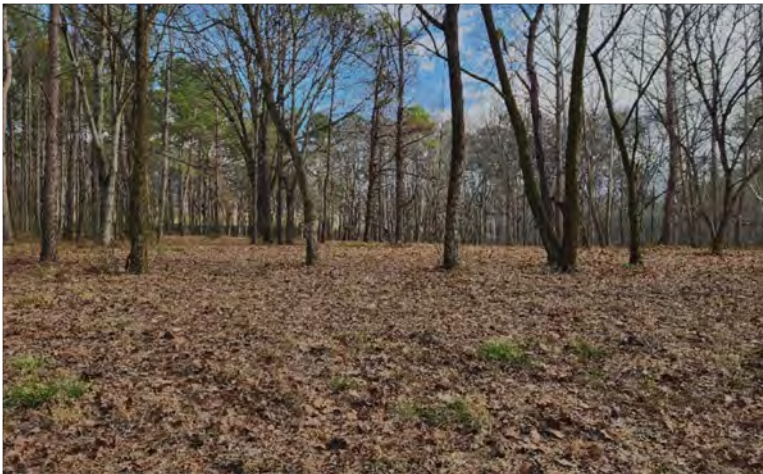
The vegetation across the cap appeared to be in good condition during the inspection.

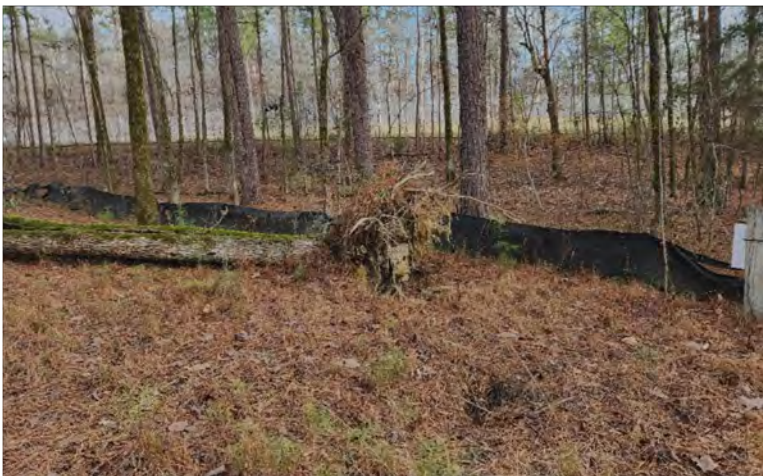
The vegetative cover was observed to be in good condition during the inspection. No bare areas were observed. One tree is uprooted near Monument 3. The root ball created a divot near the perimeter of the cap.

New deadfall adjacent to monument 3.

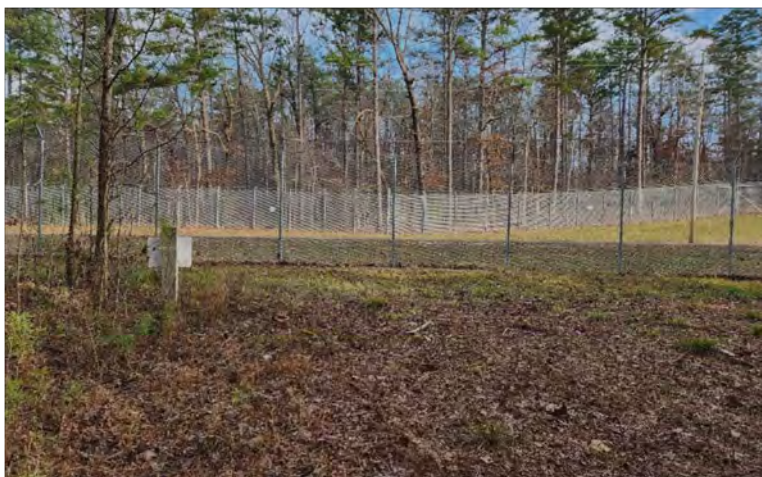
☒ Monument 2, Comments: Good condition, no damage. No digging sign was detached and replaced during inspection.

No Digging sign on monument 2 was replaced. New perimeter fence installed by Department of Homeland Security adjacent to monument 2 and 8.

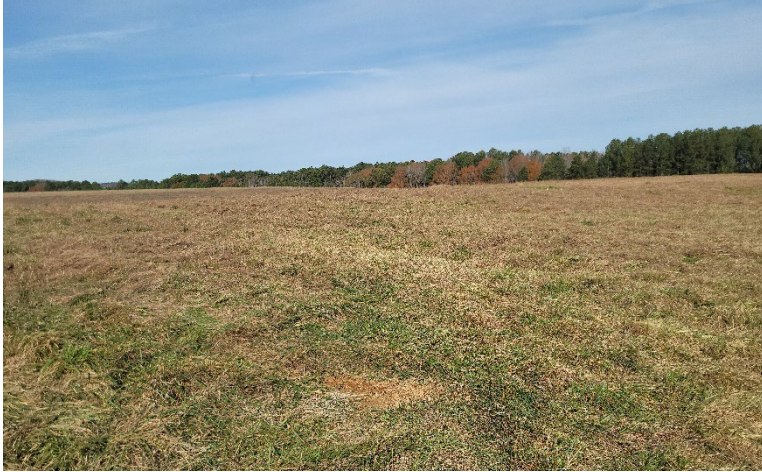
LF4-01: The vegetation across the landfill cap was observed to be in good condition.

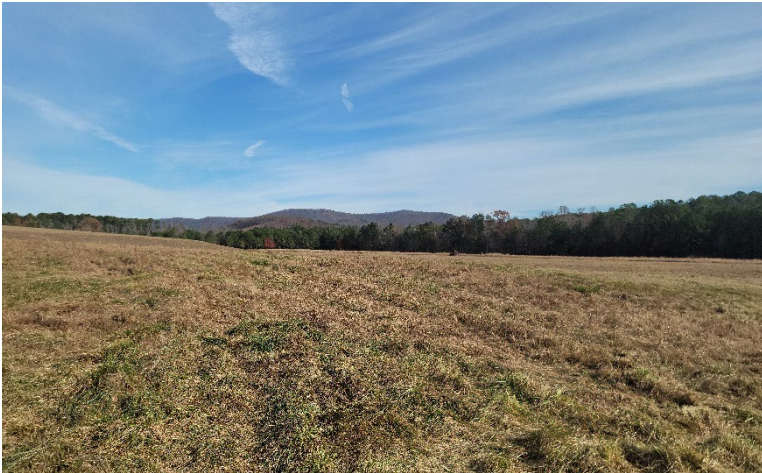
LF4-02: Cap and closure activities were completed in February 2022 and areas of subsidence have been repaired.

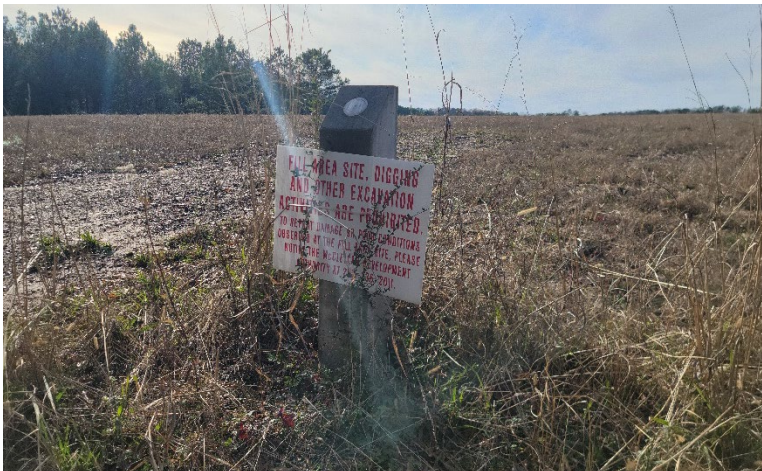
LF4-03: Four signs were missing and were repaired at the time of inspection.

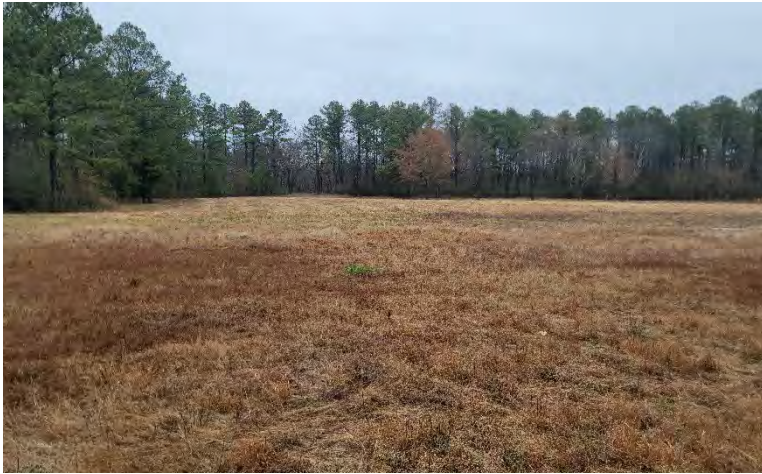
GD-01: No bare areas or damage to the cap were observed during the inspection.

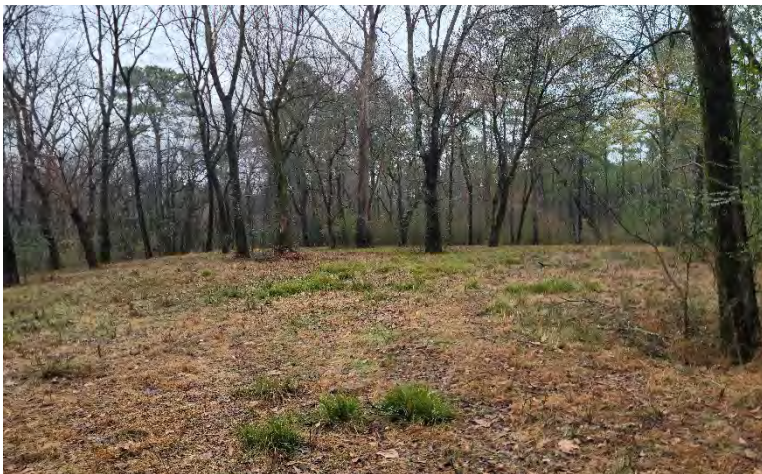
GD-02: The vegetation across the landfill cap was observed to be in good condition during the inspection.

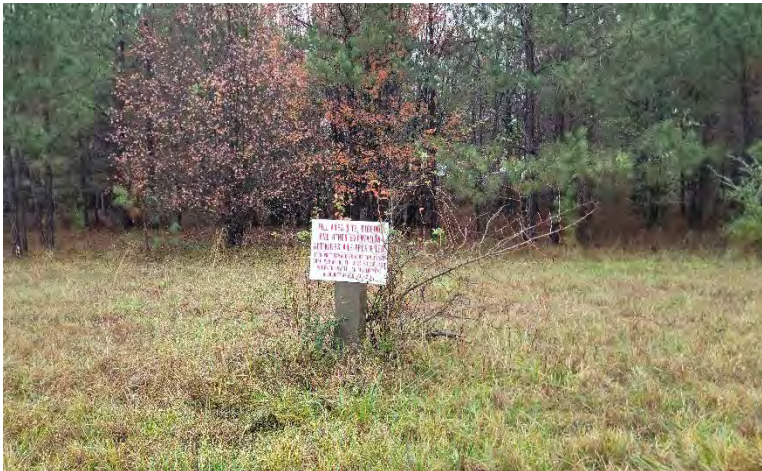
GD-03: Two boundary monument signs were missing and were repaired at the time of inspection.

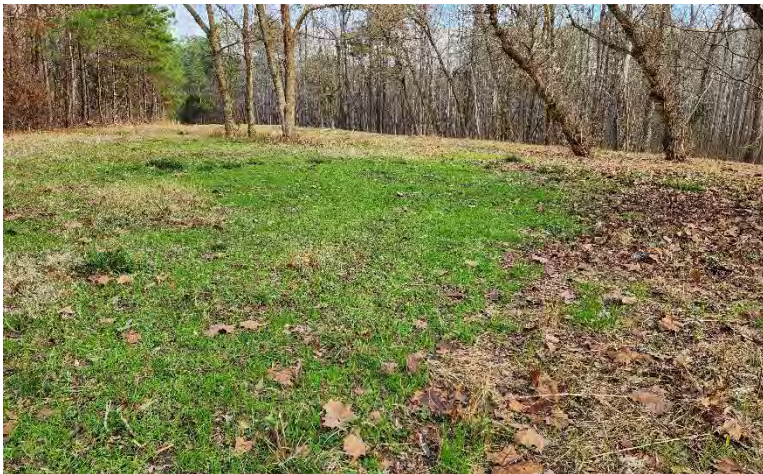
The vegetation across the cap appeared to be in good condition during the inspection.

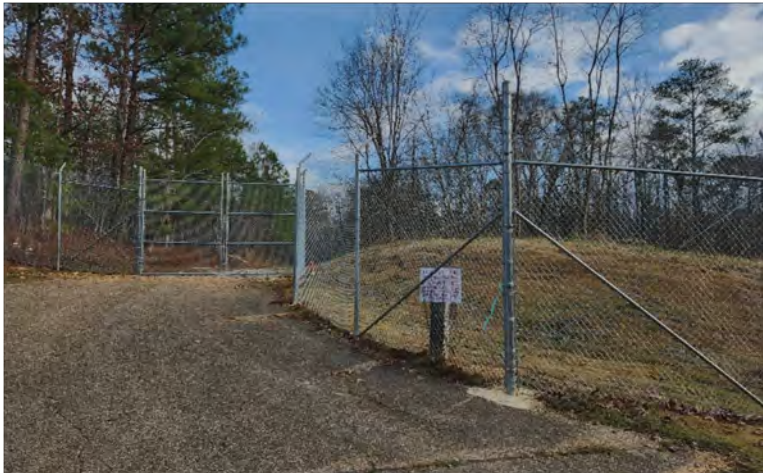
New perimeter fence installed adjacent to Monument 1 and 1

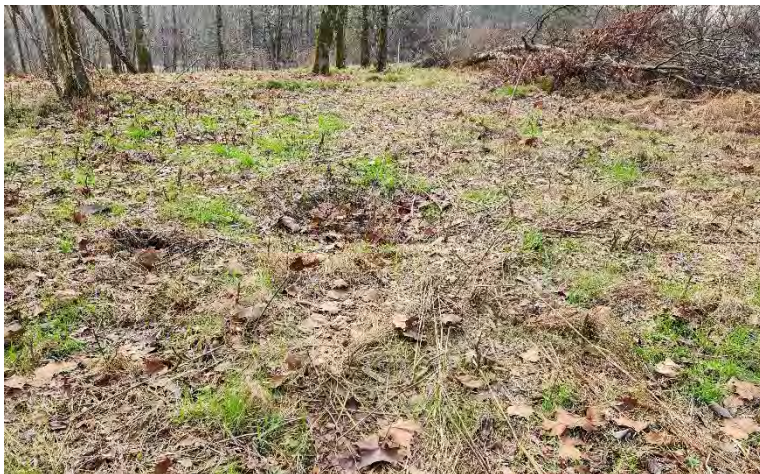
A cap inspection was conducted for the Fill Area North of Landfill 2 on December 15, 2022. Monuments were in good condition. One no digging sign was attached but replaced due to damage or deterioration during the inspection. The cap and vegetative cover appeared to be in good condition during the inspection. No bare areas were observed. No exposed debris was observed. There are several large areas that show signs of subsidence near monument 3 and

monument 4 along with several down trees with exposed root balls that have created divots in the cap structure. The area of subsidence near monument 4 has adequate vegetation but the low area has created a pocket of standing water. These areas were scheduled for repair in the spring of 2022, but repairs were not completed due to delays in closure activities on Butler Green Industrial Landfill. MES plans to fill in divots caused by dead fall and will continue to monitor areas of subsidence to see if they progress. No monitoring wells are located at the Fill Area North of Landfill 2 and none were installed. The Landfill Cap Inspection Checklist Items report for the cap inspection is provided in Appendix B.

Several areas near monuments 3 and 4 show signs of subsidence.

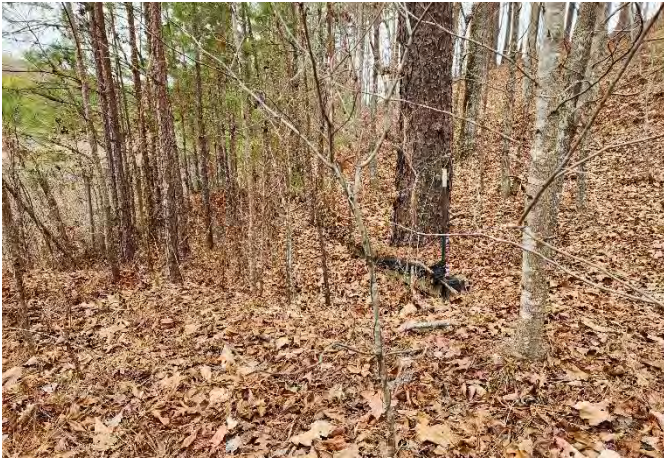
The BMPs repaired in March of 2015 were observed to be in place and in good condition.

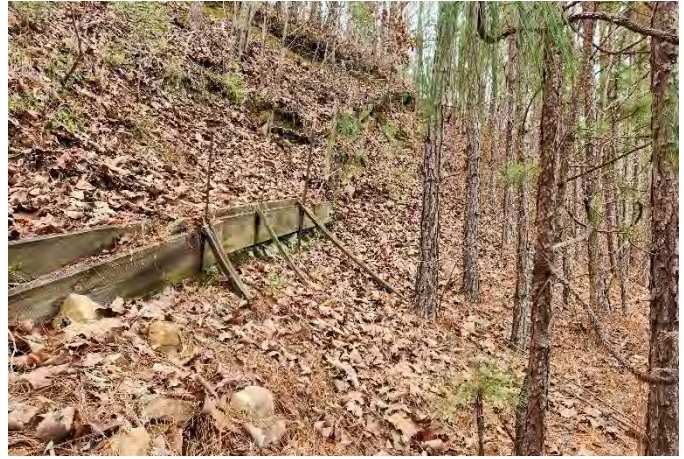
Vegetation is improving and continues to help limit erosion.

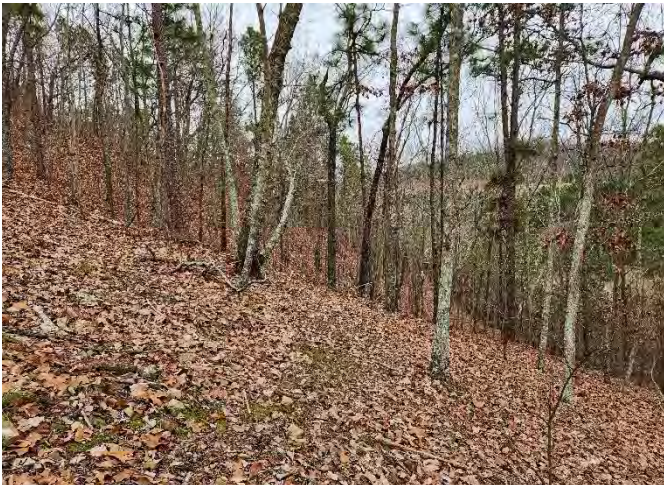
Vegetation on the slope of Range 12 is limited to small pine trees and other small woody stemmed plants.

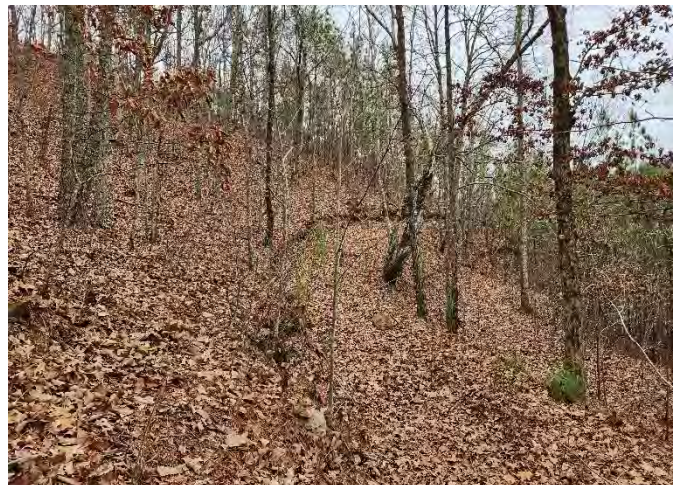
No erosion on the face of the slope was observed during the inspection. No soils were observed to have migrated offsite.

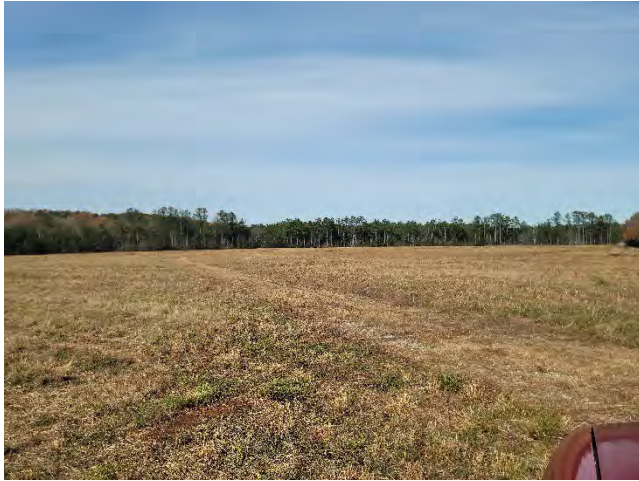
LF3: Vegetation was stable and in good condition. No standing water was observed at the time of inspection.

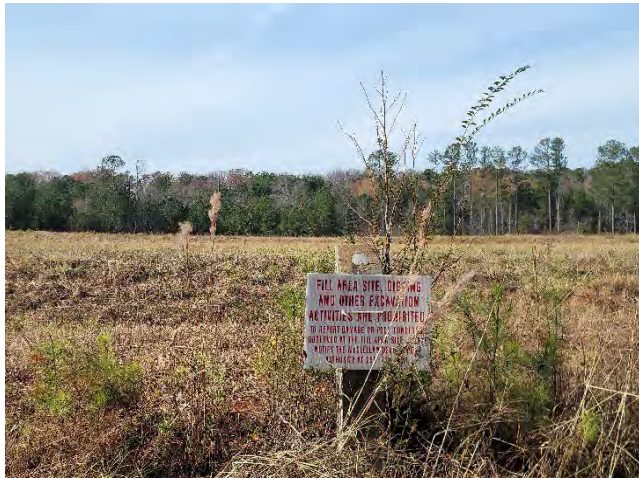
LF3: Three signs were damaged or missing and were replaced at the time of inspection.

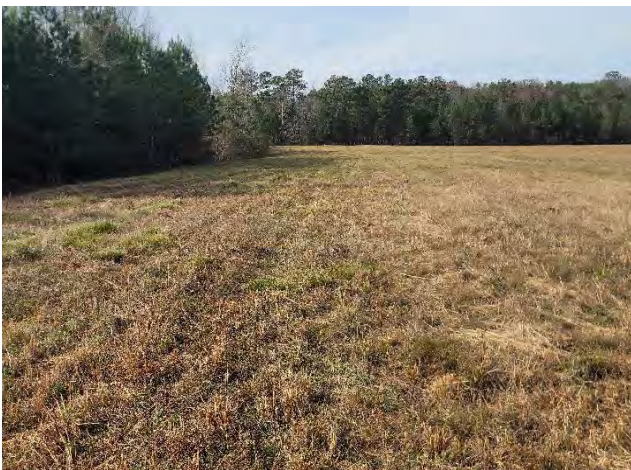
LF3: Vegetation was in good condition at the time of inspection.

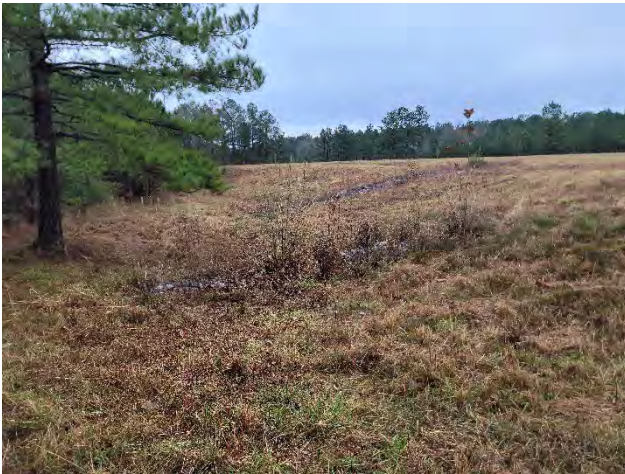
FANWR: The culvert and drainage ditch were in good condition. No sediment accumulation was observed during the inspection.

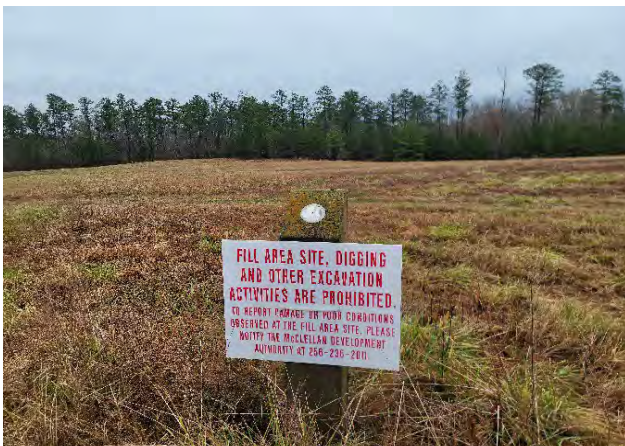
FANWR: All boundary monuments were in good condition. Two No Digging Signs were replaced at the time of inspection.

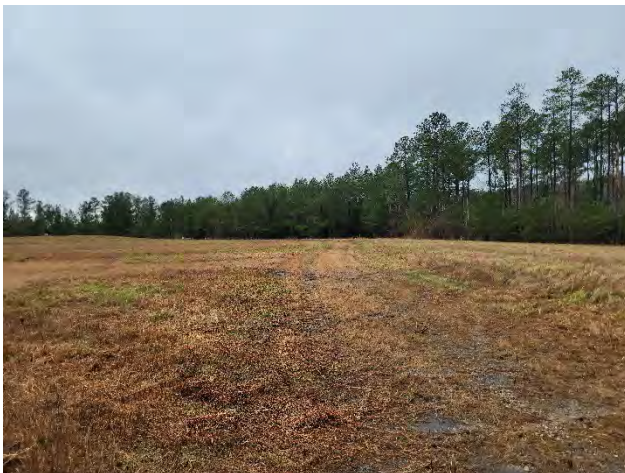
FANWR: The vegetation was observed to be in good condition at the time of inspection.
