**Land Use Control Effectiveness Report - 2016**  
**McClellan, Anniston, Alabama**

**McClellan Development Authority**  
**McClellan, Anniston, Alabama**

**Matrix Environmental Services, LLC**  
**283 Rucker Street**  
**Anniston, Alabama 36205**

**January 2017**  
**Revised November 2017**

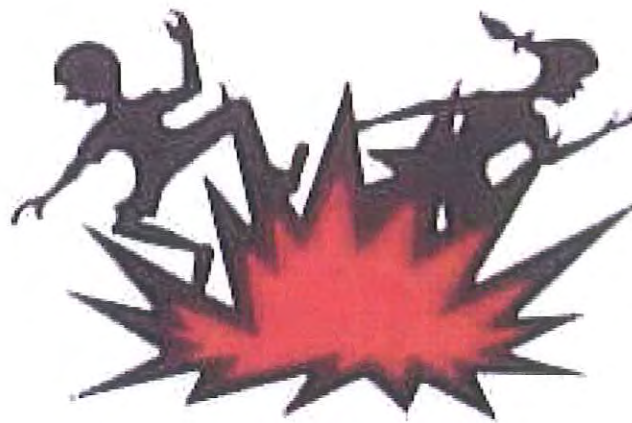
MEC warning signs (Figure 2) are installed around the perimeter of the Alpha MRA and Bravo MRA, and are inspected by Matrix Security officers on a weekly basis. Missing or damaged signs are replaced. The MDA coordinates the community outreach program with the Army. A training video explaining the dangers of MEC is mandatory for anyone performing work on McClellan. The MDA and Matrix brief all contractors conducting work in these areas at McClellan on the possibility of encountering MEC, and describe procedures to implement should MEC happen to be encountered.

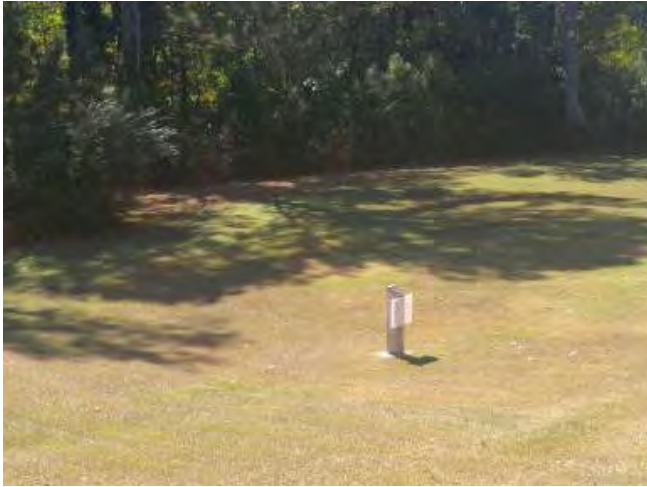
The vegetation across the cap surface appeared to be in good condition at the time of the inspection. No bare areas were observed.

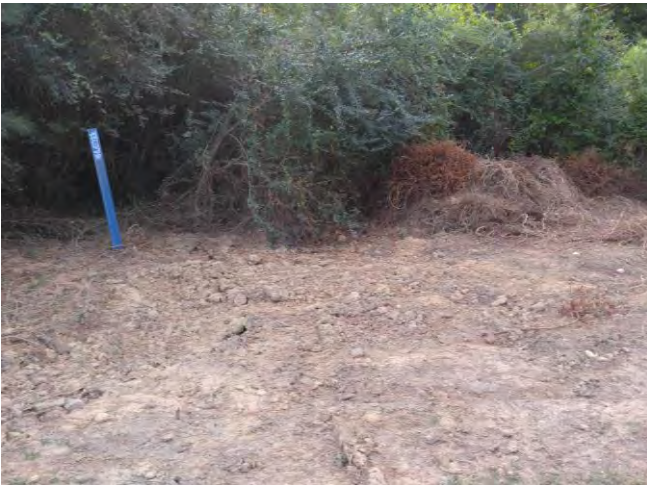
The Water company installed or fixed a valve on the edge of the cap near monument #1.

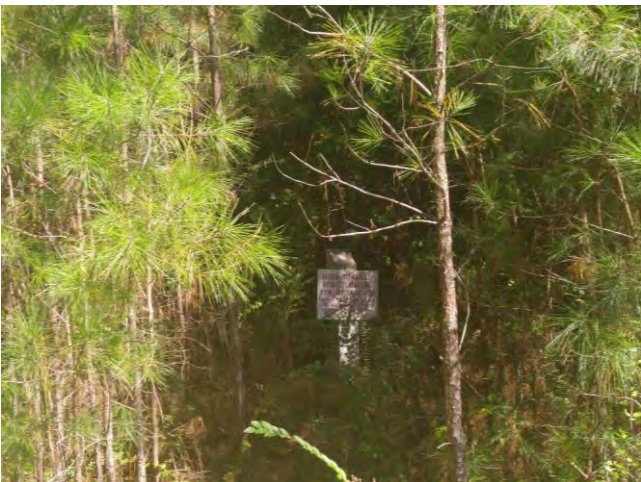
Some of the boundary monuments along the perimeter of Landfill1 had become overgrown and were difficult to see. The vegetation had become very thick along the perimeter boundary. The vegetation was trimmed to allow the boundary monument and sign to be visible.

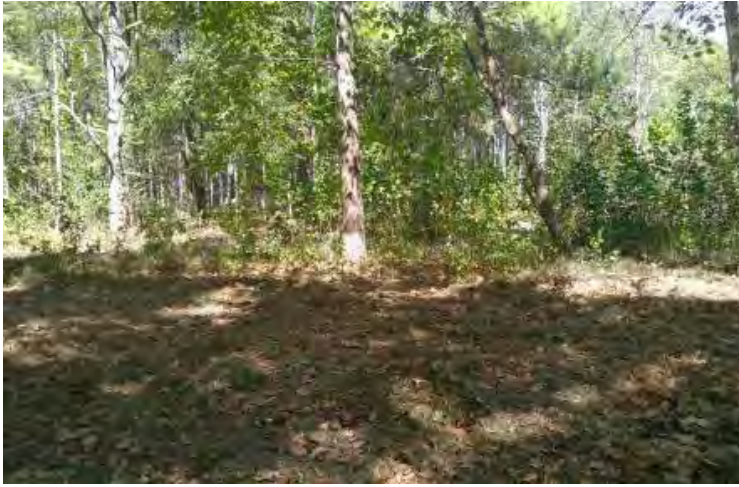
The vegetation across the landfill was observed to be in good condition at the time of the inspection. No bare areas were observed. No erosion of the landfill cap was observed during the inspection. No low areas or exposed debris was observed.

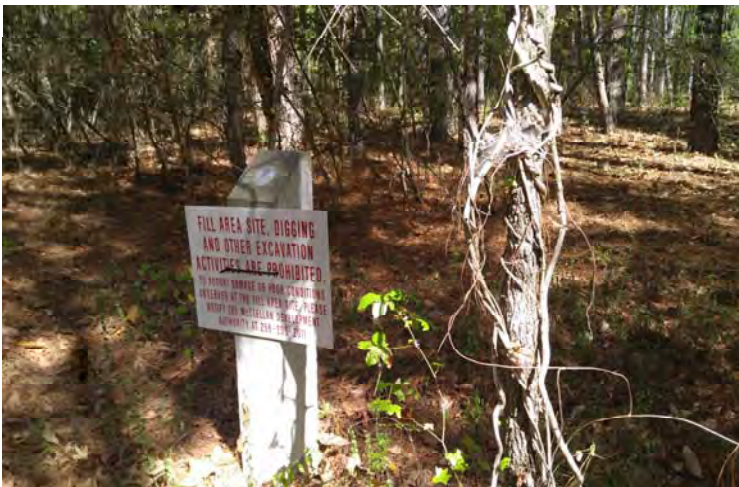
The landfill boundary monuments were in good condition with no visible signs of damage. The signs prohibiting digging on the landfill were all attached and in good condition.

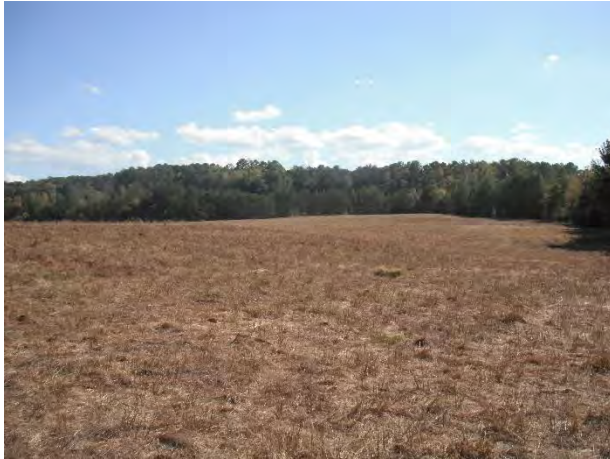
**LF4-001:** The cap surface appeared to be in good condition at the time of the inspection. The vegetation was mowed at the beginning of October 2016.

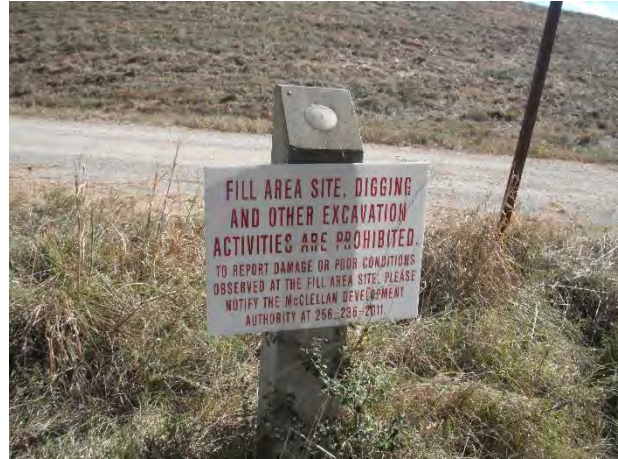
**LF4-002:** The boundary monuments were observed to be in good condition. The no digging signs were attached to the monuments at the time of the inspection.

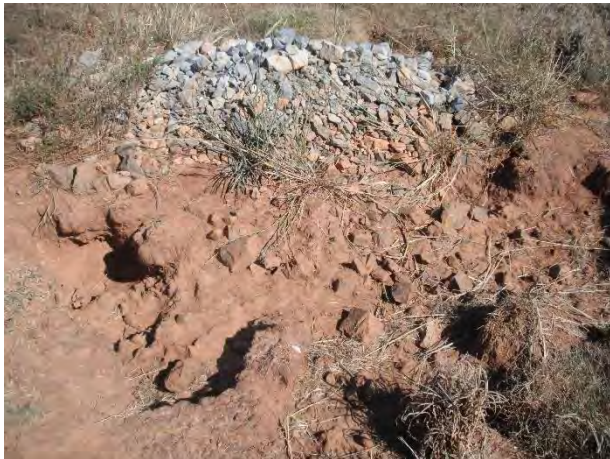
additional area of disturbance was observed in the northeastern section of the landfill. The areas of subsidence will be repaired during the final closure of the Industrial Landfill. The Landfill Cap Inspection Checklist Items report for the cap inspection is provided in Appendix B.

**LF4-003:** An area in the northeastern corner of the landfill (Area A on the attached figure) was observed to have been disturbed. This area is often frequented by deer.

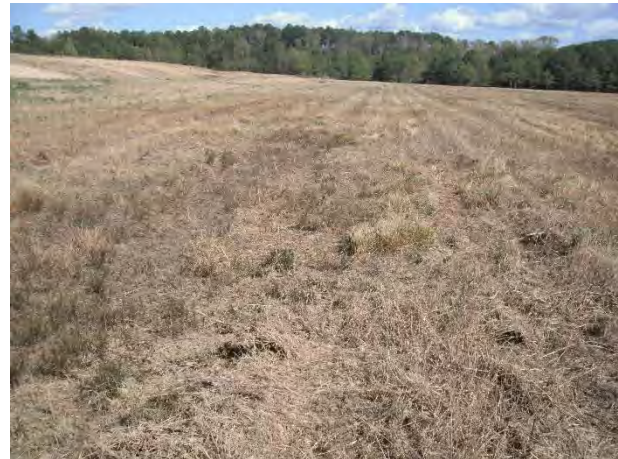
Four areas of minor subsidence were observed south of the centrally located drainage ditch. The approximate size and location of the areas was noted on the attached figure. One additional area of disturbance was observed in the northeastern section of the landfill. This is an area that has been repaired multiple times due to deer damaging the surface. Deer prints were observed in this area during the inspection. The areas of subsidence will be repaired during the final closure of the Industrial Landfill.

**LF4-004:** Four areas of minor subsidence were observed south of the centrally located drainage ditch. These areas appear to be areas that hold water during the wet seasons. The areas will be repaired during Phase II of the Industrial Landfill closure.

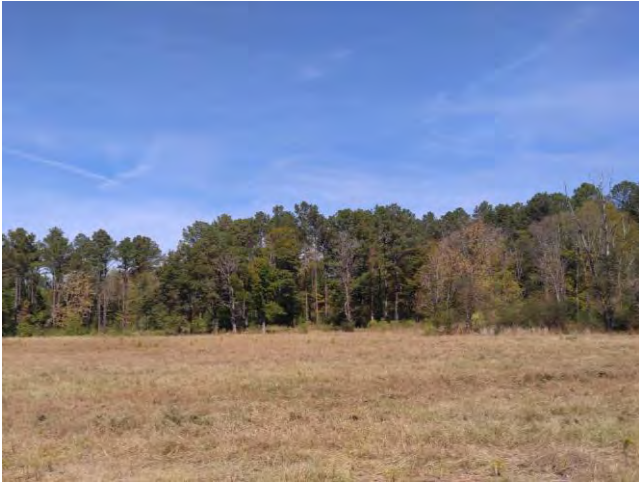
The vegetation appeared to be in good, but dormant condition due to drought.

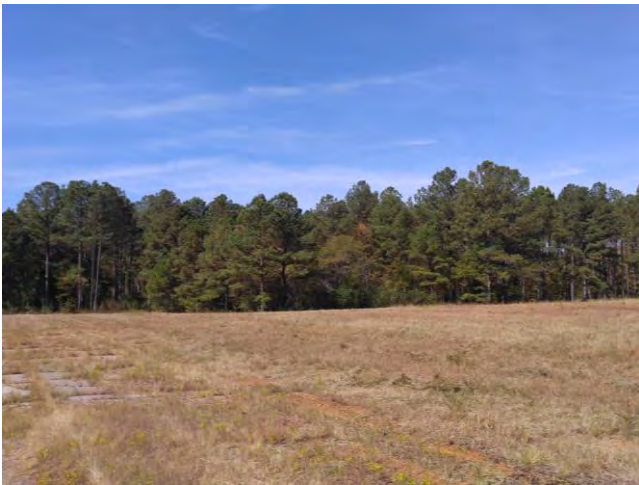
No erosion of the landfill cap was observed during the inspection.

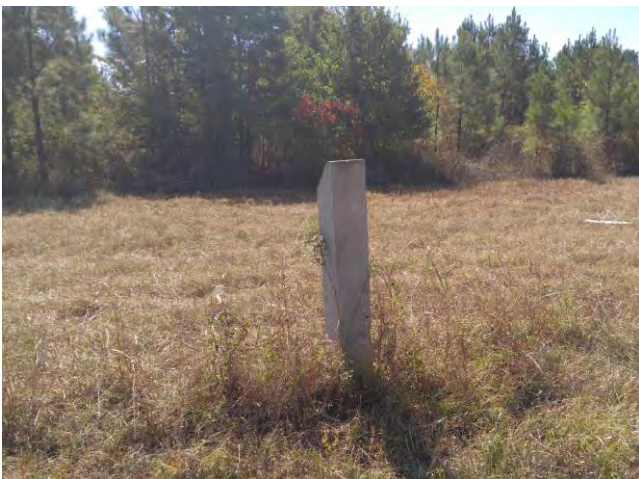
The no digging sign attached to Boundary Monument #4 had fallen and was reattached during the inspection.

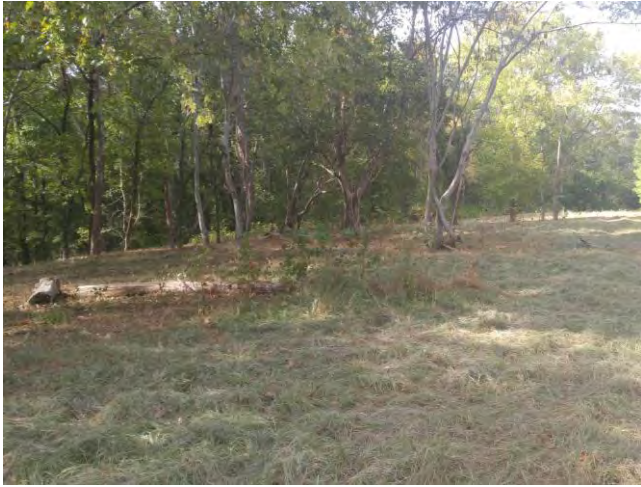
The vegetation across the cap appeared to be in good condition during the inspection. It is dormant due to drought like conditions.

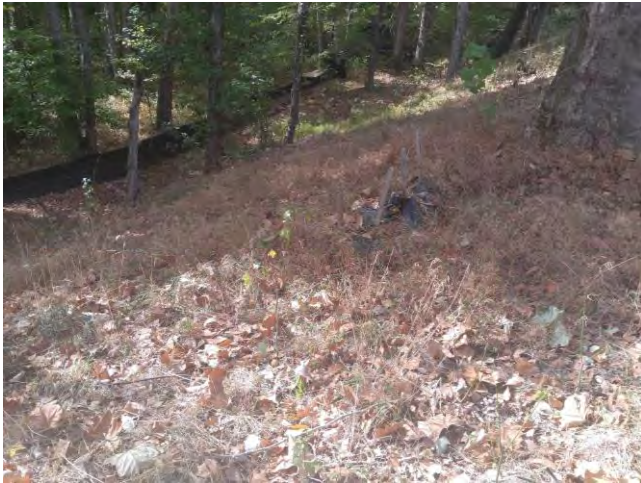
No erosion of the landfill cap was observed during the inspection. No low areas or exposed debris was observed.

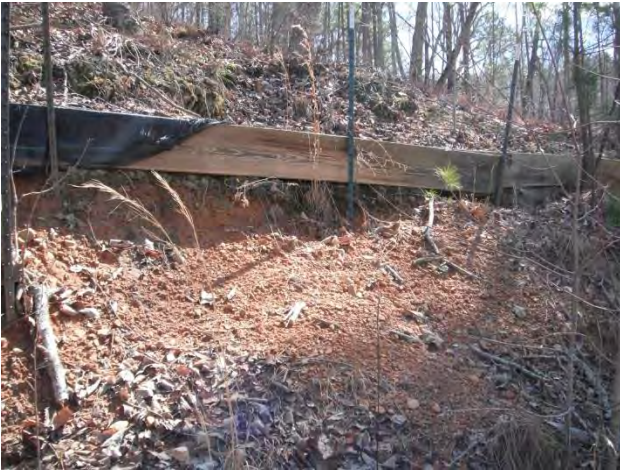
The BMPs repaired in March of 2015 were observed to be in place and in good condition.

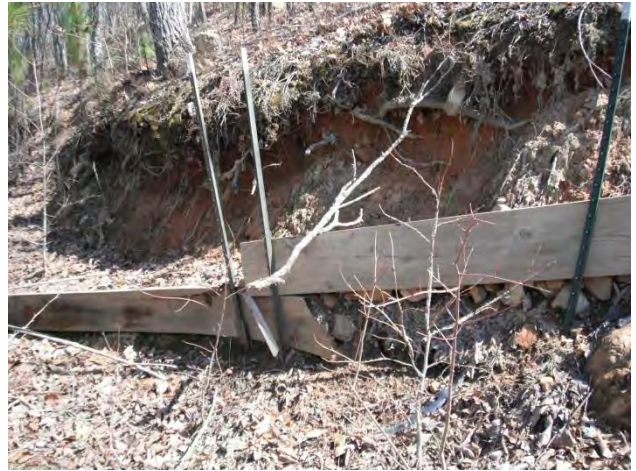
The t-posts located behind the wooden board helps to keep the board in place and helps limit erosion.

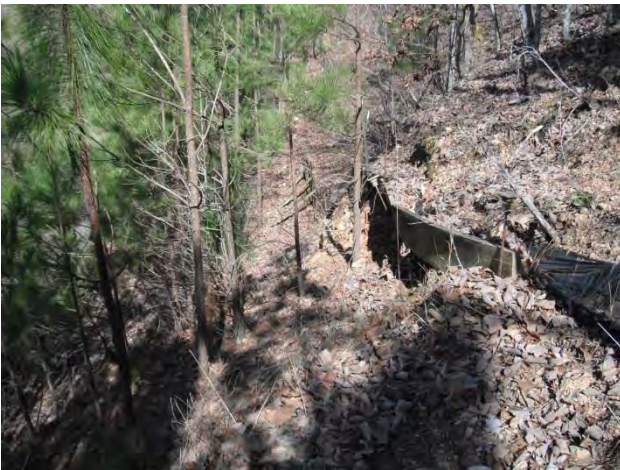
Vegetation on the slope of Range 12 is limited to small pine trees and other small woody stemmed plants.

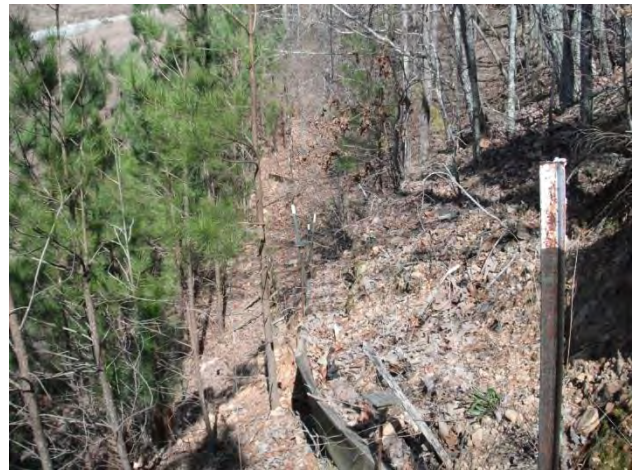
The pine trees grow beneath the BMPs and provide additional stabilization to the slope.

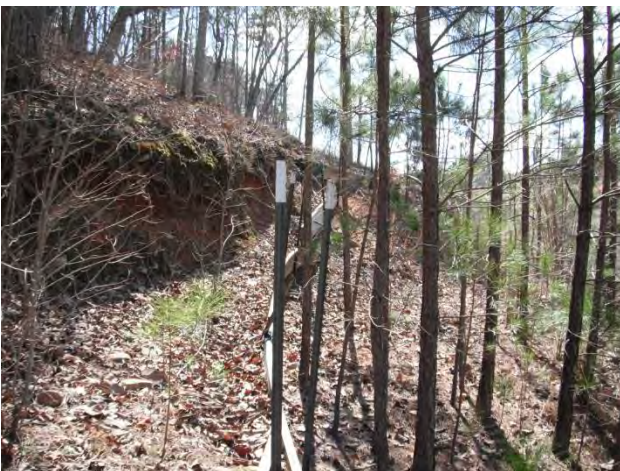
No new erosion was observed during the March 2016 inspection. Annual inspections will continue in 2017.

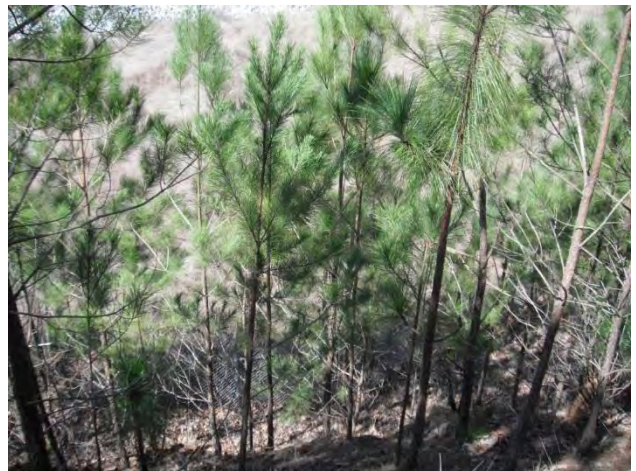
Pines help to stabilize the area beneath the BMPs. No new signs of erosion were observed during the inspection.

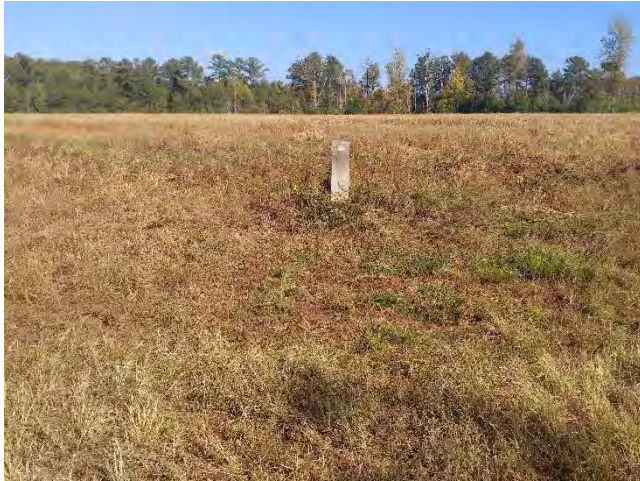
LF3: The vegetation across the cap surface was in good condition at the time of the inspection. Two no digging signs were observed to be missing but replaced at the time of the inspection.

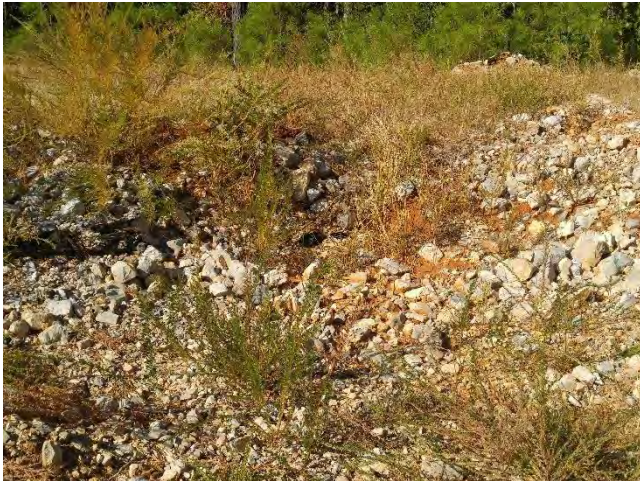
LF3: Gravel inlets are clear and free of debris.

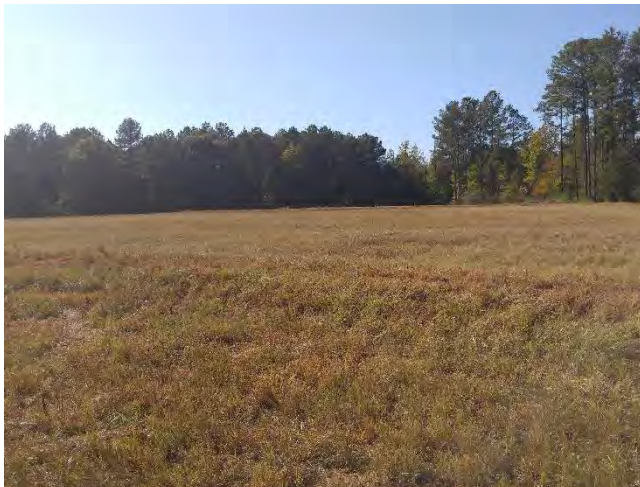
LF3: No erosion or channeling was observed during the inspection.

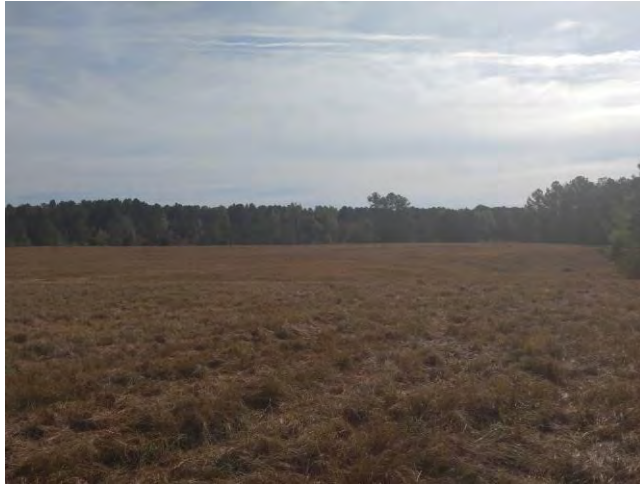
FANWR: The vegetation across the cap surface was in good but dormant due to drought like conditions.

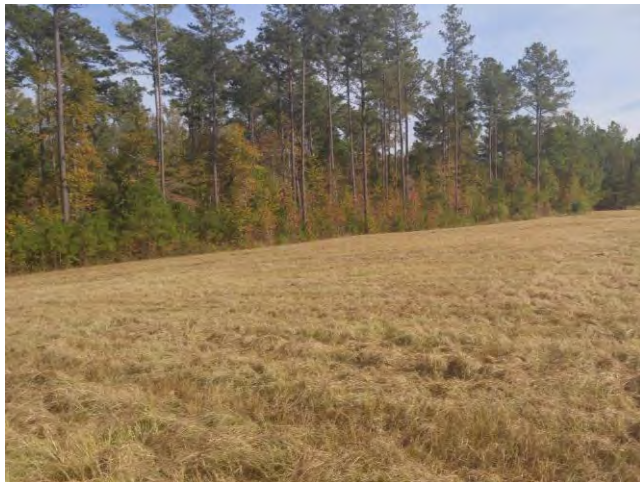
FANWR: No erosion or channeling was observed during the inspection.

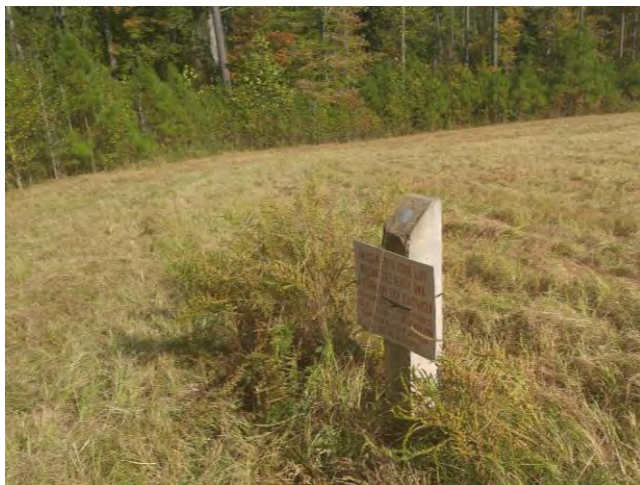
FANWR: Monuments are all intact with appropriate signs.
