**Land Use Control Effectiveness Report - 2023**  
**McClellan, Anniston, Alabama**

**McClellan Development Authority**  
**McClellan, Anniston, Alabama**

**Matrix Environmental Services, LLC**  
**283 Rucker Street**  
**Anniston, Alabama 36205**

**January 2024**  
**Revised May 2024**

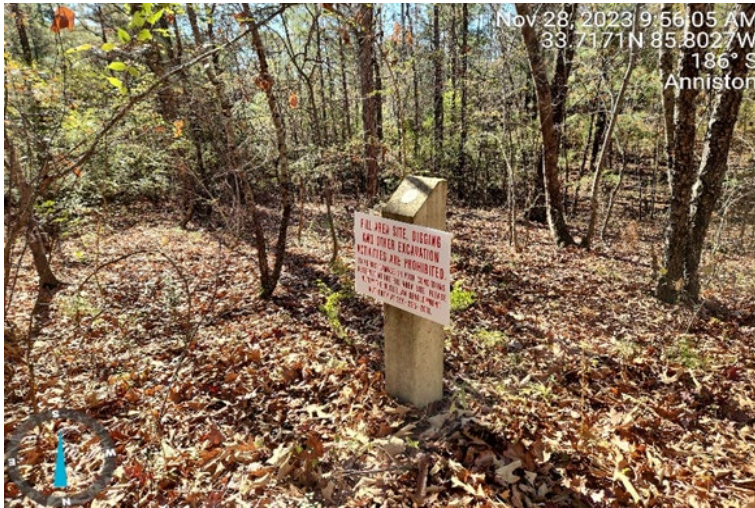
The #2 boundary monument sign was missing at time of inspection and replaced.

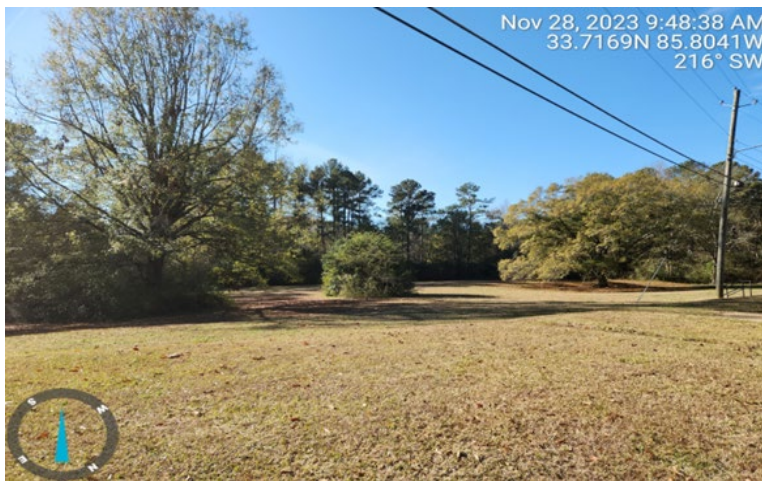
The cap was recently mowed. No erosion was observed

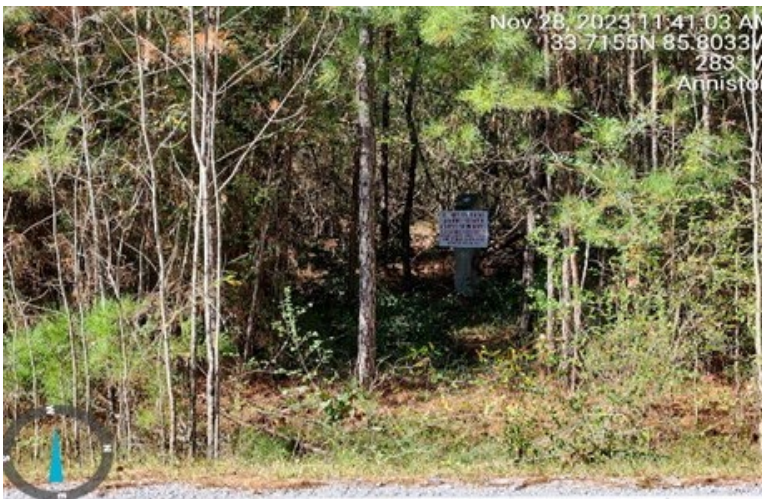
Monuments on the southeastern boundary were cleared around and signage replaced to improve visibility.

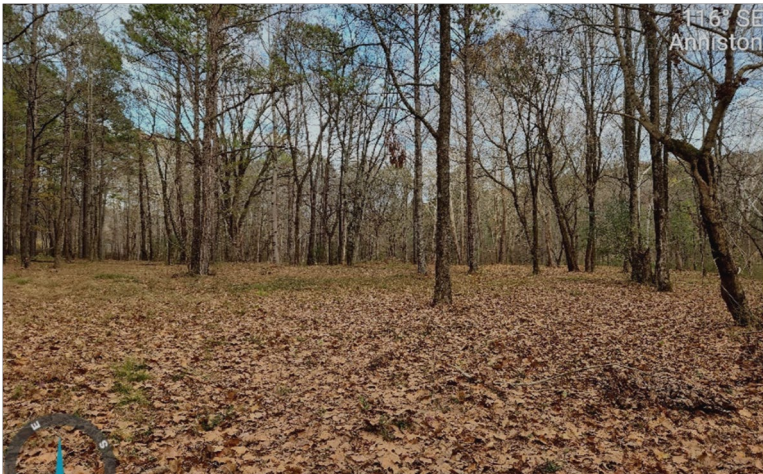
The vegetation across the cap appeared to be in good condition during the inspection.

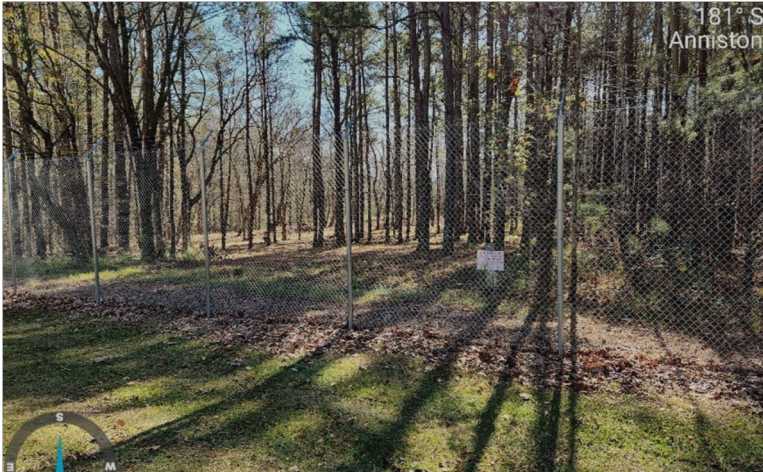
Fill Area boundary monument 3 remains highly visible through the Homeland Security perimeter fence.

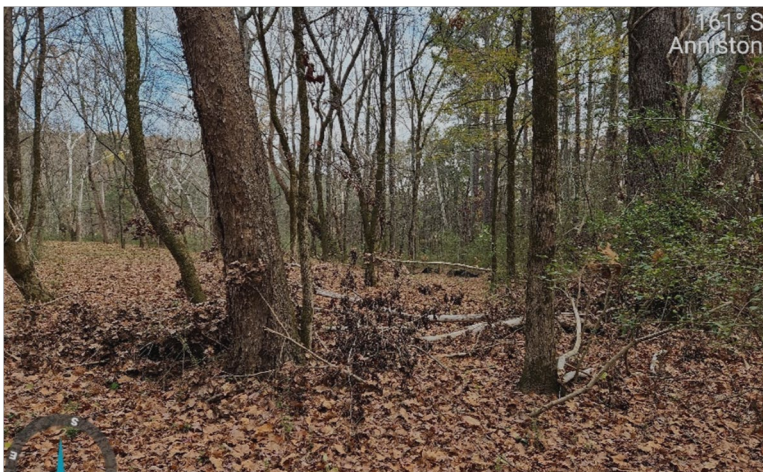
Small deadfall on the edge of the cap near monument number 7 was removed during the cap inspection.

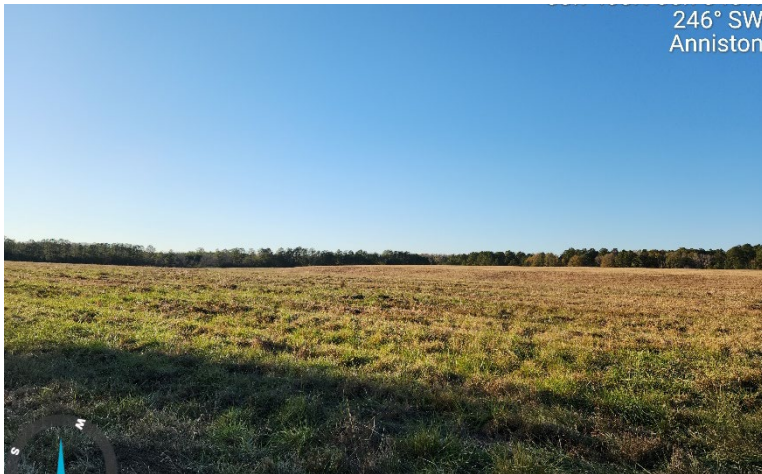
LF4-01: Recent mowing shows that the landfill cap has sufficient vegetative cover and the

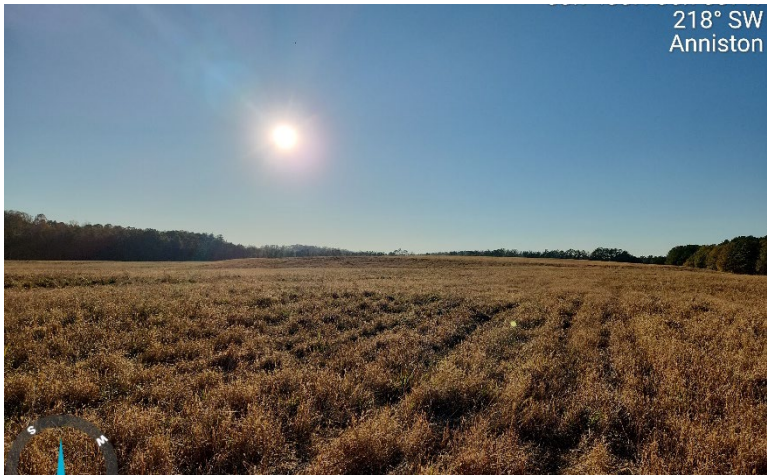
LF4-02: All areas of vegetation new and old have completely covered the landfill cap.

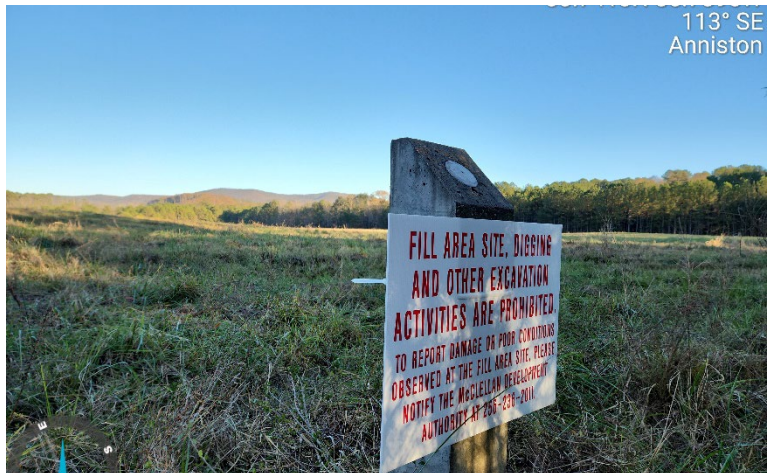
LF4-03: One monument sign was missing during the inspection and replaced.

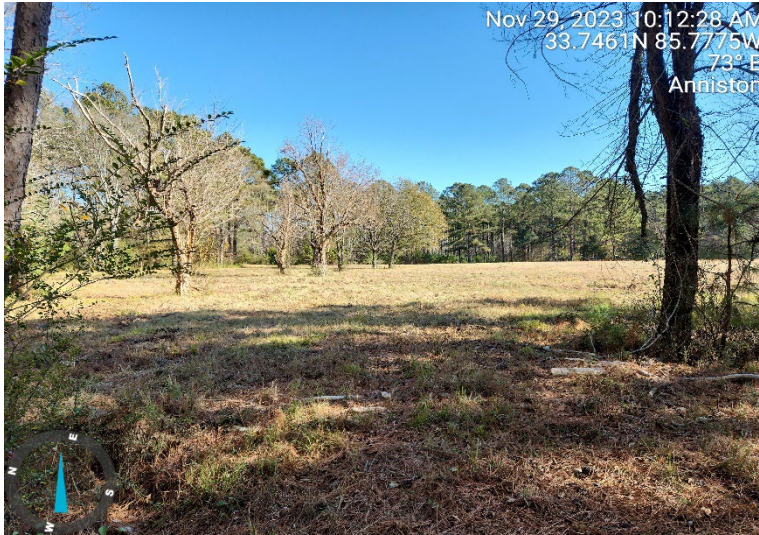
GD-01: No bare areas or damage to the cap were observed during the inspection.

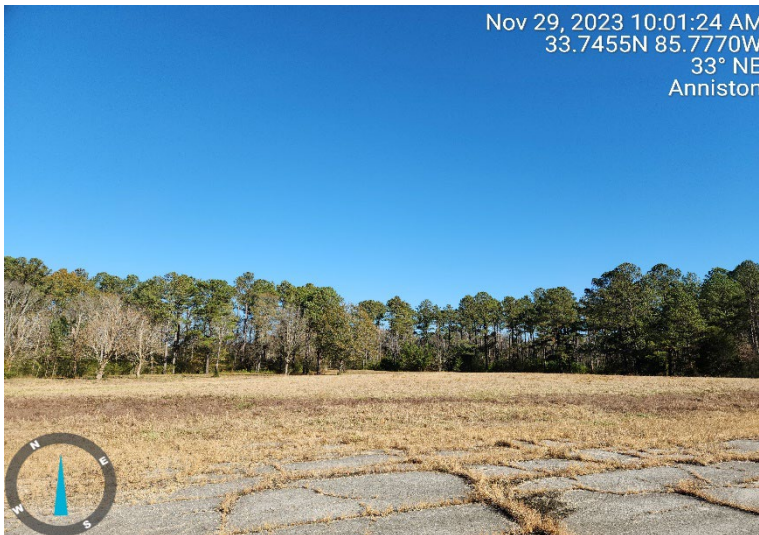
GD-02: The vegetation across the landfill cap was observed to be in good condition during the inspection.

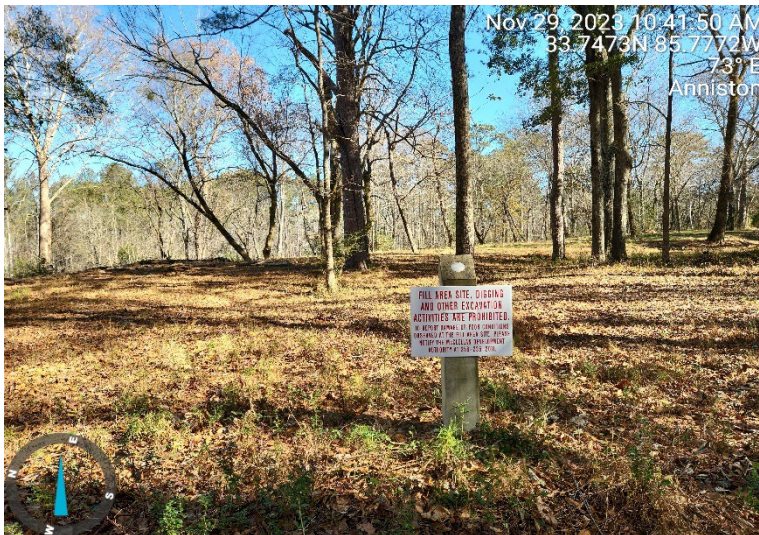
GD-03: Five No digging signs were missing or damaged and were replaced at the time of inspection.

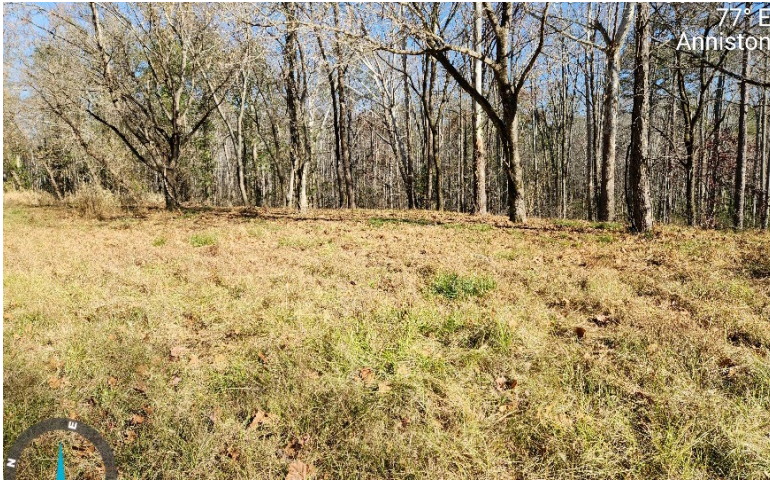
The vegetation across the cap appeared to be in good condition during the inspection.

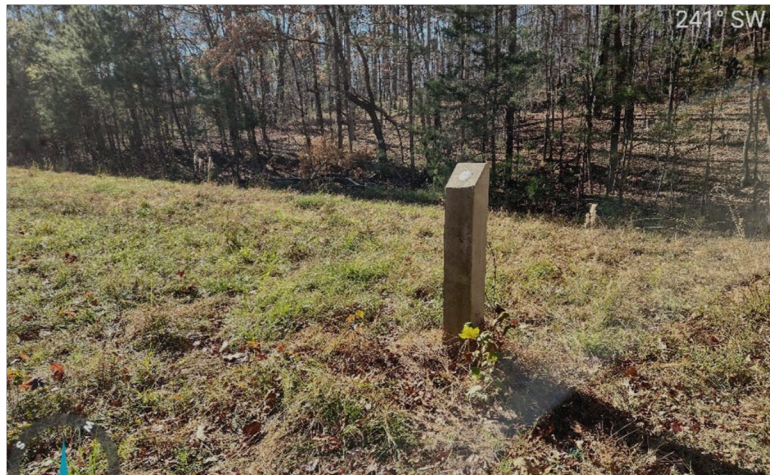
No digging sign on fill area boundary marker four was missing.

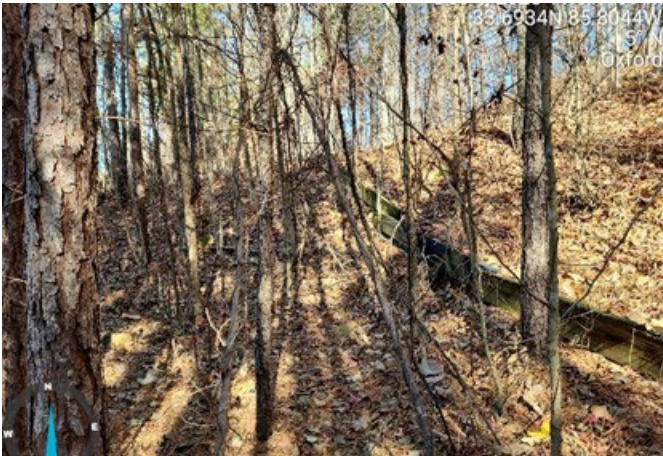
The BMPs repaired in March of 2015 were observed to be in place and in good condition.

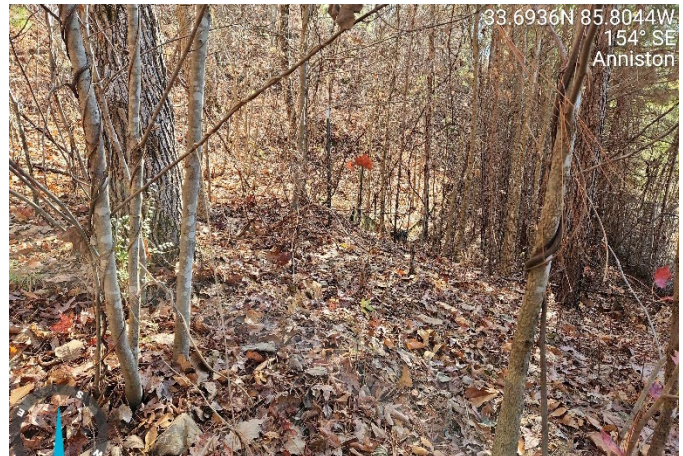
Stable vegetation and leaves have created a covered surface to help mitigate future erosion.

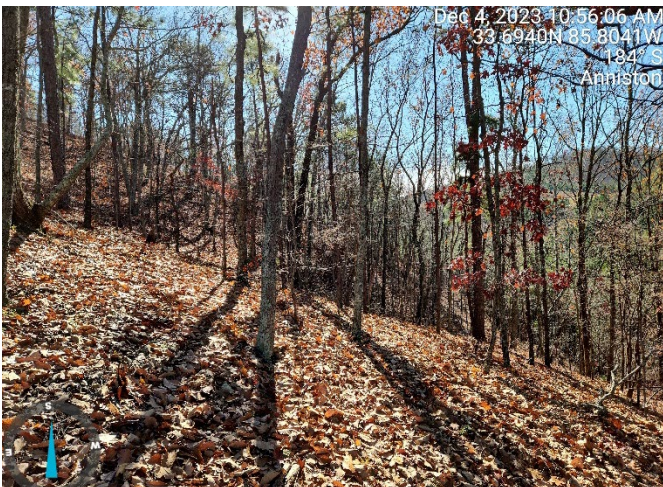
Vegetation on the slope of Range 12 is limited to small pine trees and other small woody stemmed plants.

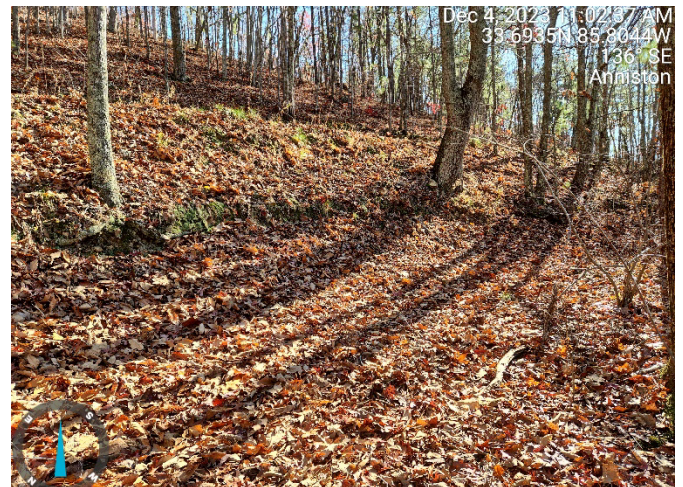
No erosion on the face of the slope was observed during the inspection. No soils were observed to have migrated offsite.

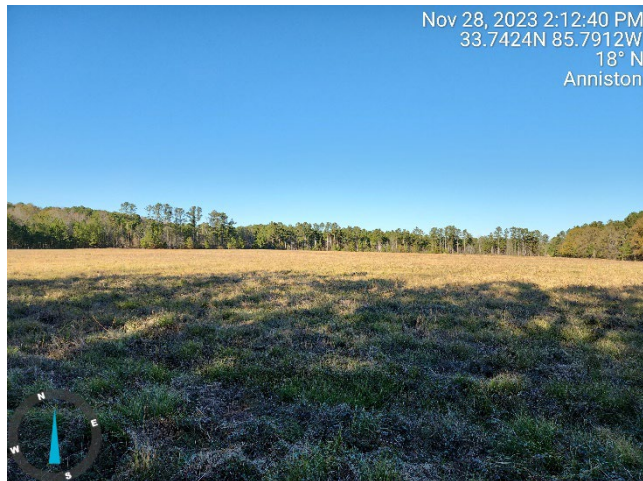
LF3: Vegetation was stable and in good condition. No standing water was observed at the time of inspection.

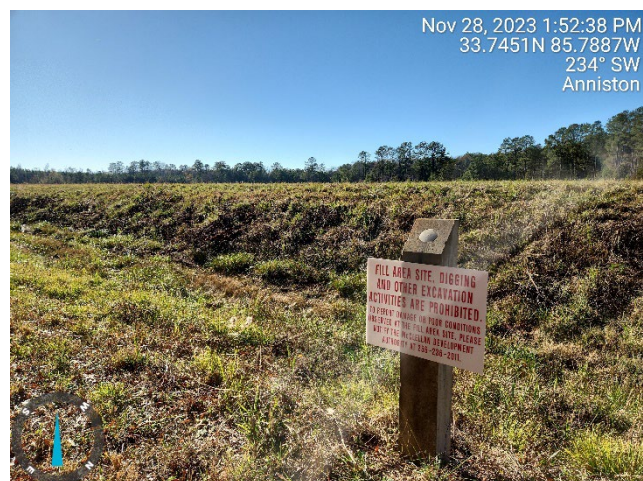
LF3: Four signs were damaged or missing and were replaced at the time of inspection.

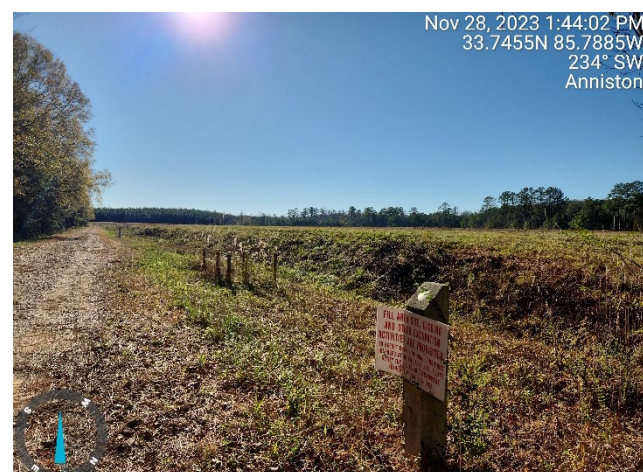
LF3: Vegetation was in good condition at the time of inspection and drainage ditches were free of standing water.

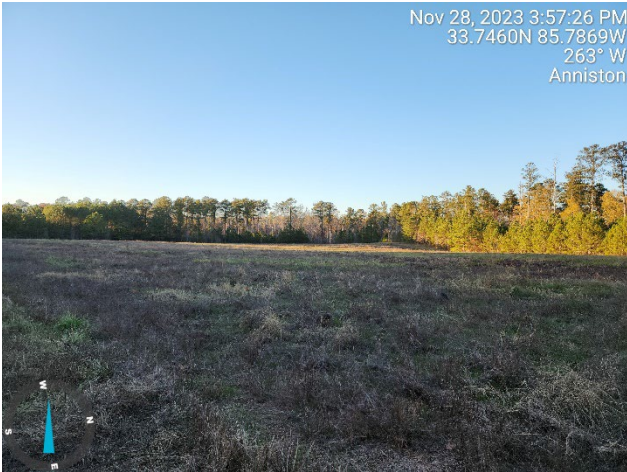
FANWR: Complete vegetative cover was present. Recent Landfill mowing showed no signs of subsidence or erosion.

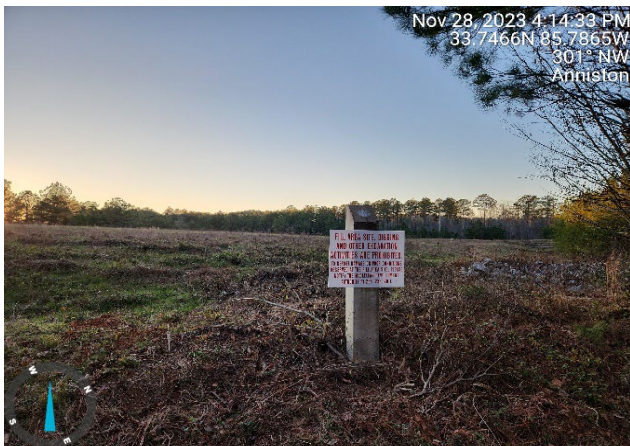
FANWR: All boundary monuments were in good condition. Five No Digging Signs were replaced at the time of inspection.

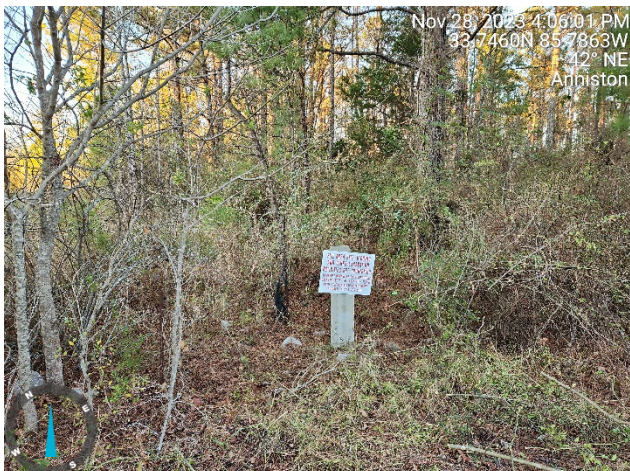
FANWR: Vegetation was removed around monuments to increase visibility.
