Appendix M

ECC/ EODT DNR/NCR Log

Deficiencies and Non Conformance LOG

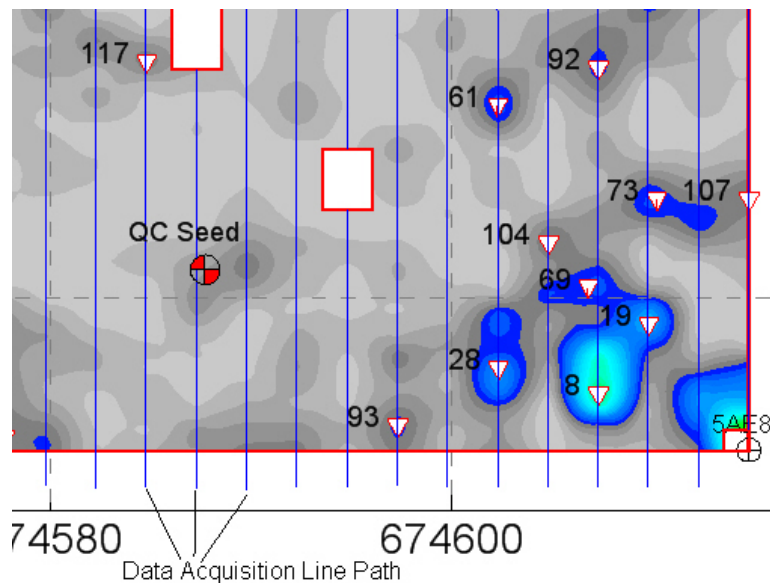
Figure 1: Detail of Grid 5AD88

After determining that the QC Seed Item was accurately located and detectable using the same methodologies proven effective by NAEVA in the GPO, the second step of the root cause analysis was to look for a systematic error in the geophysical data collection process. To do this, the NAEVA Geo Lead verified the locations of the other targeted anomalies in the grid using an EM61 MK2 in conjunction with the contour map for Grid 5AD88. It was established that the target locations depicted on the map and target list coincided with those found at the grid with the EM61 MK2. A comparison was then made of the tree gaps and field data collection notes and it was found that these also coincided with the actual locations of trees in the grid.

Using the EM61 MK2 in automatic mode (the method used for reacquisition), the operator was able to achieve a maximum response of approximately 17 mV with the long axis of the instrument oriented north-south. Changing the long axis of the instrument to an east-west orientation reduced the maximum response to approximately 10 mV. NAEVA's field personnel then utilized tape measures and pin flags to reestablish the locations of the north-south lanes used by the data collection team. Segments of four lanes were marked in the field, two on either side of the Seed Item's location. The locations of two trees adjacent to the data collection lanes were confirmed, suggesting that the field data were correctly positioned. The original instrument was then used to replicate the data collection lanes while monitoring its response in the vicinity of the seed item. The maximum observed response was found to be 6 mV above background (peak of 8 mV with a local background of 2 mV).

Because of the seed item's buried depth, its orientation perpendicular to data acquisition paths, and the unclear physical state of the item itself, this blind QC seed item was not targeted by the data analyst. Based on the investigation conducted at this seed location, it is believed that this seed item was likely untargeted due to its very subtle EM response above the surrounding area background. The processed data set for this grid revealed only a 4.7 (channel 2) mV response at the seed location.

Proposed Corrective Action: On January 3, 2007, the untargeted blind QC seed of grid 5AD88 was discussed between NAEVA and the ECC QC team. It was agreed upon by both parties that a deficiency and/or a non-conformance in work effort was not the cause resulting in the untargeted seed item and therefore not a “QC failure”. Because the location of the seed item is only known by the ECC QC team and the NAEVA Geo Lead, it is suggested that this seed location be targeted by the GeoQCS. This action should allow for this blind seed to be successfully recovered by the dig team assigned to excavate this grid as the reacquisition team will be able to establish an above-threshold-mV-response at this target location.

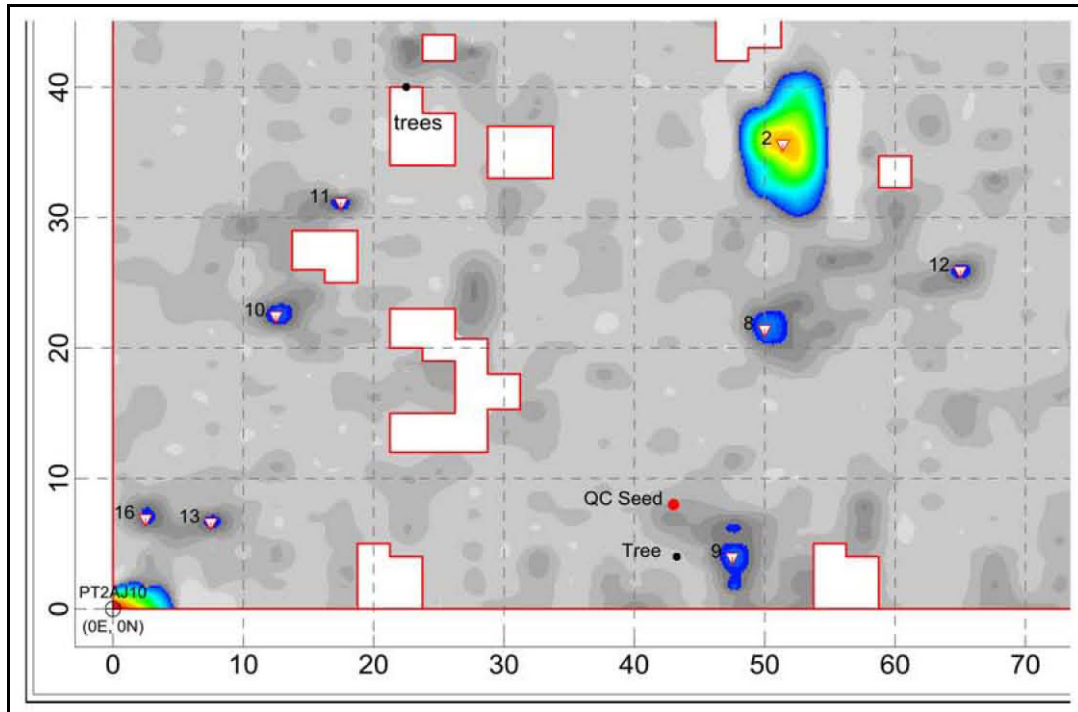
Figure 1: Detail of Grid 2AJ10

After determining that the QC Seed Item was accurately located and detectable using the same methodologies proven effective by NAEVA in the GPO, the second step of the root cause analysis was to look for a systematic error in the geophysical data collection process. To do this, the GEOQCS and the NAEVA Geo Lead verified the locations of the other targeted anomalies in the grid using an EM61 in conjunction with the contour map for Grid 2AJ10. Both parties agreed that the target locations depicted on the map and target list coincided with those found at the grid with the EM61. A comparison was then made of the tree gaps and field data collection notes and it was found that these also coincided with the actual locations of trees in the grid. However, during the course

of investigating tree gap locations it was noticed that a 4-5 inch diameter tree was located approximately 4 feet south of the QC Seed in question, and that there was no corresponding gap shown on the contour map. A tape measure stretched along the Grid's southern boundary revealed that the tree was located directly between data collection lines 42.5 and 45 (See Figure 1 below).

During data acquisition, NAEVA's field teams routinely stop data collection whenever an obstruction (i.e. trees) is encountered. Their standard operating procedure is to stop data collection, go around the obstruction, and then continue data collection on the other side of the obstacle. However, in this case, a relatively small tree was encountered directly between two acquisition lanes. Rather than break the acquisition line into separate segments thereby creating a data-gap the geophysical team deviated slightly from the straight lane path on either side of the tree. This relatively small lane variance resulted in the instrument not passing directly over the seed, therefore not attaining sufficient response to generate a target selection. Furthermore, the seed item was oriented parallel to the direction of data collection. Field observations revealed that a change in the EM61's position of 3-4 inches laterally relative to the seed location caused a change in the instrument's response from that of two times the anomaly selection threshold to a response below the anomaly selection threshold.
