RESTORATION OF POW MURALS

REMINGTON HALL
Building 51

FORT McCLELLAN, ALABAMA

U.S. Army Contract No. DABT02-96-D-0005
Delivery Order 0038

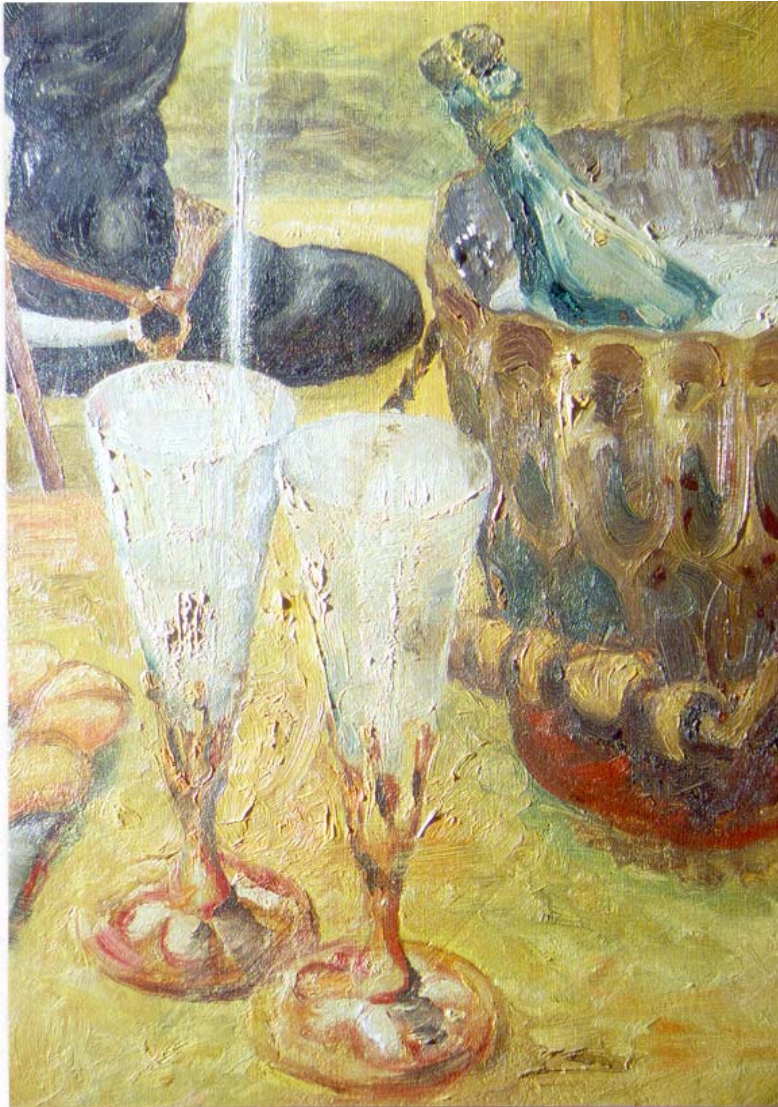
result of an earlier restoration work done in 1985 by Kay McFarland. In some areas of original paint application, drying cracks are noted in the surface. This is clearly illustrated in Picture 2. In areas of previous restoration work, these drying cracks do not exist, which helps the viewer detect the original work from restoration work.

Picture 2:
Detailing of
impasto on mural
located on the
South wall
depicting two men
pouring wine into
glasses and
holding riding
crop. The picture
was taken before
treatment using a
raking light
method, which
illuminates the
flaking paint.
(Close-up of
Pictures 16 and
17).

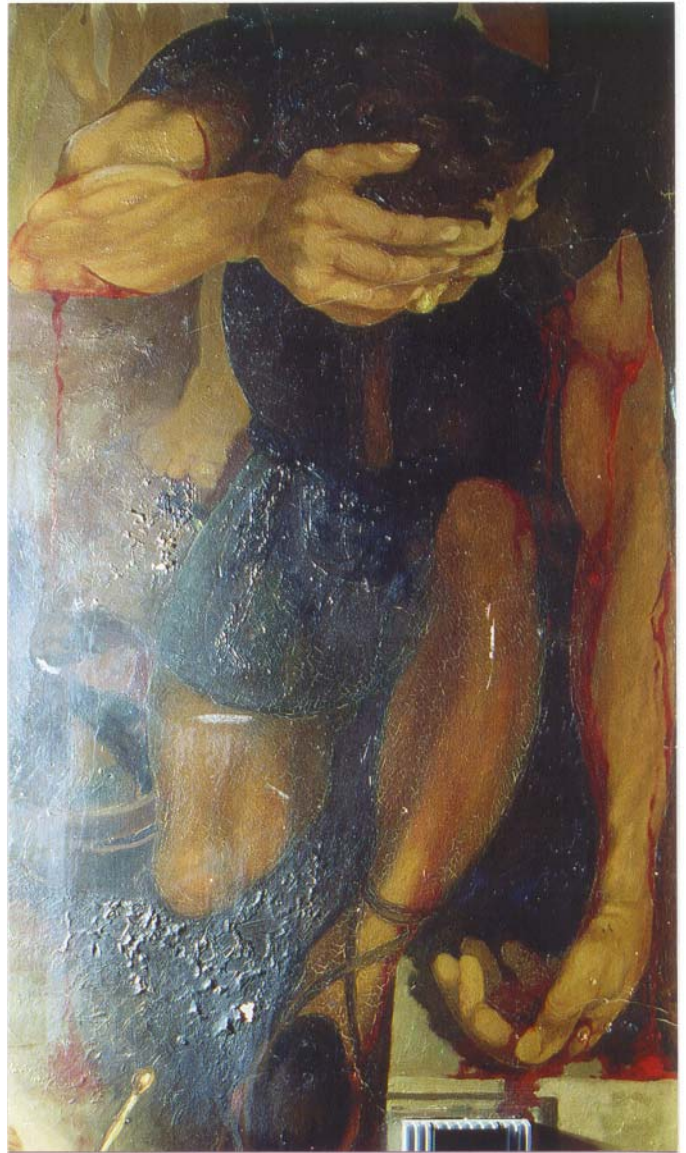
Picture 3: Mural portraying a hurt man, which is located on the East wall just right of the fireplace. The picture was taken before treatment using a raking light method, which illuminates the flaking paint. (Close-up of Picture 6)

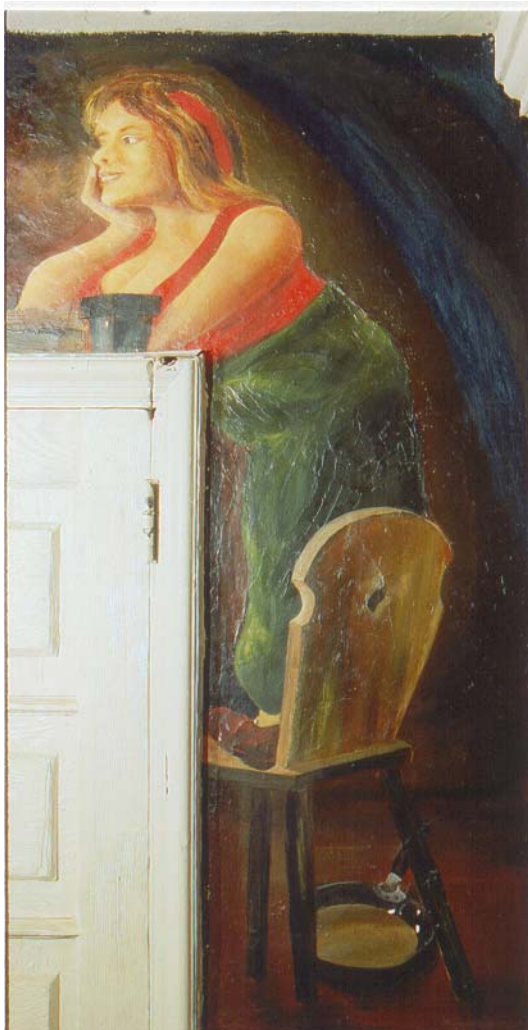
Picture 4: Located on the North wall, this mural is of a woman standing in a chair. The picture was taken before treatment, in normal lighting.

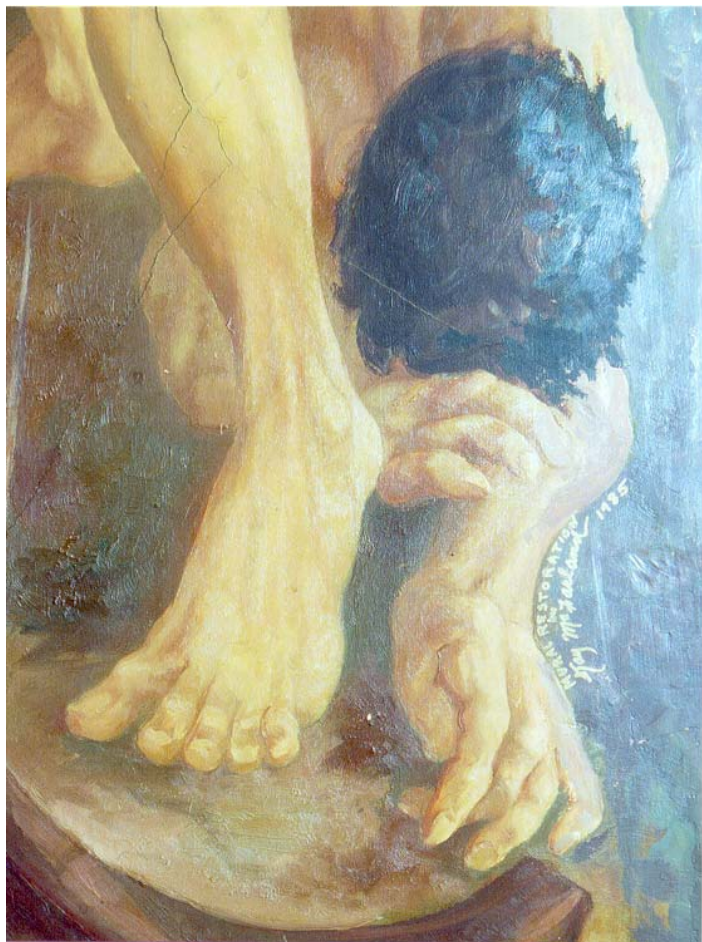
Previous restoration work is documented on the murals by an inscription/signature by the restorer which reads, "Mural Restoration//Kay McFarland 1985". It is located in two places: one on the mural to the left of the fireplace on the East wall (refer to Picture 5) and the other located on the North wall in the mural of the men fighting.

Picture 5:
Detail of the
previous
restorer's
signature that is
part of the
mural of men
with snakes,
which is located
on the East wall
left of fireplace.
The picture was
taken before
treatment, in
normal lighting.

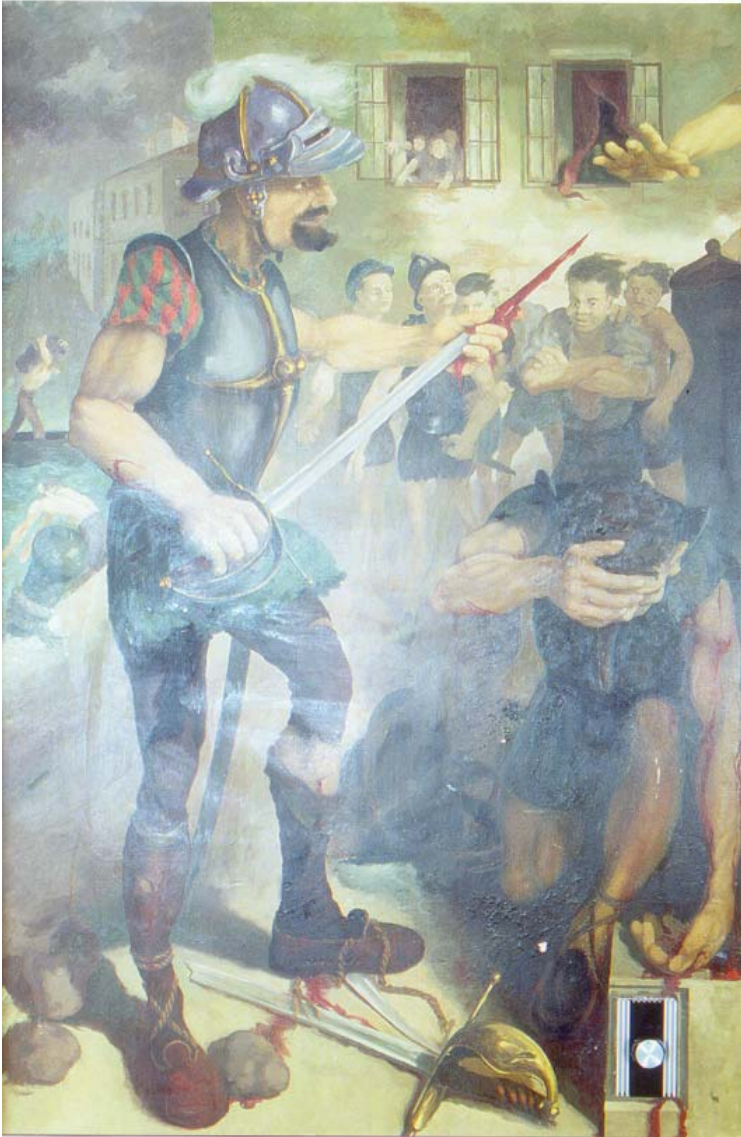
Areas of flaking and lifting paint were consolidated using Beva D-8 adhesive and the heat from a tacking iron. Flaking and lifting paint was especially noted on the East wall in the mural of the soldier with the bloody sword, Picture 6; and on the West wall in the mural of the two men with a duck, the dog, and the woman in red dress on the chair (Picture 4). Damage to the mural on the East wall was concentrated along the lower edge near the light switch, while the damage on the West wall was more extensive and most likely caused by leaking water. The West wall shows evidence of large areas of previous restoration both to the painting's design and support.

Picture 6: Located on the East wall just right of fireplace, this mural depicts a man holding a bloody sword with a crowd of people around him. The picture was taken before treatment, in normal lighting.

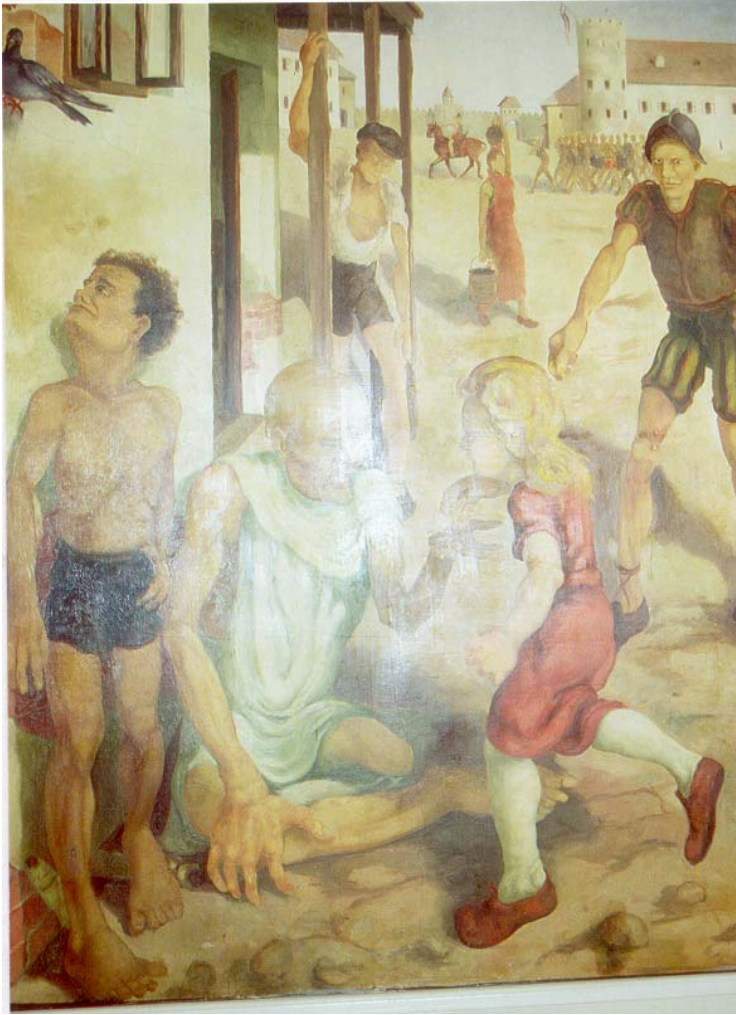
Picture 7: Detail of the mural of a beggar seated with children around him, which is located on the East wall left of fireplace. The picture was taken during treatment in a specular lighting setup, which aids in the interpretation of brushstrokes from a prior application of surface coating.

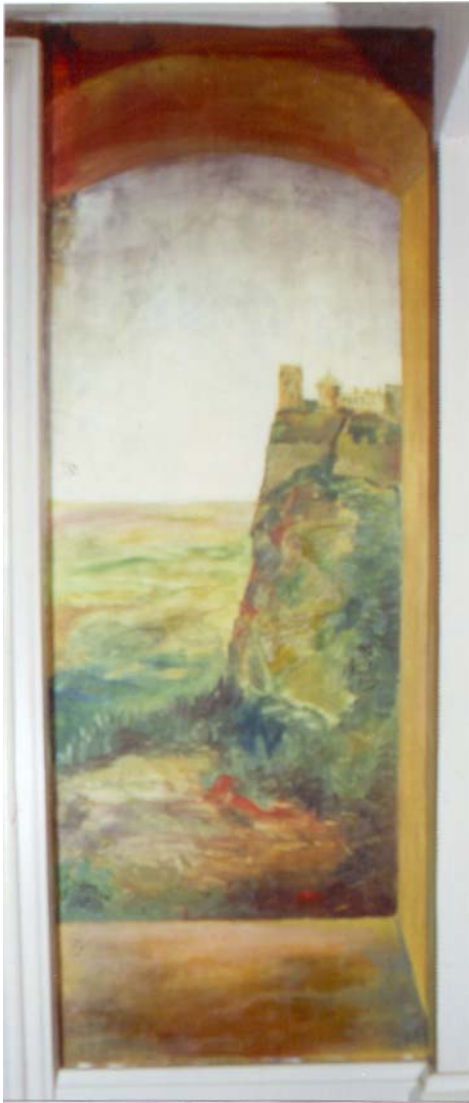
Picture 8 (above): Mural on South wall exhibiting a castle atop a bluff with surrounding landscape. The picture was taken before treatment, in normal lighting.

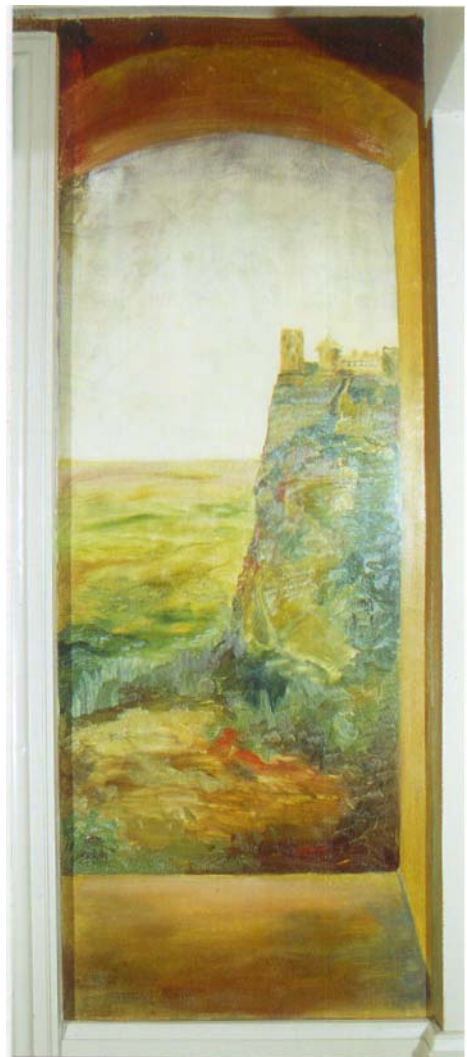
Picture 9 (below): Mural on South wall exhibiting a castle atop a bluff with surrounding landscape. The picture was taken after treatment, in normal lighting.

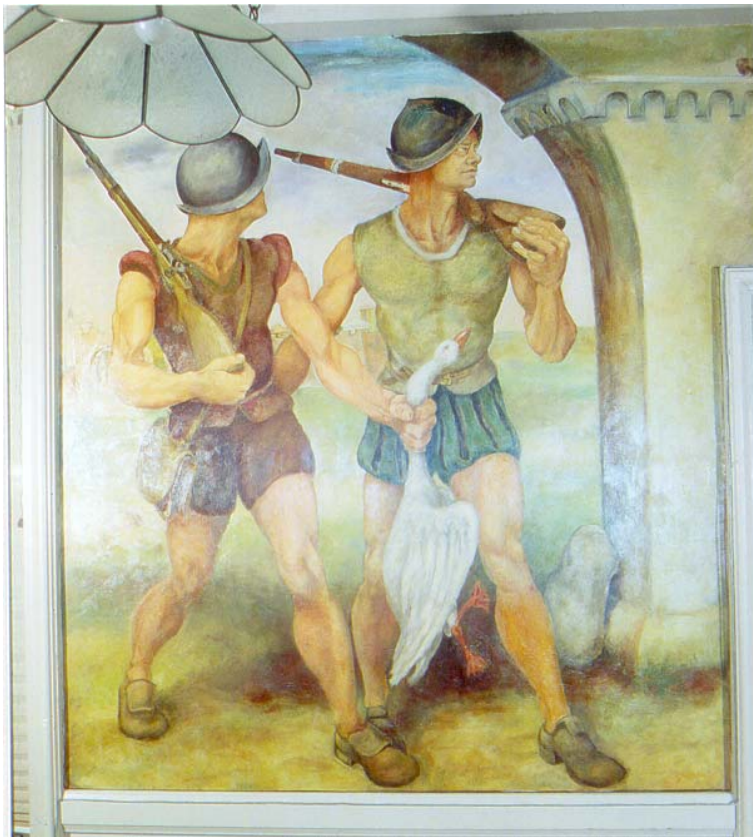
Picture 10 (left): Mural on North wall displaying two soldiers who are carrying a goose. The picture was taken before treatment, in normal lighting.

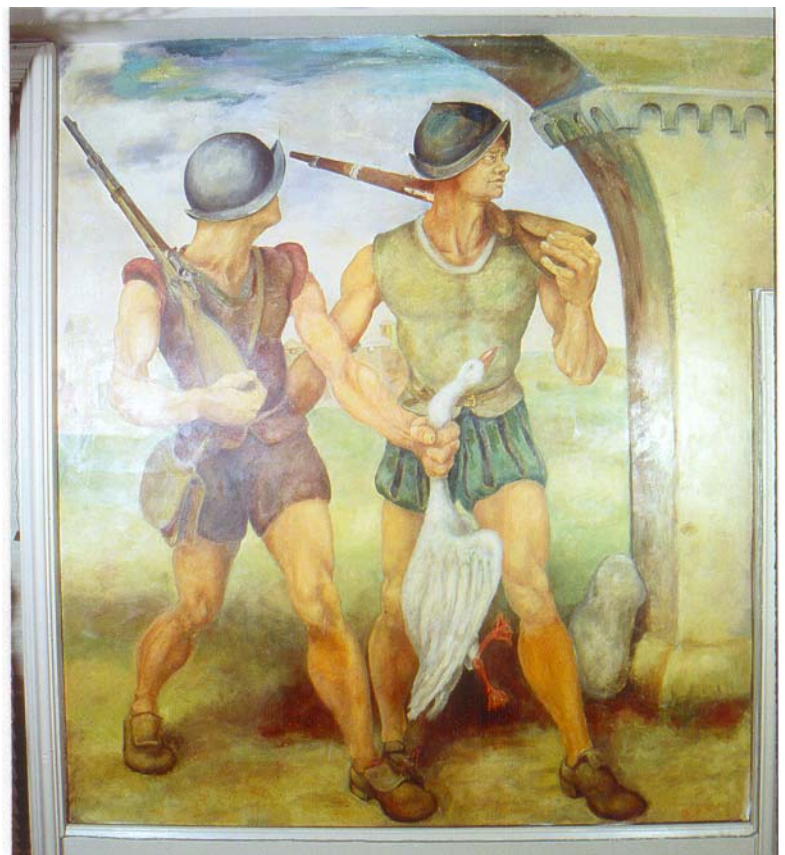
Picture 11 (right): Mural on North wall displaying two soldiers who are carrying a goose. The picture was taken after treatment, in normal lighting.

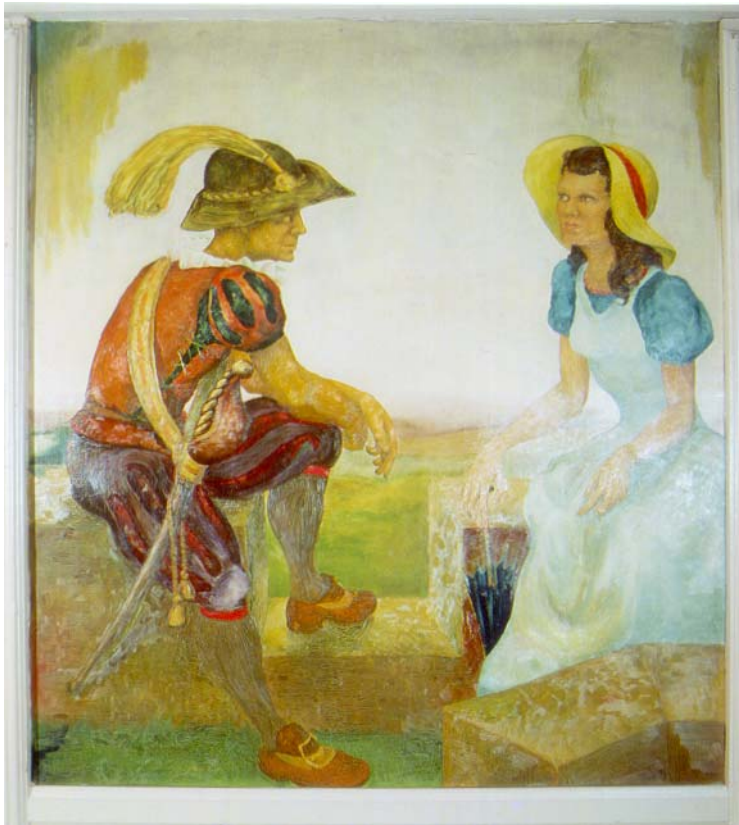
Picture 12 (left): A South wall mural of soldier talking to a young woman holding a folded umbrella. The picture was taken before treatment, in normal lighting.

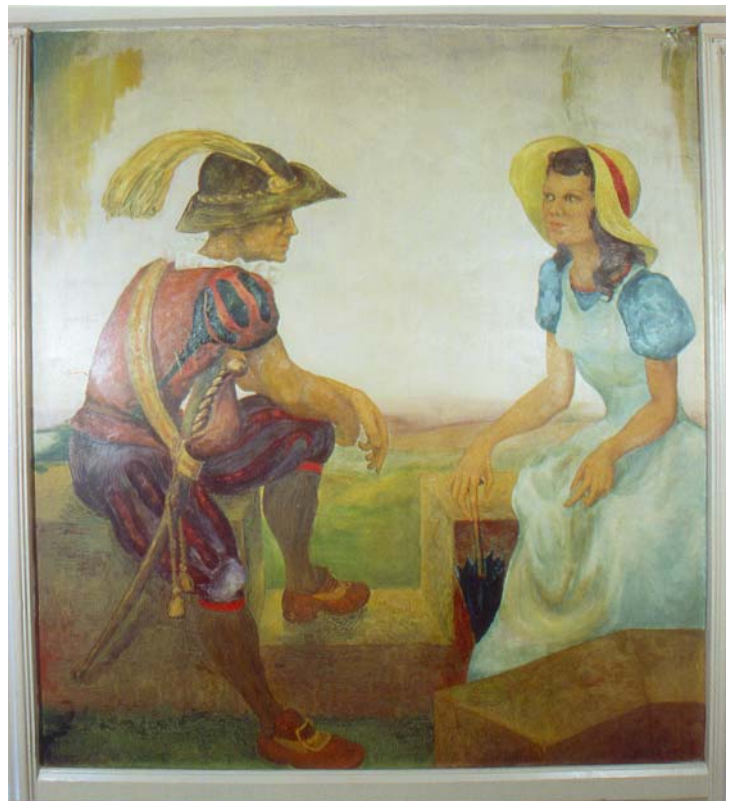
Picture 13 (right): A South wall mural of soldier talking to a young woman holding a folded umbrella. The picture was taken after treatment, in normal lighting.

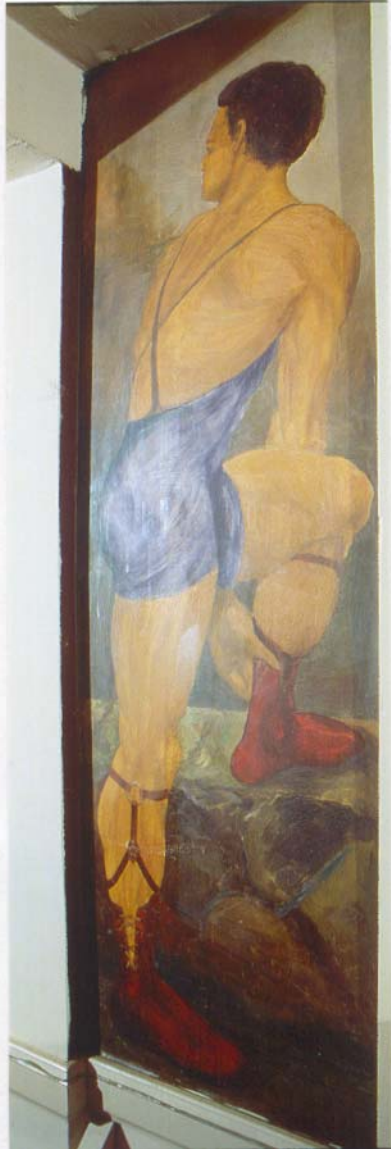
Picture 14 (above):
A North wall mural displaying a man with one leg propped up on a stone wall. The picture was taken before treatment, in normal lighting.

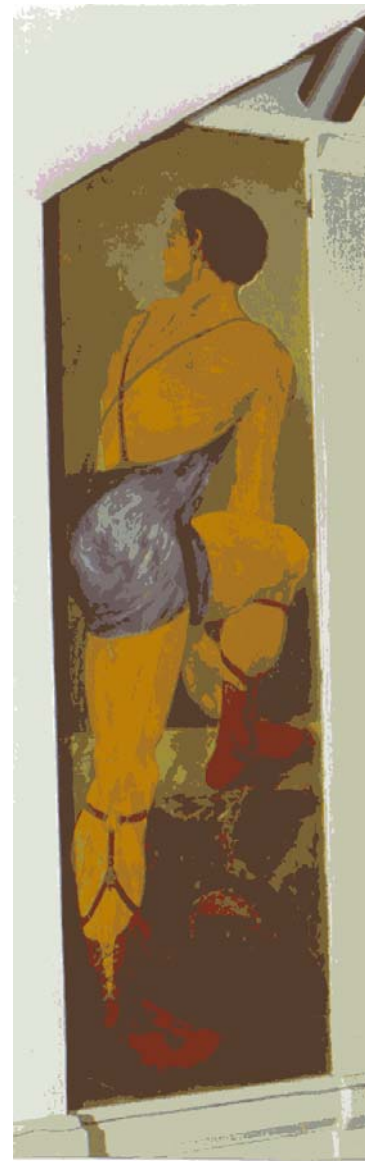
Picture 15 (below):
A North wall mural displaying a man with one leg propped up on a stone wall. The picture was taken after treatment, in normal lighting.

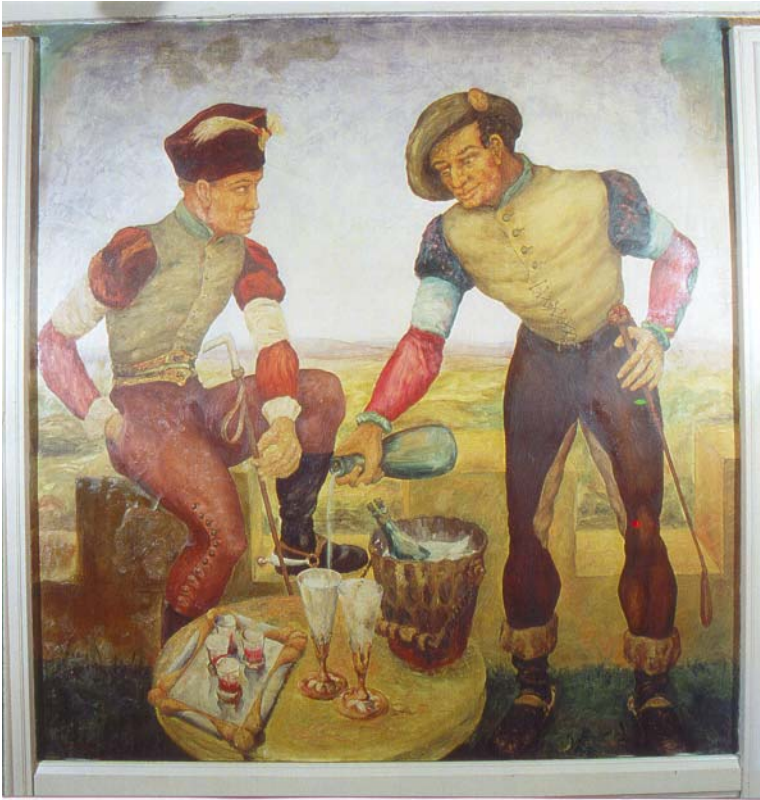
Picture 16 (left): Mural located on the South wall that illustrates two men pouring wine into glasses. The picture was taken before treatment, in normal lighting.

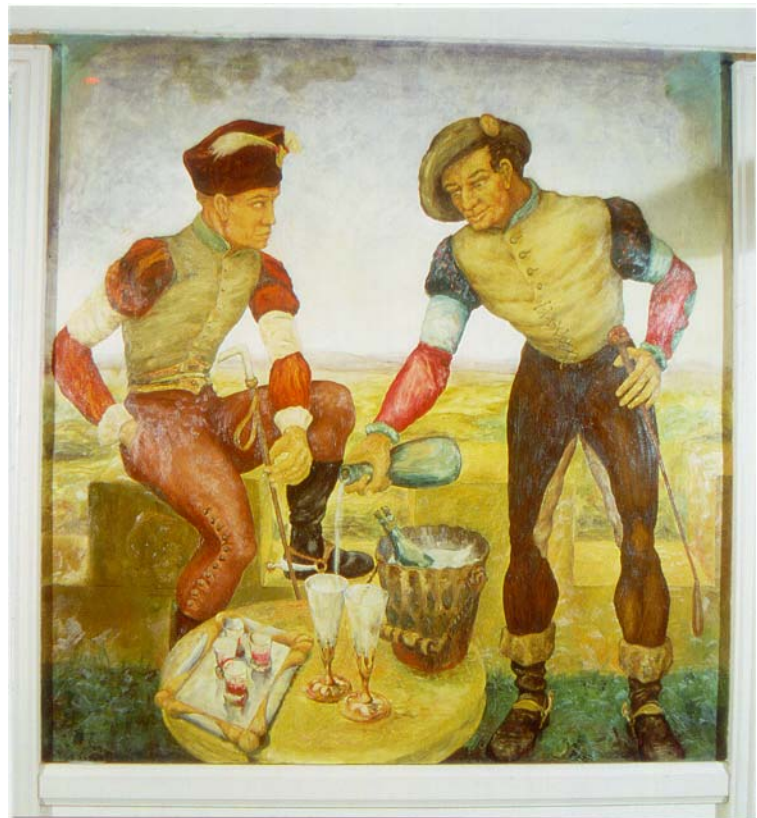
Picture 17 (right): Mural located on the South wall that illustrates two men pouring wine into glasses. The picture was taken after treatment, in normal lighting.

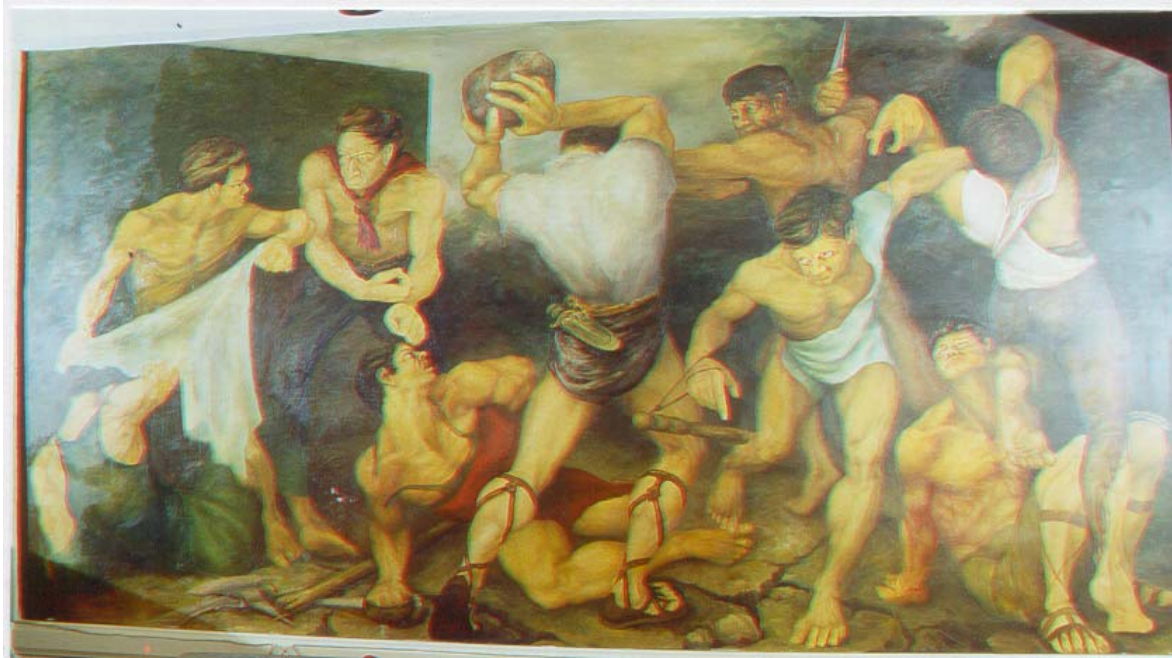
Picture 18: Mural located on the North wall displaying muscular men fighting with barbaric crude weapons. The picture was taken before treatment, in normal lighting.

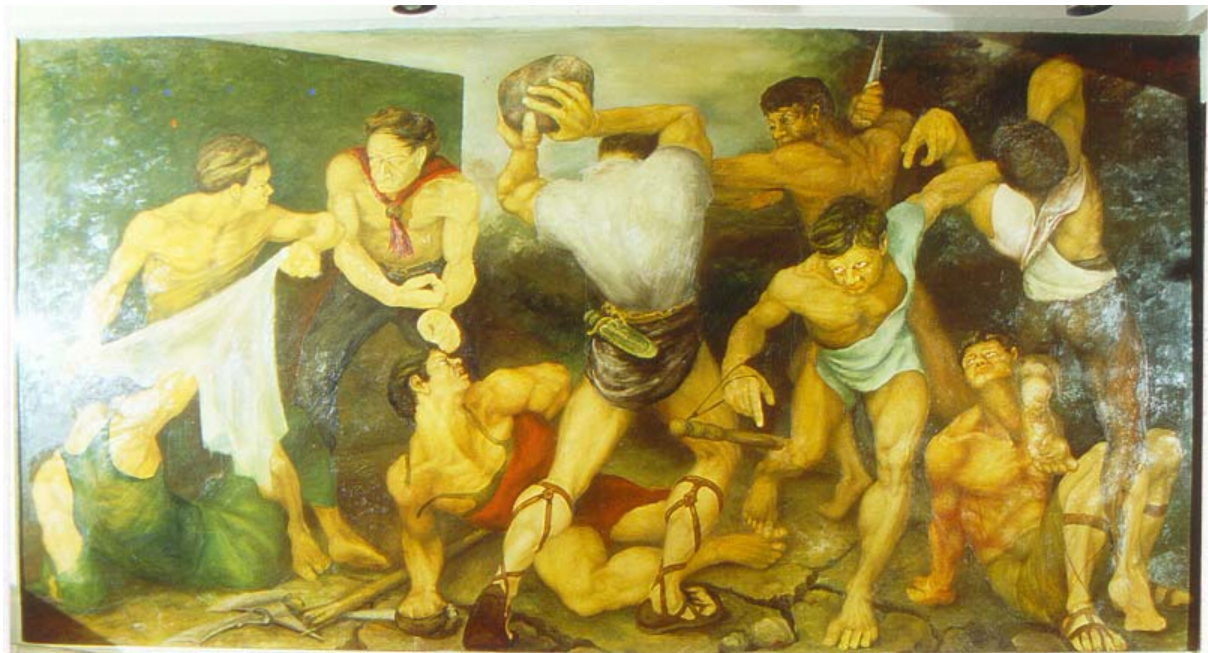
Picture 19: Mural located on the North wall displaying muscular men fighting with barbaric crude weapons. The picture was taken after treatment, in normal lighting.

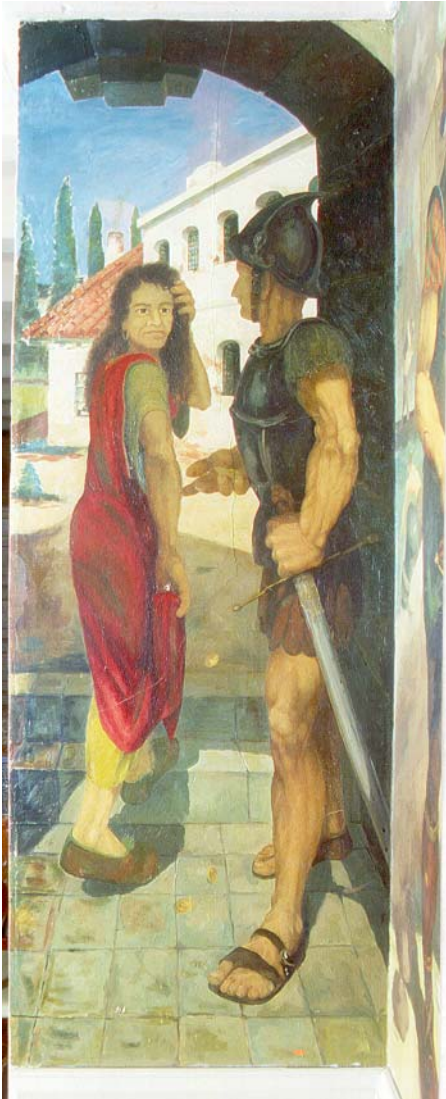
Picture 20 (above): East wall mural located just right of fireplace exhibiting a soldier with sword dropping coins at a woman in a red dress. The picture was taken before treatment, in normal lighting.

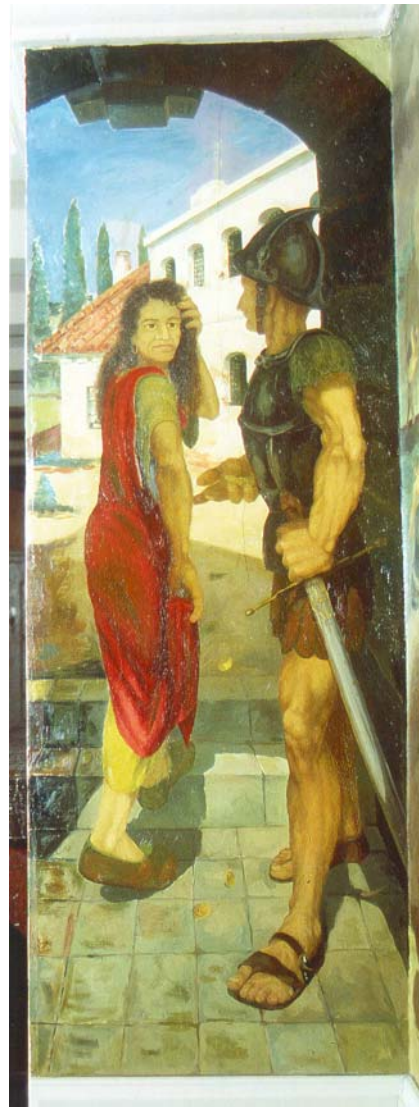
Picture 21 (below): East wall mural located just right of fireplace exhibiting a soldier with sword dropping coins at a woman in a red dress. The picture was taken after treatment, in normal lighting.
