October 31, 2016

**Re: MEC Safety Support Letter Report, Response Event 5, Bains Gap Road Ranges
Environmental Remediation Services at Four Sites, Fort McClellan, Anniston, AL
Contract: W912DY-10-D-0023, Task Order No. CK01
HGL Project Number: H10501**

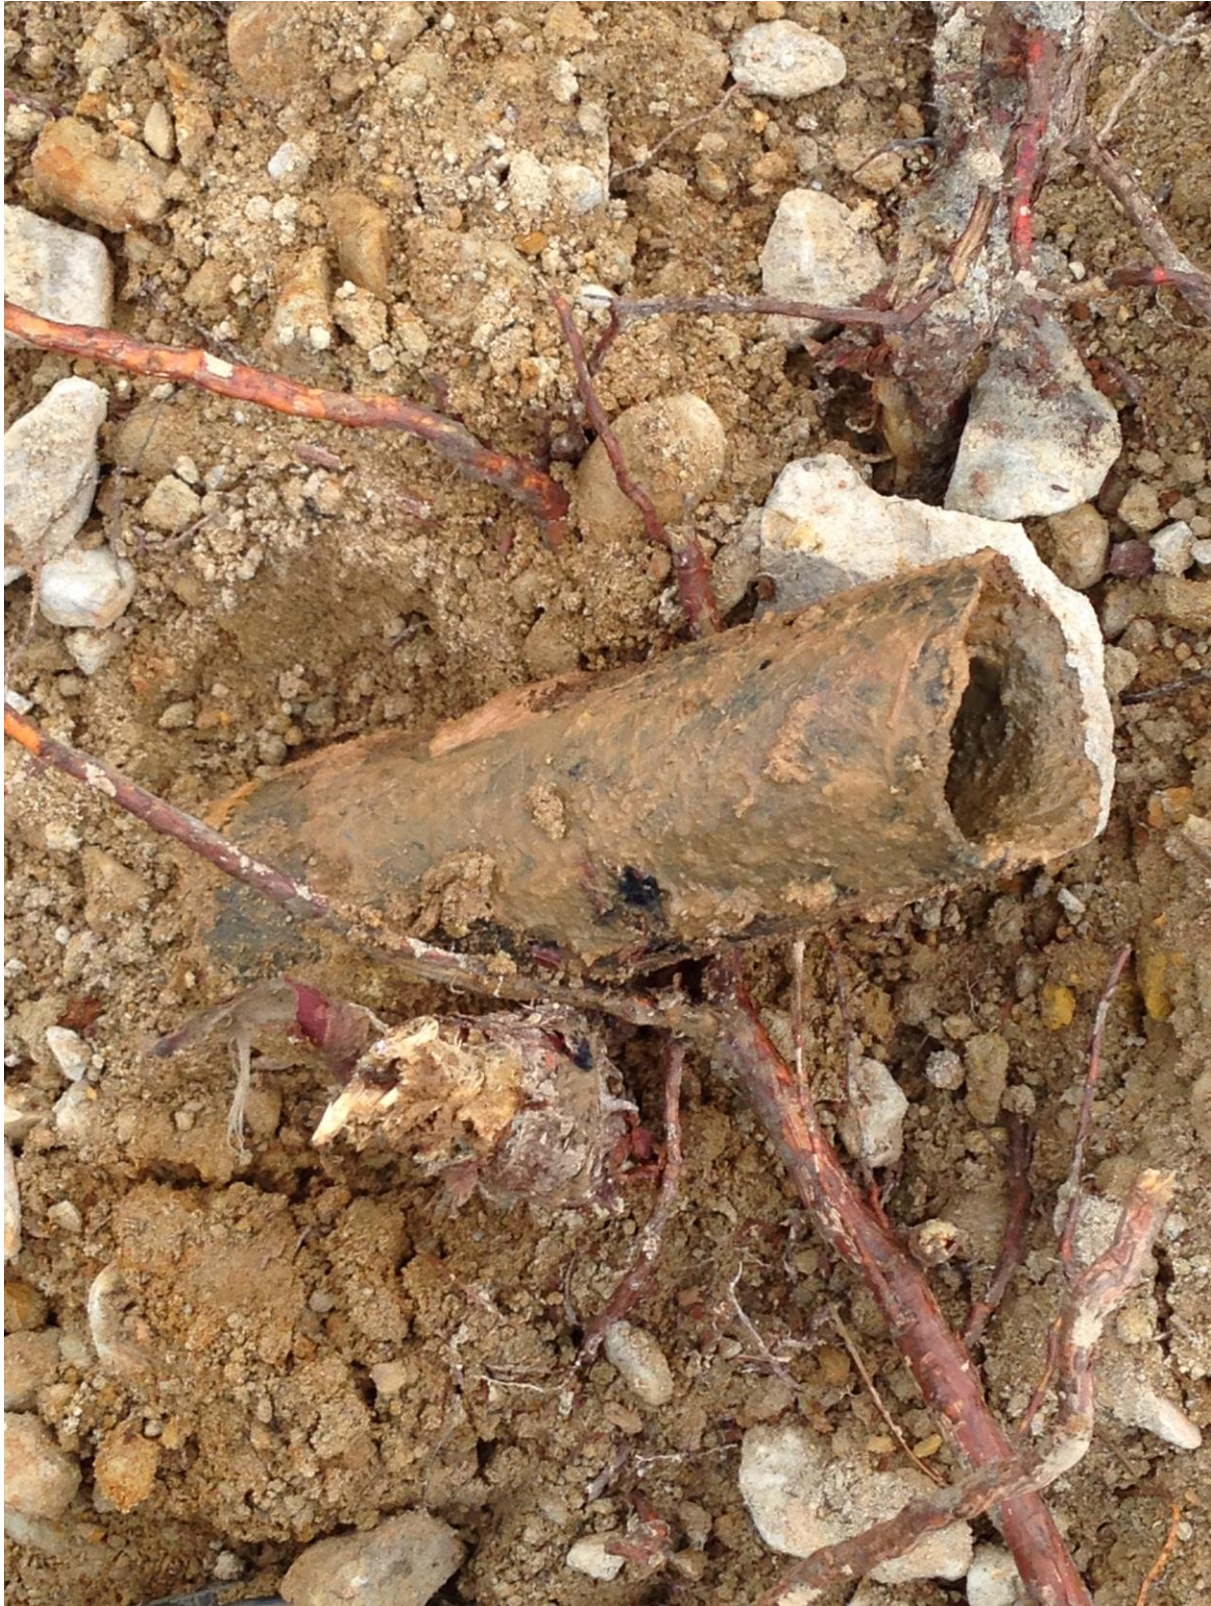
ATTACHMENT 1 - PHOTOGRAPH

During the conduct of the remedial activities at the subject project site, HGL's field team identified what appeared to be Material Potentially Presenting an Explosive Hazard (MPPEH) on August 11, 2016 (see **Attachment 1**). HGL's Site Safety and Health Officer established a cordon around the area and all project personnel were instructed to keep out of the affected area. A photo was provided to the unexploded ordnance (UXO) staff assigned to respond to the project location for MEC Safety Support who confirmed that the item was MPPEH. On August 12, 2016, HGL's lead Senior UXO Supervisor (SUXOS), Mr. Neil Feist, and the UXO Quality Control Specialist (UXOQCS), Mr. Scott Schroepfer, responded to Fort McClellan in accordance with the MEC Safety Support Work Plan to assess the item. Upon arrival and initial inspection, the item was determined to be an expended MK 1, 75mm Shrapnel projectile. The UXO personnel conducted independent 100% inspections of the item in accordance with EM 385-1-97 and the MEC Safety Support Work Plan and it was determined to be Material Documented as Safe (MDAS).

Expended MK 1, 75mm Shrapnel Projectile

The UXO staff placed the MDAS in the drum with a numbered seal and locked it inside the Conex at the project office location. Upon completion of field construction activities at Fort McClellan, the SUXOS and UXOQCS will mobilize to the site to prepare a chain of custody and DD Form 1348-1a certifying and verifying all items, and any future finds as MDAS. The MDAS drum will then be manifested and shipped to our MDAS vendor Demil Metals for final disposition and smelting. Disposition documentation, including chain of custody, DD Form 1348-1a and the letter certifying final disposition will be provided at that time.
