July 13, 2016

**Re: MEC Safety Support Letter Report, Response Event 3, Choccolocco Corridor Ranges, Environmental Remediation Services at Four Sites, Fort McClellan, Anniston, AL
Contract: W912DY-10-D-0023, Task Order No. CK01
HGL Project Number: H10501**

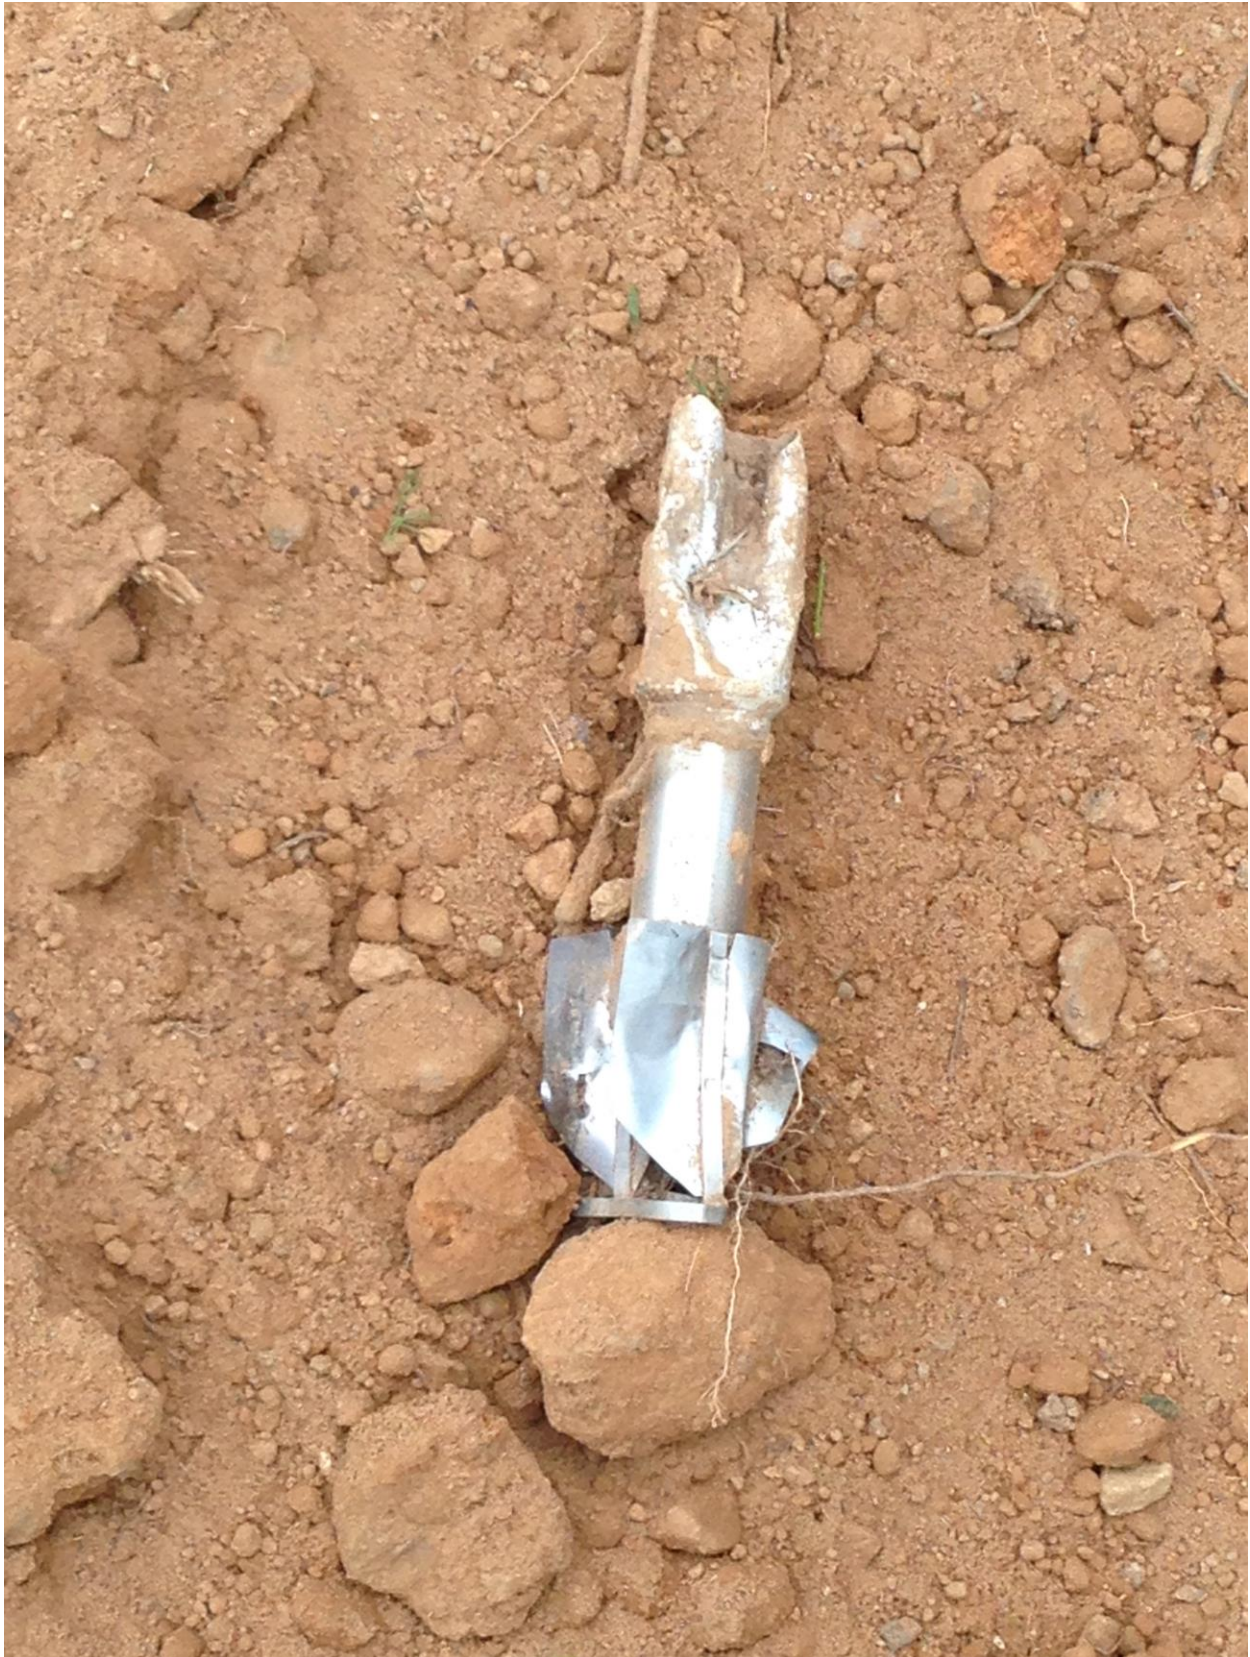
During the conduct of the remedial activities at the subject project site, HGL's construction subcontractor identified what appeared to be an expended Signal, Illumination, Ground, commonly referred to as a slap flare during excavation of a plunge pool at the Choccolocco Corridor Ranges site (see attached Figure). A photo was provided to the unexploded ordnance (UXO) staff assigned to respond to the project location for MEC Safety Support who confirmed that the item was likely an expended flare.

On June 23, 2016, HGL's lead Senior UXO Supervisor (SUXOS), Mr. Neil Feist, and the UXO Quality Control Specialist (UXOQCS), Mr. Scott Schroeffer, responded to Fort McClellan in accordance with the MEC Safety Support Work Plan to assess the item. Upon arrival and initial inspection, it was confirmed that the item was in fact an expended slap flare. The UXO personnel conducted independent 100% inspections of the item in accordance with EM 385-1-97 and the MEC Safety Support Work Plan, and it was determined to be Material Documented as Safe (MDAS).

Expended Signal, Illumination, Ground (Slap Flare) - First Object

The SUXOS and UXOQCS placed the MDAS in a drum with a numbered seal and locked it inside the conex at the project office location. Upon completion of field construction activities at Fort McClellan, a chain of custody and DD Form 1348-1a will be prepared certifying and verifying this item and any future finds as MDAS. The MDAS drum will then be manifested and shipped to our MDAS vendor Demil Metals for final disposition and smelting. Disposition documentation, including chain of custody, DD Form 1348-1a and the letter certifying final disposition will be provided at that time.

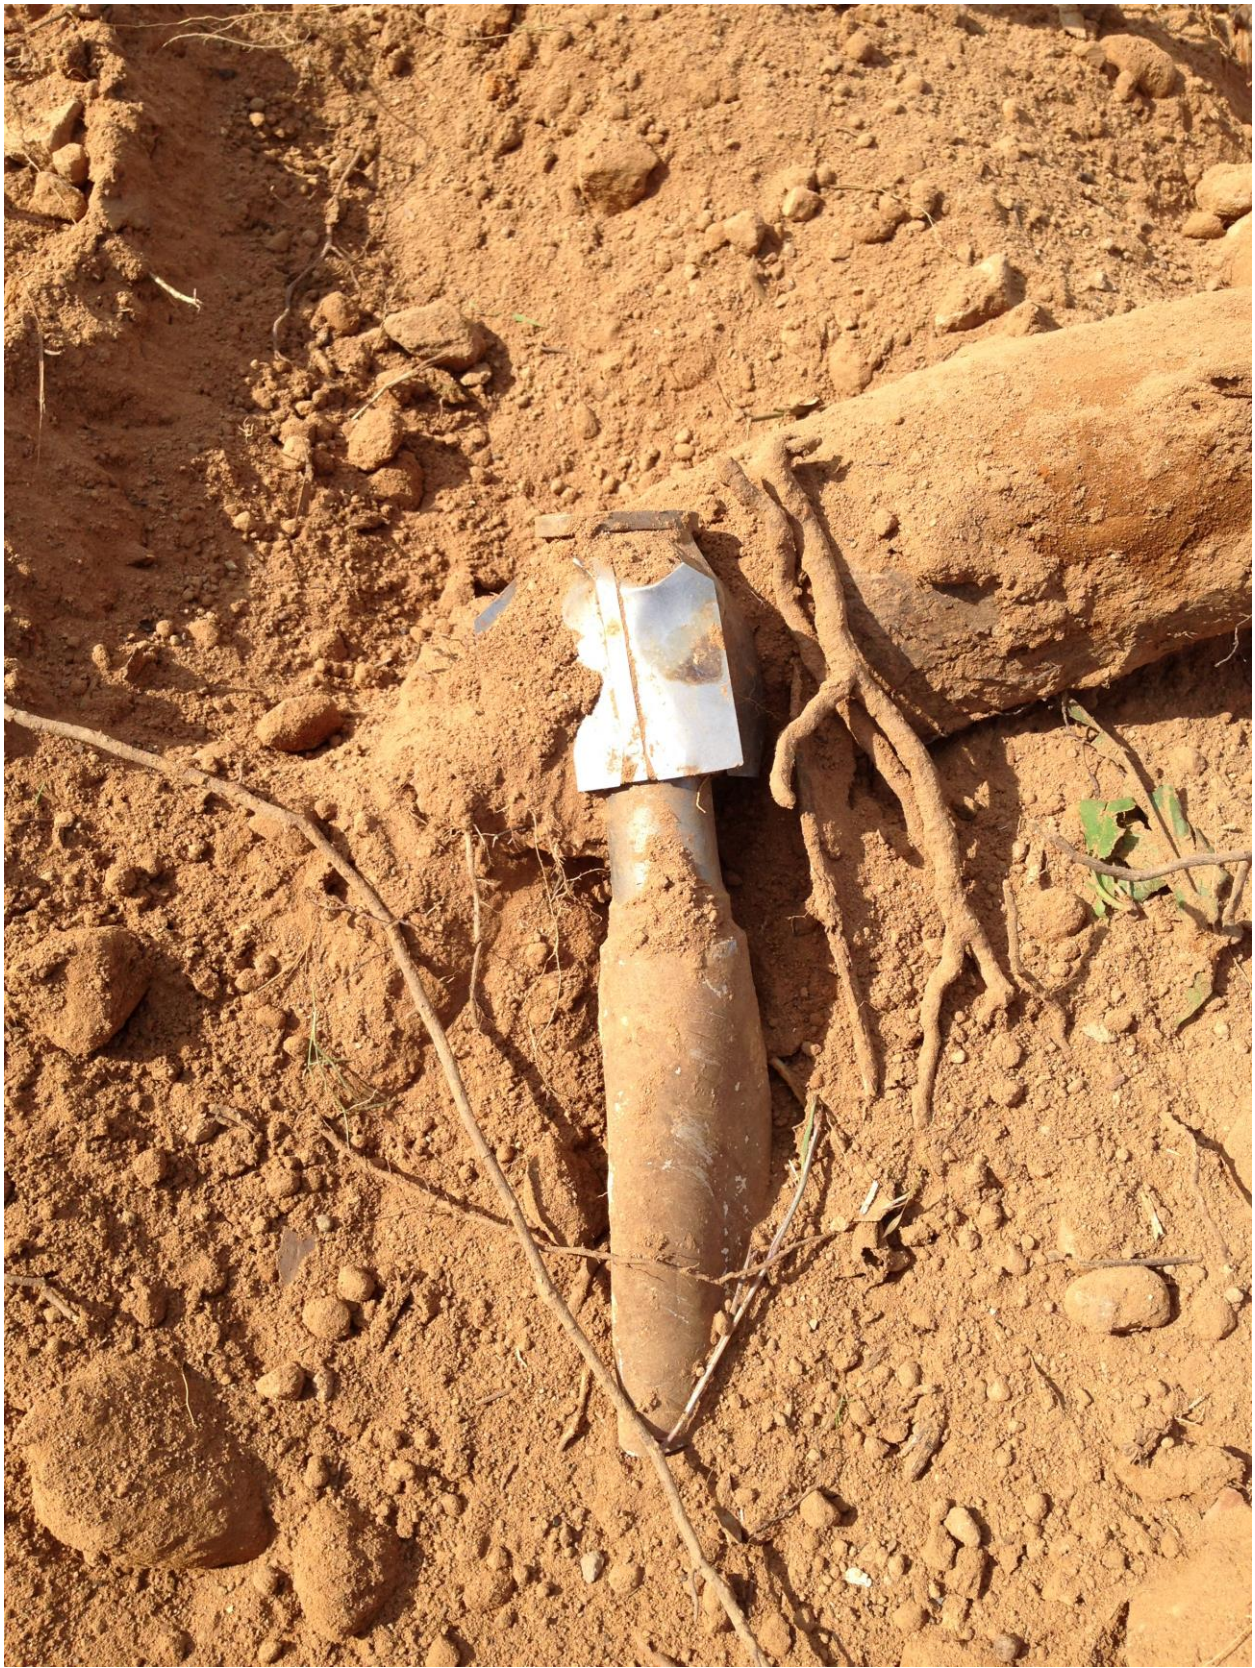
The SUXOS returned on June 24, 2016, as an additional expended flare was observed in the same location. The SSHO and SUXOS determined that a UXO team should be on site during the excavation of the remaining plunge pools.

Expended Signal, Illumination, Ground (Slap Flare) – Second Object
