# BLACK WARRIOR/TOMBIGBEE RIVER: DEMOPOLIS LOCK – UPPER MITER SILL FAILURE – 29 JAN 2024

# BLACK WARRIOR/TOMBIGBEE RIVER: DEMOPOLIS LOCK – UPPER MITER SILL FAILURE – 20 JAN 2024

# BLACK WARRIOR/TOMBIGBEE RIVER: DEMOPOLIS LOCK – UPPER MITER SILL FAILURE - 19 JAN 2024

# BLACK WARRIOR/TOMBIGBEE RIVER: DEMOPOLIS LOCK – UPPER MITER SILL FAILURE - 16 JAN 2024

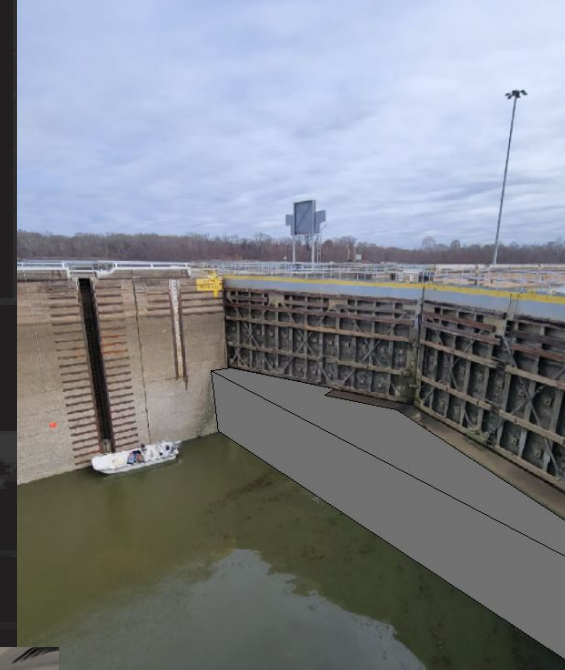
Mass Concrete Repair  
Rendering

The District Crisis Response Team met over the weekend to develop repair Courses of Action (COAs) and plans for the upper sill. Two COAs were discussed: a concrete mass pour or a steel cover plate. After pros and cons were weighed for each option, it was determined the mass concrete was the appropriate COA.

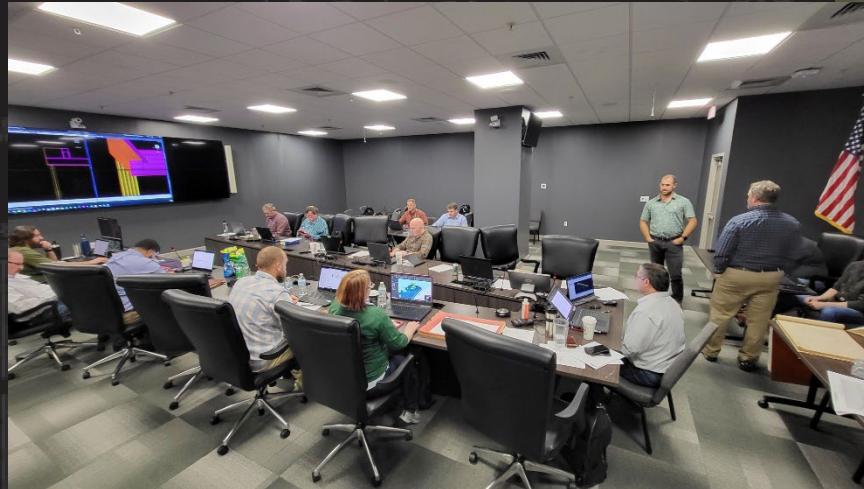
Crisis Response Team  
Developing Repair  
Plans

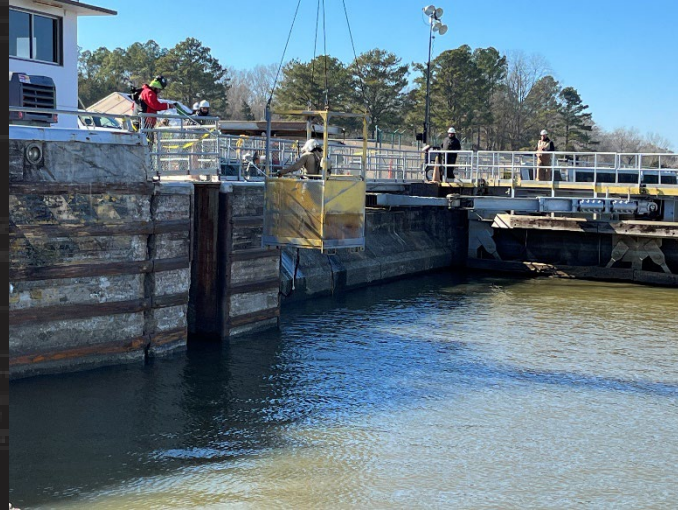
At 1300, the dive team inspected the stoplog slot. No issues were found.

Diver Inspecting Stoplog Slot

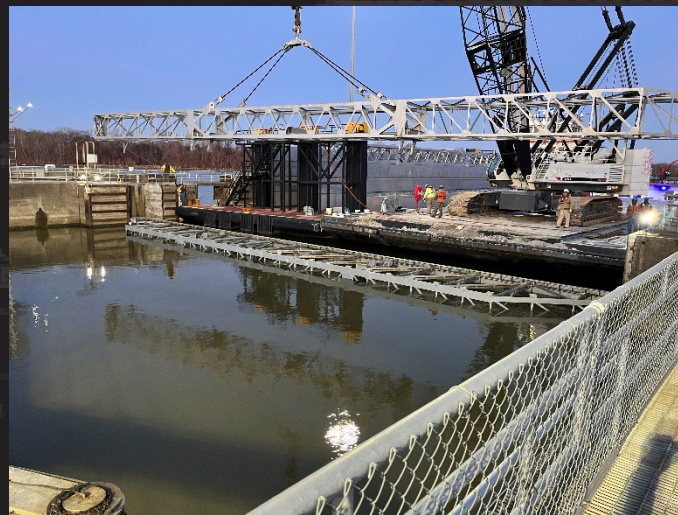
Setting Stoplogs

At 1330, TVA began setting 5 stoplogs (1 heavy, 2 regular BWT, 2 regular TTWW). Last stoplog was set at 1700.

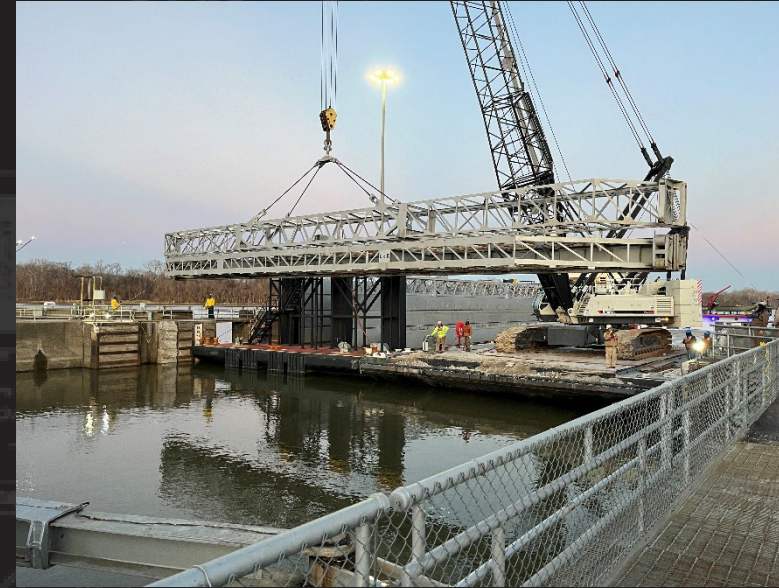
Last Stoplog Set

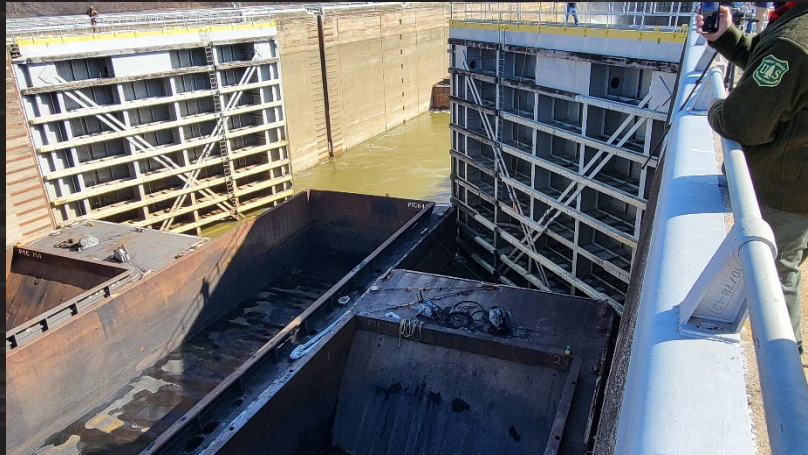
Lower Miter Gates Closed

The lower miter gates were moved out of recess at 1130 and, following the gate closing procedure, were successfully placed into mitered position by 1145.

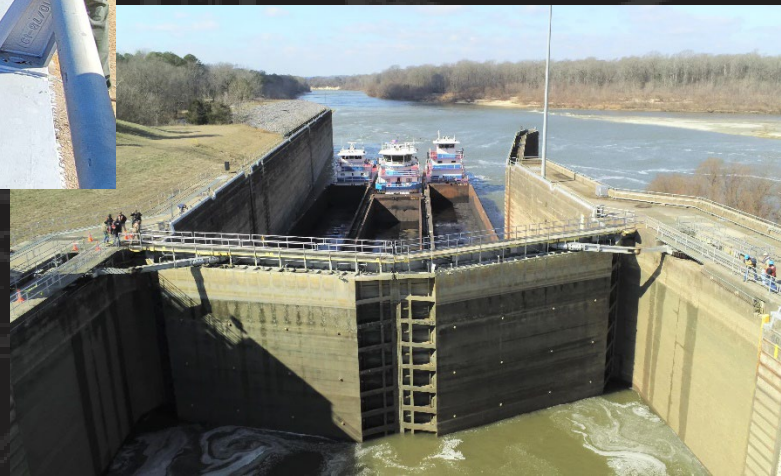
Lower Miter Gates Closing

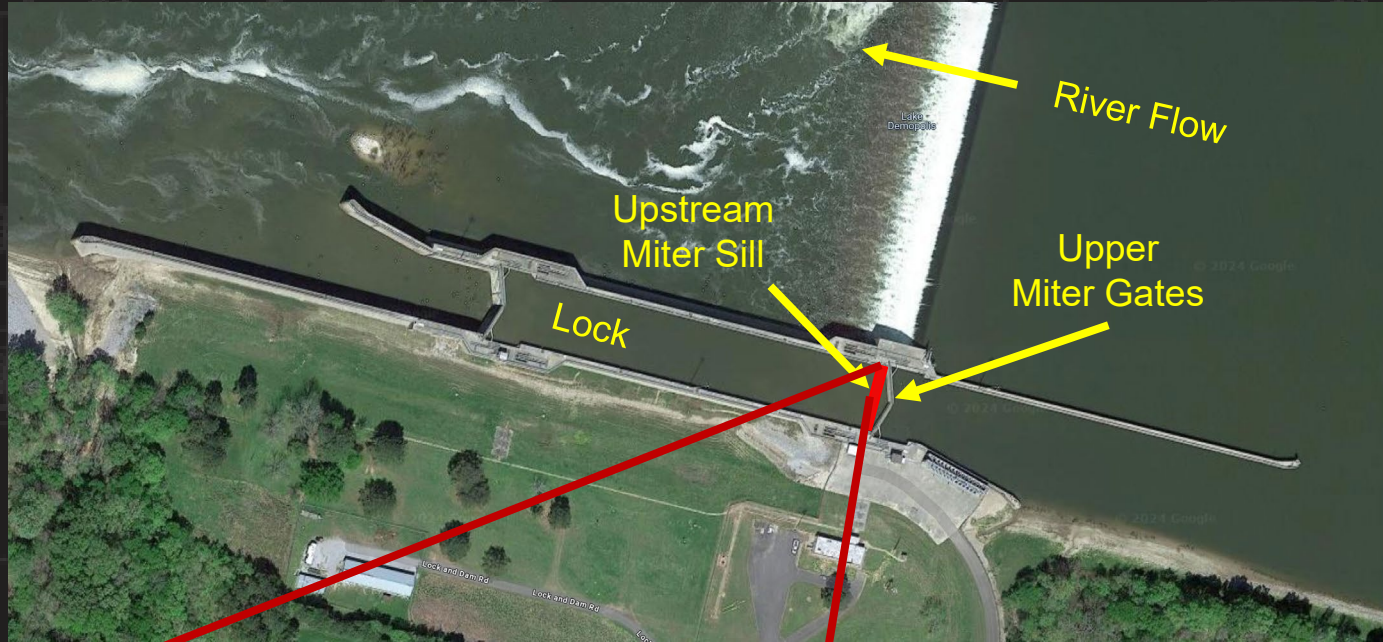
16 January 2024 Incident:  
At 0600 the on-duty lock operator heard a loud noise and while investigating noticed water flowing under the upper miter gate. The concrete that comprises the upper miter sill fractured, allowing water to pass under the gate. The lower lock gates were open at time of the incident.

Current operations are to close the lower miter gates to allow the pool to equalize and set the upper stoplogs to get the lock chamber under control. Operation will take place 19-21 January. Engineering and Operations are continuing to analyze the extent of damages and are working other courses of action to stop the flow and get the lock under control.
