BLACK WARRIOR/TOMBIGBEE RIVER: DEMOPOLIS LOCK – UPPER MITER SILL FAILURE – 16 APRIL 2024

16 April 2024 condition update:

BLACK WARRIOR/TOMBIGBEE RIVER: DEMOPOLIS LOCK – UPPER MITER SILL FAILURE - 16 JAN 2024

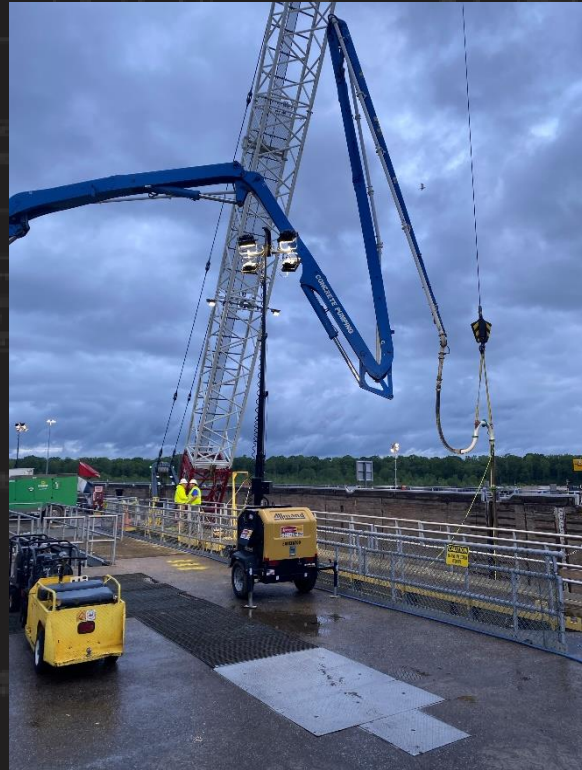
Concrete Placement on first monolith

The first concrete placement took place on 11 April. The placement was successful, and instrumentation has indicated the mixture is curing satisfactorily.

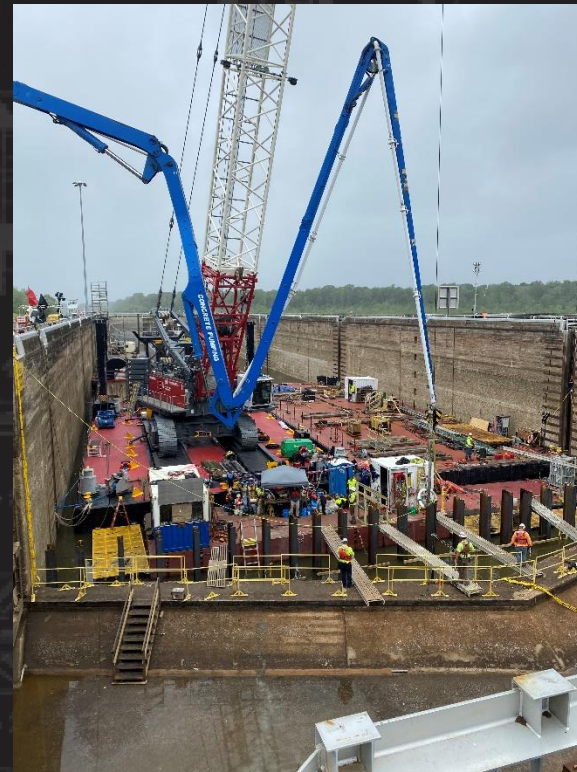
Concrete Placement on second monolith

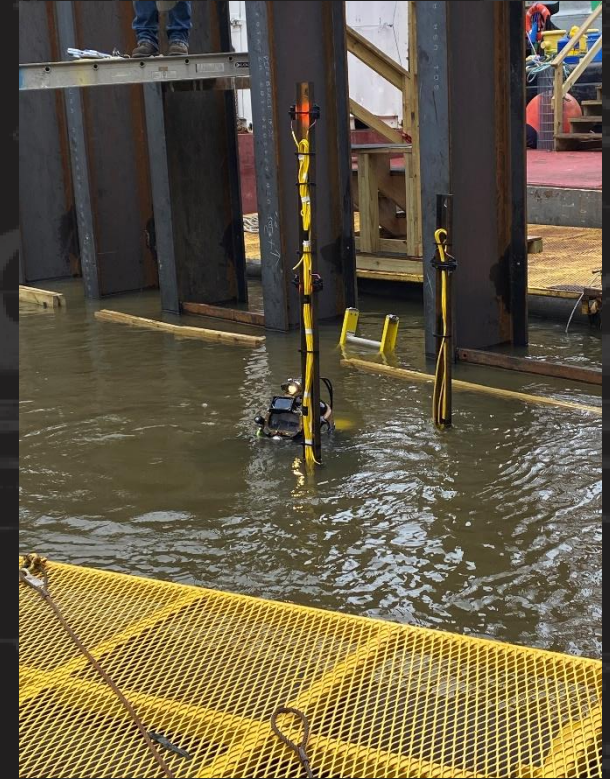
Diver ensuring proper placement

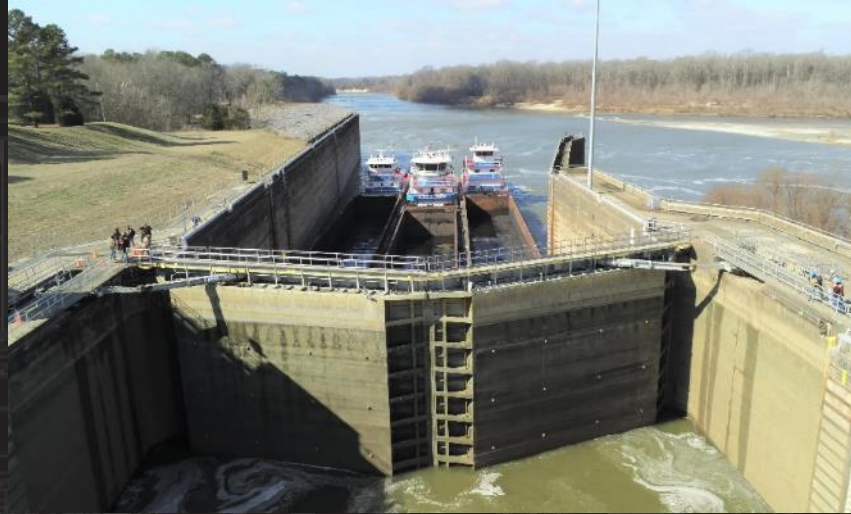
Parker Towing Barges & Towboats

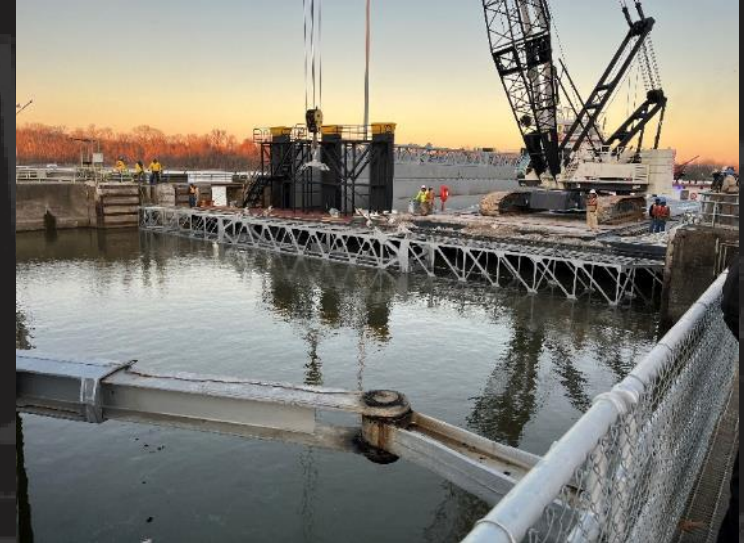
TVA Setting Upper Stoplogs

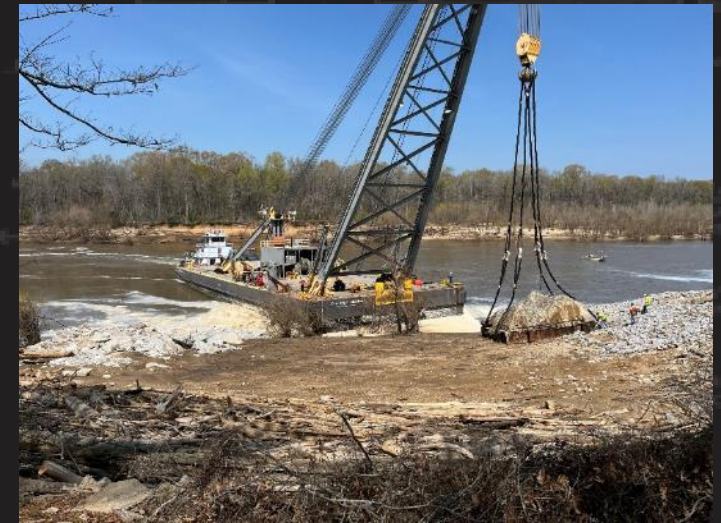
McKinney Salvage Debris Removal

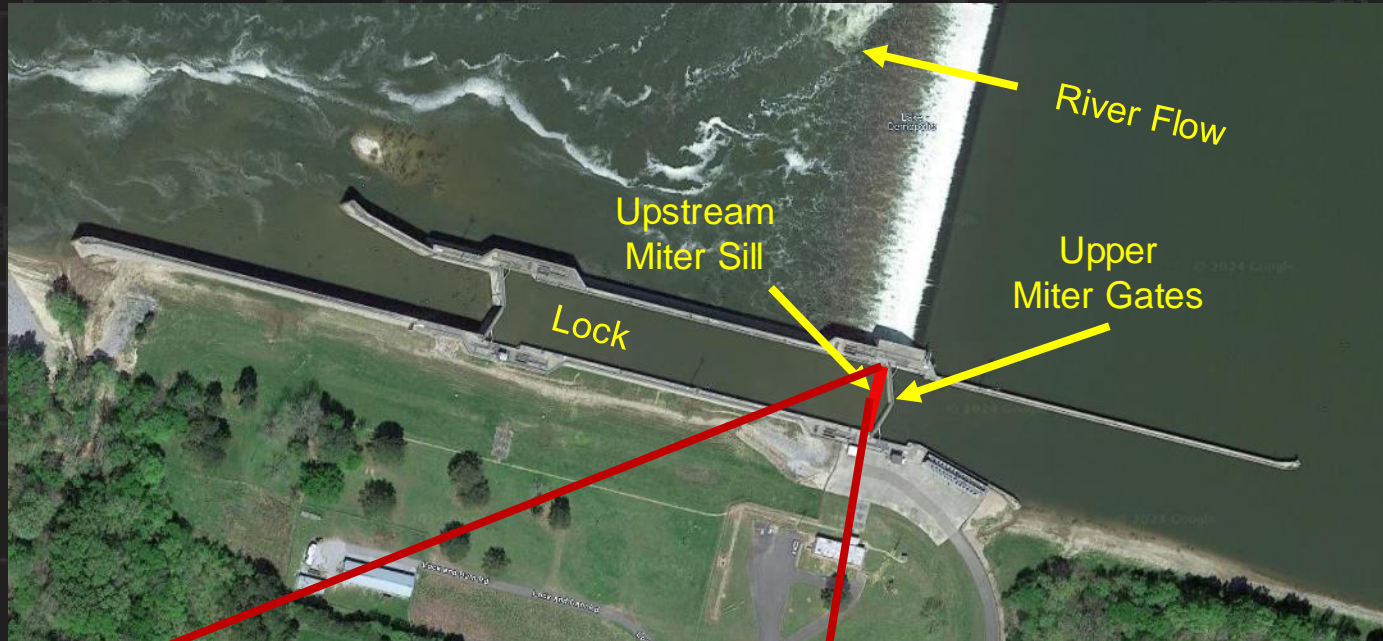
16 January 2024 Incident:
At 0600 the on-duty lock operator heard a loud noise and while investigating noticed water flowing under the upper miter gate. The concrete that comprises the upper miter sill fractured, allowing water to pass under the gate. The lower lock gates were open at time of the incident.

At this time, the extent of damages have not been determined. Once the lock is dewatered damage assessment and repair plans can be developed. No accurate estimate for closure duration is available at this time. This schedule will be refined once a full assessment of the damages can be performed.

Current operations are to close the lower miter gates to allow the pool to equalize and set the upper stoplogs to get the lock chamber under control. Operation will take place 19-21 January. Engineering and Operations are continuing to analyze the extent of damages and are working other courses of action to stop the flow and get the lock under control.
