# STRUCTURAL ASSESSMENT REPORT BUILDINGS 06 & 07

## HISTORIC BUILDING STRUCTURAL ASSESSMENT

1014 & 1018 WATER AVENUE SELMA, AL 36703

**14 FEB 2025**

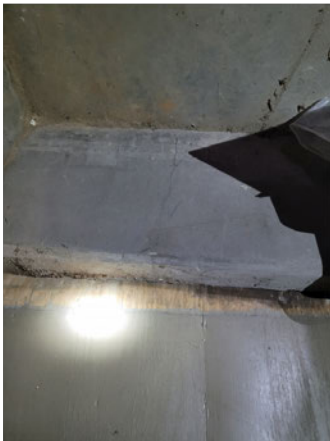
The grade slab at the south side of the basement appears to have sunk. There is evidence that the grade slab has shifted down with respect to the west and south walls and the column adjacent to the south wall has pulled away from the first level floor girder. Additionally, the concrete kneewall at the west wall has a large crack located where the grade slab begins to slope.

FB-1: Basement, separation between the grade slab and the south wall

<p>FB-1</p> <p>Picture FB-1: Basement, separation between the grade slab and the south wall, 1014 Water Ave.</p>	<p>FB-2</p> <p>Picture FB-2: Basement, separation between the grade slab and the kneewall on the west wall, 1014 Water Ave.</p>

2. While foundation condition and depth could not be determined from this non-destructive visual assessment, there are cracks in the basement walls and concrete slab on grade that indicate settlement movement towards the river. If the wall construction causes any settlement of the grade surrounding the building, the deteriorated south wall may not have sufficient strength to resist the changes in subgrade bearing; therefore, underpinning of the foundation for the south wall may be required.

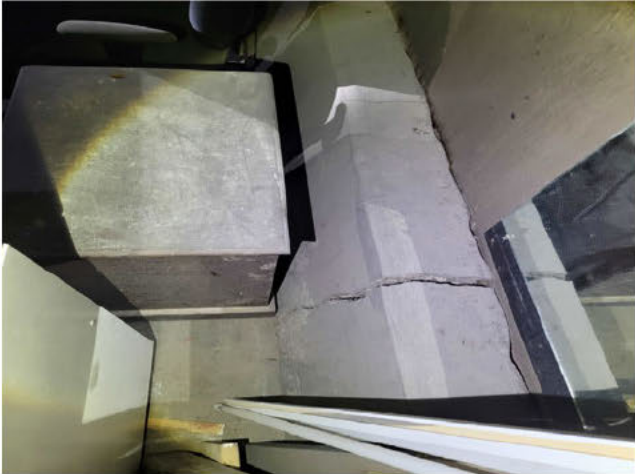
FB-3: Basement, crack in kneewall on the west wall

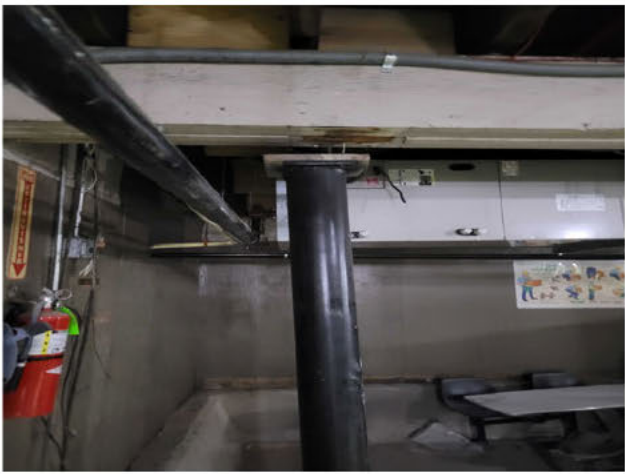
FB-4: Basement, column pulling away from the girder near the south wall

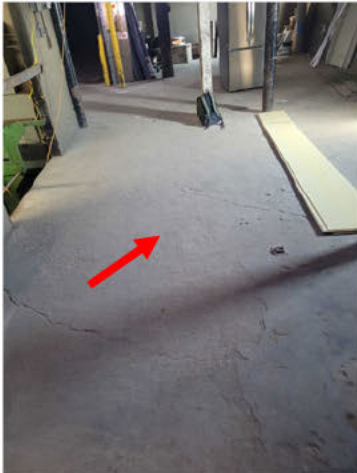
FB-5: Basement, minor cracking in basement grade slab on south side

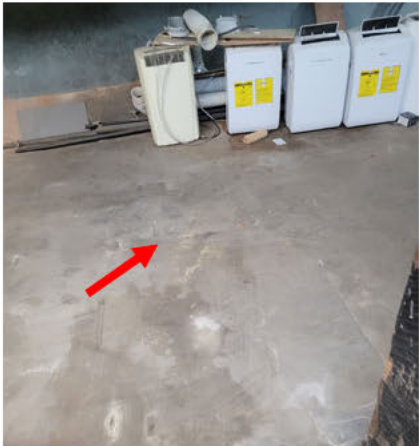
Minor cracking was observed in the grade slab on the 1018 Water Avenue side. These cracks appeared to be quite old and did not show signs of recent movement.

FB-6: Basement, minor cracking in basement grade slab on east side

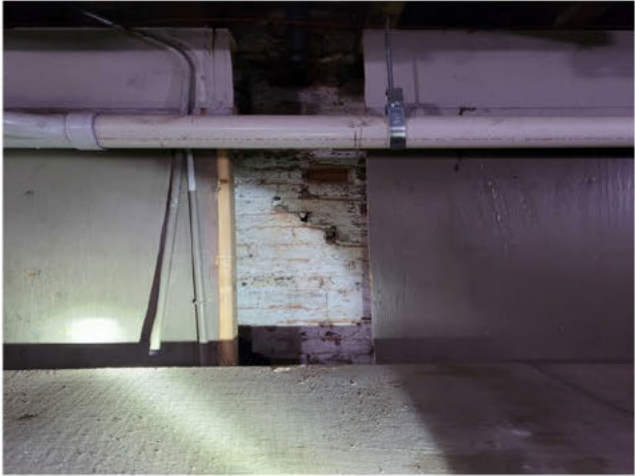
WB-1: Basement, small stairstep crack in west interior wall

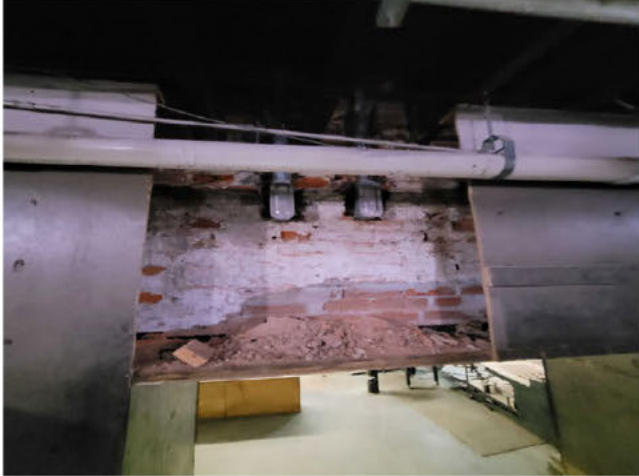
WB-2: Basement, brick repair on west interior wall

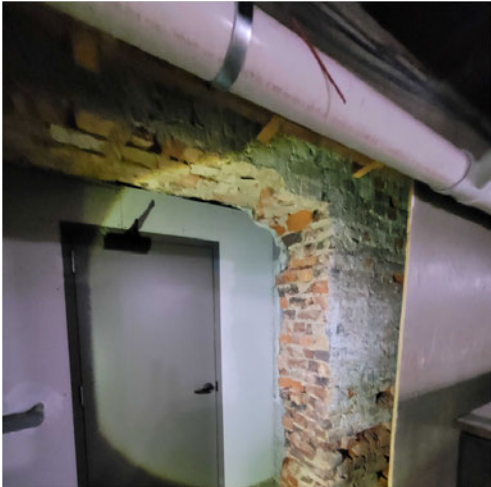
WB-3: Basement, opening cut in east wall (shared wall with the building at 1018 Water Avenue)

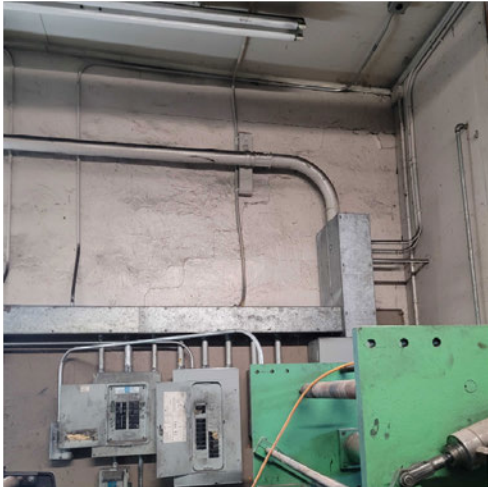
WB-4: Basement print room pit, crack on east wall of pit

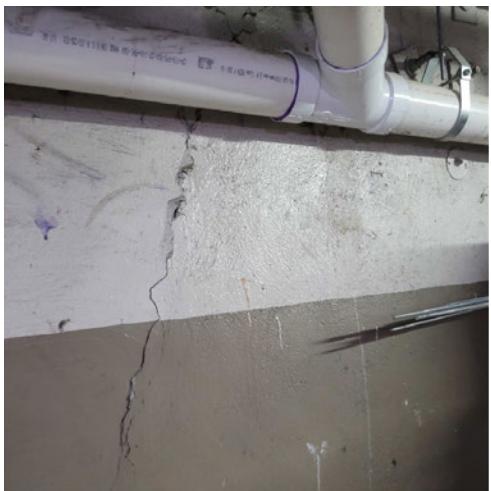
WB-5: Basement print room pit, Crack on west wall of pit

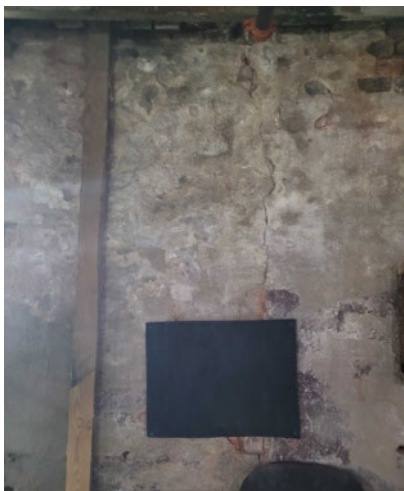
WB-6: Basement print room pit, crack on west wall of pit

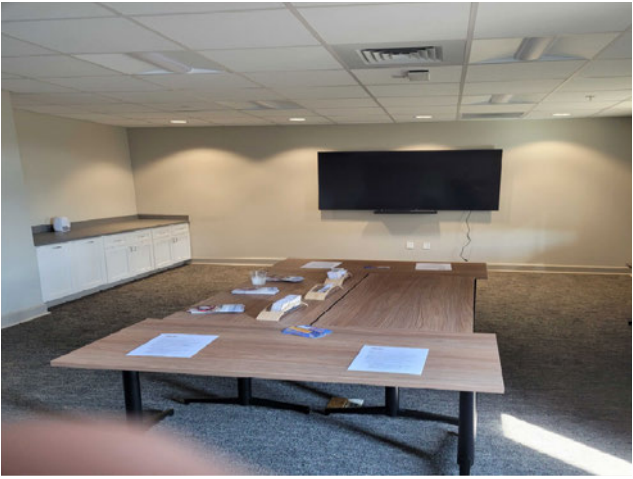
W1-1: First level, room on south side of building 1018 Water Ave

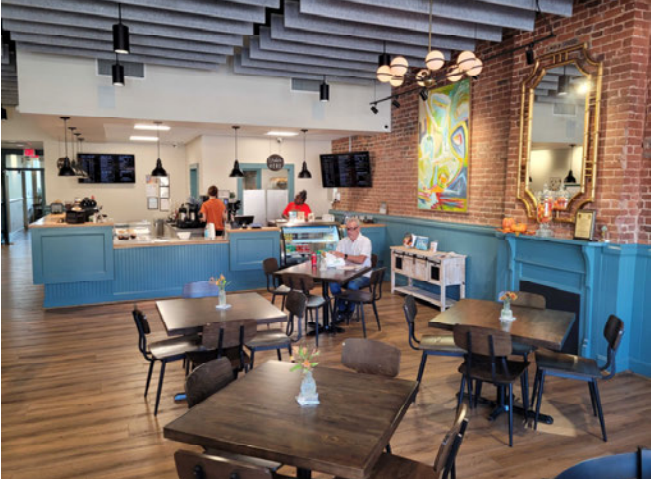
W1-2: First Level, room on north side of 1014 Water Ave.

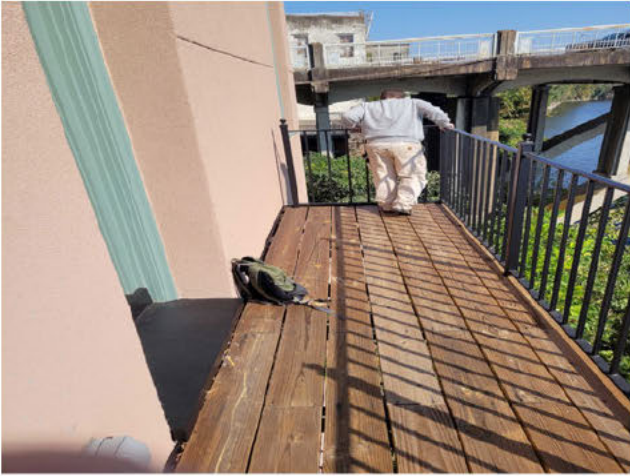
W1-3: First level, exterior deck on south wall of 1018 Water Ave.

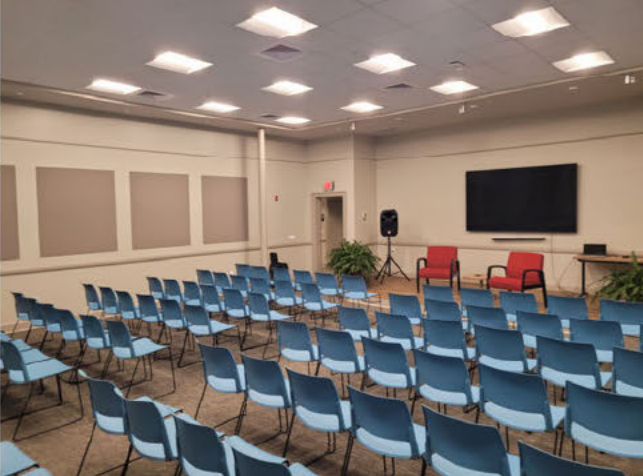
W1-4: First level, media conference room at 1018 Water Ave.

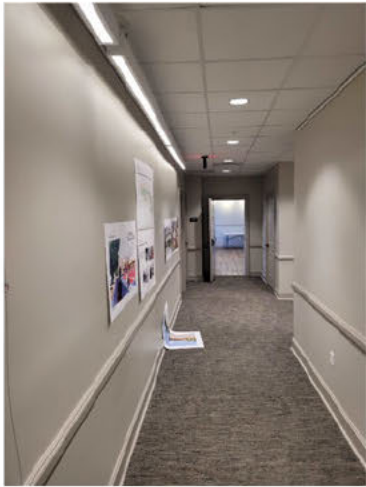
W2-1: Second level, at 1018 Water Ave

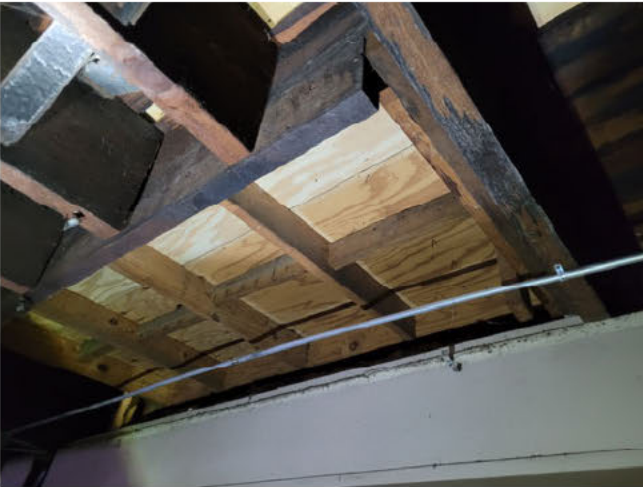
The first level floor joists and floor appeared to be in good condition. In a few locations, new plywood decking has been installed.

HF1-1: The floor joists and new decking for 1014 Water Ave.

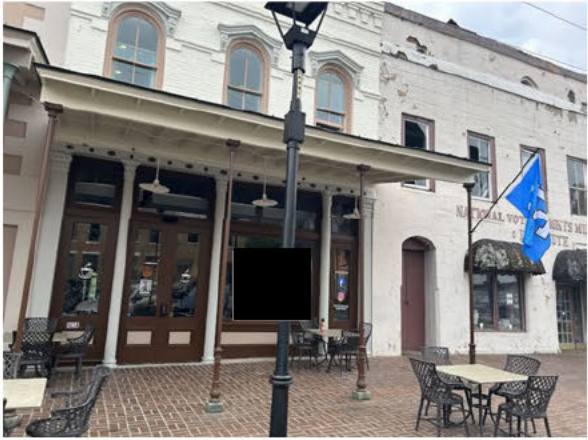
BE-1 North elevation of 1014 Water Ave.

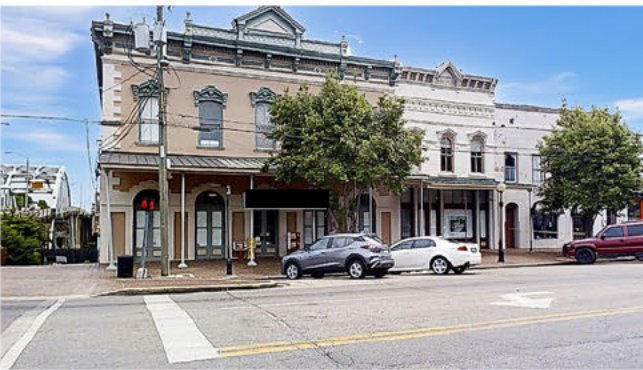
BE-2 North Elevation of 1018 Water Ave.
