SUBJECT: Response to ADEM Review and Comments: *Range 12: Iron Mountain Road Ranges Maintenance and Inspection Plan*, dated February 24, 2012 Fort McClellan, Calhoun County, Alabama Facility I.D. No. AL4210 020 562

**Response to Comments**  
**ADEM Review Comments Dated February 24, 2012**  
**Range 12: Iron Mountain Road Ranges Maintenance and Inspection Plan**  
**McClellan, Anniston, Alabama**

**Parcel 70Q, Range 12  
Iron Mountain Road Ranges**

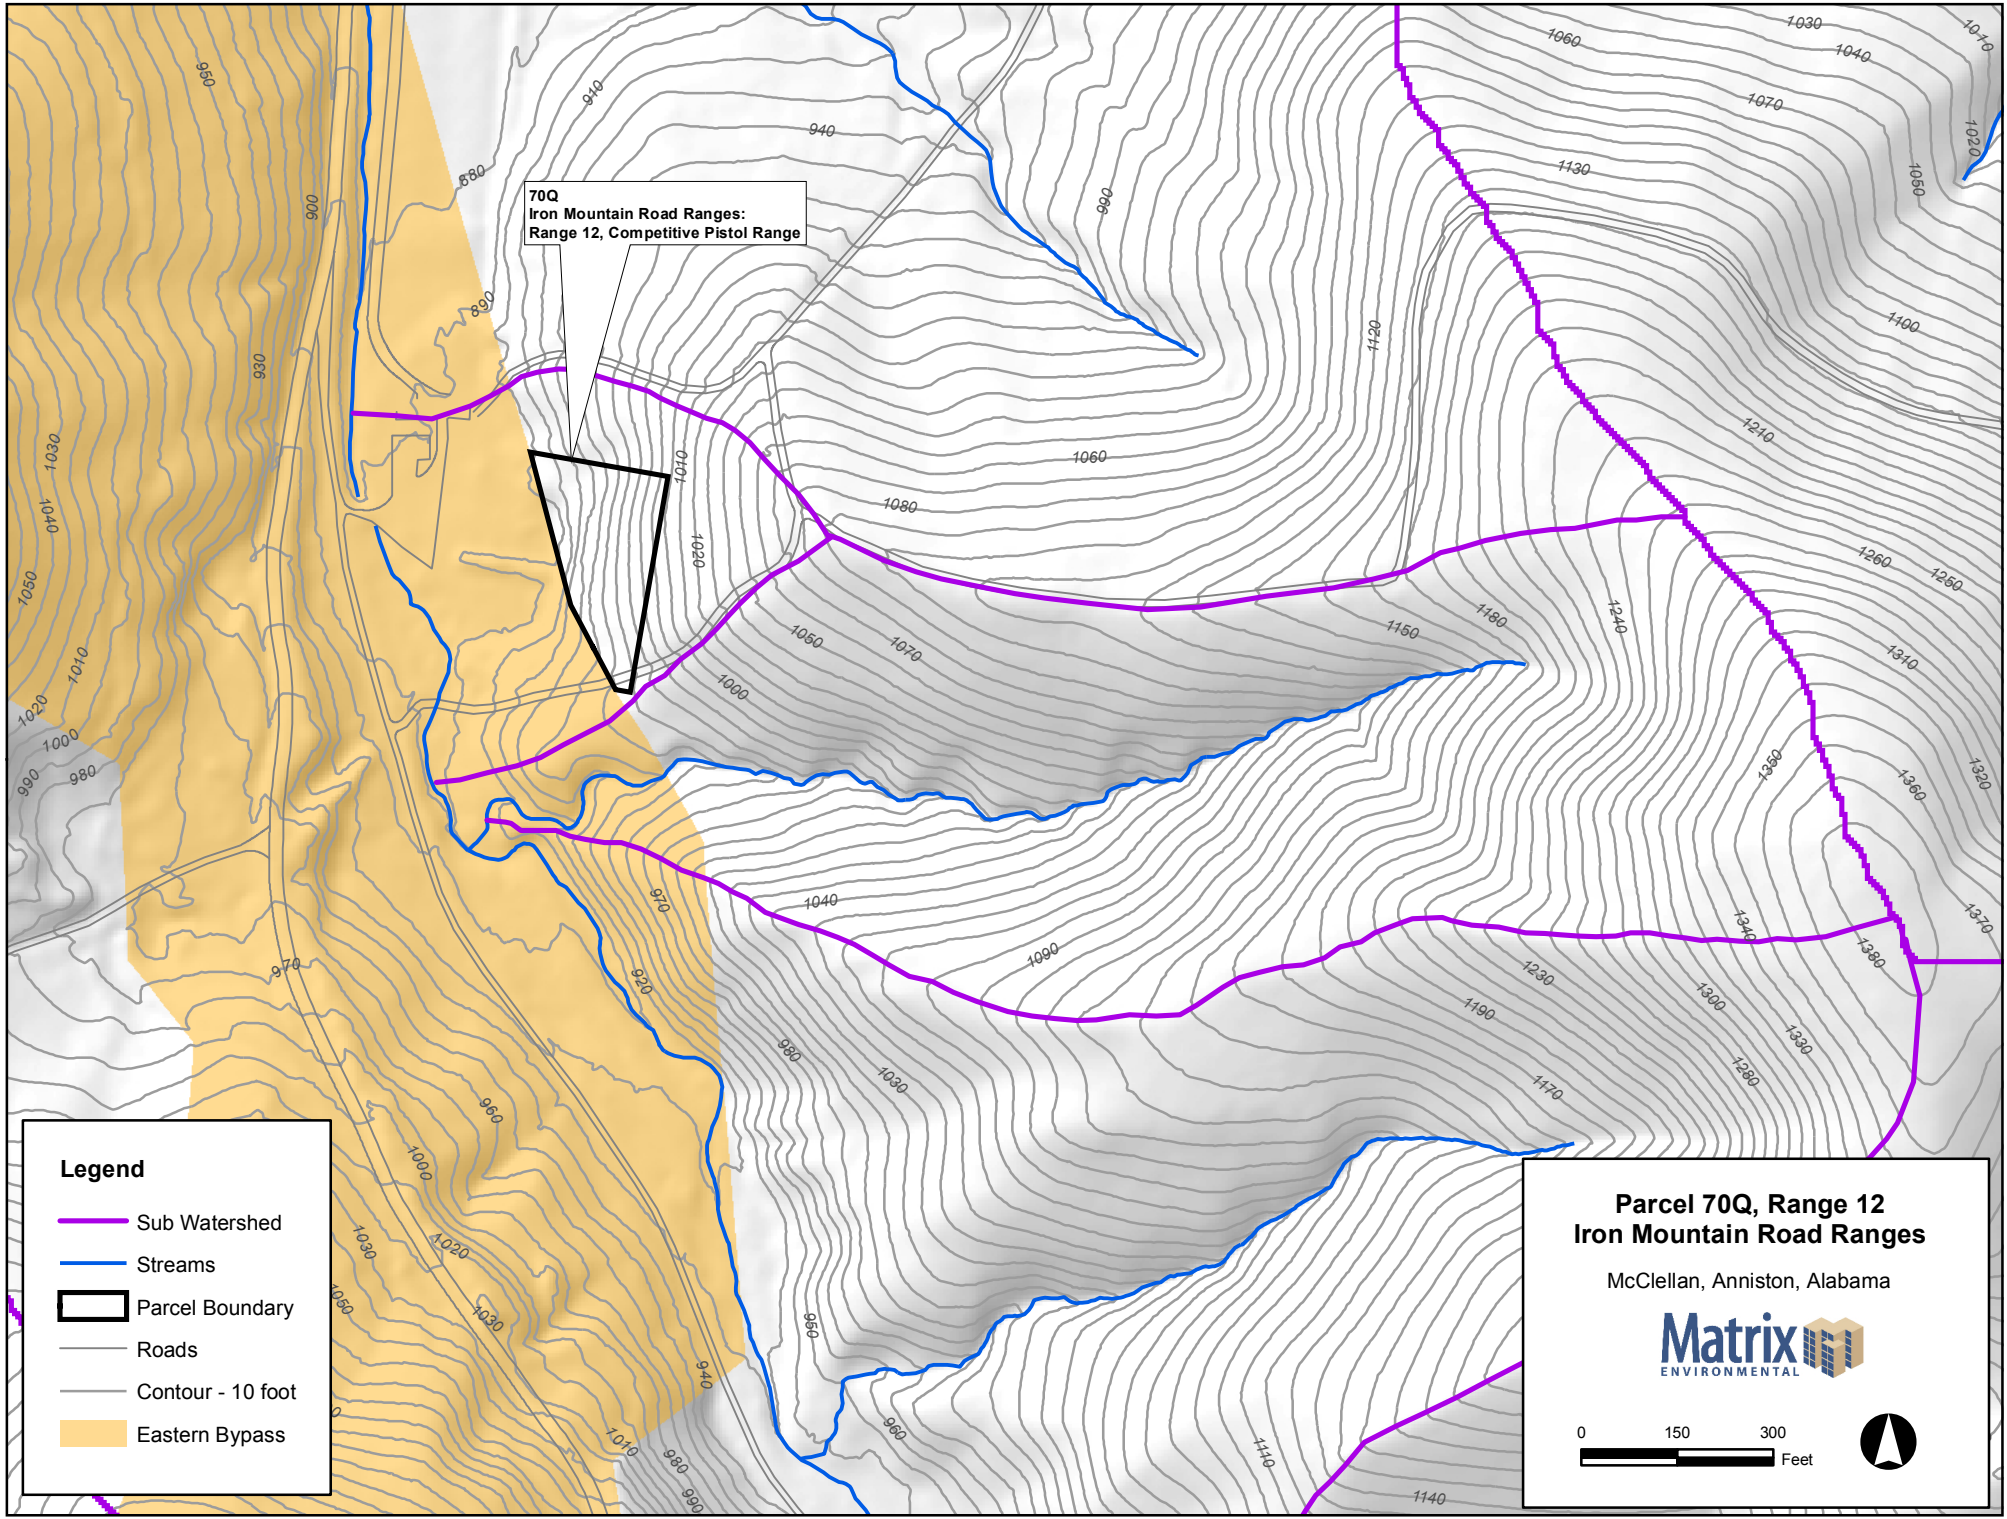
70Q  
Iron Mountain Road Ranges:  
Range 12, Competitive Pistol Range

Comment	Response to Comment
<b>General Comments</b>	
1. Please provide a drawing of the area containing best management practices (BMPs) including topography contours and drainage patterns.	Matrix has attached a 1ft Lidar map of parcel 70Q. We have shown drainage features, as few as exist, on the attached map. The BMPs installed by Shaw, which include silt fence, are in some disrepair. However, removal, or an attempt to upgrade the silt fence will not increase stability of the site.
