# Claiborne and Millers Ferry Locks and Dams Fish Passage Study

SUBJECT: Potential Failure Mode Analysis and Screening-Level Risk Assessment – Claiborne and Millers Ferry

# Screening-Level Risk Assessment Claiborne and Millers Ferry Fish Ladders

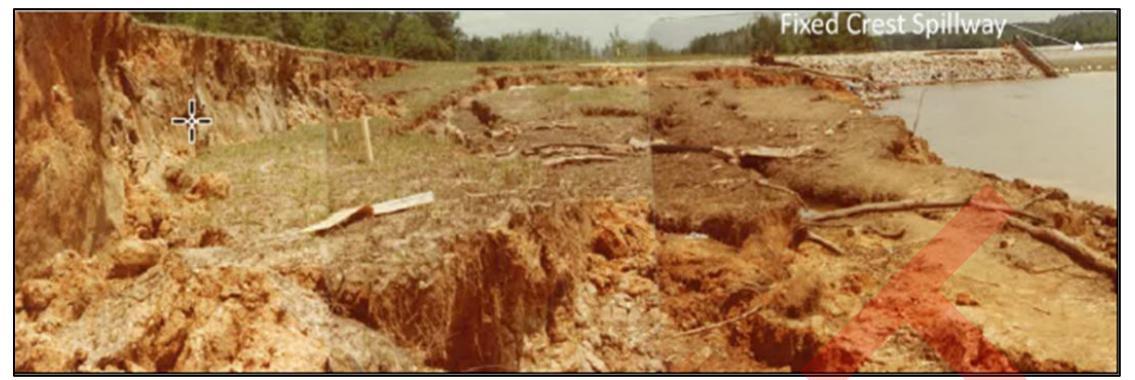
Claiborne L&D has not had any incidents or failures at the project since construction; however, historically there has been erosion on the right streambank downstream of the overflow dike. Figure 17 and Figure 18 are pictures taken in April 1977 and included in Periodic Inspection (PI) No. 6 in 1978 that show the bank failure caused by the erosion. In 1977, a project was designed to remediate the erosion. A combination of riprap, grouted riprap, and bedding material was used to fill in the erosion areas shown in Figure 19. Typically, plastic filter cloth was used beneath the bedding material for areas that did not contain grouted riprap.

Figure 17 – Right bank erosion, facing upstream towards the fixed crest spillway 1977.

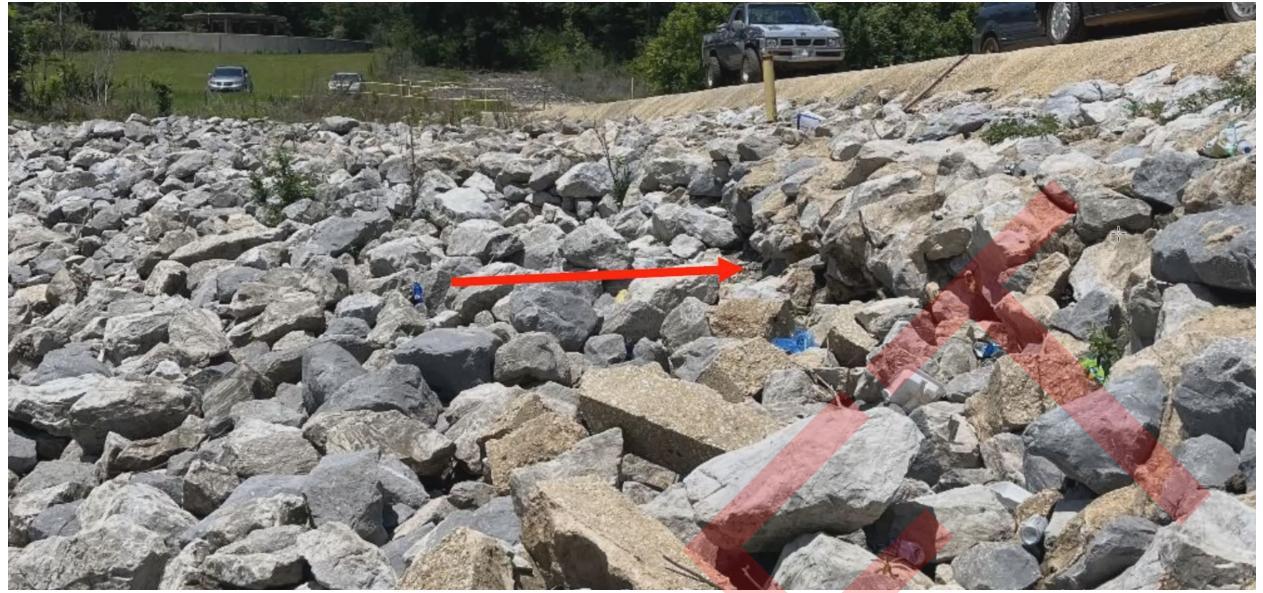
During the last PI, the elevated tailwater made it impossible to fully inspect the grouted riprap voids. Previous inspections identified voids/differential movement beneath the grouted portion of the riprap created by some erosion of the underlying fill; however, the water was too high to view during that inspection to evaluate their condition. There had been concerns about embankment material being piped from beneath the concrete overlaying the crest. In 2014, the Mobile District cored several holes into the concrete cap to determine if the feature had been undermined but no voids were detected. Figure 20 shows more current 2023 picture of the differential movement between grounded and ungrouted riprap.

Figure 20 – Differential movement between grouted and ungrouted riprap (PDT photograph from 2023).

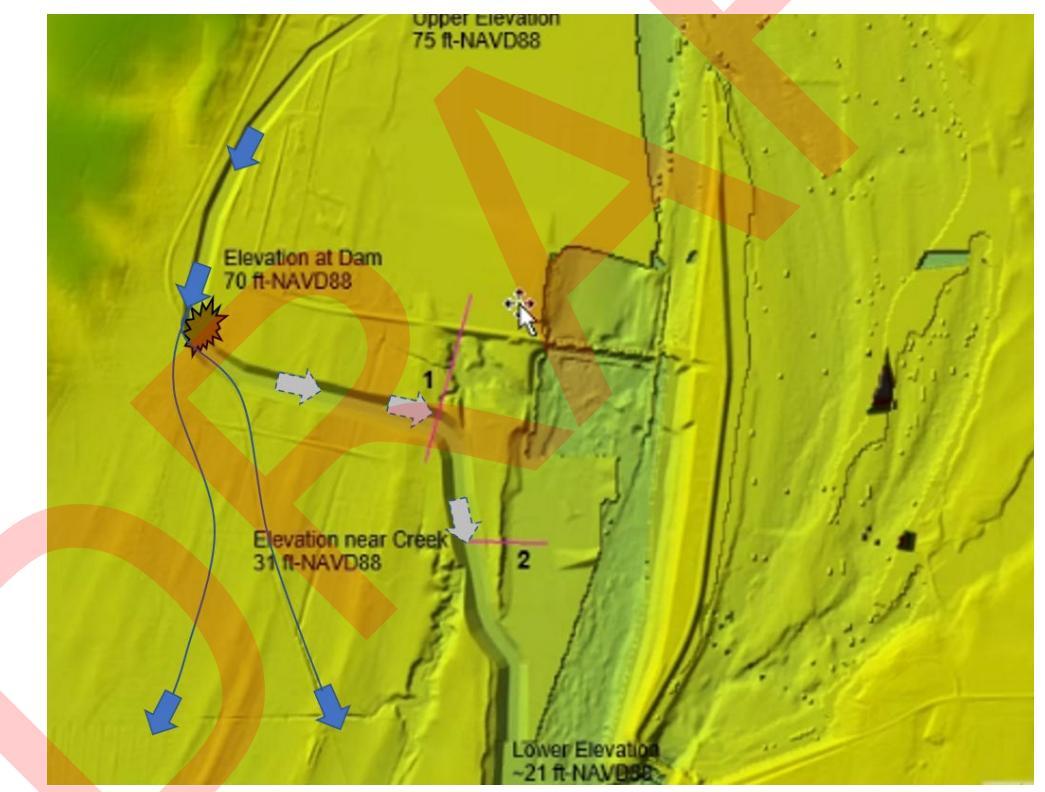
Description: Float debris during a flood passes through the fish channel gates and causes a debris jam in one of the fish ladder pools. The debris accumulates and restricts flow, causing water to stack up within the channel upstream of the blockage. Water begins to overtop the channel banks and flows across private lands before it makes its way back to the Alabama River. The overland flow erodes the channel banks and forms a new flow path. This erosion from the new flow path undermines the boulders and bypass cannel bottom protection, allowing head cutting to progress upstream. The erosion destabilized the dam embankment toe followed by slope failure and breach. The channel blockage and overflow sequence is illustrated in Figure 38.

Figure 38 – Example flow paths from debris blockage in fish ladder channel.

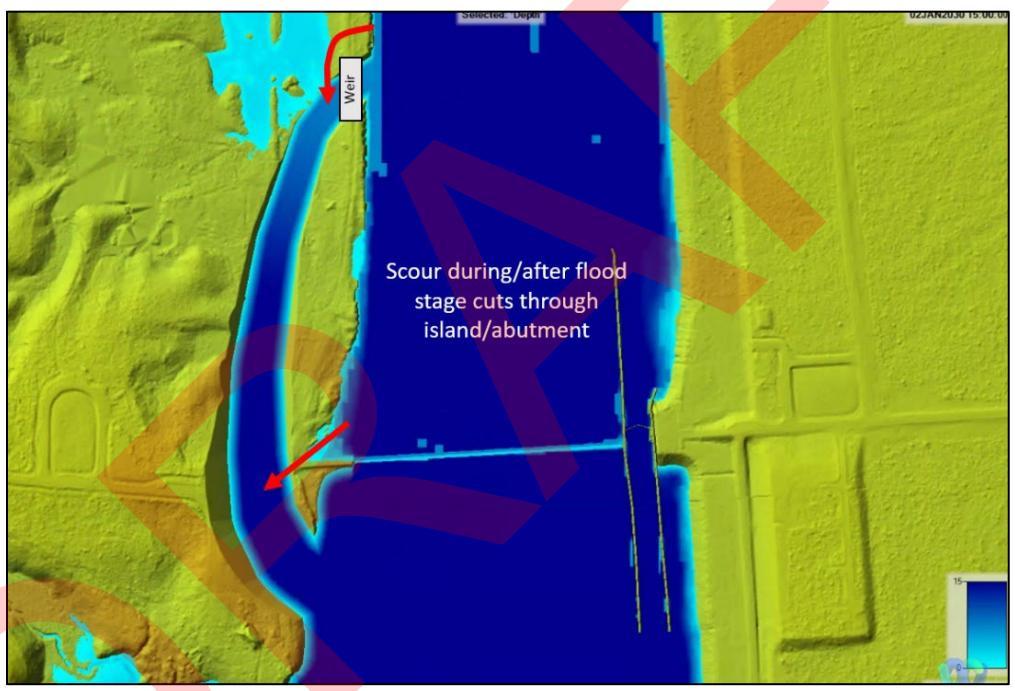
Description: An overtopping event (approx. 1/3 AEP) inundates the island between the river and the fish ladder bypass. As the flood recedes, water channelizes around the right abutment causing scour erosion. The rate of head cutting is the same or faster than the receding rate of the river. This forms a new channel around the right abutment and breach of the dam. This PFM could initiate anywhere between the right abutment and the entrance weir or even upstream of the weir since the weir does not tie into high ground. Two potential failure paths are shown by the red arrows in Figure 54.

Figure 54 – Scour during overtopping event creates channel through island/abutment.

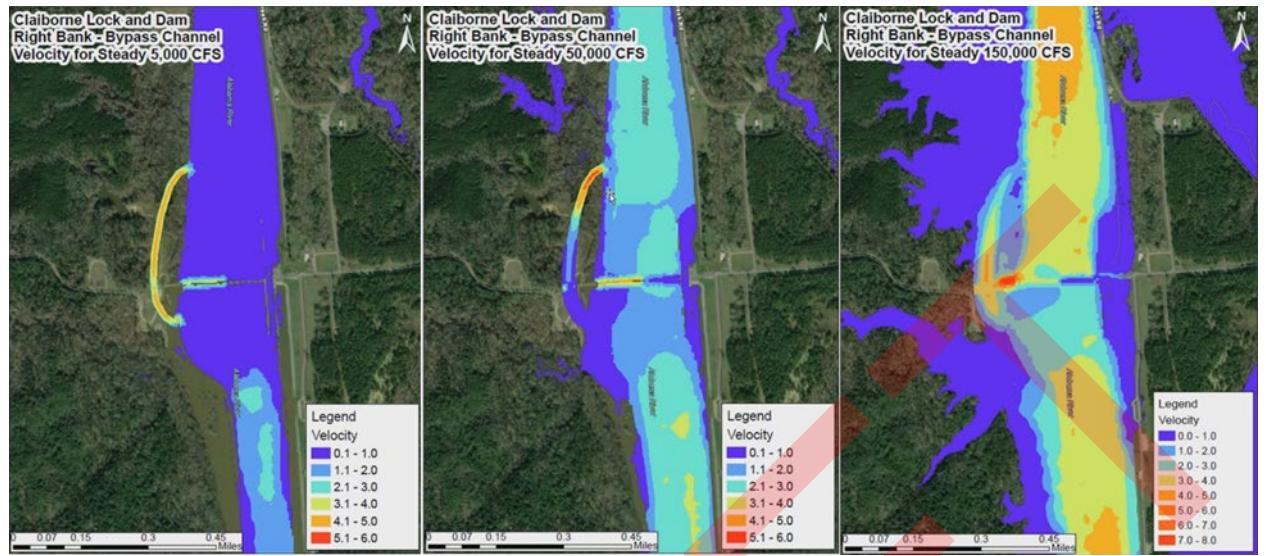
Figure 60 – Bypass Channel velocities exceed 7 fps.

The design team proposes 3-D hydraulic modeling or CFD modeling to better understand the flows within the channel as well as the interaction as the water meets the tailwater at different elevations to understand how the out of bank flow interacts with the channel. The design will include appropriately sized riprap or can use grouted riprap to create weir pools throughout the channel. Figure 61 shows a typical section that includes riprap protection along the channel invert. This PFM cannot be fully evaluated at this time without more suffocated hydraulic models to predict maximum velocities; however, it was excluded given that the feasibility design includes armoring along the channel invert to prevent scour erosion.

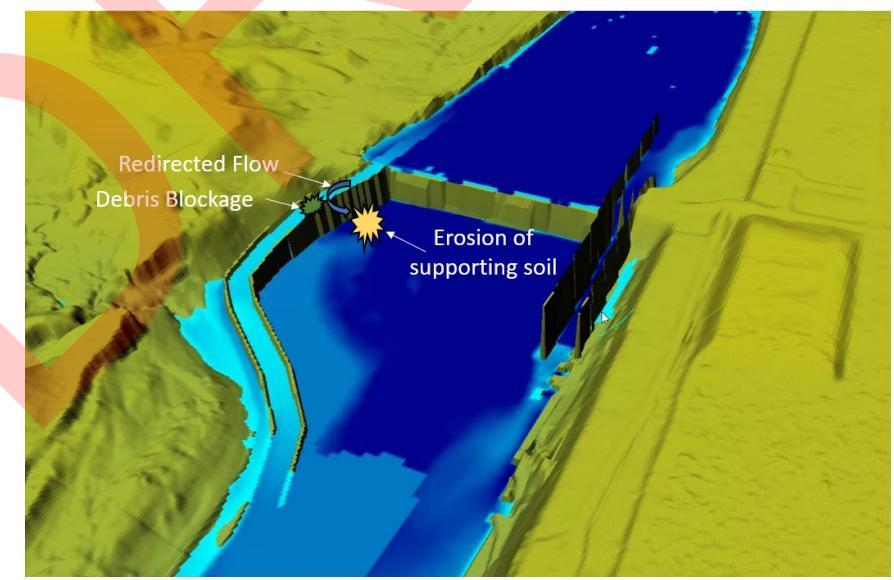
Description: Sedimentation and or debris in the channel restricts flow leading to out of channel flow over the sidewalls of the structure which erode the side slope protection and lead to undermining of the new structure. Figure 73 shows a debris blockage in the fish ladder channel redirecting flow out of bank and eroding downstream soils. Figure 74 shows the plunge pool erosion the undermines the concrete causing tilting and a point for water to short circuit the intended flow path down the fish ladder.

Figure 73 – Plan view of the debris blockage leading to out of channel flow.

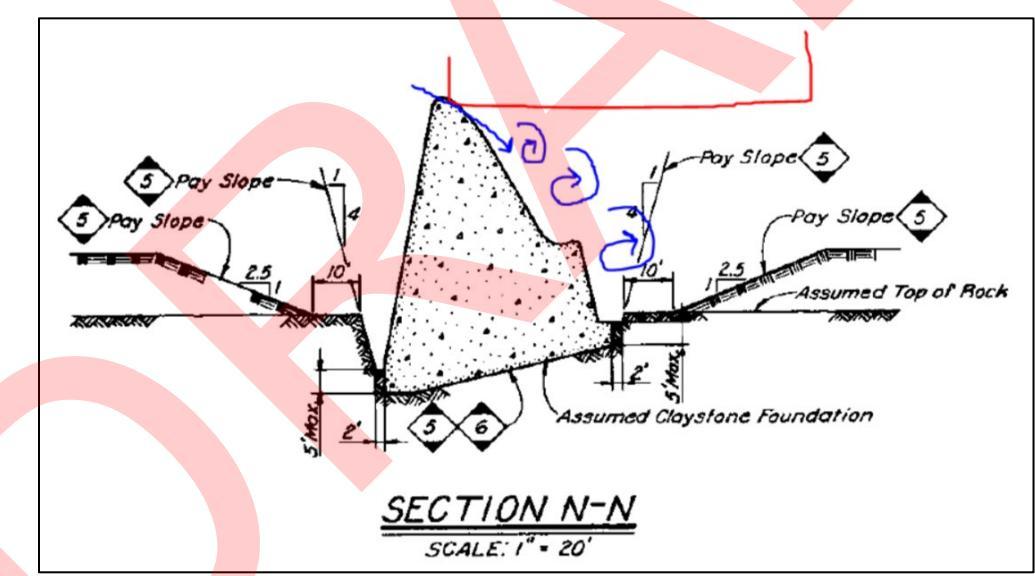
Water entering in between the concrete lined fish ladder and the existing dam shown in Figure 76 scours the supporting fill and causes instability of the fish ladder structure. This PFM could not be fully evaluated at this time as there is currently not a design for evaluation for water stops and concrete keys into the foundation between the two structures.

Figure 76 – The water path infiltration at the interface of new structure and existing.

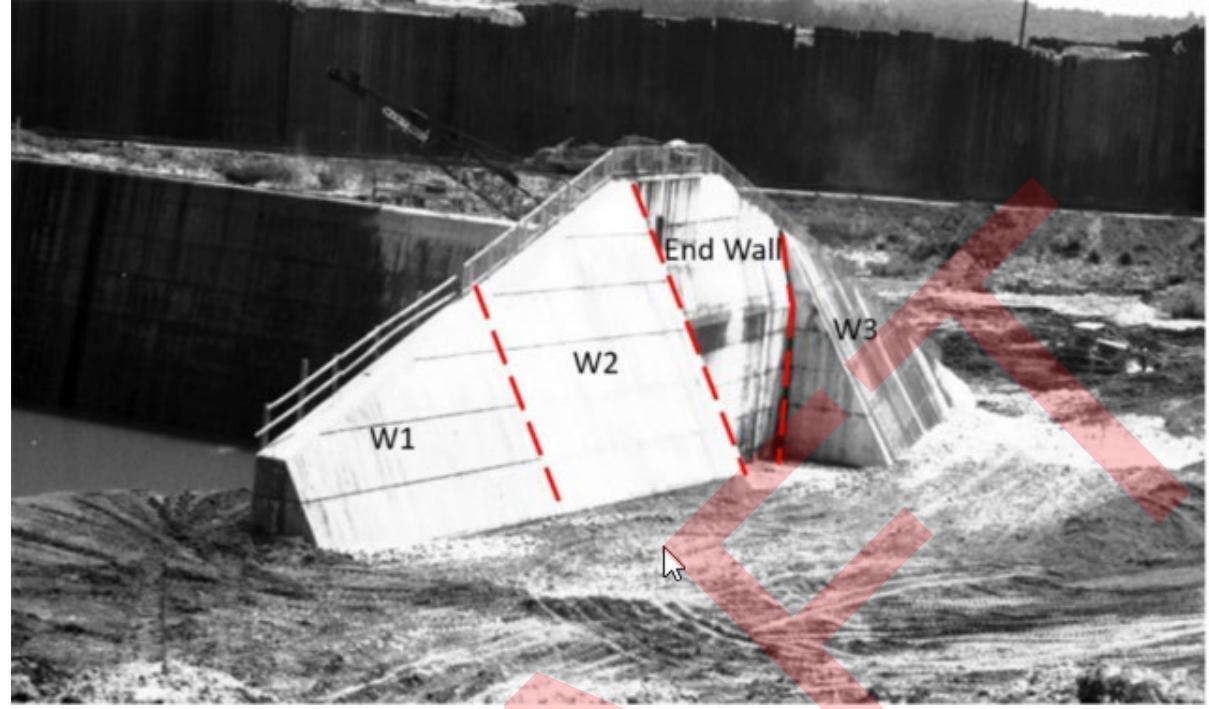
The existing crest spillway is founded on sandstone and claystone which greatly reduces any likelihood of differential settlement. There has been observed cracking at the right abutment wall at sections W2 and W3 documented in Figure 77 and Figure 78 respectively. New settlement from the construction of the structure may exacerbate the existing cracks in the right abutment wall sections. Additionally, the intent will be to fill both sides of the dam evenly so as not to produce an unbalanced load on the existing structure. The potential for induced settlement appears unlikely due to the foundation condition consisting of claystone and sandstone, ultimately excluding this PFM as a risk driver.

Figure 77 – Right Abutment monolith W2 is cracked, as the end wall which is leaning towards the river.

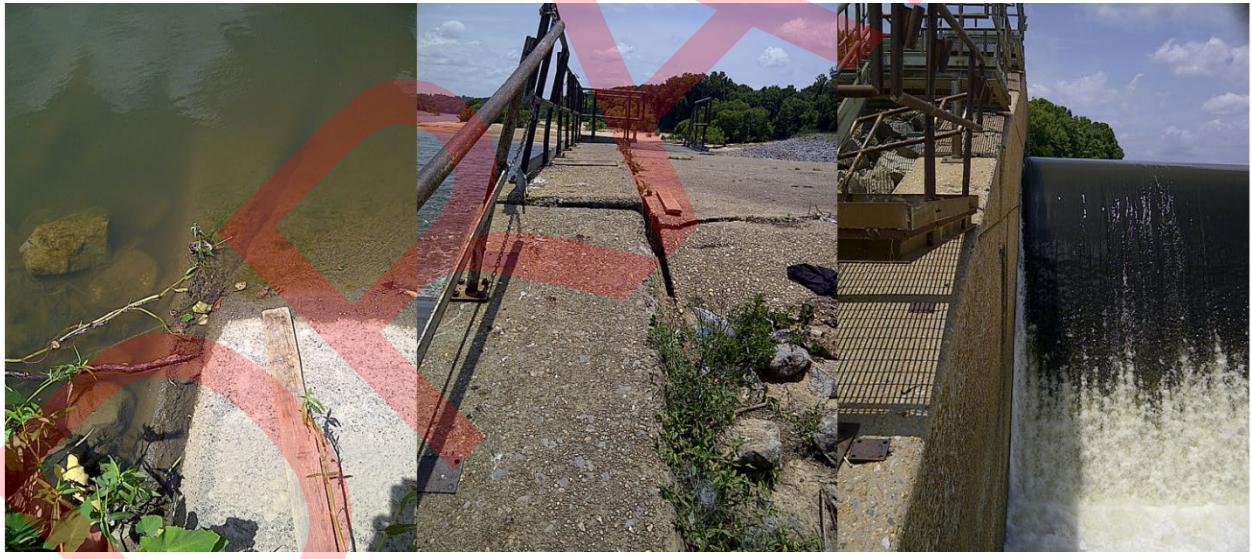
Figure 78 - Monolith with cracks and leaning towards the river.
