STRUCTURAL ASSESSMENT REPORT BUILDING 01

HISTORIC BUILDING STRUCTURAL ASSESSMENT

1000 WATER AVENUE SELMA, AL 36703 CONTRACT NO. W91278-21-D-0003, TASK ORDER NO. W91278-24-F-0153

14 FEB 2025

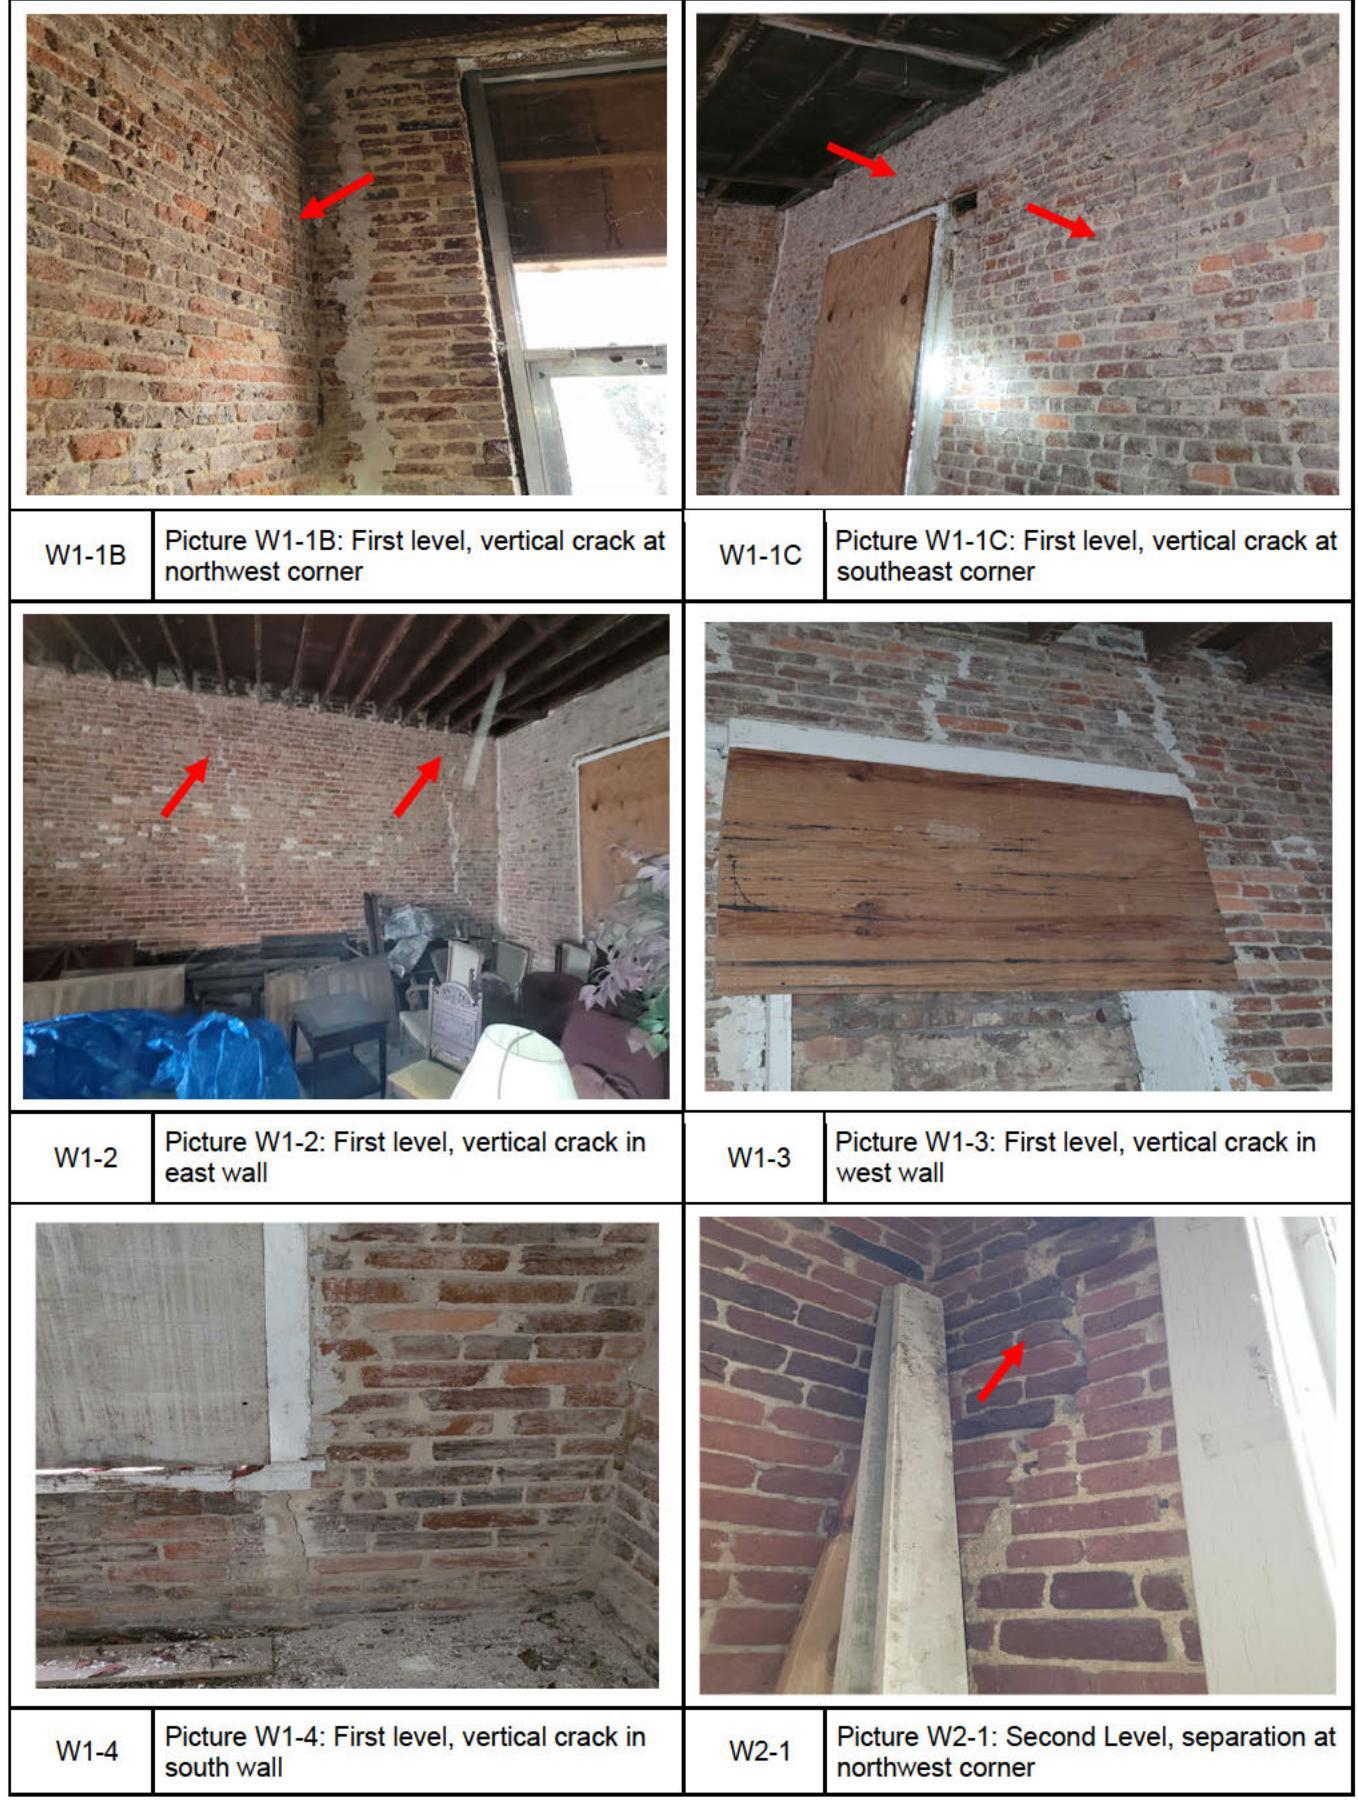
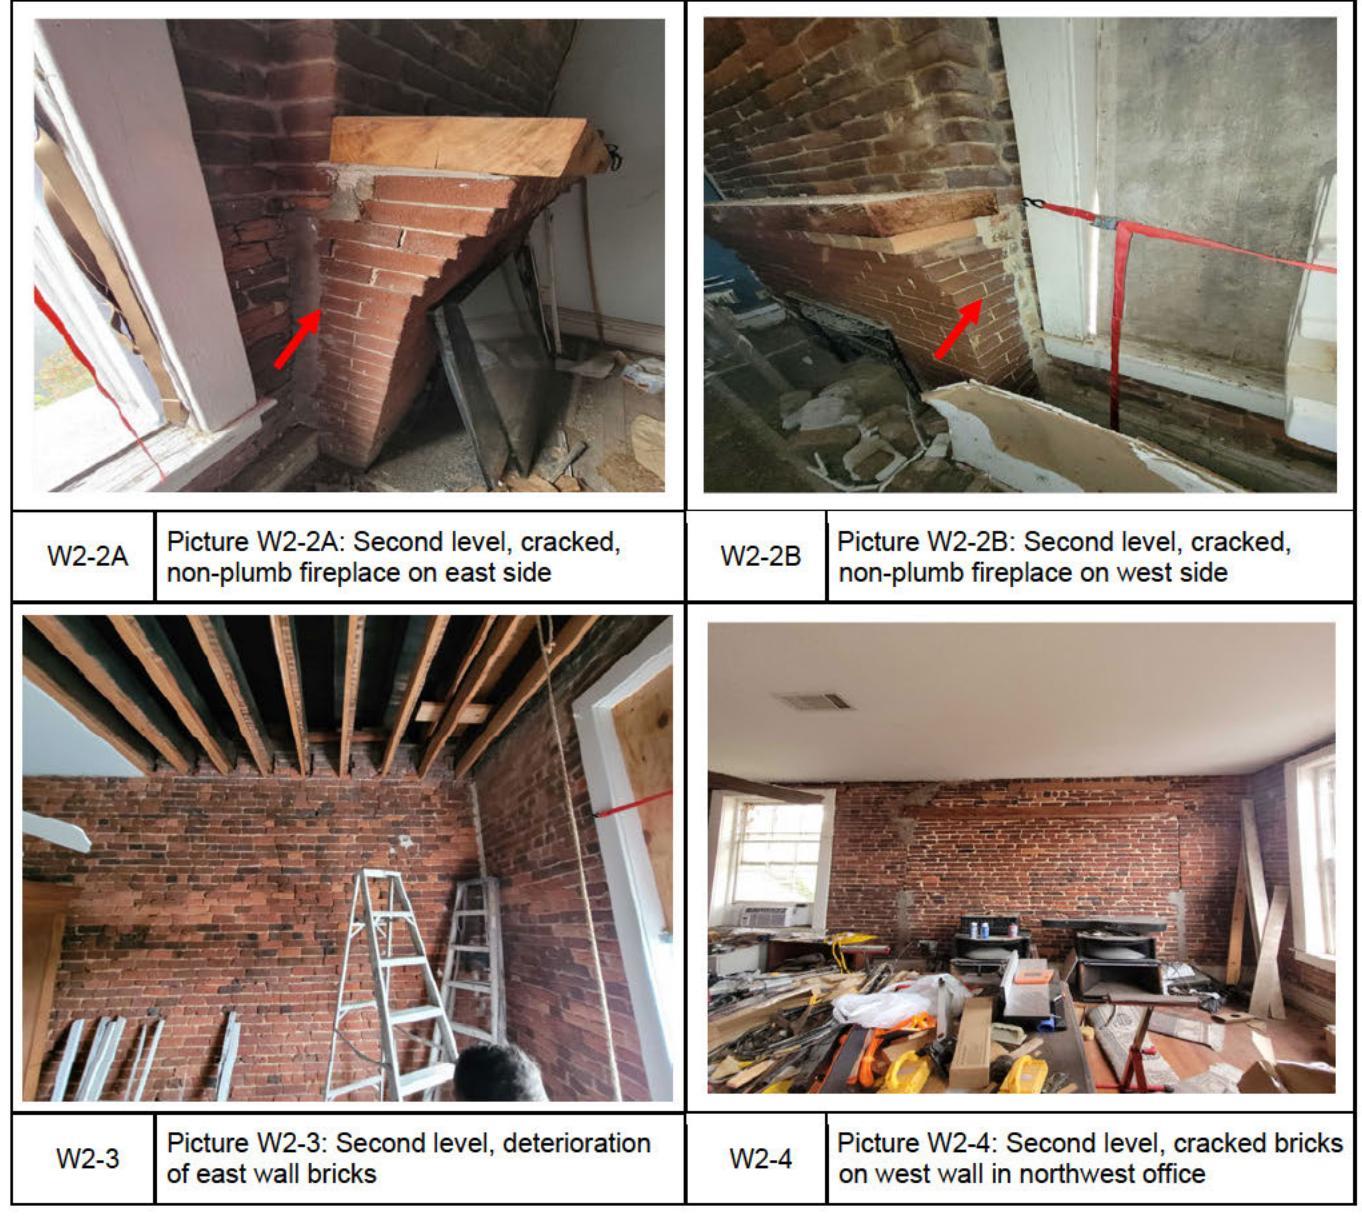
W2-5	Picture W2-5: Second level, large crack on east wall in southeast office

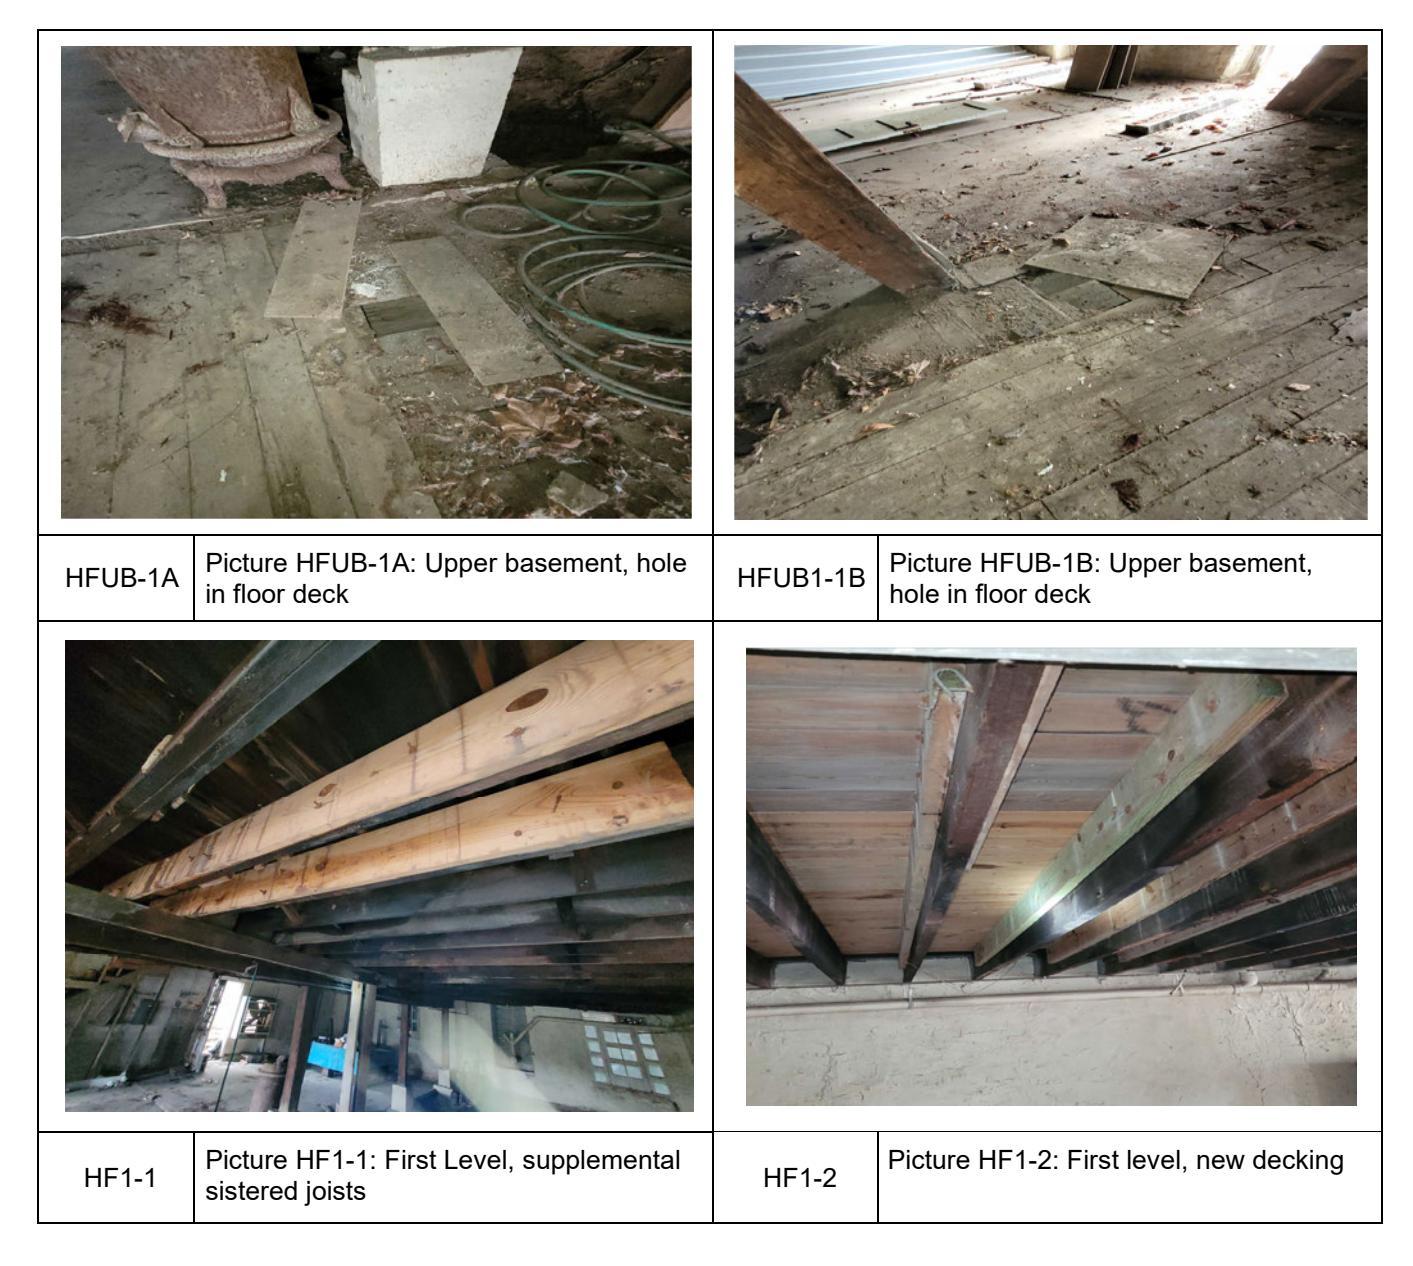
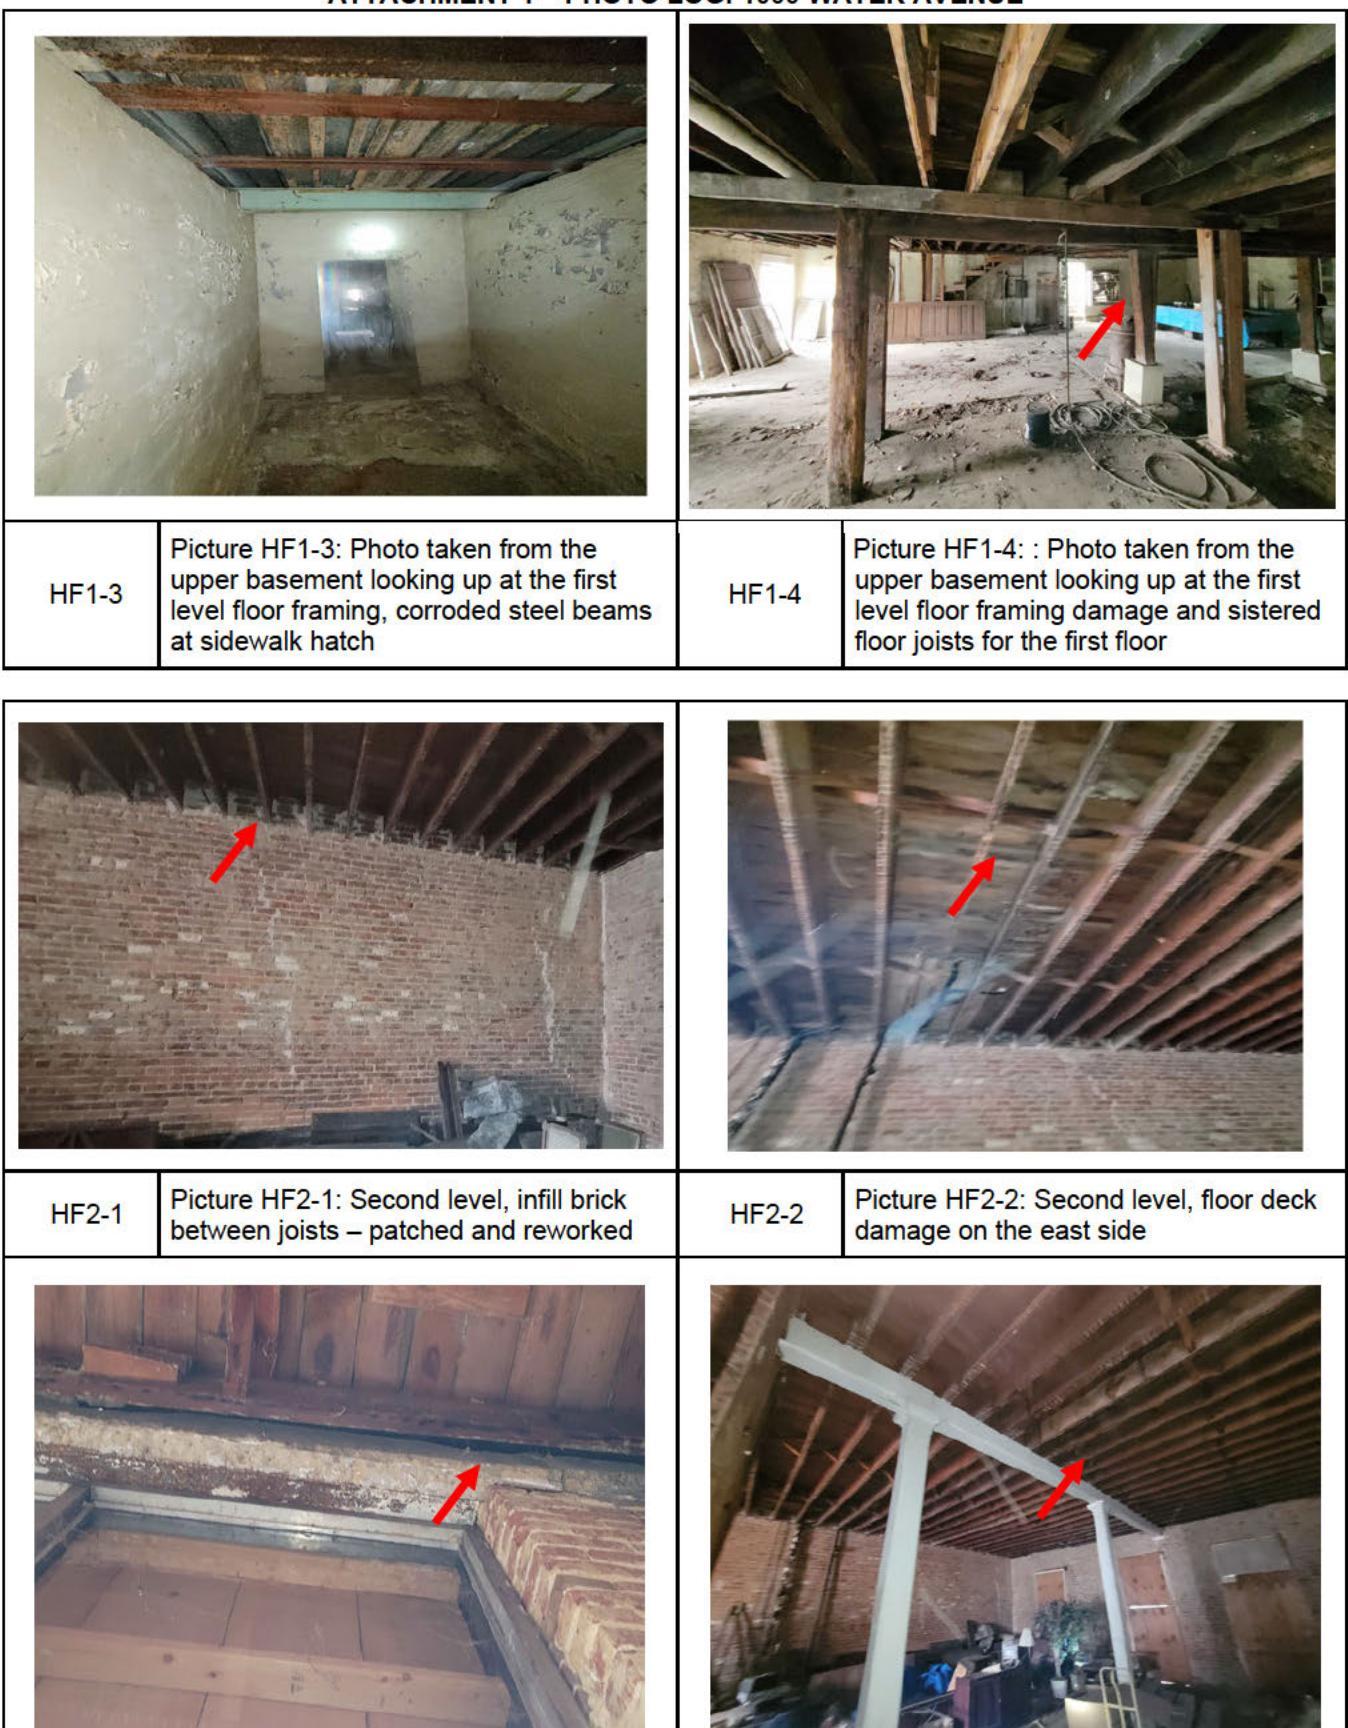
HF2-3	Picture HF2-3: Second level, north wall appears shifts from joist on west side of building	HF2-4	Picture HF2-4: Second level, supplemental joist added on west side near center
HF2-5	Picture HF2-5: Second level, floor deck is sloped on east side of building
