Cursory Geomorphologic Evaluation of the Apalachicola River

David S. Biedenbarn

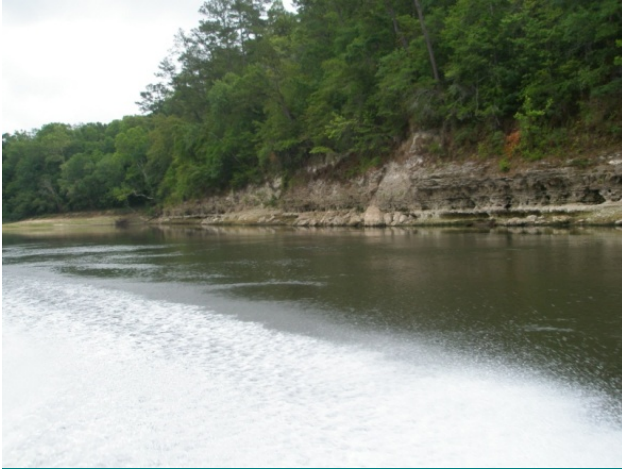
- The degradational response due to the dam appears to extend downstream to about RM 77 near Blountstown. About 4 to 5 feet of lowering has occurred in this reach.
- Reach 1 (Dam to RM 78) is a relatively straight reach with little sediment stored in the channel, and is controlled in places by local geologic outcrops of limestone.
- The streambanks in Reach 1 are predominately composed of cohesive material and bank erosion and channel widening is minimal.
- The dike fields in Reach 1 do not contain significant amounts of sediment.

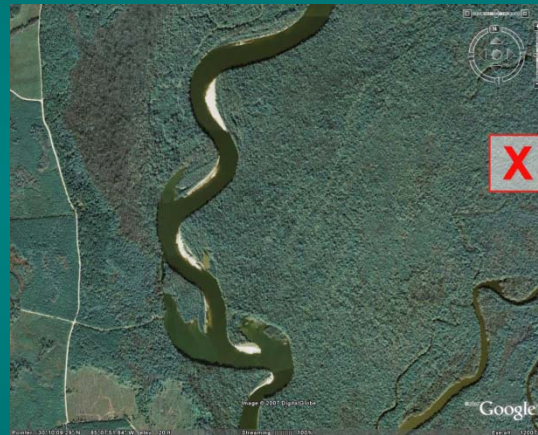
- The river in Reach 2 (RM 78 to RM 35) downstream of Blountstown is a much more active meandering channel with a high sinuosity (sinuosity =1.9).
- Low water gage records and water surface profiles indicate that the channel between Blountstown and RM 20 has experienced about 1 to 2 feet of lowering. However, comparative thalweg plots between 1960 and the early 1980s indicate that the channel has experienced localized areas of scour and fill.
- Reach 2 has the largest erosion rates on the river. This erosion appears to be part of the natural down-valley meander migration which is common to most meandering streams, and does not appear to be the result of some system-wide adjustments such as degradation, aggradation, or channel widening.

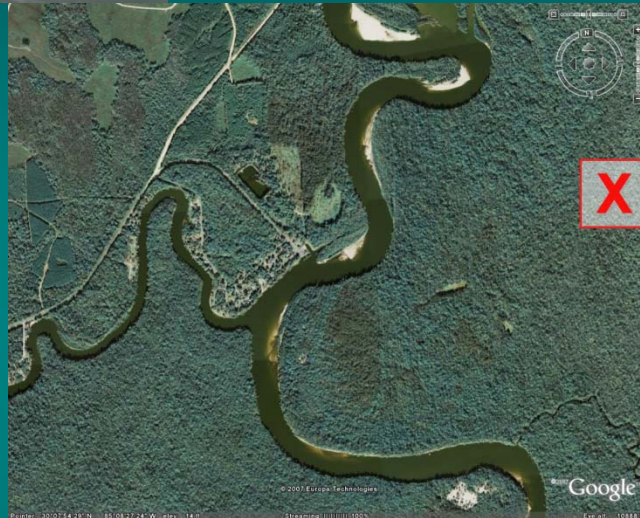
- The channel between the Chipola Cutoff and RM 35 has been one of the most frequently dredged areas on the river. It appears that little sediment is diverted into the Chipola Cutoff, which might be a partial explanation for the frequent dredging just downstream.
- The processes responsible for the apparent increase in the percent of flow (25% to 34%) diverted at the Chipola Cutoff warrants further study.
- There is considerable sediment storage in Reach 2 as evidenced by the large point bars.
- The effects of the cessation of dredging in the 2000 timeframe on the morphology of the channel warrants further study
- Comparison of the 1941 and 2004 channel widths indicated that channel widening throughout the river down to RM 20. Further analysis is needed to determine if these width increases are real, and if so, what are the factors responsible for them.

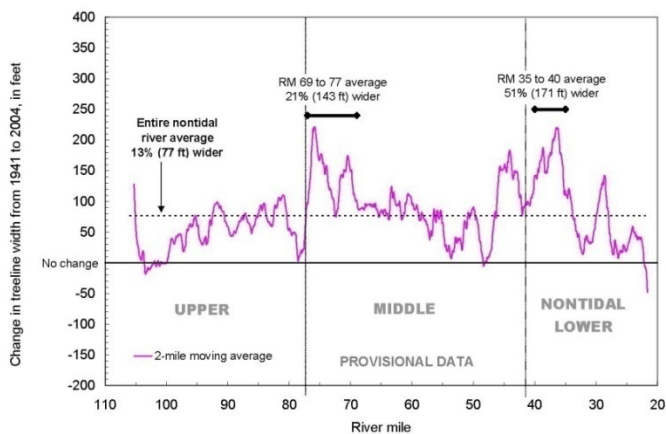
Figure 2. Change in treeline width of main channel of nontidal reach of Apalachicola River, Florida, from 1941 to 2004. Widths were measured at approximately 2,800 points at 164-foot intervals along channel centerline in aerial photographs. Data shows a 2-mile (64-point) moving average. River miles represent those depicted on the most recent USGS quadrangle maps available in 2005.

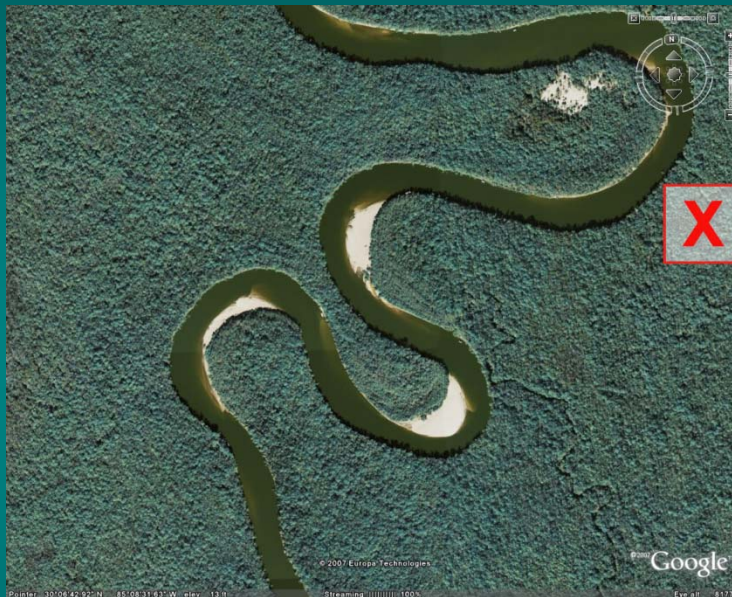
- The river downstream of the River Styx (RM 35) has a lower sinuosity (1.3) and less bank erosion.
- Local meander cutoffs downstream of the River Styx may be responsible for some of the bed lowering in this area.
- Preferred mussel habitat appears to occur in the lower energy environments associated with the flow separation zones (eddies) in the transition between meander bends
- The size and location of the eddie zones change with flow and through time as the meanders migrate through the floodplain
