# Cursory Fluvial Geomorphic Evaluation of the Apalachicola River in Support of the Jim Woodruff Dam Interim Operations Plan: Summary of Findings

Prepared by Michael D. Harvey, Ph.D., P.G.  
Mussetter Engineering, Inc.

August 28, 2007

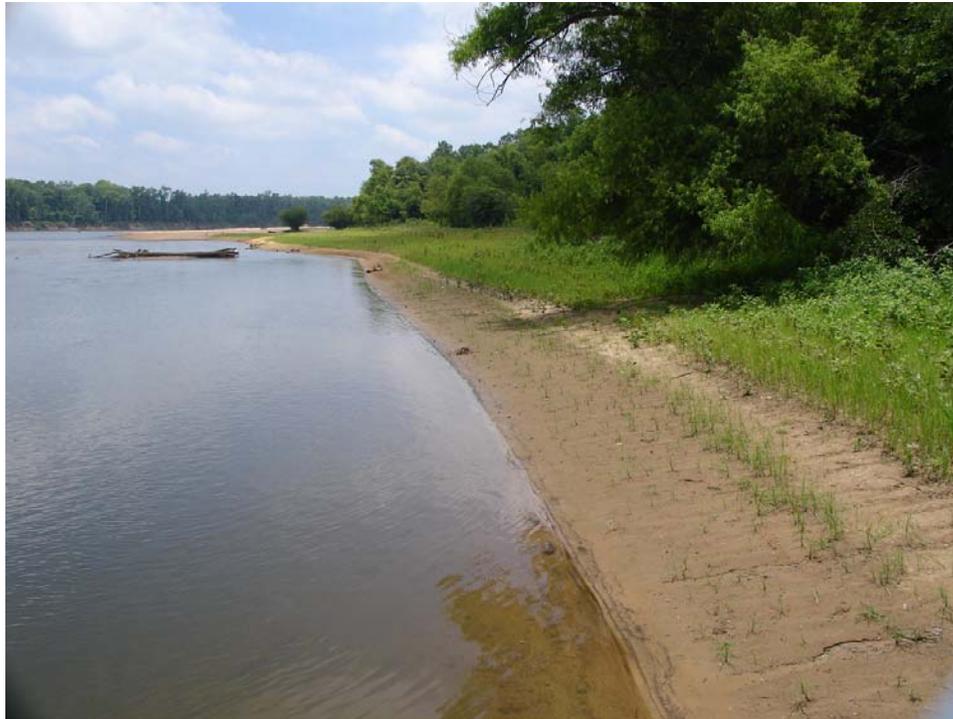
Figure 9. Upstream view of FTM habitat at RM 73.2L.

During the course of the boat inspection of the non-tidal reach of the Apalachicola River, a number of locations where fat threeridge mussels (FTM) were present were identified by the mussel experts and these sites were inspected. Sites inspected that had FTM present included RM 73.2L (downstream end of a point bar) (**Figure 9**), RM 51.8L (downstream end of a point bar & mouth of Equiloxic Creek) (**Figure 10**), RM 48L (downstream of a sharp bend caused by erosion-resistant bank materials) (**Figure 11**), RM 47.2R (dike field) (**Figure 12**) and RM 43.1L (backwater-induced bank-attached bar) (**Figure 13**). While these sites have different macro-scale physical characteristics, they all have common meso- and micro-scale hydraulic characteristics (Harvey et al., 1993). All of the sites are located in flow separation zones (eddies) at higher flows than were present in the river (about 5,000 cfs) at the time of the field inspection. Within the eddy zones finer sediments (fine to medium sand and some silts and clays) are deposited against the bankline and appear to create conditions that provide suitable FTM habitat. In general, the flow separation zones occur on the inside of the bends downstream of the point bar apexes, and therefore, the FTM habitat appears to be related to meander bend dynamics. Consequently, the location of the preferred habitat is likely to change through time and space as the bends migrate laterally and down-valley. This is in contrast to the situation where eddy deposits are formed in fixed locations within canyons (Schmidt and

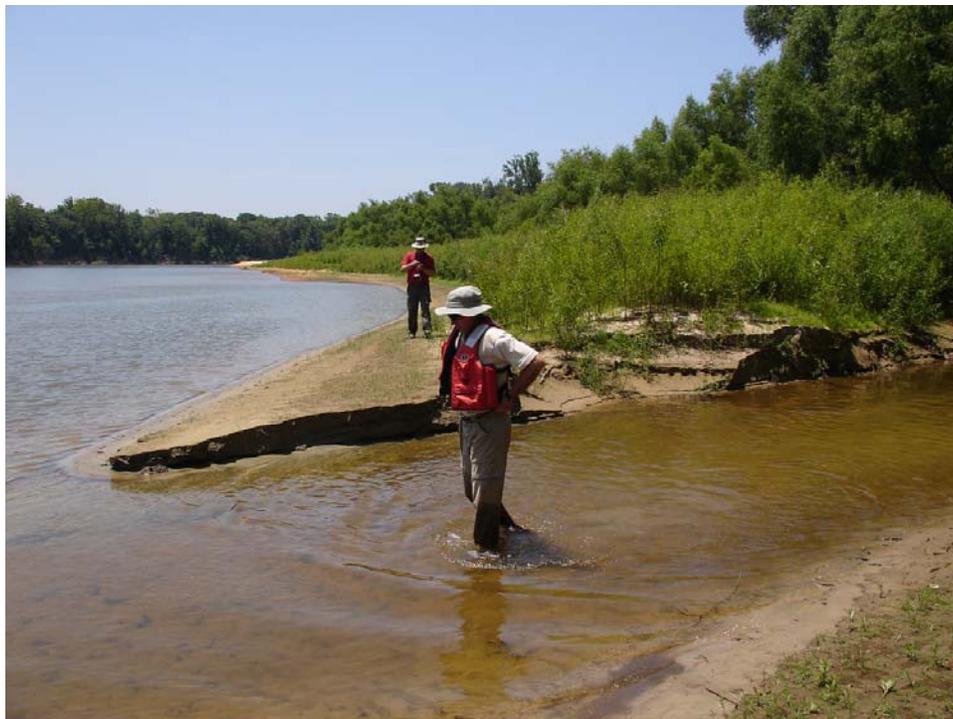
Figure 10. Upstream view of FTM habitat at RM 51.8L.

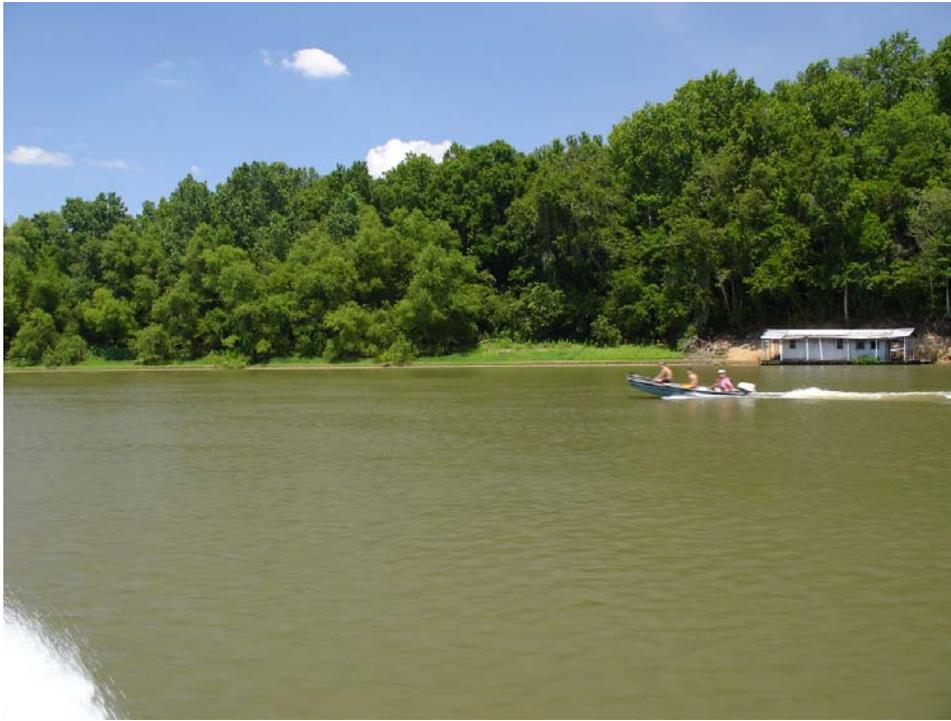
Figure 11. Upstream view of FTM habitat (upstream of house boat) at RM 48L.

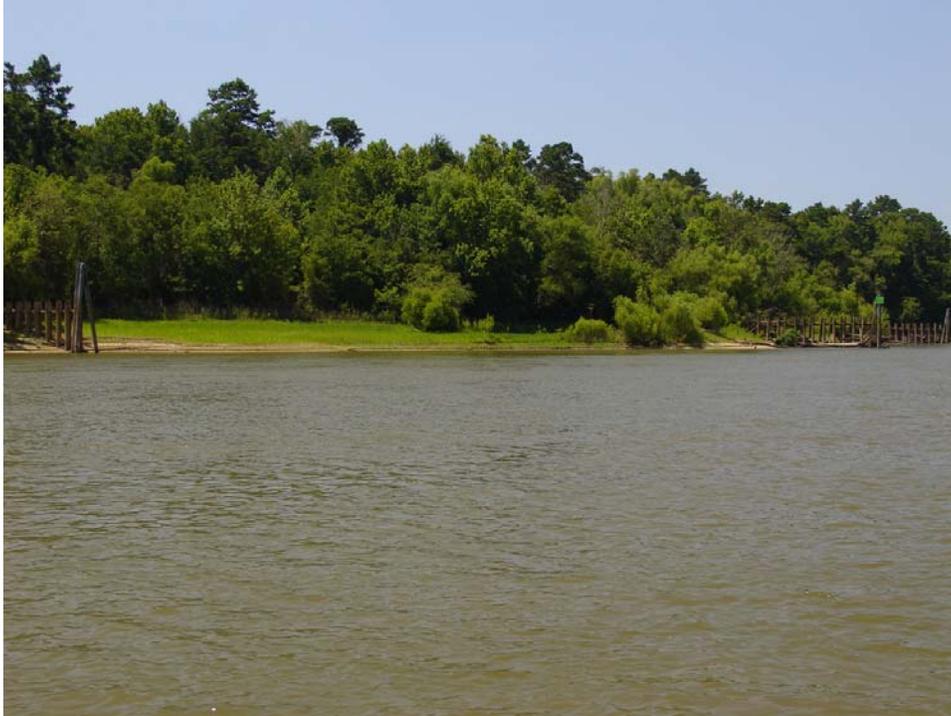
Figure 12. View of sediment deposition and FTM habitat in the dike field at RM 47.2R.

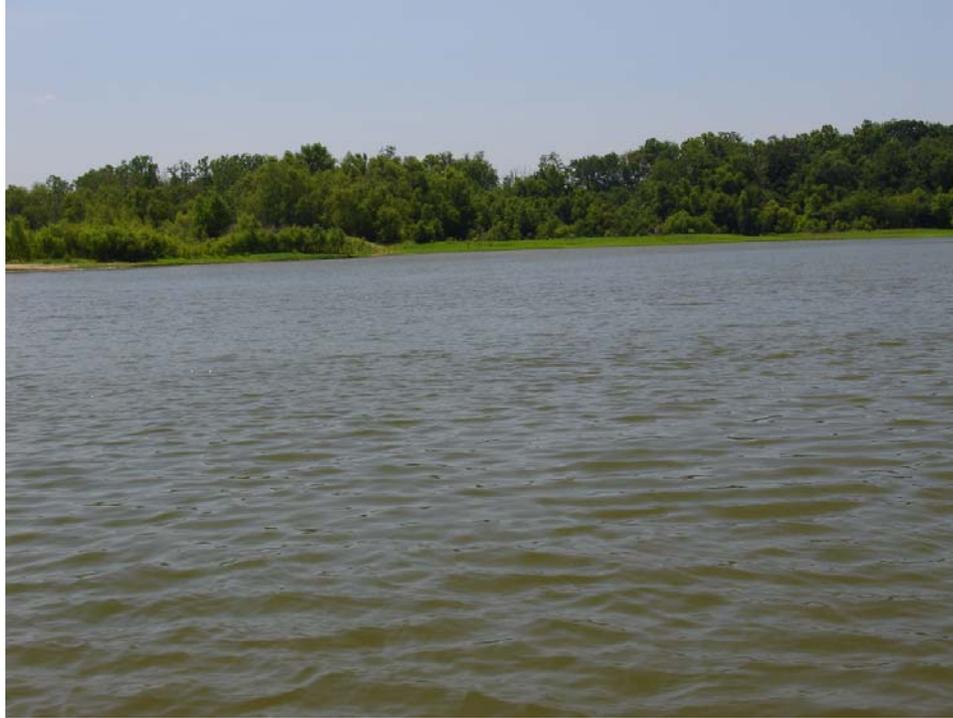
Figure 13. FTM habitat associated with a backwater-induced bar at RM 43.1L.

Rubin, 1995; Cenderelli and Cluer, 1998). Where the local sinuosity is very high and there are a number of very low radii of curvature bends present that cause upstream backwater, mid-channel and bank-attached bars are formed in the upstream limbs of the bend because of the very high energy losses through the bends (Bagnold, 1960; Harvey, 1989). Such conditions are present for example from RM 43 to RM 46. The eddy deposits associated with the backwater-induced bars also appear to create suitable habitat for the FTM.

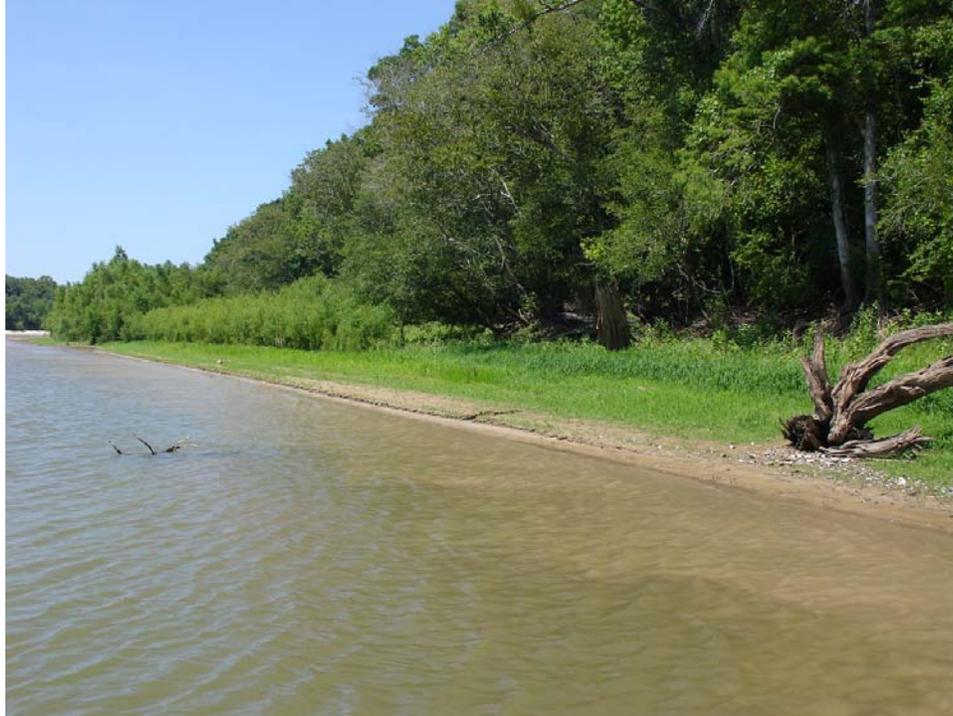
FTM mortality observed in 2006 following the high sustained flows of 2005 (peak flow of 159,000 cfs at the Chattahoochee gage) is a matter of concern for the Corps and the USFWS. Three sites were inspected where FTM mortality had occurred following the 2005 high flows. These included RM 44L (**Figure 14**) and RM 43.6R (**Figure 15**) on the Apalachicola River and

Swift Slough (RM 40.2L) (**Figure 16**). Mortality of the FTM at each of the sites appears to be related to deposition of sandy bed material, and can be explained by the dynamics of the river. It is axiomatic that most changes in a meandering river occur during periods of high flow, since these are the conditions that cause sediment transport, bank erosion and sediment deposition. At RM 44L, the FTM mortality occurred in an eddy deposit on the downstream end of the bend centered at RM 44.5. Field observations of the conditions at the site (age and size of the willows) indicate that the eddy deposit has moved downstream through time in response to the shift of the bend caused by erosion of the opposing bank (**Figure 17**). Thus, at this site, suitable FTM habitat prior to the 2005 high flows is no longer present at the same location, and FTM present at the site appear to have been killed by excessive sedimentation that is expected as the bendway moves across and downvalley. However, the downstream shift of the eddy appears to be creating suitable FTM habitat downstream of that identified prior to 2005 which indicates that FTM habitat at a given location is likely to be ephemeral, but that new habitat is formed as the bends adjust.

Figure 14. Upstream view of FTM mortality site at RM 44L.

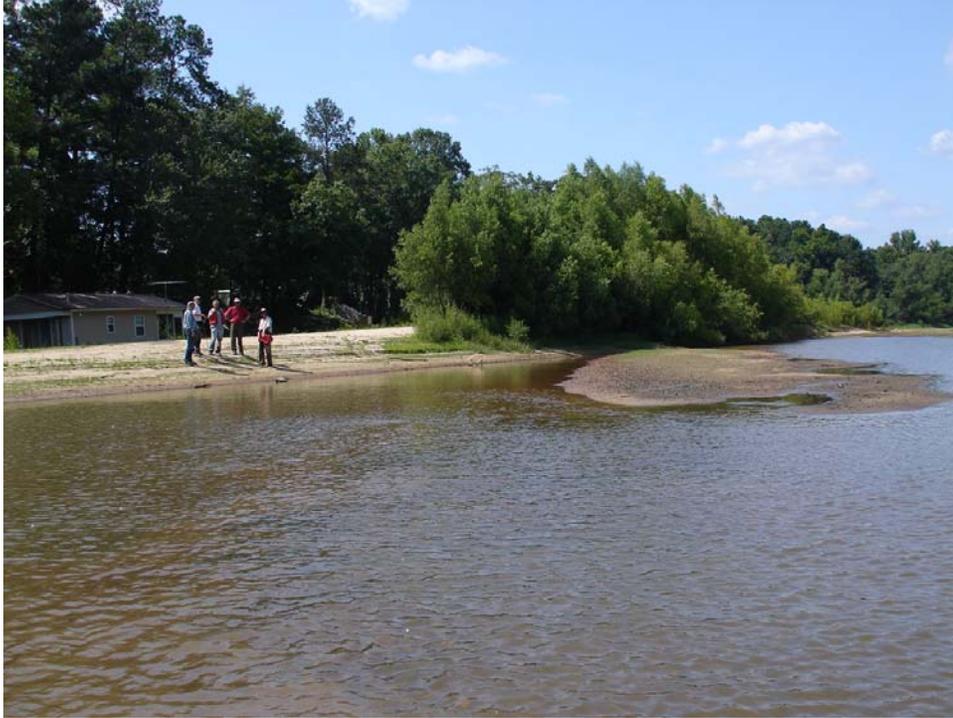
At RM 43.6R, FTM mortality was associated with growth of a bank-attached bar on the outside of the bend. An extremely low radius of curvature bend is located downstream of this site at RM 43. During the high and long duration flows of 2005, the downstream bend created backwater conditions that induced further sedimentation on the bank-attached bar, which was probably responsible for the deaths of the FTM that were present at the site prior to 2005 when the site provided suitable habitat. Whether new suitable FTM habitat will be created in this general location is difficult to predict without a better knowledge of the hydraulic characteristics of the river at a range of higher flows. It is quite possible that the bank-attached bar has a limited lifespan as suitable habitat for FTM.

Figure 15. Upstream view of FTM mortality site at RM 43.6R (Kentucky Landing).

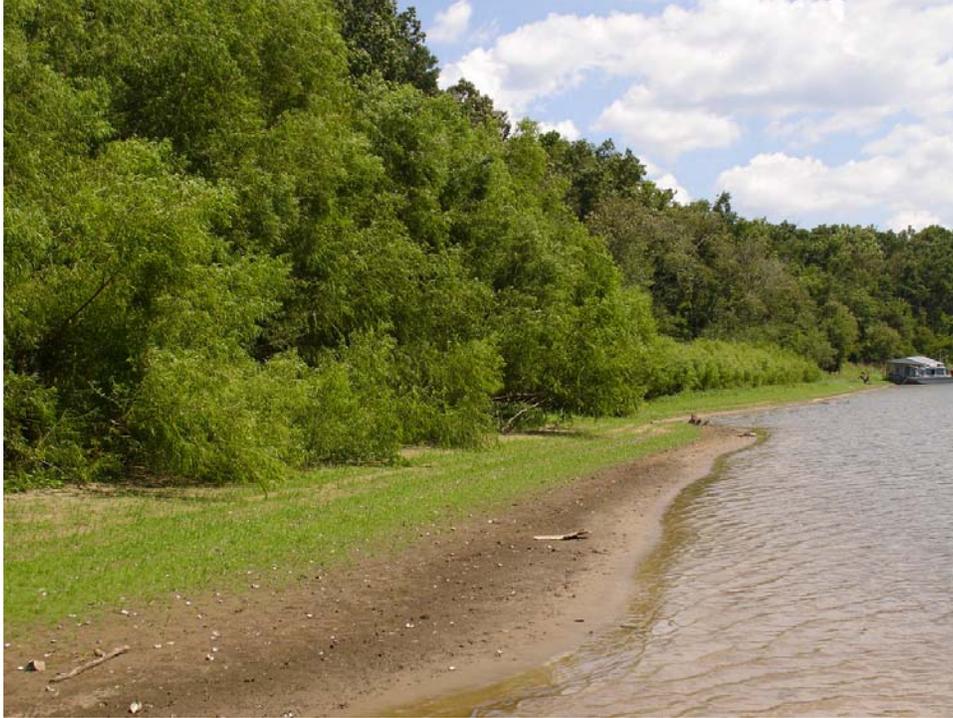
Figure 17. Downstream view of willow succession at RM 44L.

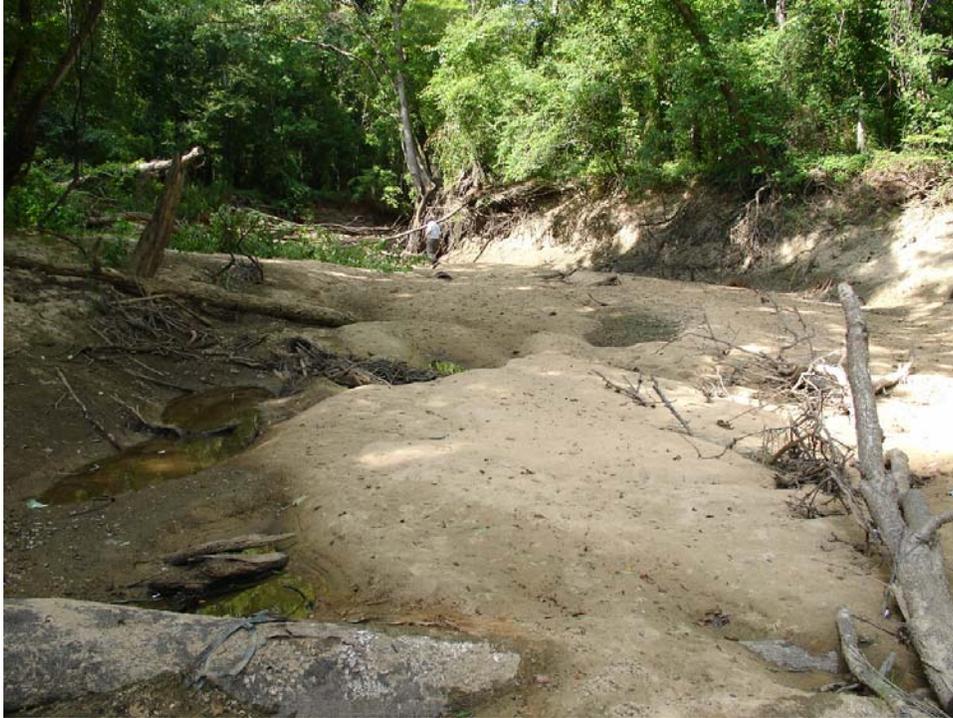
In the upper reaches of Swift Slough, which is a distributary channel for the Apalachicola River at about RM 40.2L, there is little doubt that relatively recent flows have introduced sandy bed material into the upper reaches of the slough and dead FTM were observed in the channel (**Figure 18**). Prior to 2005, there appears to have been a population of FTM in the upper reaches of Swift Slough, but the large numbers of mussels observed in the channel following the 2005 high flows were probably transported into the slough (Jerry Ziewitz, USFWS, personal communication). During the 2005 high and long duration flows it is quite likely that the cumulative energy losses created by the low radius of curvature bends between RM 38 and RM 40 created sufficient backwater to cause in-channel sedimentation at about RM 40. Additionally, the loss of about 35 percent of the flow without a commensurate amount of the sediment into the Chipola Cutoff was probably also responsible for in-channel sedimentation upstream of RM 40. Annual dredging of the reach between the cutoff and RM 40 was required historically to permit navigation (Terry Jangula, Corps, personal communication), and dredging has not been conducted since 2001, which could have led to a build up of bed material in the reach prior to and subsequent to the 2005 event. The hydraulics of the river at the mouth of Swift Slough are not known with certainty, but it is likely that during the high flows of 2005, sediment deposition was occurring while the bankfull flow was exceeded (about 50,000 cfs) and the overbank areas were submerged. During the recessional flows, it is quite possible that the bed material deposited in the river at the mouth of Swift Slough was re-entrained by flows entering Swift Slough which is a steep distributary with fairly high velocities (Light et al., 1998). Hydraulic modeling of the river and slough will be required to verify or reject this hypothesis. If the hypothesis is correct, it again points to the ephemeral nature of FTM habitat, which will change in response to changes in the meander planform and dynamics of the river.

Figure 18. Downstream view of sand waves on the bed of Swift Slough.
