DRAFT ENVIRONMENTAL ASSESSMENT

PROPOSED UPGRADE OF CATCH BASIN LIDS

DEKALB COUNTY, GEORGIA

March 2010

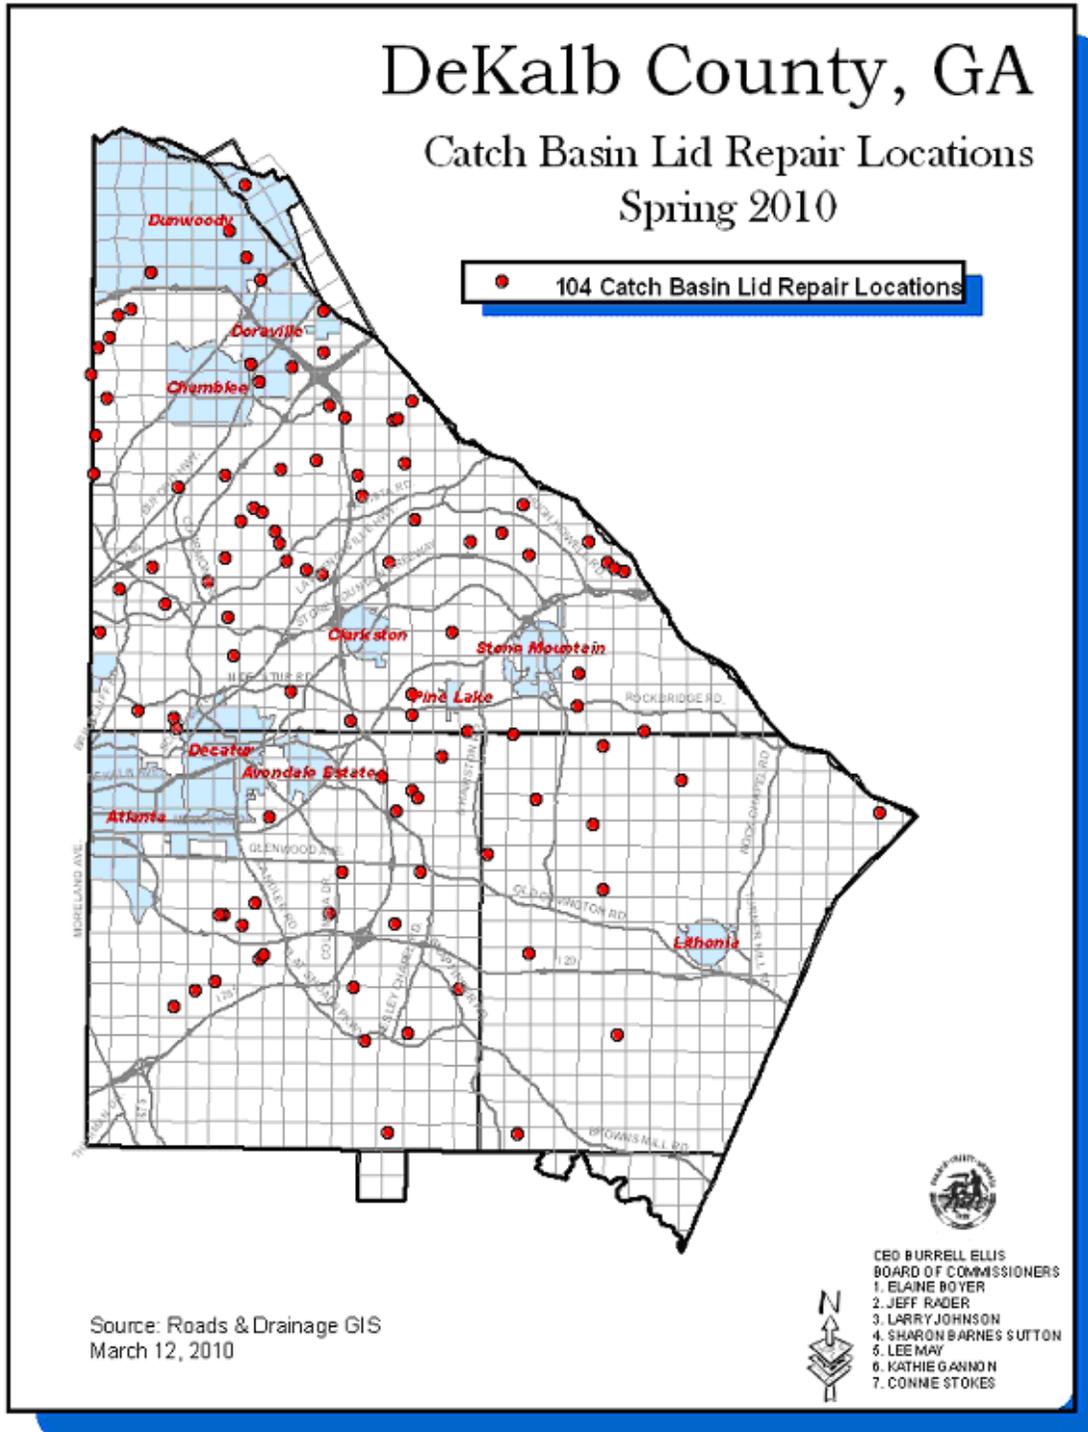
Figure 1 – Catch Basin Lid Repair Locations (104)

3.1. **General.** The proposed action would replace failed boxes at 104 locations within DeKalb County with Georgia Department of Transportation 1033 or 1034 lids along with additional repairs to catch basins throughout DeKalb County. Figure 1 and Table 1 provides a map of the catch basin locations and a list of the street locations. Figure 2 shows the typical standard design for the catch basin structure. The proposed action addressed in this Environmental Assessment includes the construction work as well as the associated periodic maintenance required at each of the catch basins. The estimated construction time for each catch basin is 2-4 days, and there would be several concurrent sites under construction during the construction phase.

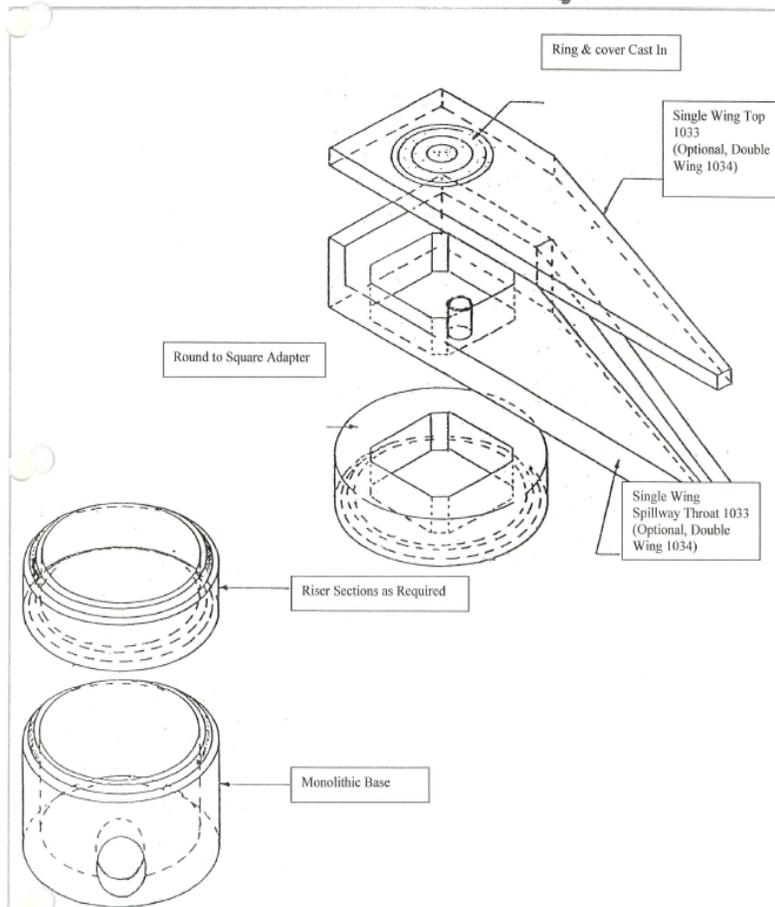
Figure 2 – Diagram of Catch Basin Upgrade

*Catch Basins Upgraded to a
Precast Catch Basin System*

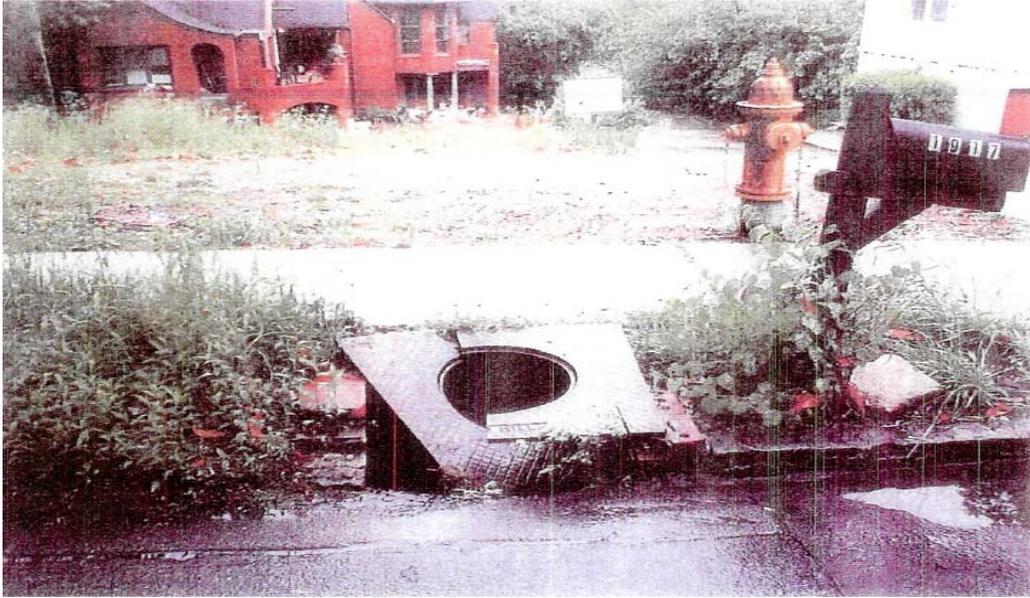
Photo 1 – Broken Metal Catch Basin Lid

1.0. **PURPOSE AND NEED FOR THE PROPOSED ACTION.** Numerous catch basins throughout DeKalb County have been identified as failed structures and are in need of repair. The damage to these structures ranges from broken lids to failed boxes. The lids could be broken due to age or as a result of being crushed by tires of heavy vehicles. The failed boxes are normally a result of rusted conveyance systems. The proposed action would replace failed boxes, which are typically catch basins with non standard lids, with Georgia Department of Transportation 1033 or 1034 lids along with additional repairs. The desired results of this action would allow for greater maintenance efficiency and productivity along with less gutter spread flow for the public.

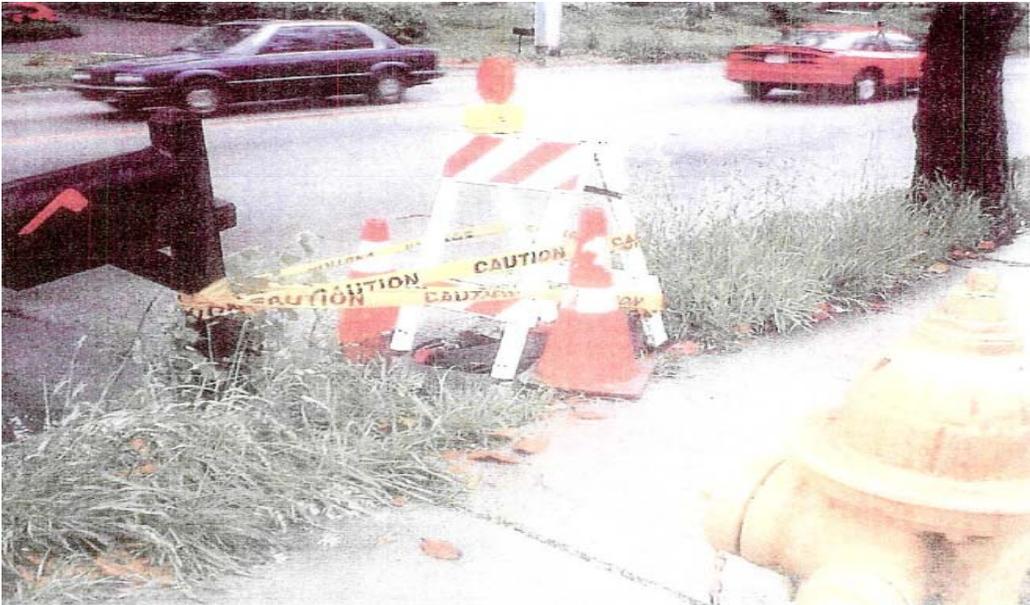
Photo 2 – Safe-Up Catch Basin

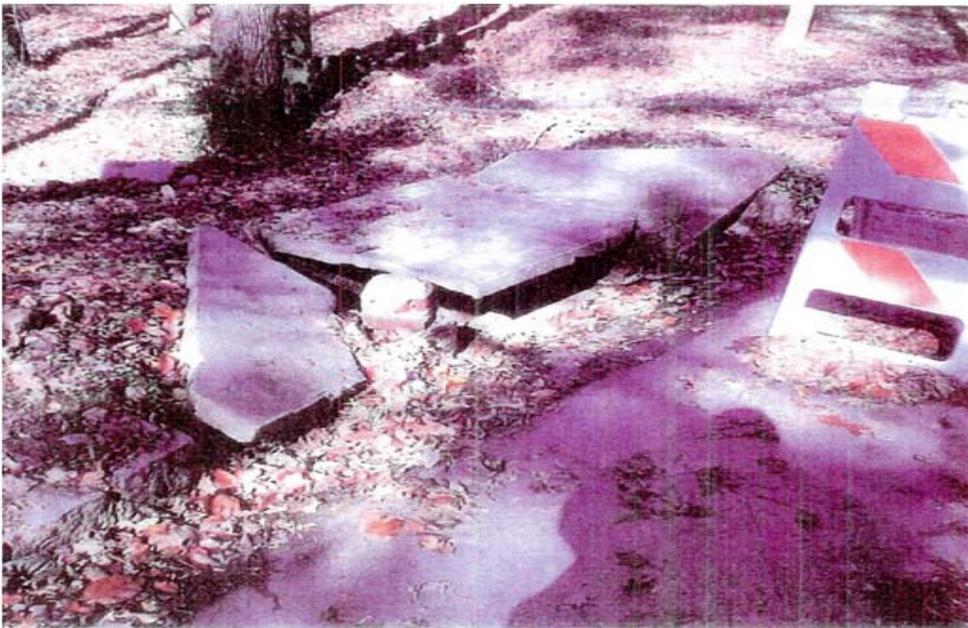
Photo 4 - Double Wing Catch Basin Lid - Broken into 3 pieces

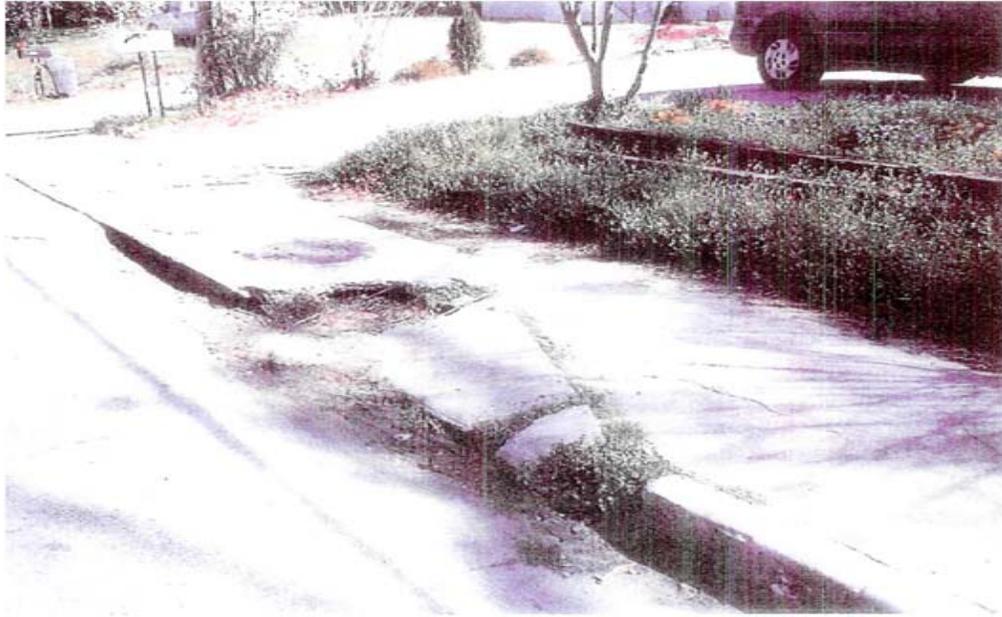
Photo 5 - Broken Standard Right Wing Catch Basin Lid

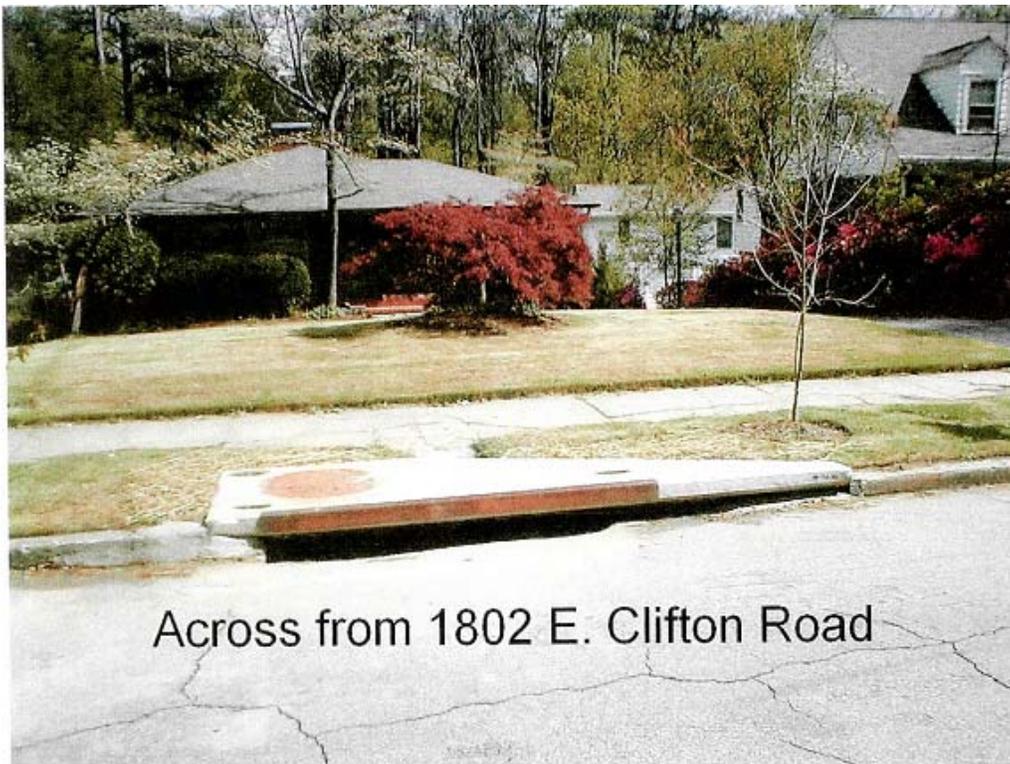
Photo 6 - Upgraded Catch Basin - Frontal View

Across from 1802 E. Clifton Road

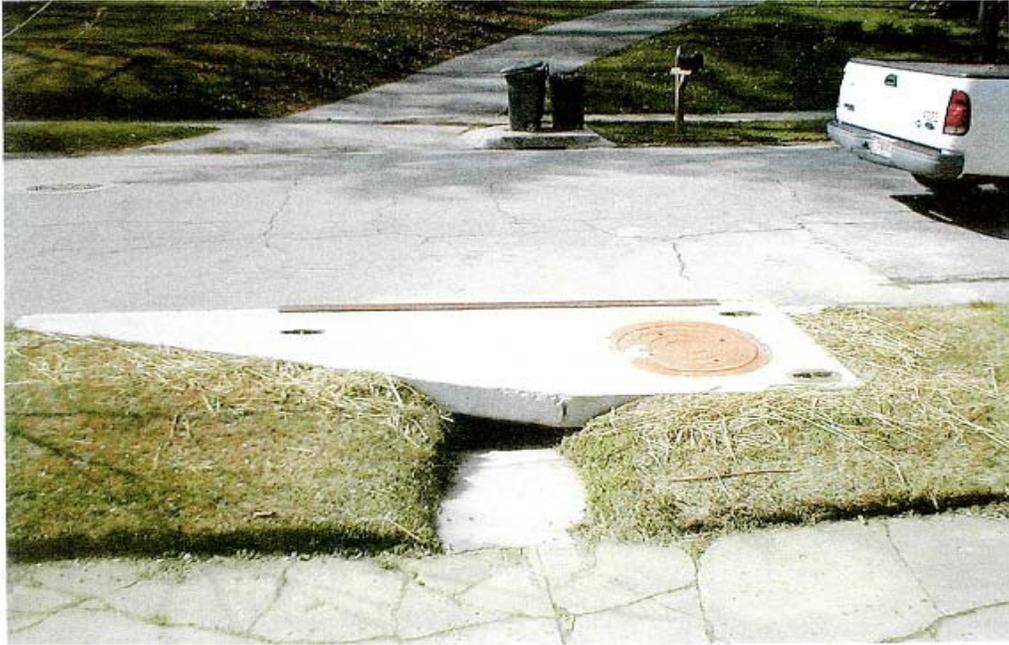
Photo 7 - Upgraded Catch Basin - Rear View

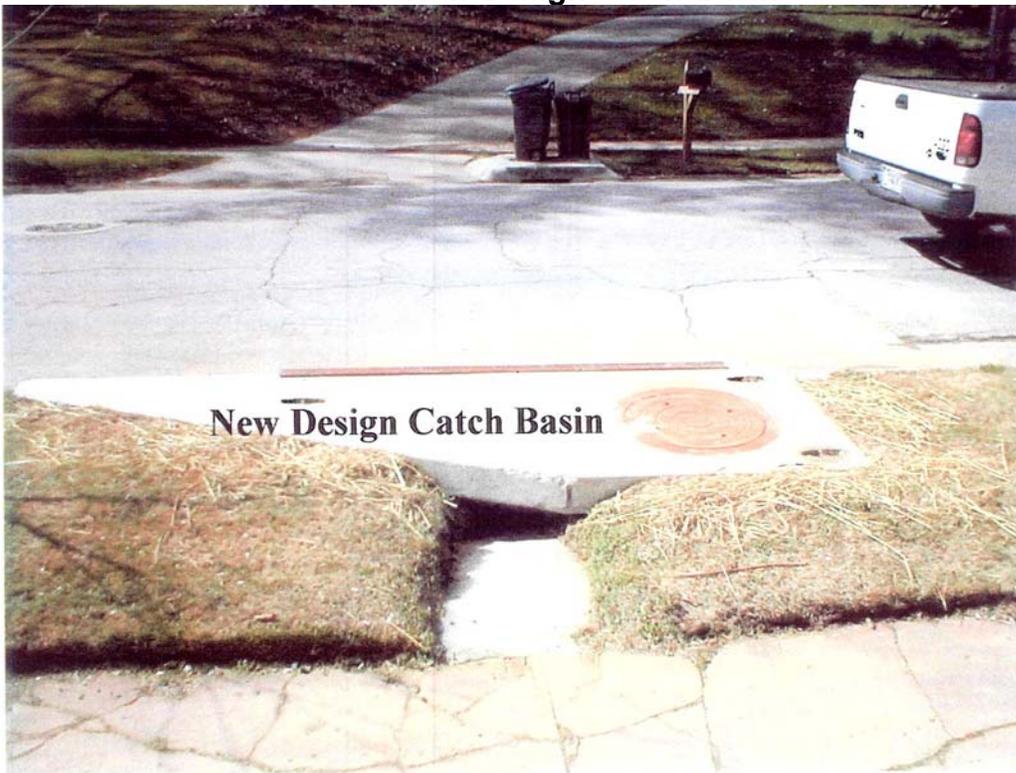
Photo 8 - New Design Catch Basin

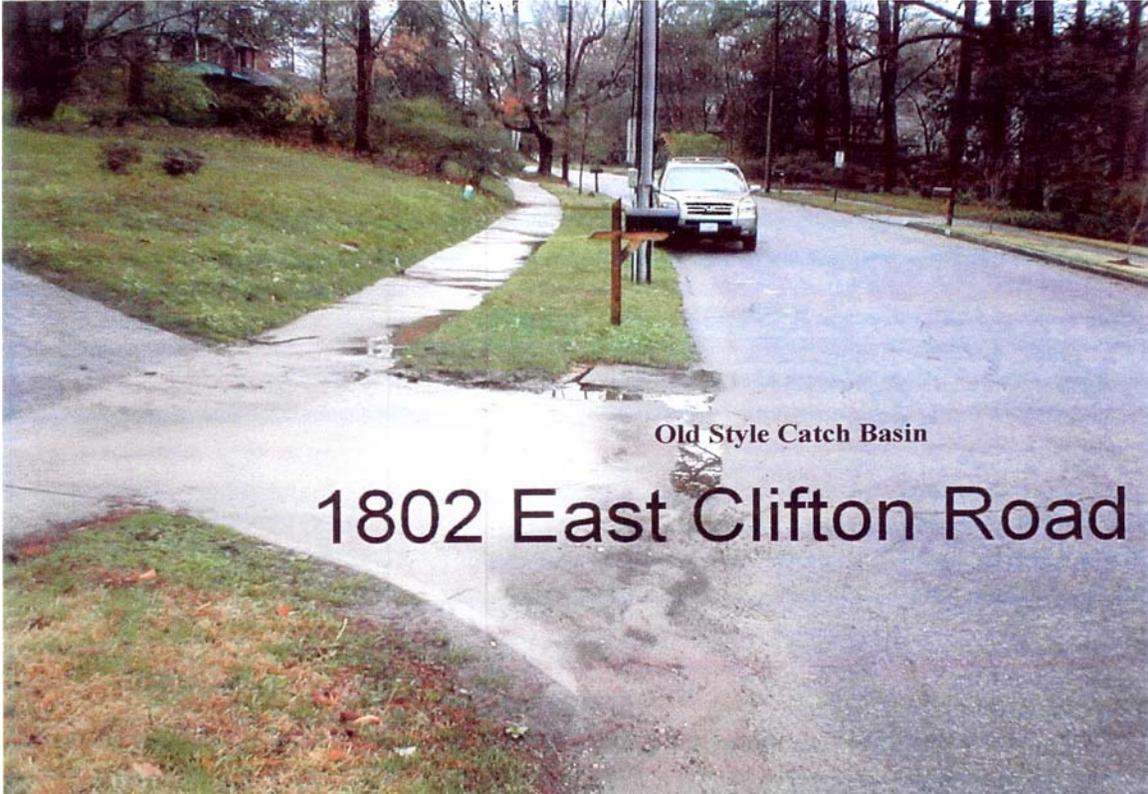
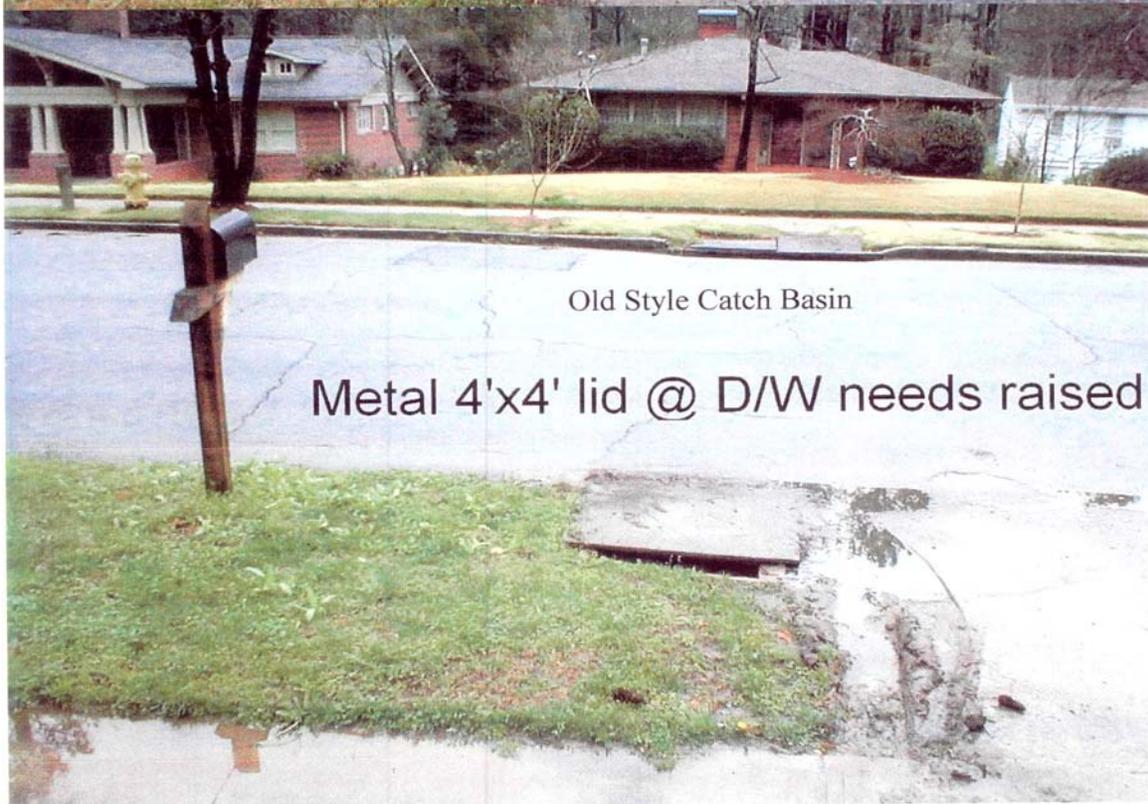
Photos 9 and 10 – 1802 East Clifton Road (Old Style Catch Basin)

Old Style Catch Basin

Metal 4'x4' lid @ D/W needs raised

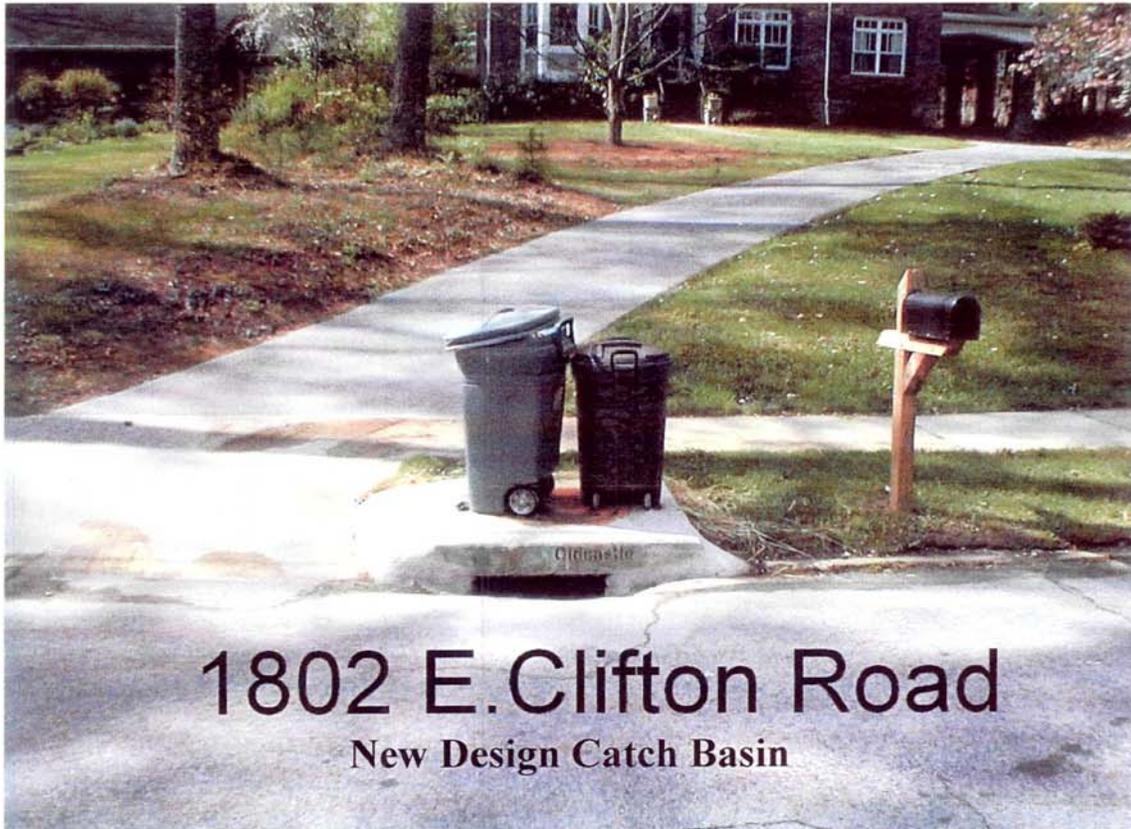
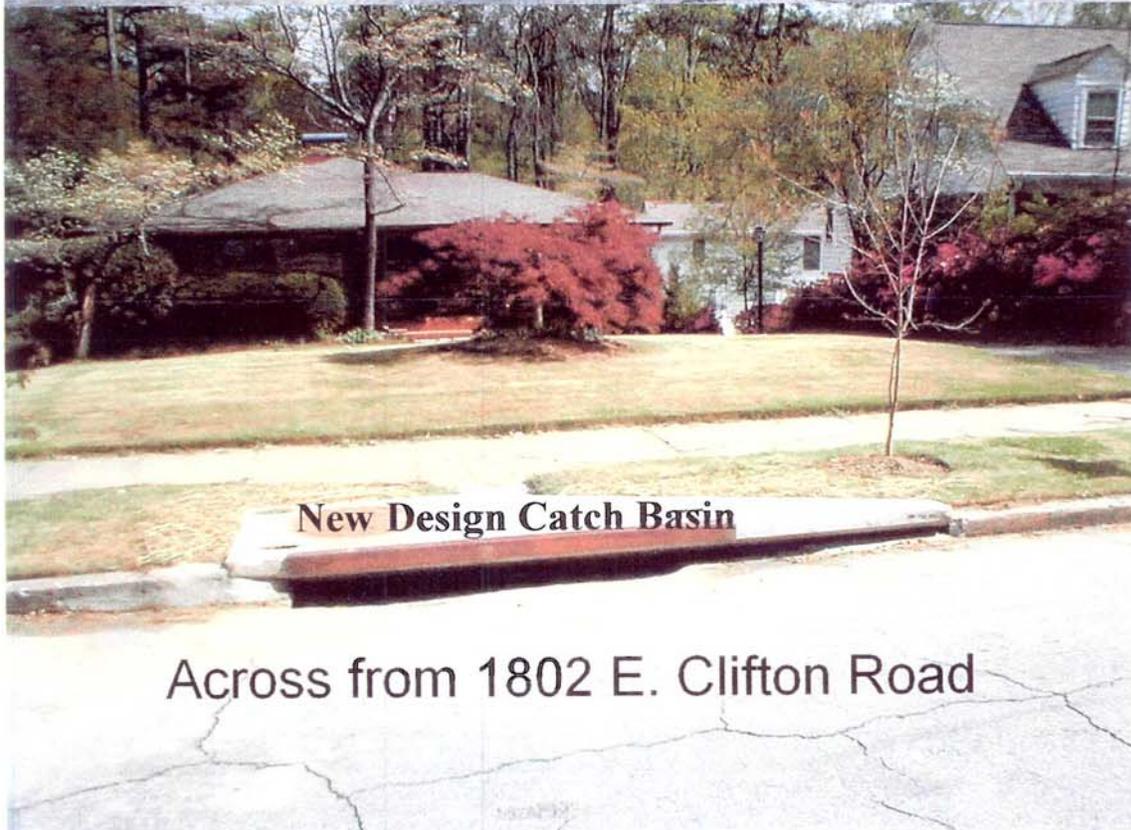
Photos 11 and 12 – 1802 East Clifton Road (New Style Catch Basin)
