PROJECT MANAGEMENT PLAN

**BUTLER CREEK SECTION 206
ECOSYSTEM RESTORATION PROJECT**

BUTLER CREEK WATERSHED, COBB COUNTY, GEORGIA

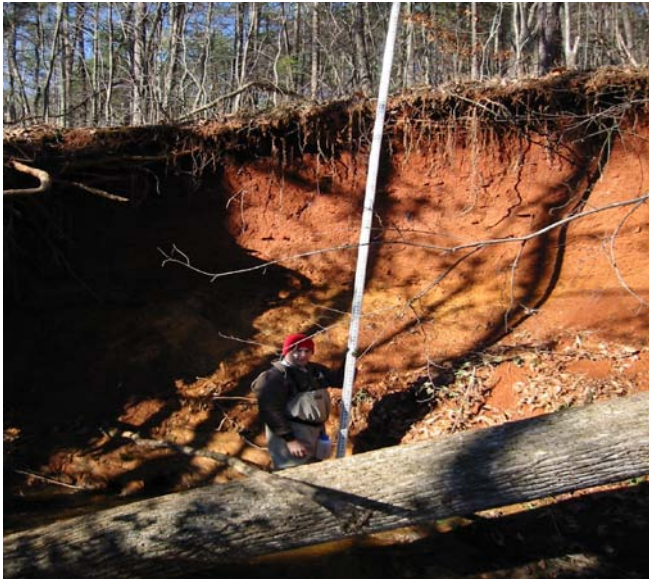
Figure 1. Severe Streambank Erosion In Butler Creek

The main contributors to the degraded habitat within this watershed were identified as flashy stormwater flows, associated sediment runoff from varying land usage within the basin, and bank erosion. While the environmental benefits for the proposed restoration project are widely recognized, the quantification of the environmental benefit is not quite so straightforward. No universally accepted environmental quantification “tool” or “method” is recognized. Therefore, the Corps, in consultation with an interagency team which included the USFWS, developed a habitat-based approach to quantify environmental benefits associated with the various measures considered as part of the restoration alternatives. Other associated separable environmental features were also evaluated during the plan formulation process for this project.

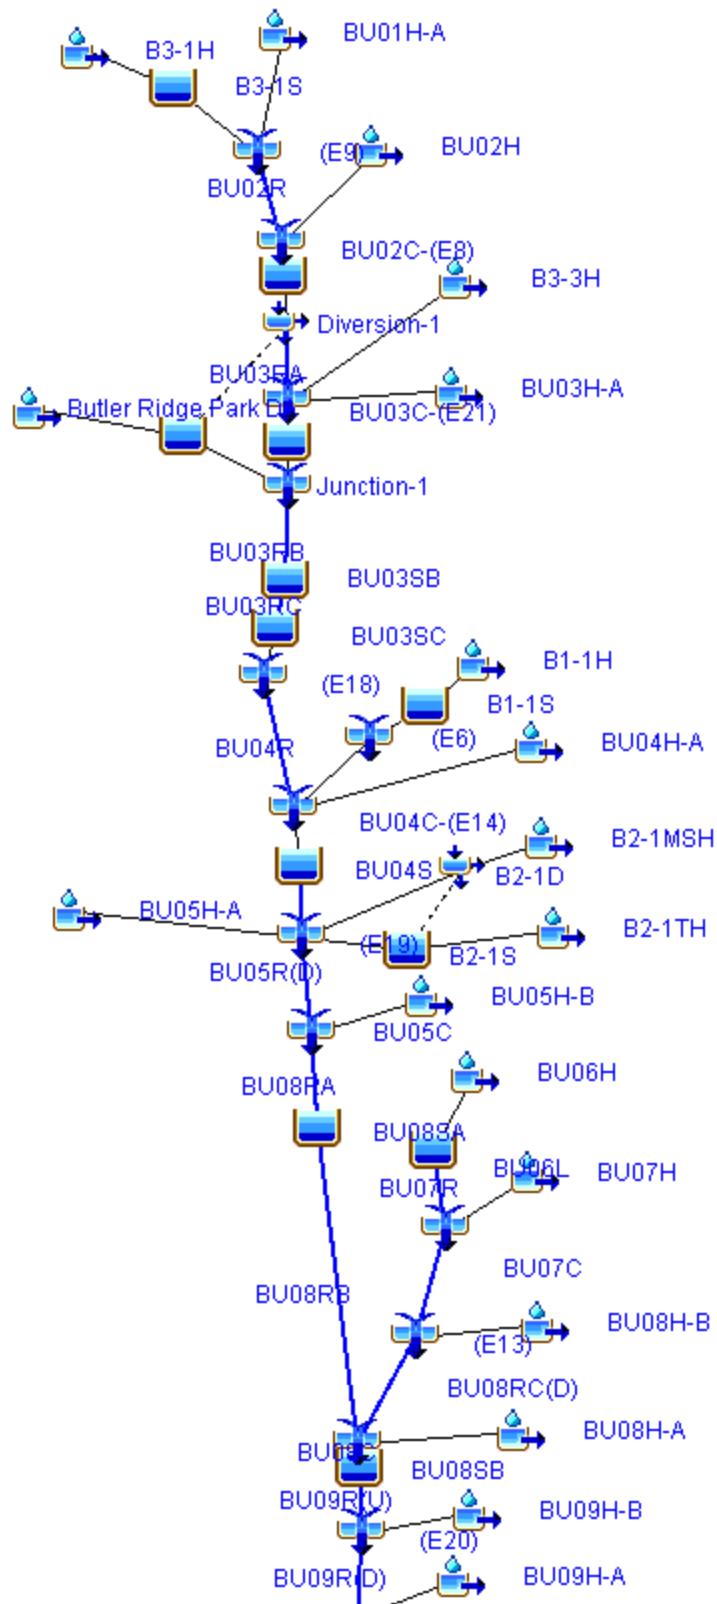
Figure E-1-3 HEC-HMS Schematic (1 of 2)

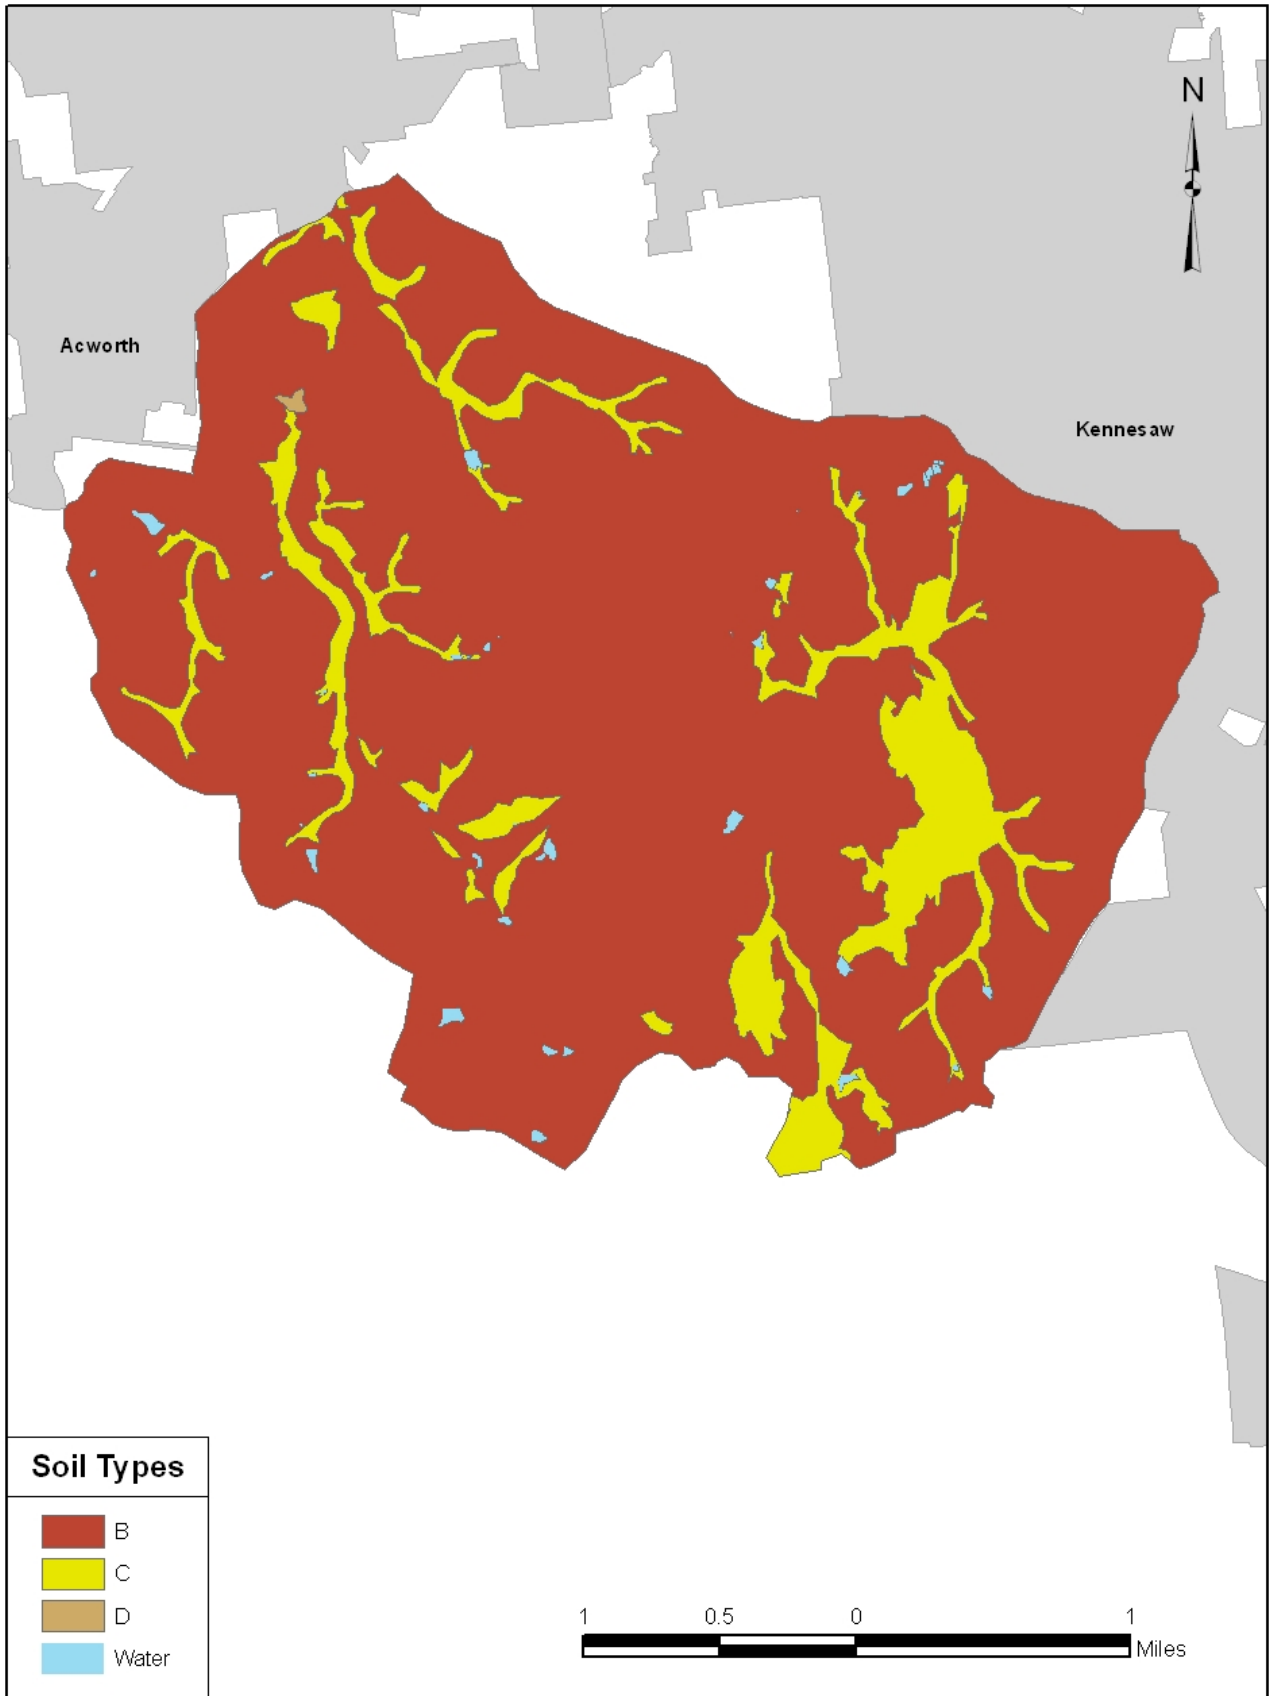
FIGURE E-I-7 Hydrologic Soils Group Map

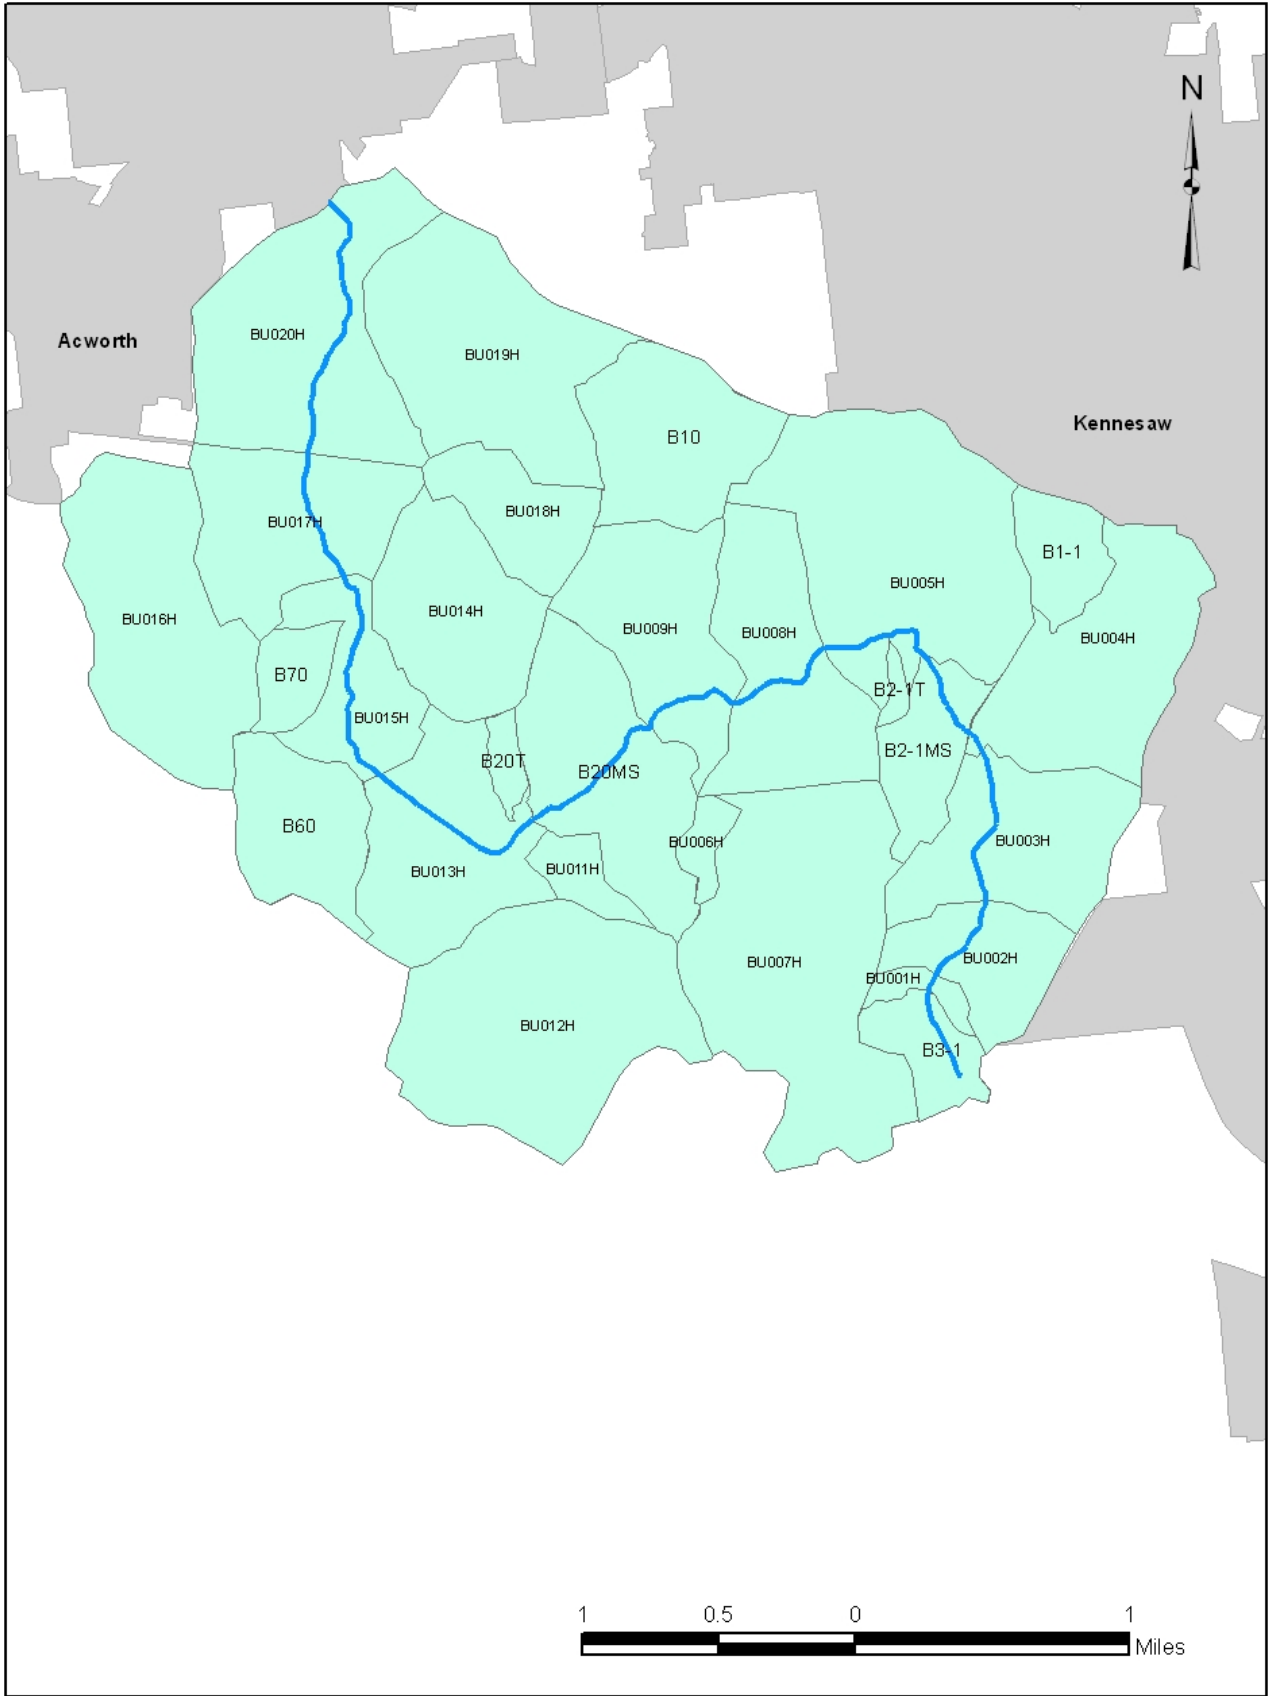
Figure E-I-8 Watershed Subbasins

Geospatial Information System (GIS) layering of the soils and land use data was used to determine the curve number for each subbasin in the study area. A polygon was used for each unique combination of land use and hydrologic soil group, and a curve number was assigned to each polygon. Average curve numbers for each subbasin were developed using area weighting of the curve numbers for each polygon. The area-weighted curve numbers were used in the HEC-HMS model as the basis for the rainfall to runoff conversion. Subbasin delineations are shown in Figure E-I-8.

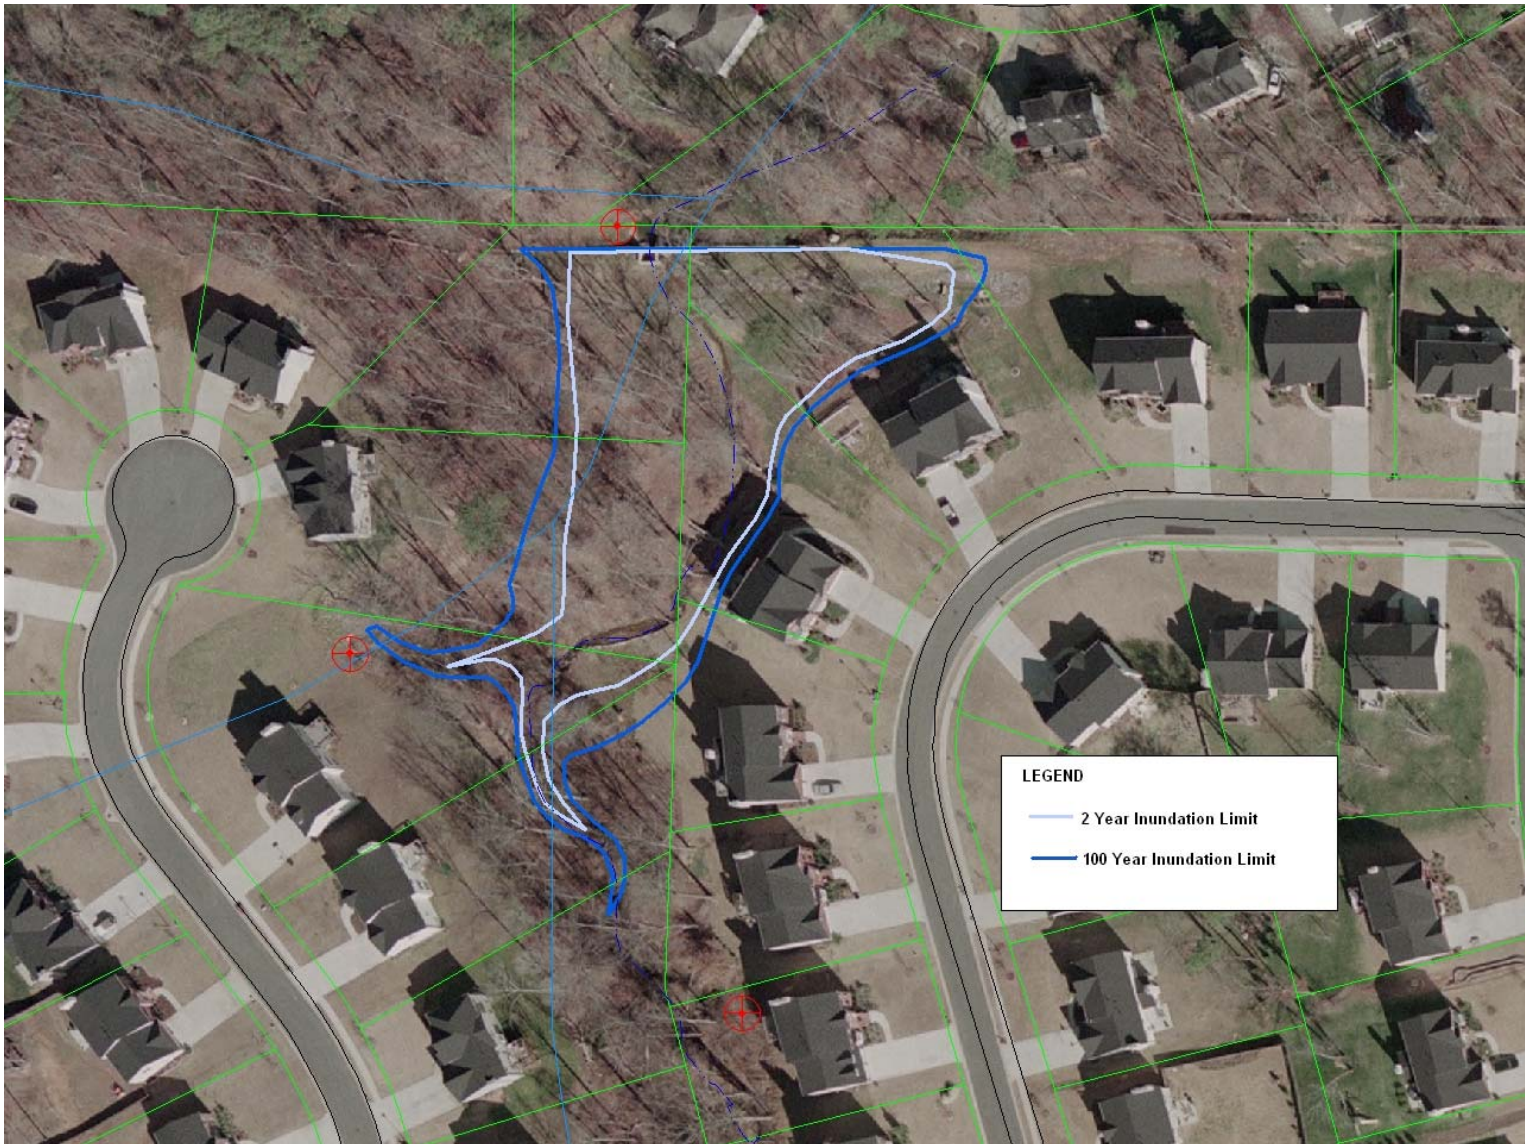
Figure E-III-1 Site B3-1 Inundation Limits

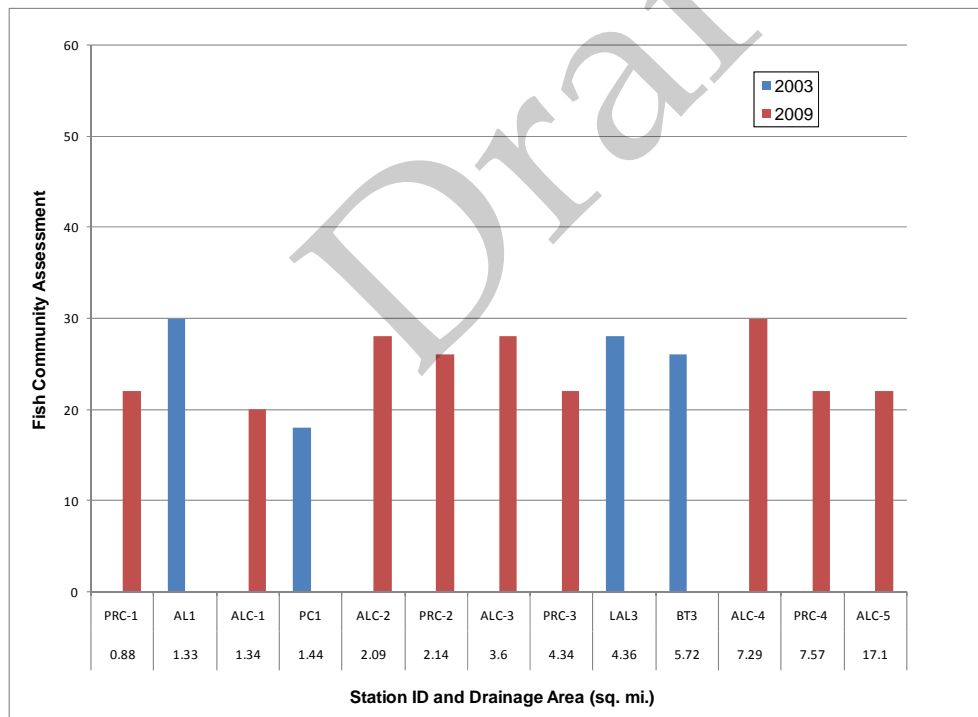
FIGURE 2-13

Figure 2-13 provides the 2003 fish community assessment data for Butler Creek at Jim Owens Road (BT3), as well as results from other Cobb County stations also located in the Coosa River basin (Allatoona Creek at Midway Road [AL1], Little Allatoona Creek at Pitner Road [LAL3], and Proctor Creek at Baker Road [PC1]). Additionally, Figure 2-13 includes results from data collected by CH2M HILL in 2009 in the Allatoona Creek (ALC-1 through ALC-5) and Proctor Creek (PRC-1 through PRC-4) watersheds, as part of other aquatic ecosystem restoration studies. The results are shown in order of increasing drainage area, for comparison of stations of similar size. As shown, fish communities in the Coosa River basin in Cobb County have historically scored at most 30 points, and are categorized as either “poor” (scores 26 through 32) or “very poor” (scores less than 24) according to GADNR qualitative categories (2005). The 2003 score for Butler Creek at Jim Owens Road was comparable to other stations in the Coosa River basin, indicating a degraded fish community.

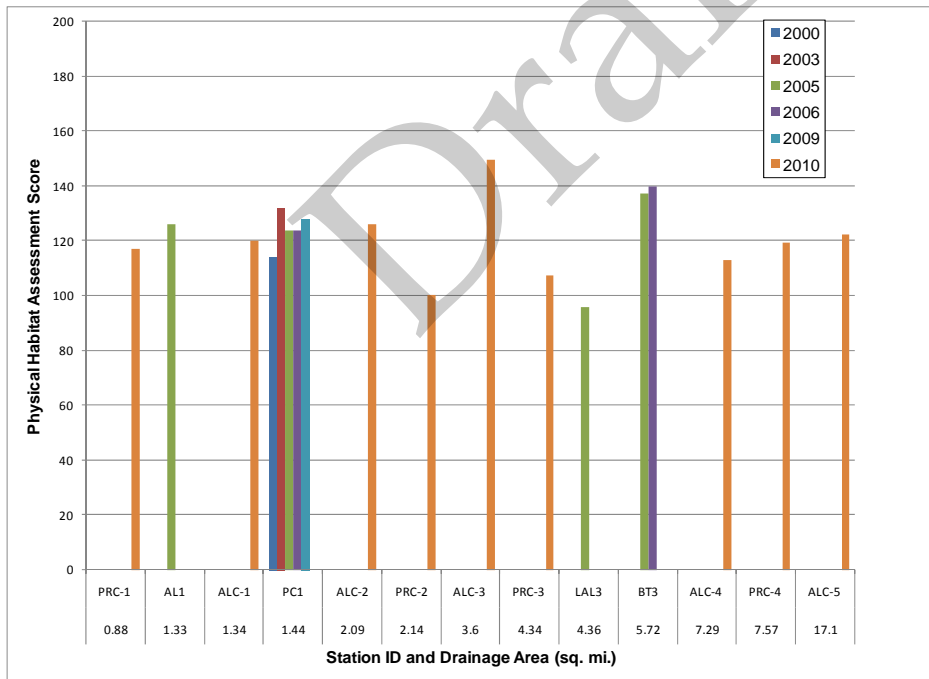
FIGURE 2-15
Physical Habitat Assessment Data in the Coosa River Basin in Cobb County
Butler Creek Watershed Detailed Project Report – Environmental Appendix

As shown in Figure 2-15, physical habitat scores at PC1 and BT3, which were assessed during more than one sampling year, show no major change over time. Additionally, there are no apparent trends based on drainage area. Of the physical habitat assessments conducted, all have scored in the “suboptimal” qualitative category, with the exception of Little Allatoona Creek at Pitner Road (LAL3), which scored in the upper range of the “marginal” category. The habitat assessment score for Butler Creek at Jim Owens Road (BT3) was 138 points in 2005 and 140 points in 2006. In 2001, GADNR measured a physical habitat assessment score of 86.2 at Nance Road on Butler Creek, as part of the TMDL analysis for impacted biota (GAEPD, 2009). It should be noted that physical habitat assessments conducted in 2010 were, on average, lower than most conducted prior, but still primarily in the suboptimal category. While the dataset is not sufficiently robust to establish trends over time, the habitat assessment scores suggest that physical habitat in the basin is currently only somewhat degraded. However, over time, localized areas of excessive erosion and incised channel conditions will likely result in continued degradation.

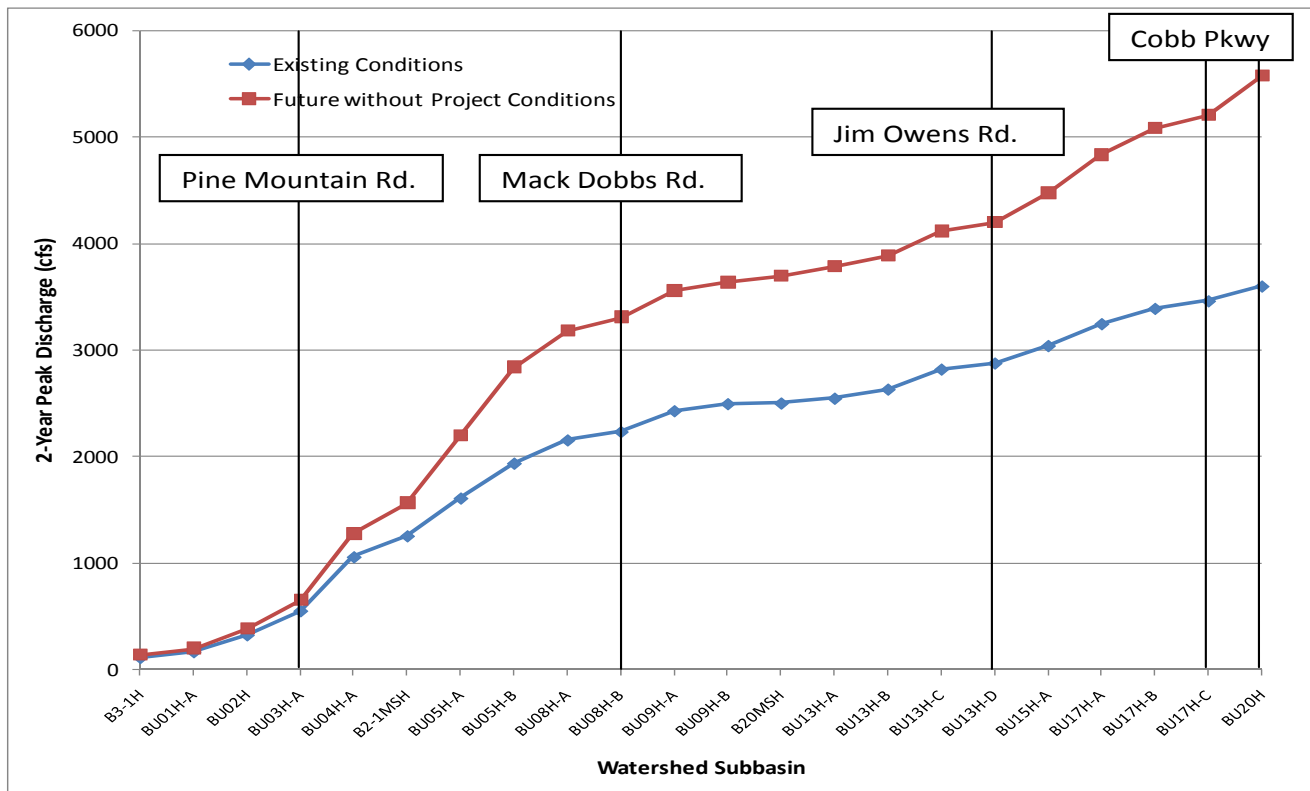
FIGURE 3-1
2-Year Peak Discharge Profile Under Existing and Future without Project Conditions
Butler Creek Watershed Detailed Project Report – Environmental Appendix

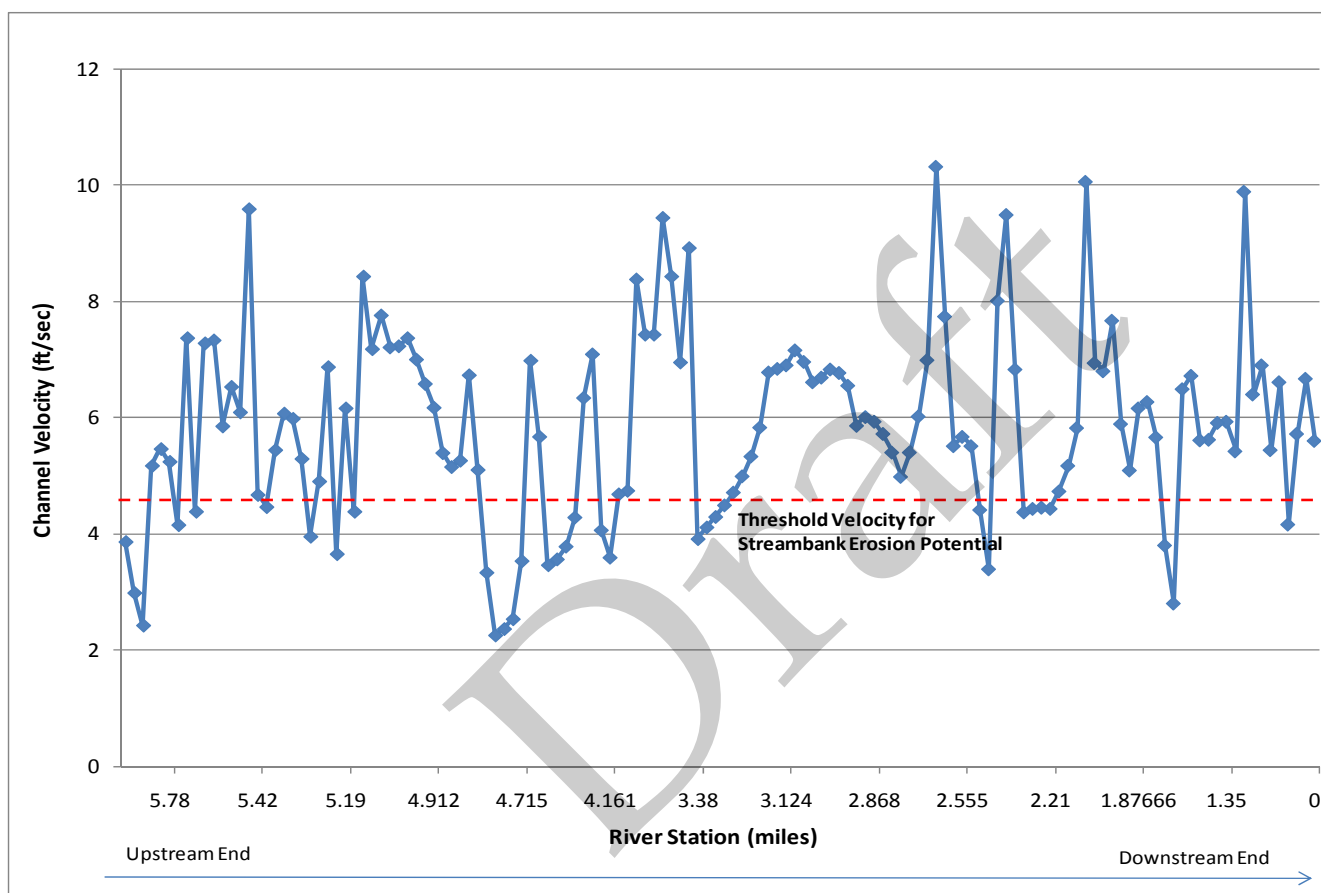
FIGURE 3-2
Velocity Profile Under Future without Project Conditions
Butler Creek Watershed Detailed Project Report – Environmental Appendix

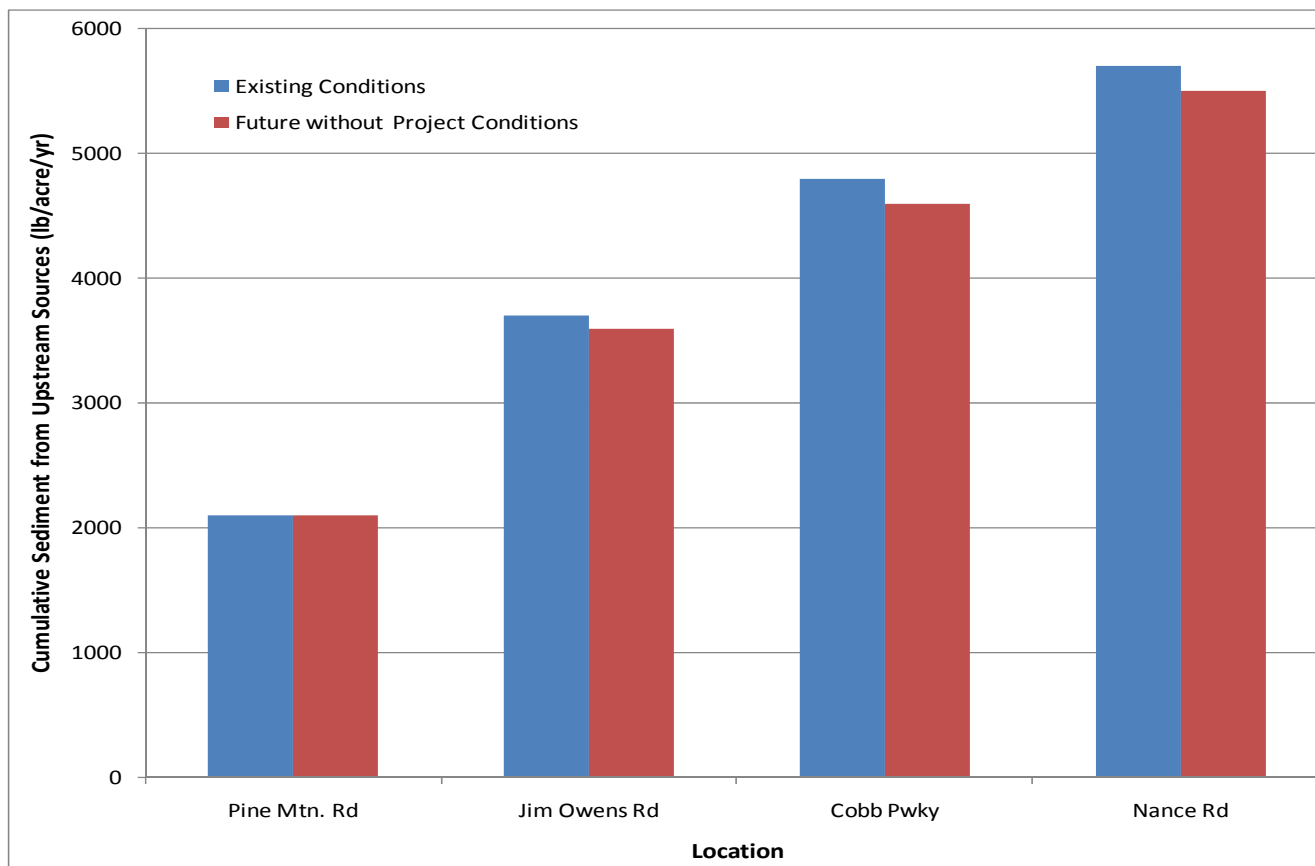
FIGURE 3-3
Sediment Yield Under Existing and Future without Project Conditions
Butler Creek Watershed Detailed Project Report – Environmental Appendix

Sediment delivery was calculated using the Watershed Characterization System (WCS) - Sediment Tool and the default data set for Cobb County provided by the Environmental Protection Agency (EPA). WCS uses the Universal Soil Loss Equation (USLE) to estimate the erosion due to raindrop impact and shallow surface runoff. Based on modeled results for existing and future without project conditions, the amount of sediment generated from the watershed remains roughly consistent with future land use conditions (Figure 3-3). A slight

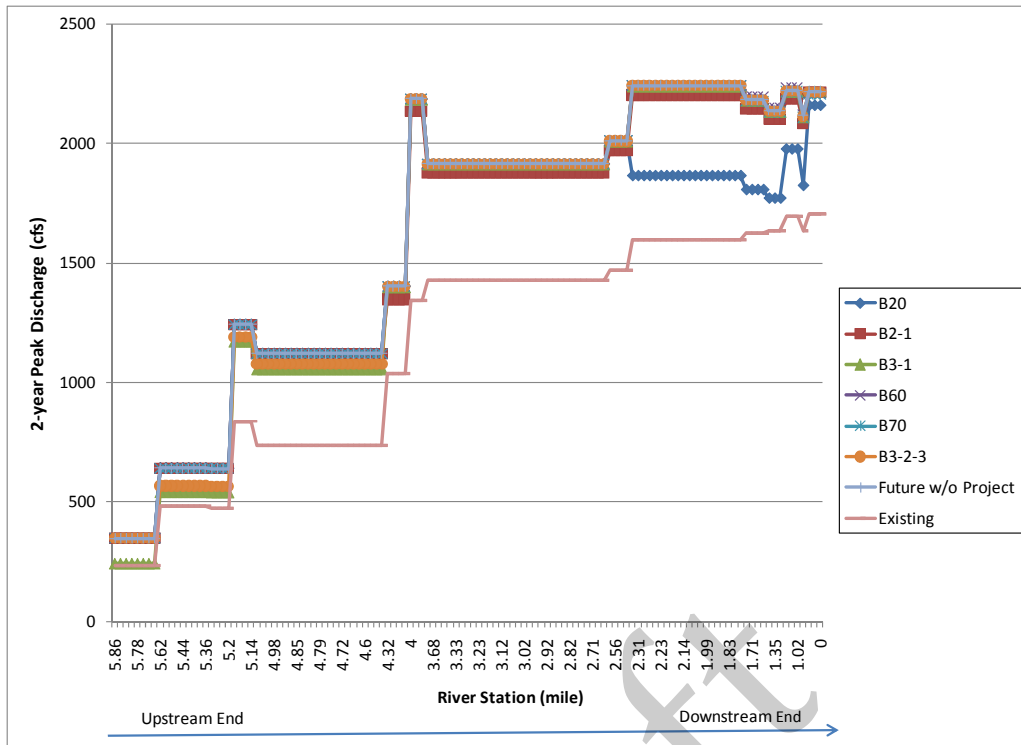
FIGURE 6-1
2-Year Peak Discharge Profile Under Future without Project and Future with Project Conditions
Butler Creek Watershed Detailed Project Report – Environmental Appendix

The future with project HEC-RAS model was developed by altering the future without project HEC-2 model with cross sections from the 2004 stream assessment in the vicinity of the proposed flow attenuation alternative sites, in order to improve characterization of existing flow conditions and to facilitate further modification for the with-project model. Overbank geometry was obtained graphically from the 2 foot contour interval topographic map of Cobb County. Channel geometry at these new cross sections was developed using judgment in consideration of local channel geometry and reach-scale channel slope. Cross-section interpolation schemes were also adopted in order to improve the accuracy of the hydraulic solution routines. Modeled channel velocity, under future without project and future with project results are shown in Figure 6-2. Similar to peak discharge results, modeled channel velocity does not show a significant variation from future with project conditions and is used only as a comparison between alternatives. Also similar to peak discharge results, Alternatives B20 and B3-1 are shown to have the greatest impact of channel velocity reduction in their respective areas of the watershed.

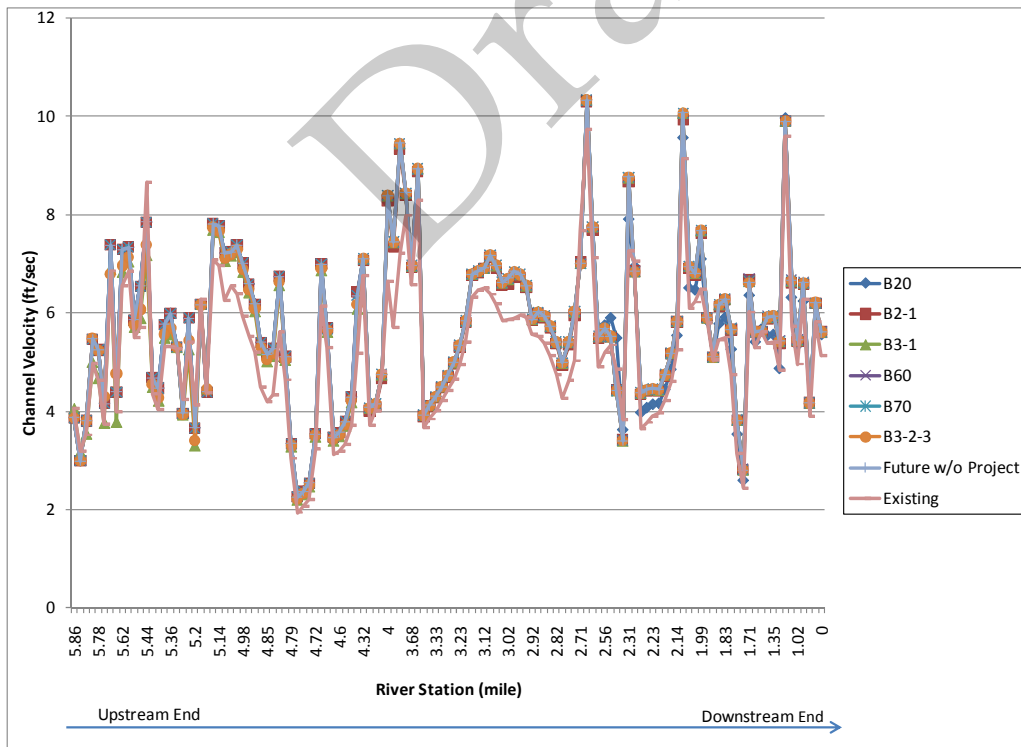
FIGURE 6-2
Velocity Profile Under Future without Project and Future with Project Conditions
Butler Creek Watershed Detailed Project Report – Environmental Appendix

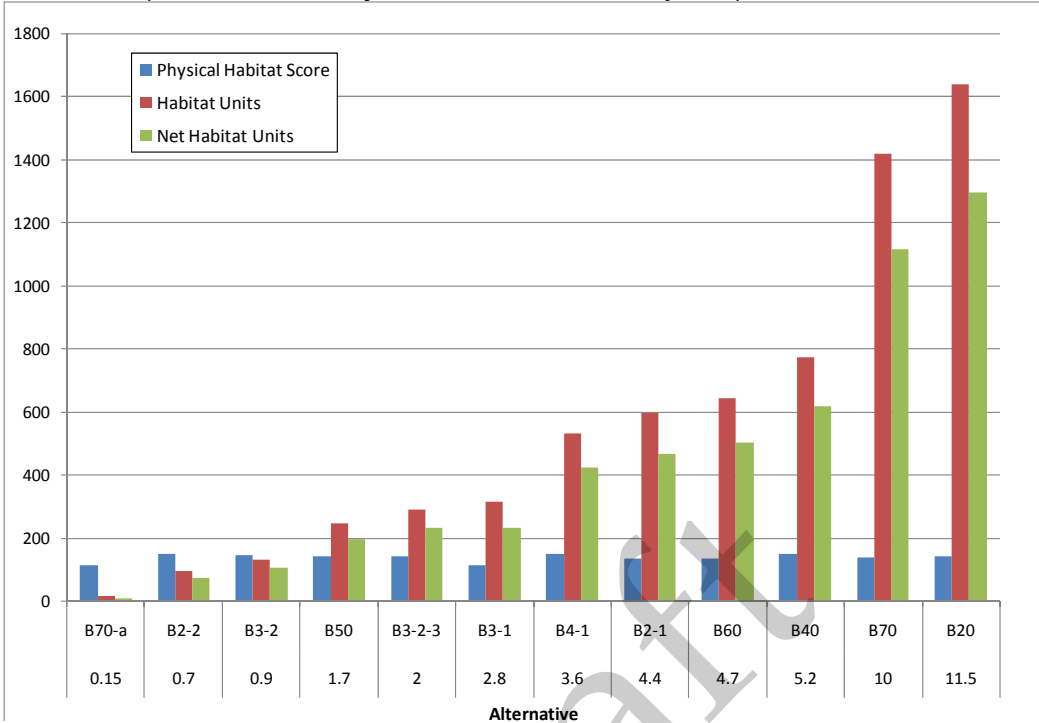
FIGURE 6-3
Predicted Physical Habitat Score and Habitat Units (Future with-Project Conditions) and Net Habitat Units
Butler Creek Aquatic Watershed Ecosystem Restoration Detailed Project Report

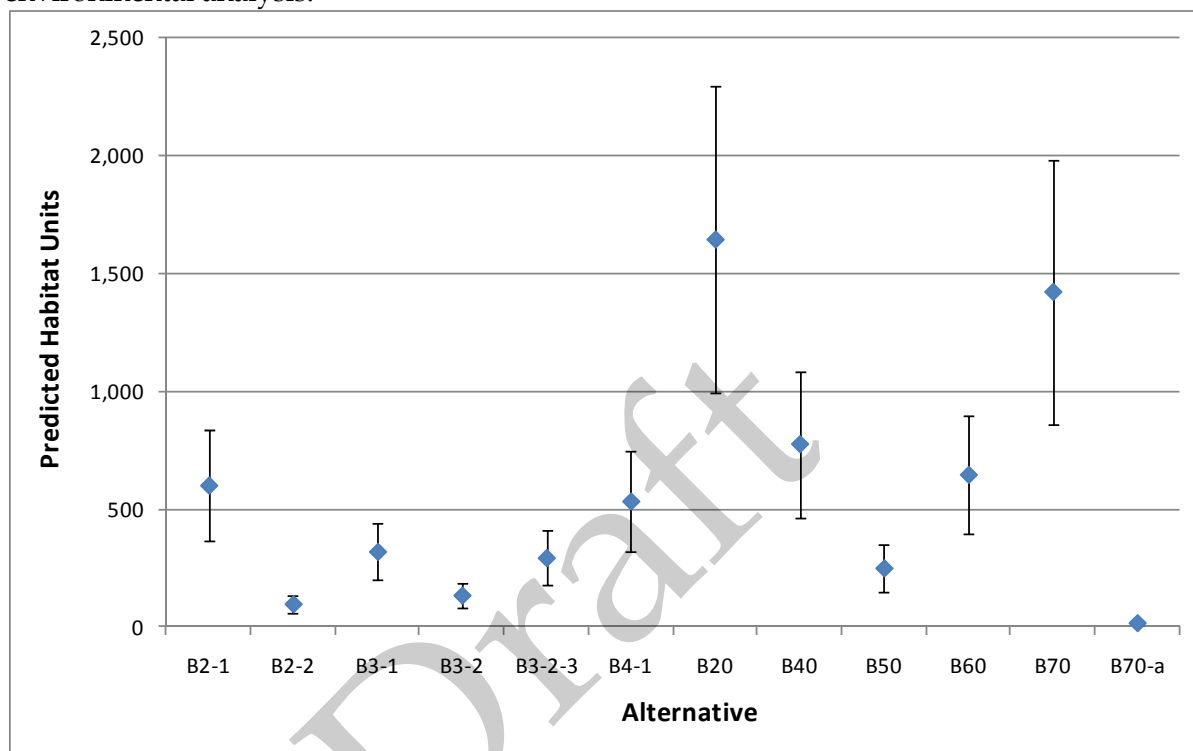
FIGURE 7-1
Range of Uncertainty Analysis in the Prediction of Habitat Units
Butler Creek Watershed Detailed Project Report – Environmental Appendix

with unique future without project conditions habitat units scores based on habitat assessment score and contributing watershed area determined for each alternative. Variability in projected benefits for each of the alternatives is similar in terms of percent deviation from the predicted values. Therefore, overall variability increases as predicted benefits increase. Figure 7-1 represents the range of the risk of uncertainty that can be expected for projected future habitat units scores for each alternative selected for further environmental analysis.

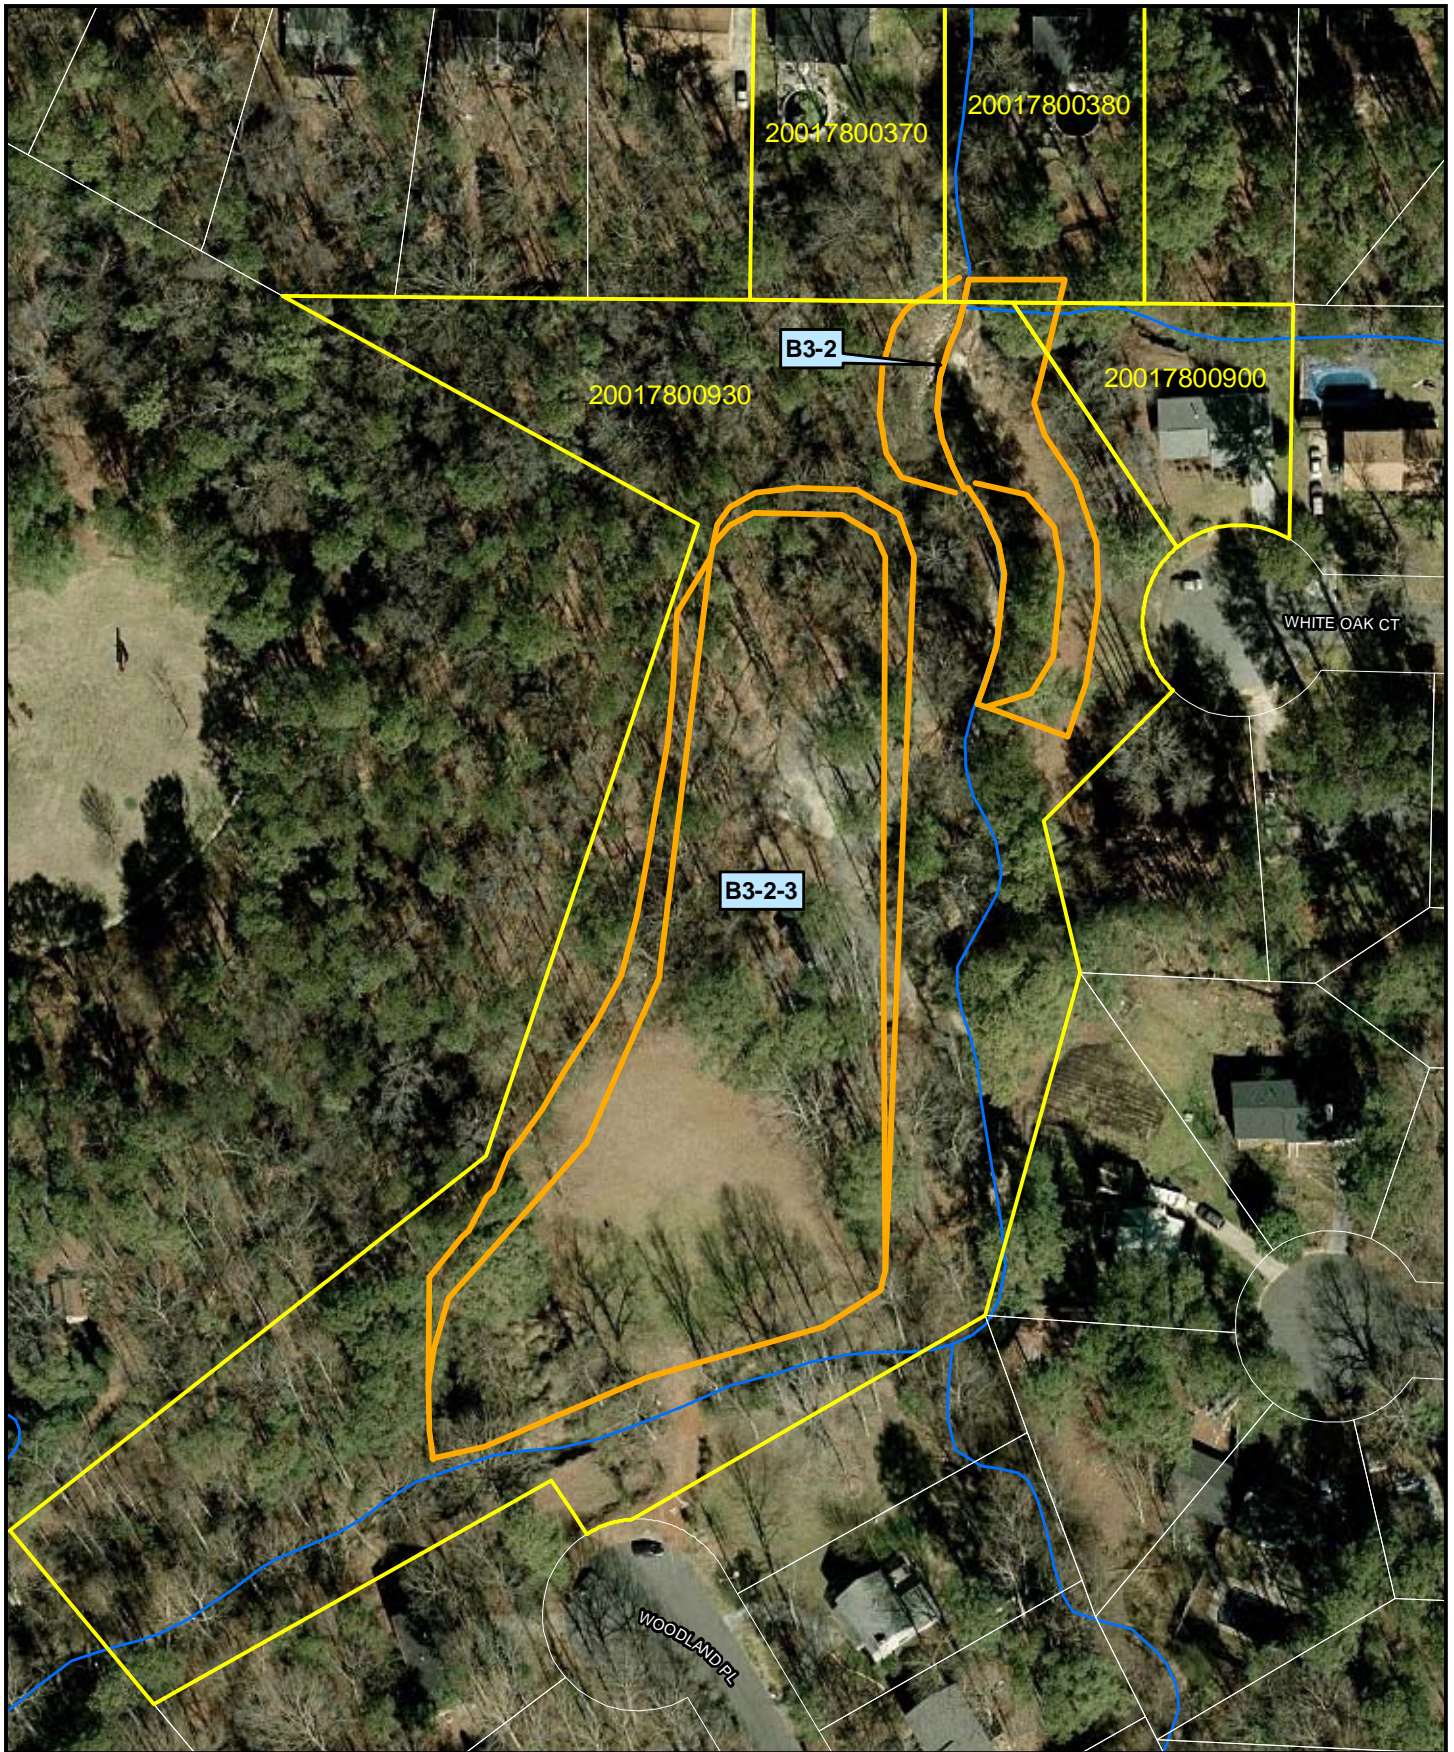
FIGURE 2-4
 Alternative B3-2 and B3-2-3
Butler Creek Phase 1 ESA

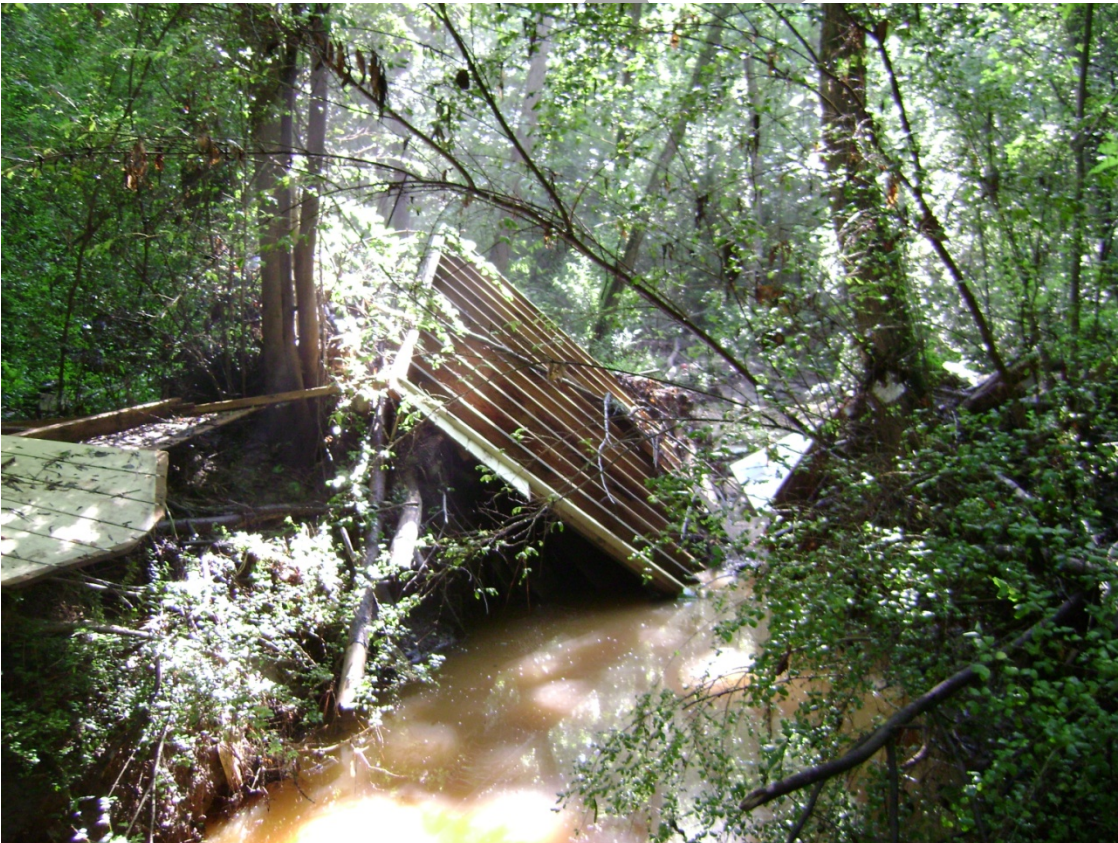
Photograph 18 - Destroyed shed found at Alternative B2-1

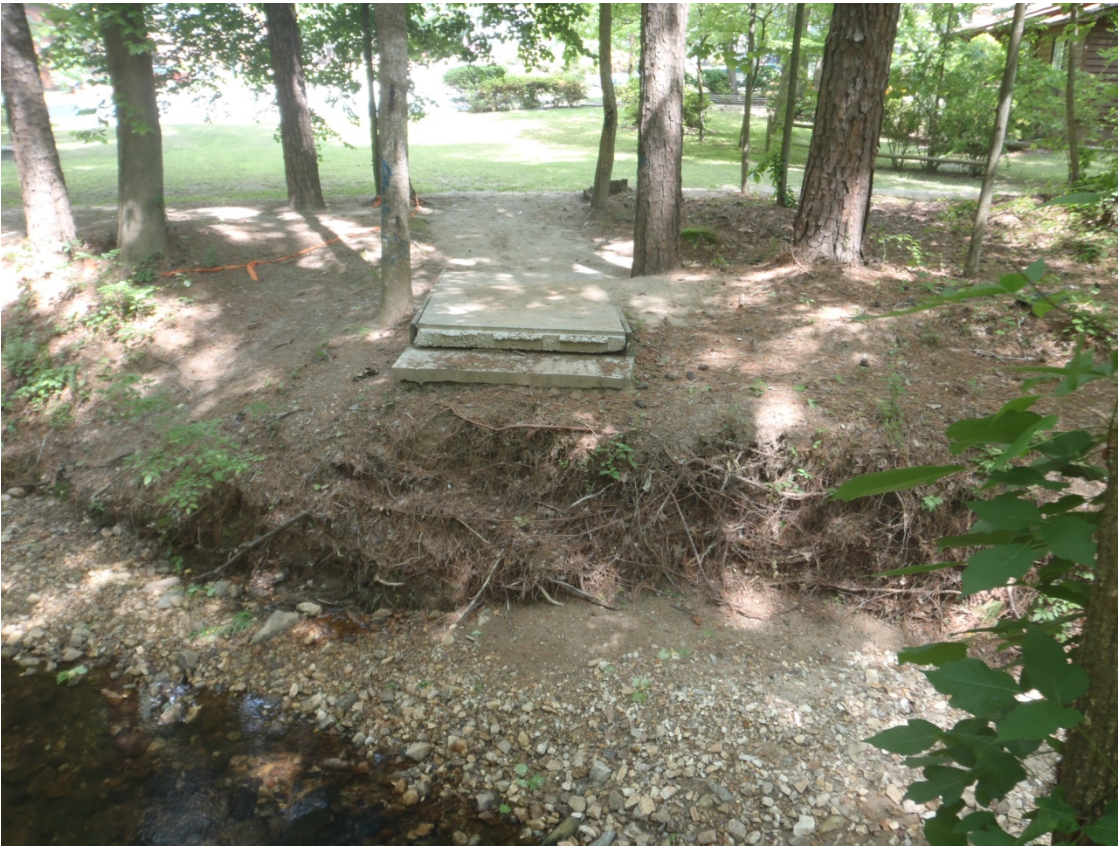
Photograph 19 - Collapsed footbridge at Alternative B3-2

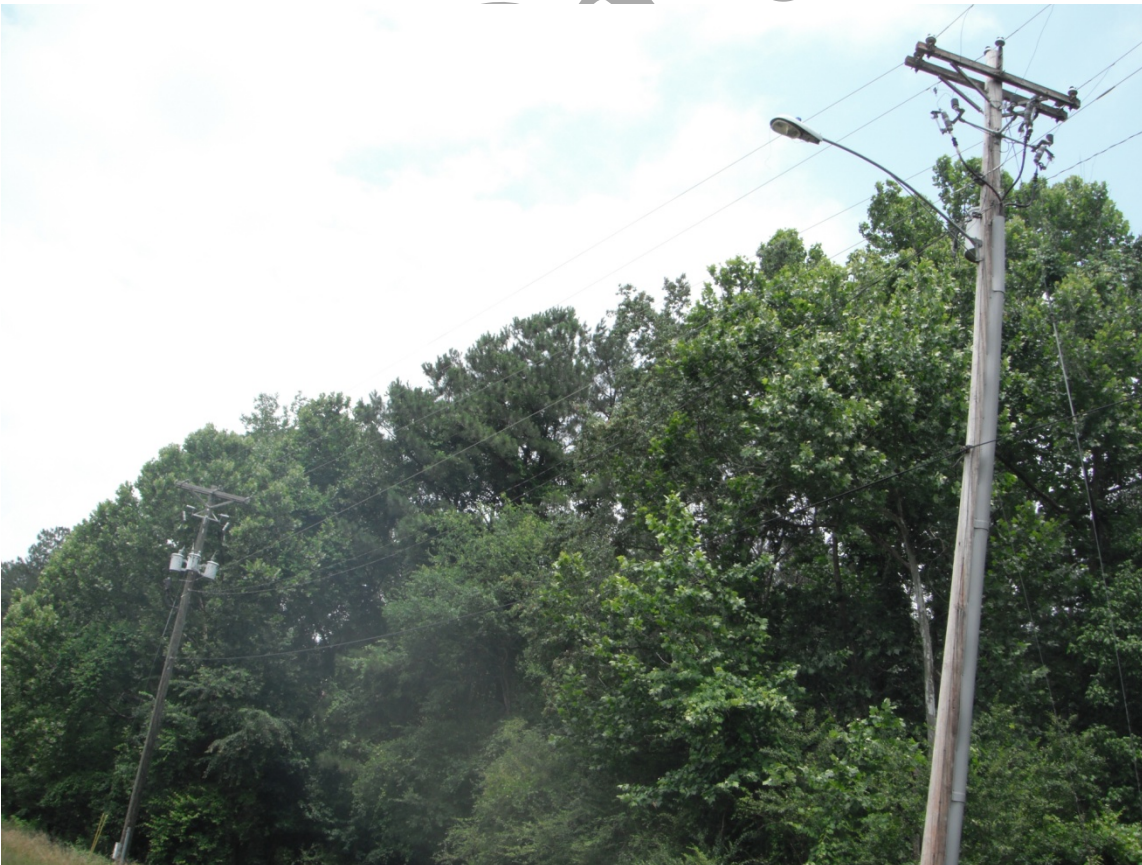
Photograph 26 - Transformers observed at Alternative B70
