*Flat Creek Watershed
Aquatic Ecosystem Restoration
Detailed Project Report*

Environmental Appendix

**US Army Corps
of Engineers**
Mobile District

June 2011

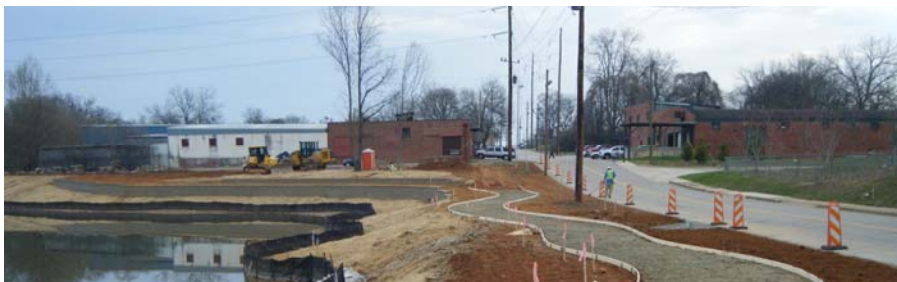
Regional stormwater detention facility adjacent to stream restoration partially funded by a 319(h) grant in the headwaters part of Flat Creek.

Upon receipt of funding from a 319(h) grant administered through the GA EPD, the City of Gainesville restored 500 feet of degraded stream channel and regional stormwater detention facility in an upstream part of the Flat Creek watershed east of Queen City Parkway. The design used a natural channel design or reference reach approach in which the pattern, dimension, and profile were developed based on a stable stream channel with similar characteristics. The stream channel was enhanced with in-stream structures, such as cross-vanes and log sills, and a robust planting plan that will control exotic species and reintroduce native vegetation to the area. The regional stormwater detention facility provided substantial hydrologic benefits for a heavily urbanized watershed through offline stormwater treatment and attenuation of peak storm flows. The regional detention facility was integrated with a diversion structure to convey the “first flush” of stormwater runoff to the detention facility.

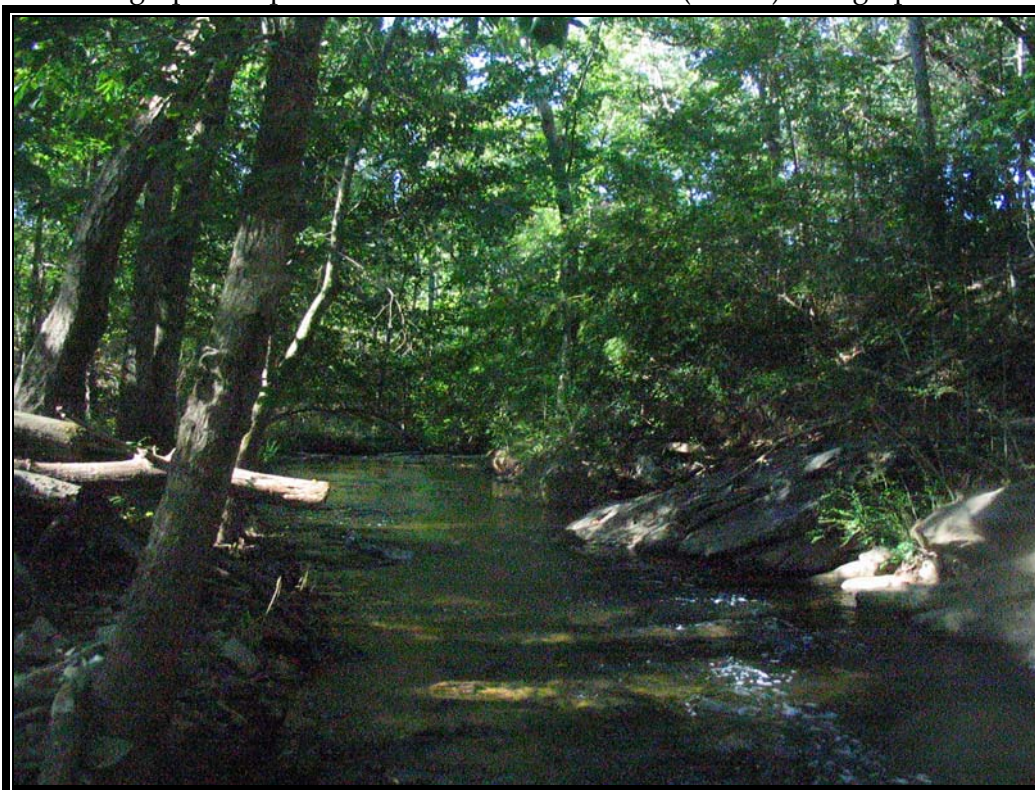
Photograph 1 Representative view of Flat Creek (FLG-5) facing upstream

Photograph 2 Representative view of Flat Creek (FLG-5) facing downstream

Station FLG-5, the most downstream station, was located upstream of McEver Road. This station was selected for long-term monitoring to represent a relatively large drainage area with high-density residential land use and to monitor water quality downstream of the WRF discharge. Station FLG-5 received the highest physical habitat rating of the Flat Creek stations during the 2007 biological monitoring. The reach was dominated by gravel and cobble, and also contains bedrock and boulders, providing excellent epifaunal substrate and cover for benthic macroinvertebrates and fish. The layering of the substrate provides a diversity of habitat and also results in the presence of a wide variety of velocity/depth regimes. Both riffle and pool habitats were optimal in this reach. The banks were only slightly eroded and were covered, almost entirely, by native vegetation. Both riparian areas were minimally impacted, with small breaks on the right bank resulting from power line clearing.

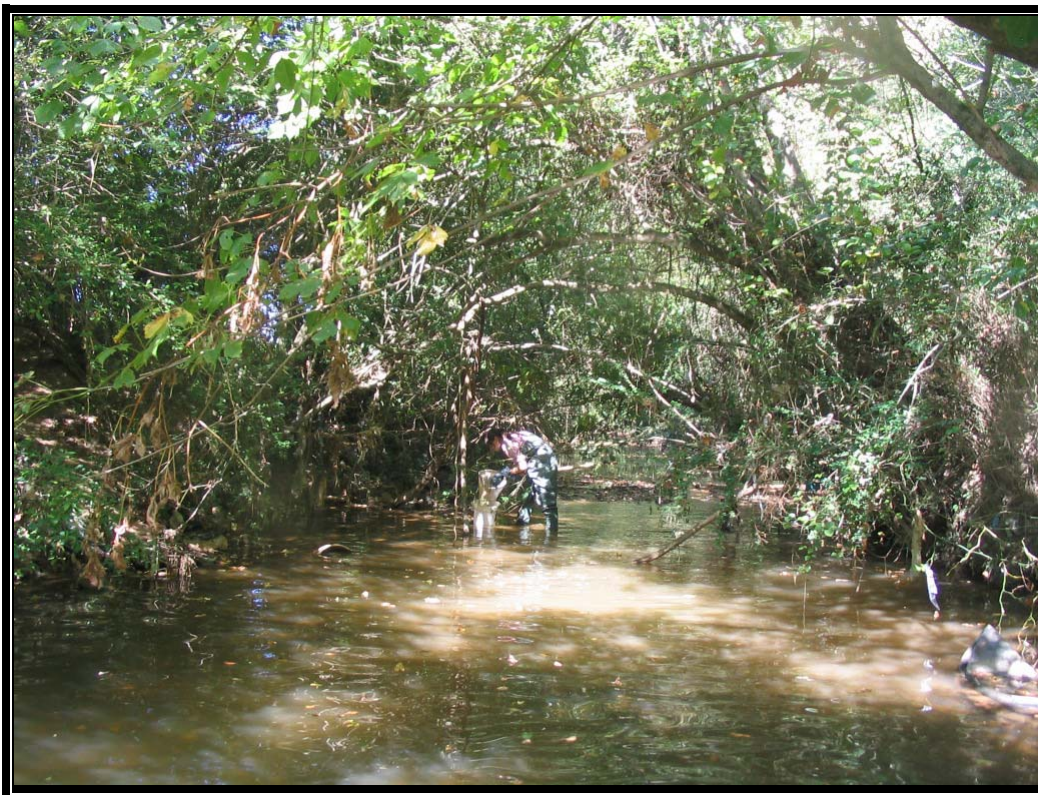
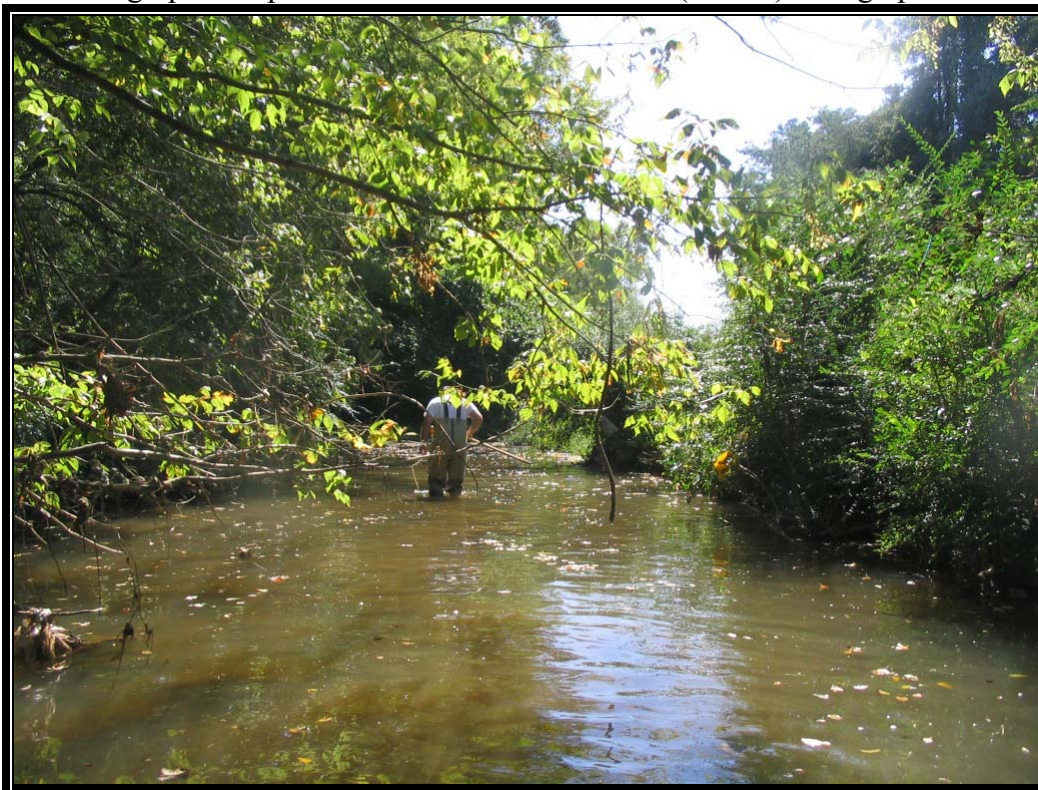
Photograph 3 Representative view of Flat Creek (FLG-4) facing upstream

Photograph 4 Representative view of Flat Creek (FLG-4) facing downstream

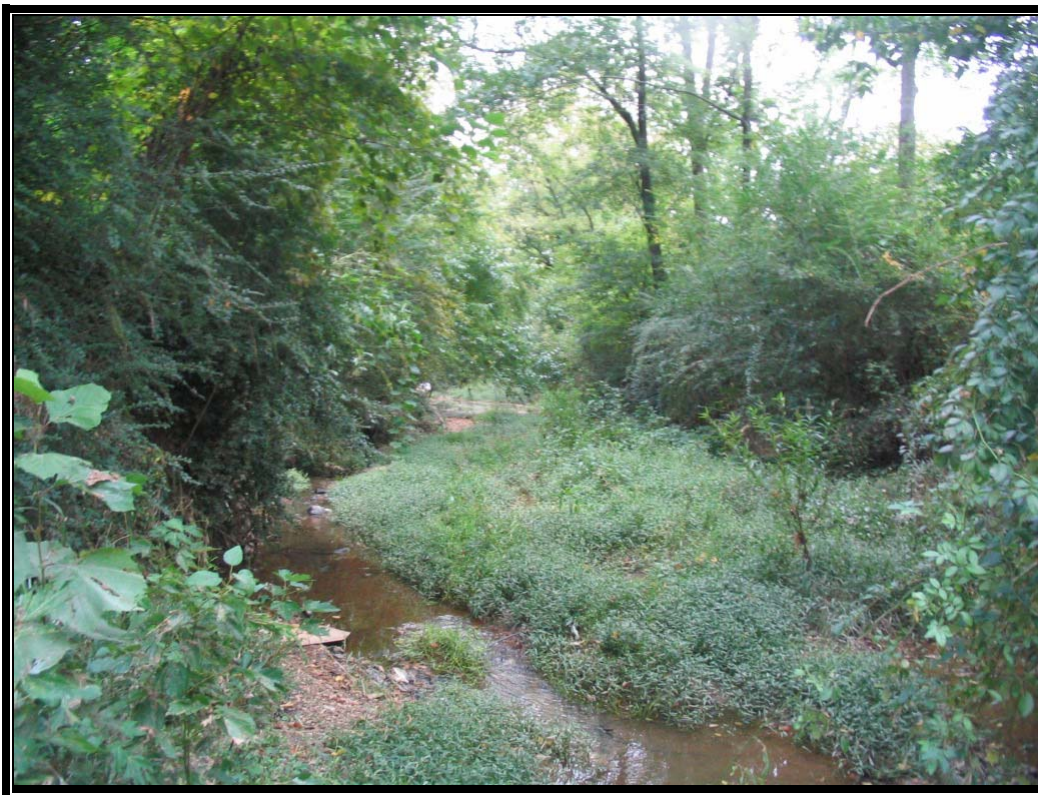
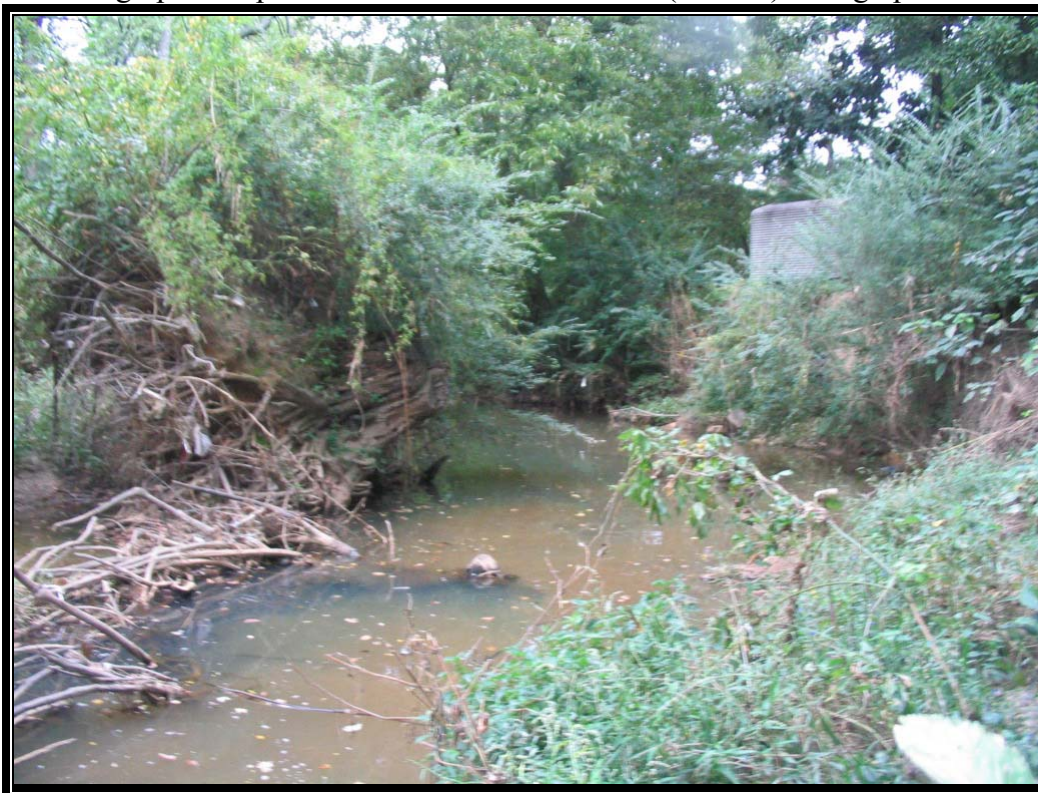
Photograph 5 Representative view of Flat Creek (FLG-A) facing upstream

Photograph 6 Representative view of Flat Creek (FLG-A) facing downstream

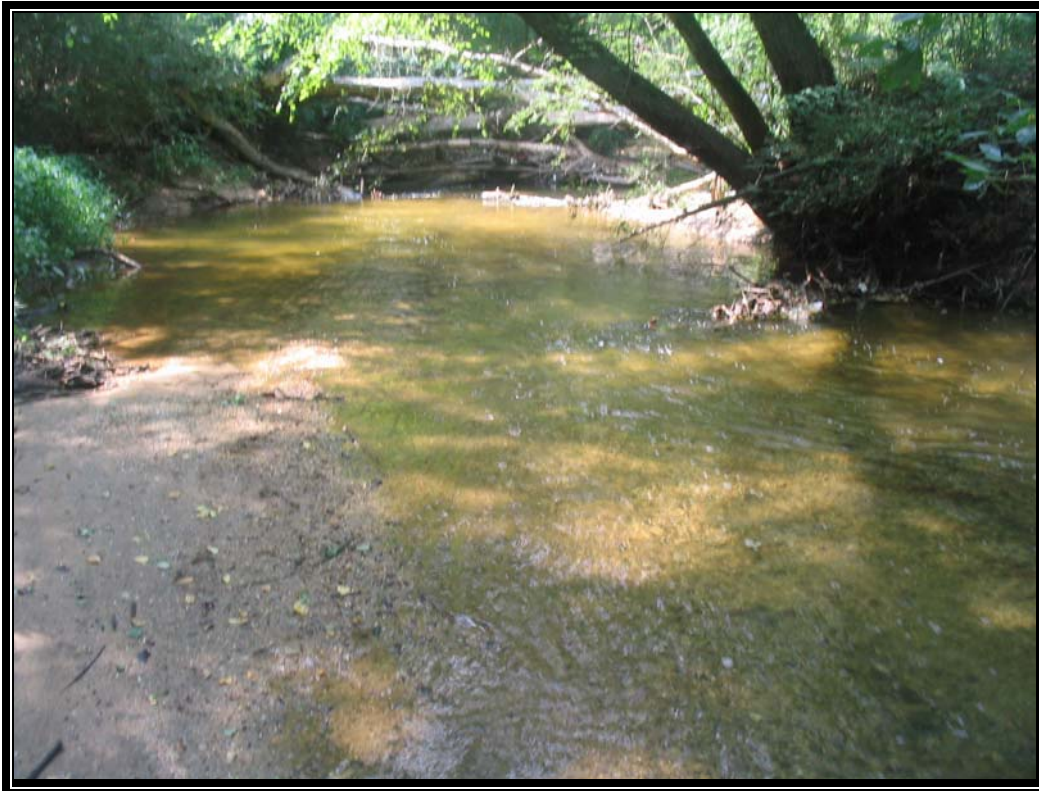
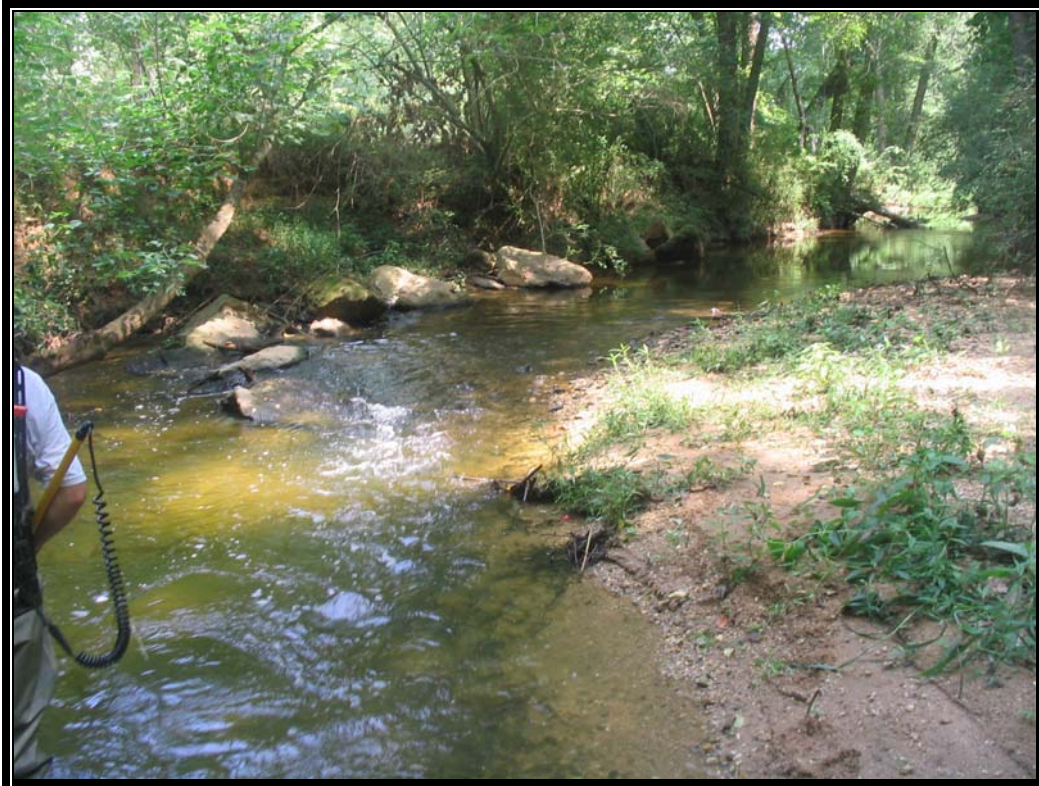
Photograph 7 Representative view of Flat Creek (FLG-B) facing upstream

Photograph 8 Representative view of Flat Creek (FLG-B) facing downstream

Station FLG-B was located approximately 400 feet downstream of Old Flowery Branch Road. It was selected according to the random sampling guidelines, in accordance with the ERM guidance document (NGWRA, 2007), and was located in an area with commercial and high-density residential land use. This station was the most first station downstream of the Flat Creek WRF, which discharges to Flat Creek. In the past, effluent from the WRF was found to contribute to high levels of specific conductance in Flat Creek downstream of the plant, which may affect aquatic communities in this reach. The City was aware of these water quality conditions and continues to monitor plant effluent and submit discharge monitoring reports to EPD. The City, like many of its municipal neighbors, was in the process of identifying ways to reduce the impact of its effluent and was focusing efforts on optimizing plant operations and maintenance.

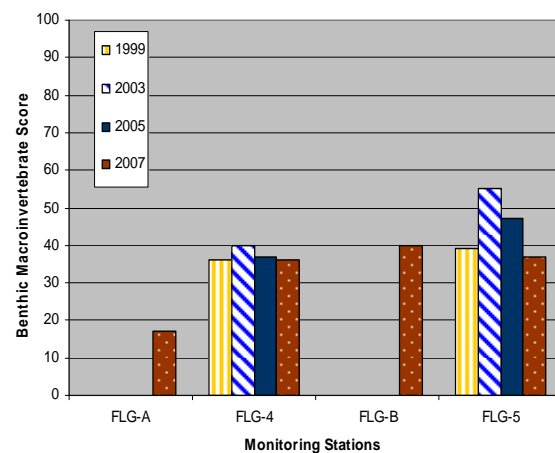
FIGURE 3-6
Historical Benthic Macroinvertebrate Scores
Flat Creek Watershed Detailed Project Report – Environmental Appendix

Benthic macroinvertebrate scores in the lower range of possible values indicate that the benthic macroinvertebrate habitat has been affected in Flat Creek. The score at the most upstream station (17 of a possible 100 points) suggests significantly degraded conditions and poor water quality. Similar to trends observed in fish communities, station FLG-4 has shown a flat trend over time, but scores at station FLG-5 have generally decreased over time.

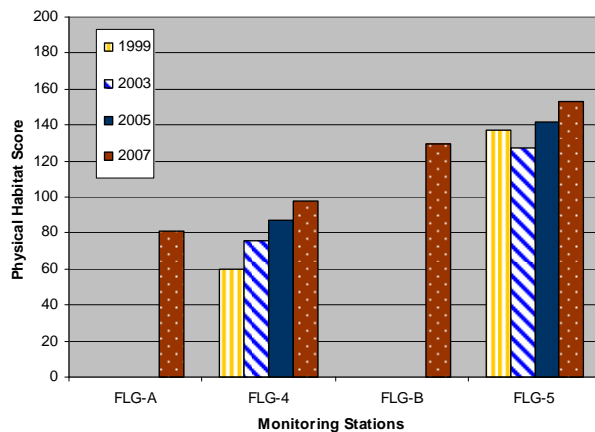
FIGURE 3-7
 Historical Physical Habitat Scores
Flat Creek Watershed Detailed Project Report – Environmental Appendix

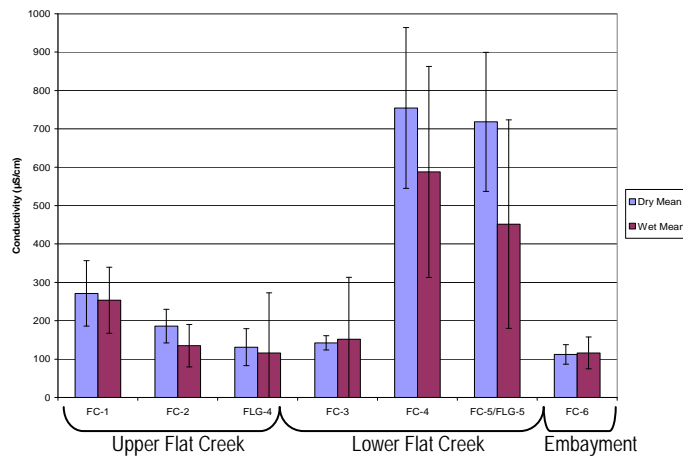
FIGURE 3-8
Mean Specific Conductance and Standard Deviation during Wet and Dry Weather (Jan. 2005—Jun. 2007)
Flat Creek Watershed Detailed Project Report – Environmental Appendix

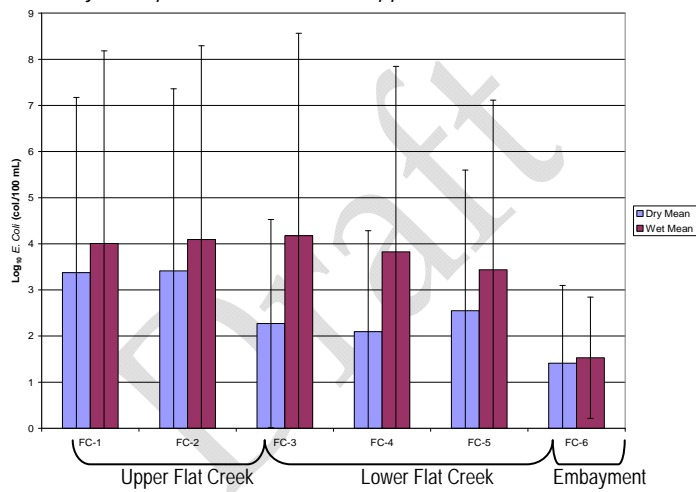
FIGURE 3-13

Log₁₀ of Mean *E. Coli* and Standard Deviation during Wet and Dry Weather (Jan. 2005—Jun. 2007)
Flat Creek Watershed Detailed Project Report – Environmental Appendix

Figures 3-12 and 3-13 present the logarithmically transformed mean concentrations of fecal coliform and *E. coli* data, respectively, at stations in the Flat Creek watershed and demonstrate trends similar to those of the TSS and turbidity values. Note that *E. coli* data were not collected at station FLG-4 during the reporting period. Compared to dry weather means, high (and variable) levels of fecal coliform and *E. coli* were seen during rain events. The likely sources were leaking or malfunctioning sewer or septic systems, illicit discharges, domestic animals, and/or wildlife such as ducks and geese.

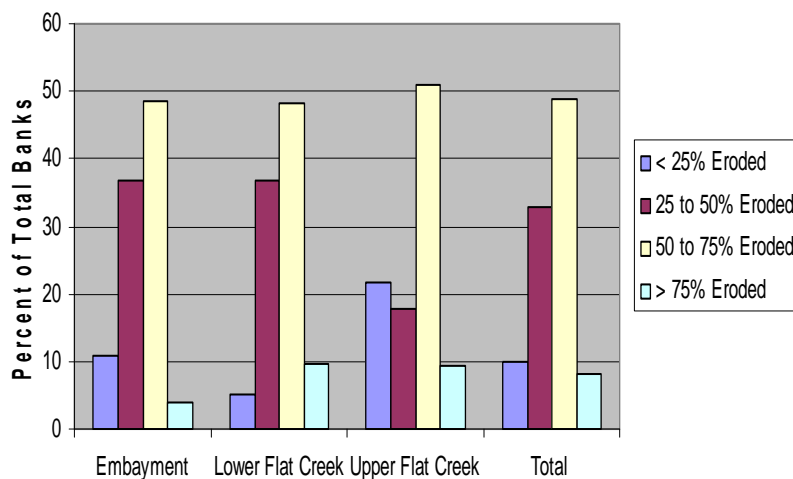
FIGURE 3-17
Percent of Bank Erosion
Flat Creek Watershed Detailed Project Report – Environmental Appendix

Subwatershed	Percent of Bank Erosion			
	Less than 25	25-50	50-75	75-100
Embayment	10.9	36.7	48.4	3.9
Lower Flat Creek	5.2	36.8	48.3	9.7
Upper Flat Creek	21.7	17.9	50.9	9.4
Totals	10.0%	33.0%	48.9%	8.2%
