# BLACK WARRIOR/TOMBIGBEE RIVER: DEMOPOLIS LOCK – UPPER MITER SILL FAILURE – 27 FEB 2024

# BLACK WARRIOR/TOMBIGBEE RIVER: DEMOPOLIS LOCK – UPPER MITER SILL FAILURE – 20 JAN 2024

# BLACK WARRIOR/TOMBIGBEE RIVER: DEMOPOLIS LOCK – UPPER MITER SILL FAILURE - 19 JAN 2024

# BLACK WARRIOR/TOMBIGBEE RIVER: DEMOPOLIS LOCK – UPPER MITER SILL FAILURE - 16 JAN 2024

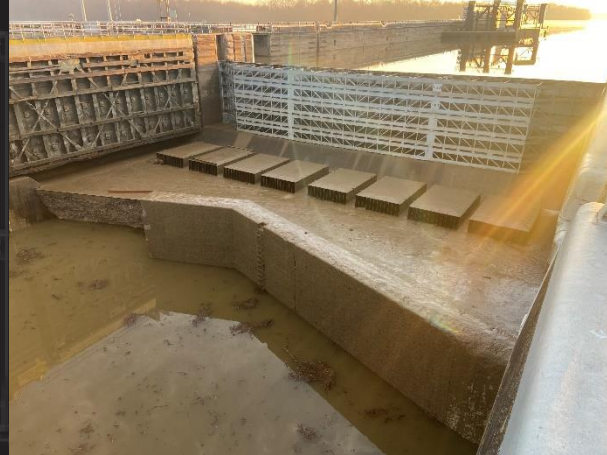
Damaged Sill

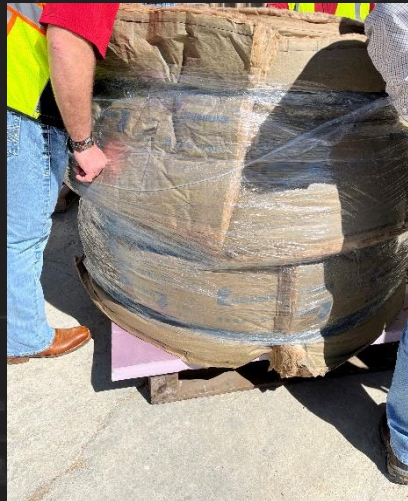
Engineering has been working with contractors on analyzing test results and admixture optimization to provide the best solution for the concrete pours.

Concrete Testing at Batch Plant

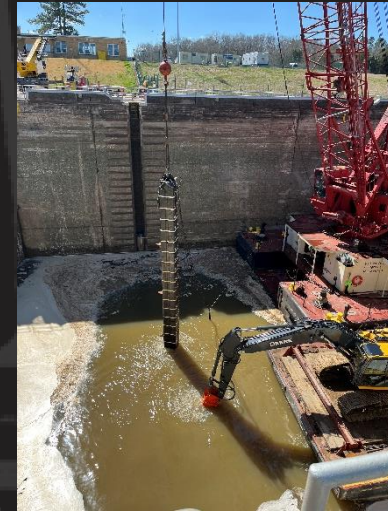
Debris removal in the lock chamber continues. A contract mod was awarded for the acquisition of a high-capacity crane to lift large pieces of debris that are expected to be in the way of formwork bracing. This crane is expected to arrive Thursday, February 29<sup>th</sup>.

Dive teams have been utilized to help assess the weight and shape of the debris, as well as develop plans to lift and remove it from the chamber.

Continued Debris Removal

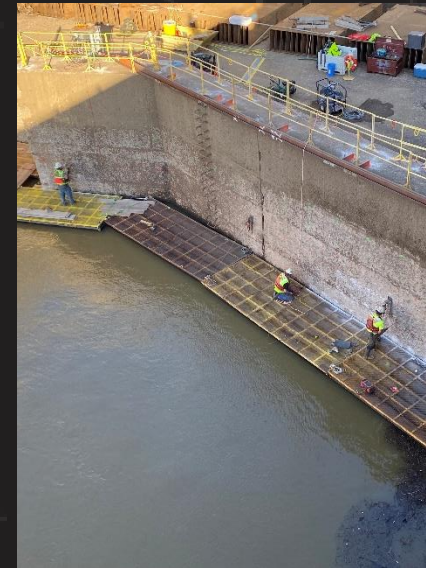
Contractors began drilling into existing sill for dowel placement on the new pours.

Dowel Location Drilling

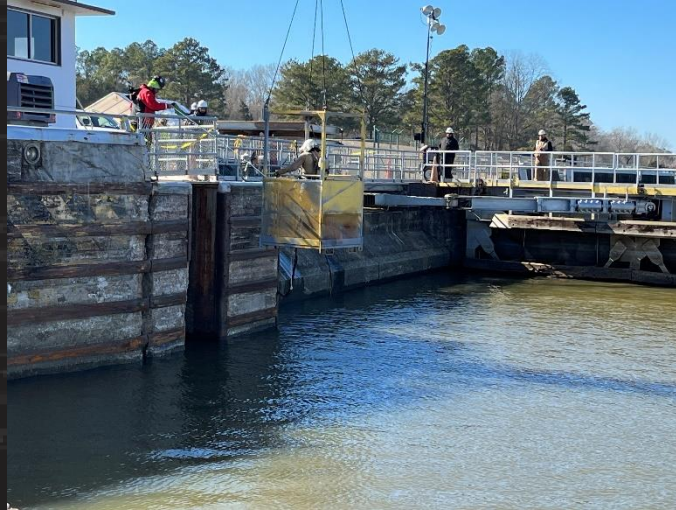
At 1300, the dive team inspected the stoplog slot. No issues were found.

Diver Inspecting  
Stoplog Slot

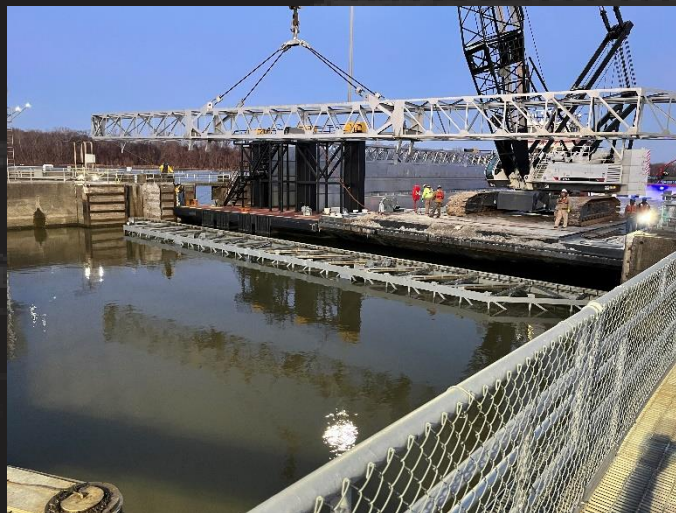
At 1330, TVA began setting 5 stoplogs (1 heavy, 2 regular BWT, 2 regular TTWW). Last stoplog was set at 1700.

Setting Stoplogs

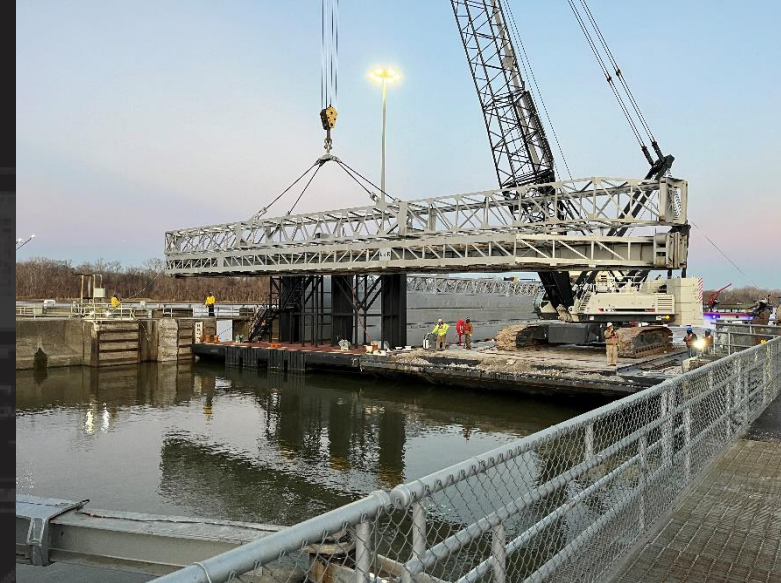
Last Stoplog  
Set

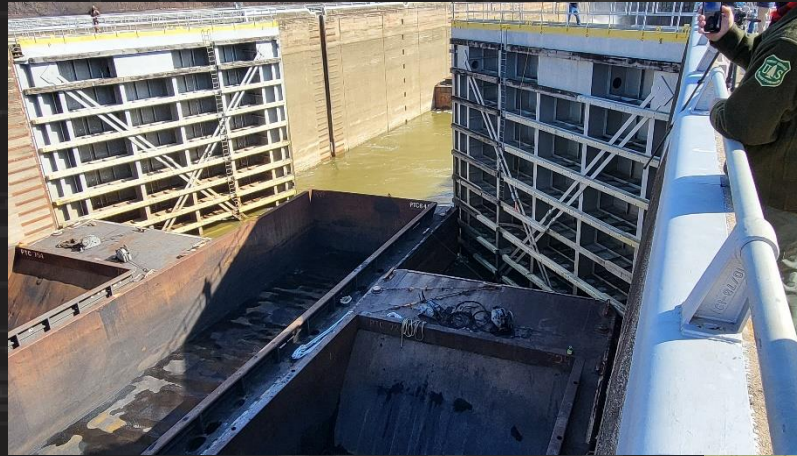
The lock chamber was filled and the head on the upper gates were equalized stopping the uncontrolled flow by 1220.

Lower Miter Gates  
Closed

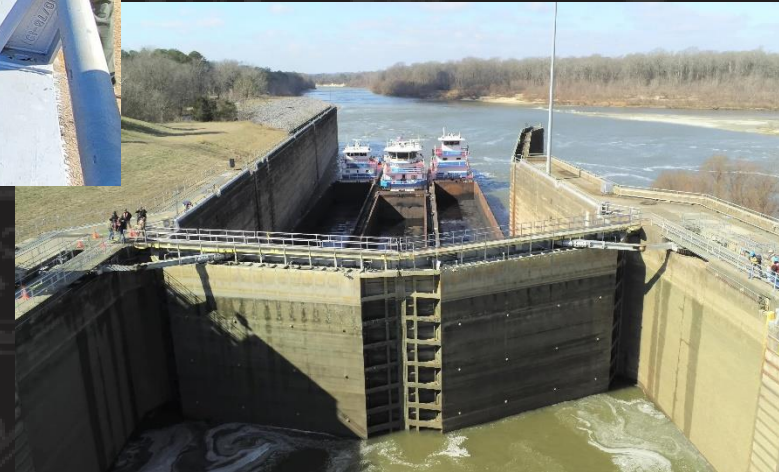
The lower miter gates were moved out of recess at 1130 and, following the gate closing procedure, were successfully placed into mitered position by 1145.

Lower Miter Gates  
Closing

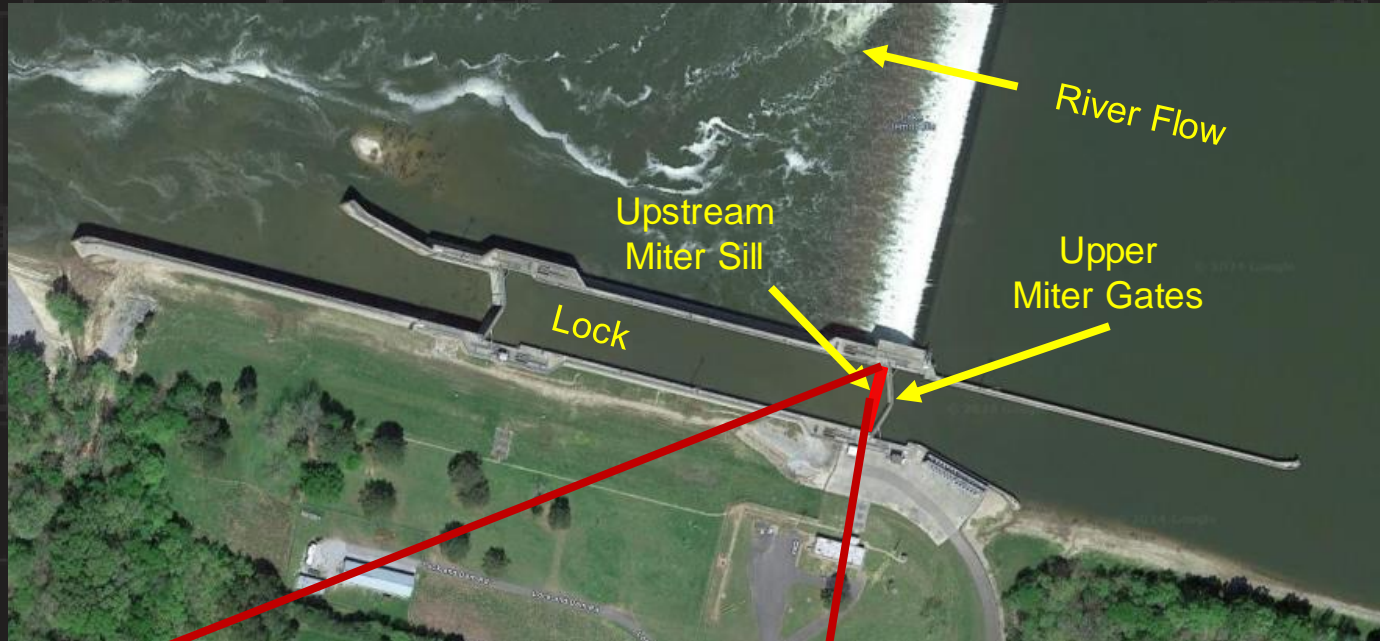
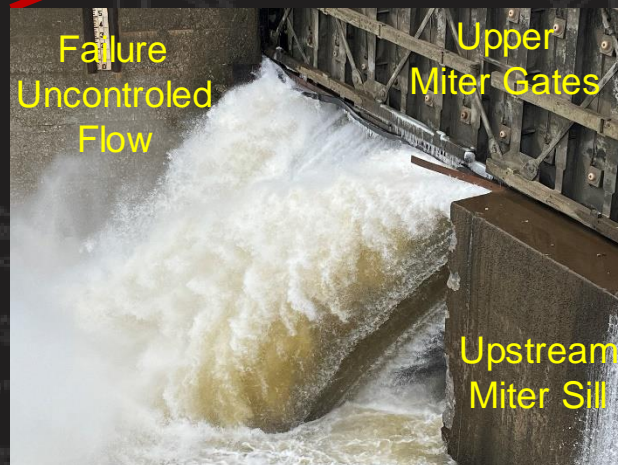
At 0600 the on-duty lock operator heard a loud noise and while investigating noticed water flowing under the upper miter gate. The concrete that comprises the upper miter sill fractured, allowing water to pass under the gate. The lower lock gates were open at time of the incident.

Current operations are to close the lower miter gates to allow the pool to equalize and set the upper stoplogs to get the lock chamber under control. Operation will take place 19-21 January. Engineering and Operations are continuing to analyze the extent of damages and are working other courses of action to stop the flow and get the lock under control.
