Effects of Hurricane Frederic on Dauphin Island, Alabama

By WILLIAM E. SCHRAMM, SHEA PENLAND, ROBERT G. GERDES, AND DAG NUNMFEDAL
Louisiana State University
Baton Rouge, Louisiana

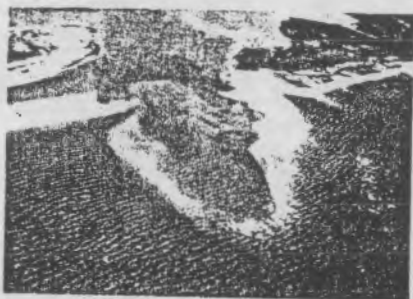
Fig. 9. Oblique view to the west of Pass Drury on October 25, 1979. The inlet gorge is 125 m wide.

Dauphin Island was not permanently breached by the hurricane. However, three breaches were formed on Little Dauphin Island. Each of these was open in the past but proved unstable, filling in relatively rapidly. After its opening by Hurricane Frederic the largest of these, Pass Drury, had a throat width of

140 meters and a maximum depth of 1.4 meters. Pass Drury and the other breaches on Little Dauphin Island probably had a two-stage development. A north wind dominated during approach of the storm. In Mobile Bay a water level set-up and wave action, cut back dunes or washed over the island, producing "weak spots" in the barrier. Following passage of the eye of the storm, winds shifted to the WNW and a wind driven storm surge flowing across the barrier actually cut the channel. Several lines of evidence support this hypothesis. A large ebb-oriented sand body associated with Pass Drury was formed in Mobile Bay (Fig. 9). This ebb-tidal delta exists in spite of both current measurements and bedform morphology, which indicates that the inlet is flood-dominated under normal conditions. In addition, channel markers behind Pass Drury in Dauphin Island Bay were bent in the direction of an ebb current during the storm.

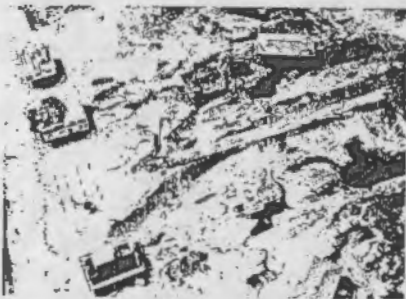
Fig. 13. Oblique aerial photo of hurricane-generated channels leading towards the back-barrier (to the right) from a beach-front housing development. (Photo courtesy of Perry Howard).

Canals within housing subdivisions and several drainage ditches which ran from midway across the spit to Mississippi Sound tended to concentrate flow, producing local increases in both amount of erosion and property damage (Figs. 10, 11, 12). Channels also developed behind beach front houses. The support pilings of these structures probably generated intense turbulence which initiated the channel scour (Figs. 13, 14).

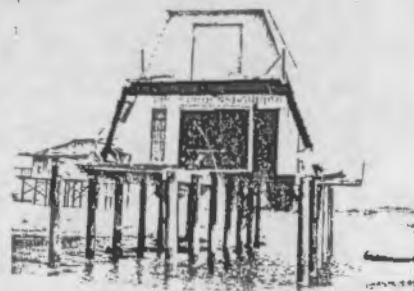
Fig. 14. Ground photo of damaged beach front home and the channel scoured underneath.

- The western three-quarters of Dauphin Island is a low spit which was completely inundated by the maximum hurricane surge. In this region, the most intense channel erosion occurred along driveways and back-barrier marina entrances. These man-made features acted as channel-ways focusing the currents during overwash.
- Support-pilings under beach front cottages also helped initiate channel scour, probably because of increased turbulence down current of these "obstacles."
