Vol. 10, No. 2, Spring 1994

Beach Erosion and Deposition on Dauphin Island, Alabama, U.S.A.

Scott L. Douglass

Department of Civil Engineering
University of South Alabama
Mobile, AL 36688, U.S.A.

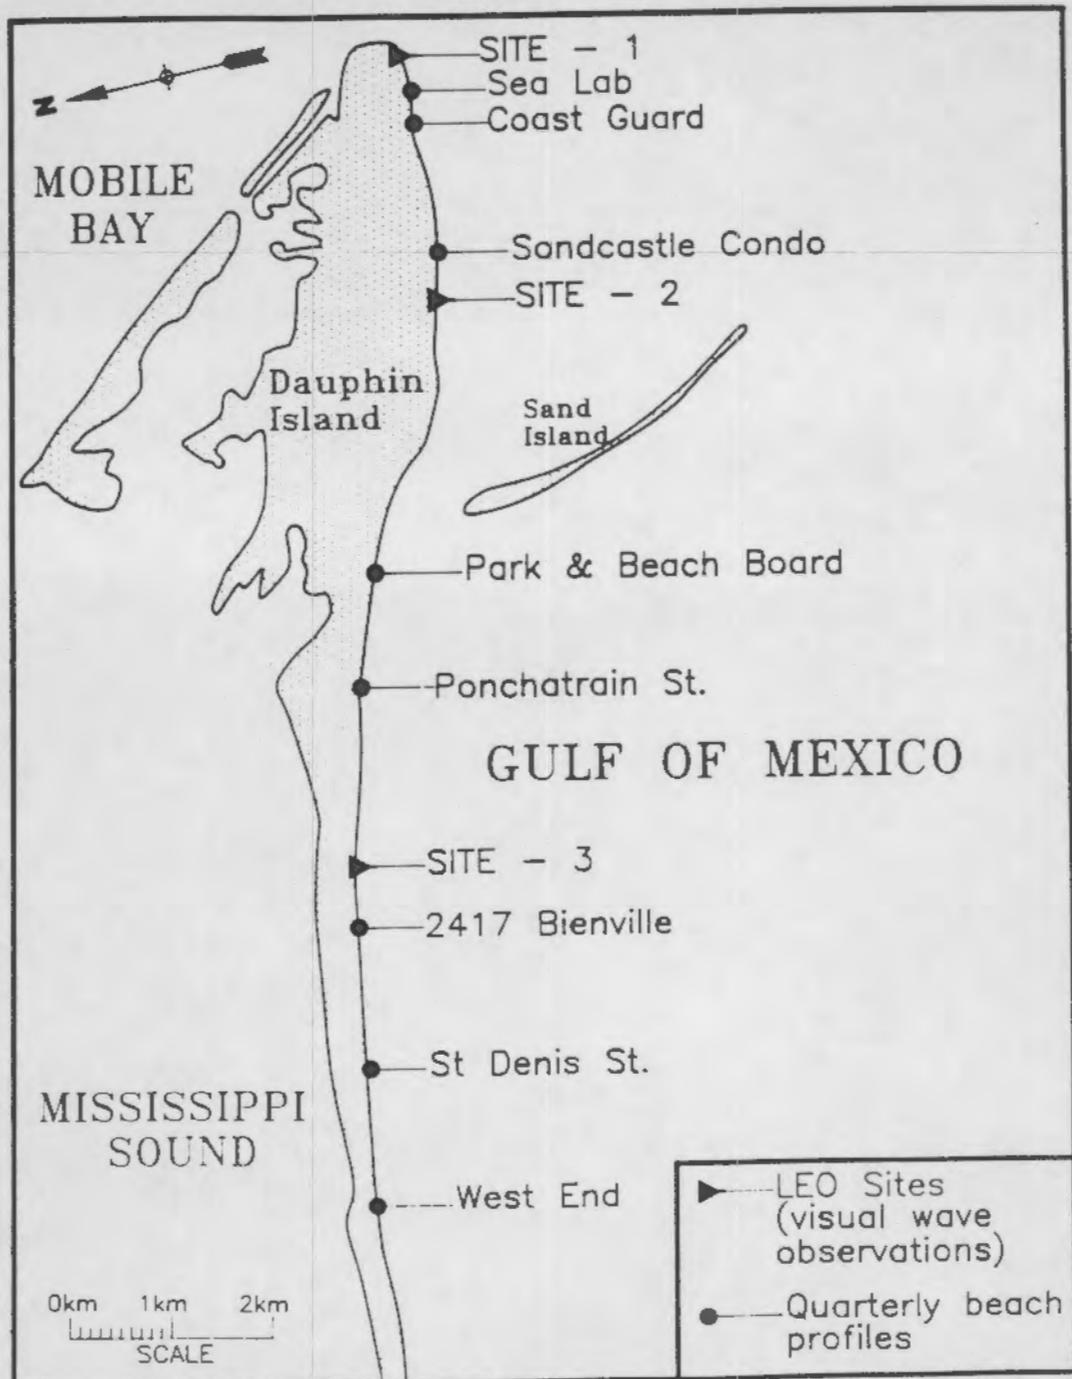
Figure 3. Monitoring program data collection locations

Elevations were surveyed quarterly along eight shore-normal transects (Figure 3). Each line began at an existing concrete monument that is part of Alabama's construction control line. Complete monument descriptions are given in DOUGLASS and HAUBNER (1992). The profiles were surveyed from the monument, usually in the sand dunes, across the beach to a convenient wading depth, usually over 1 m deep. Elevations were measured with a surveying level and rod. Distances were measured with a surveying tape on the dry beach and estimated by pacing in the water.

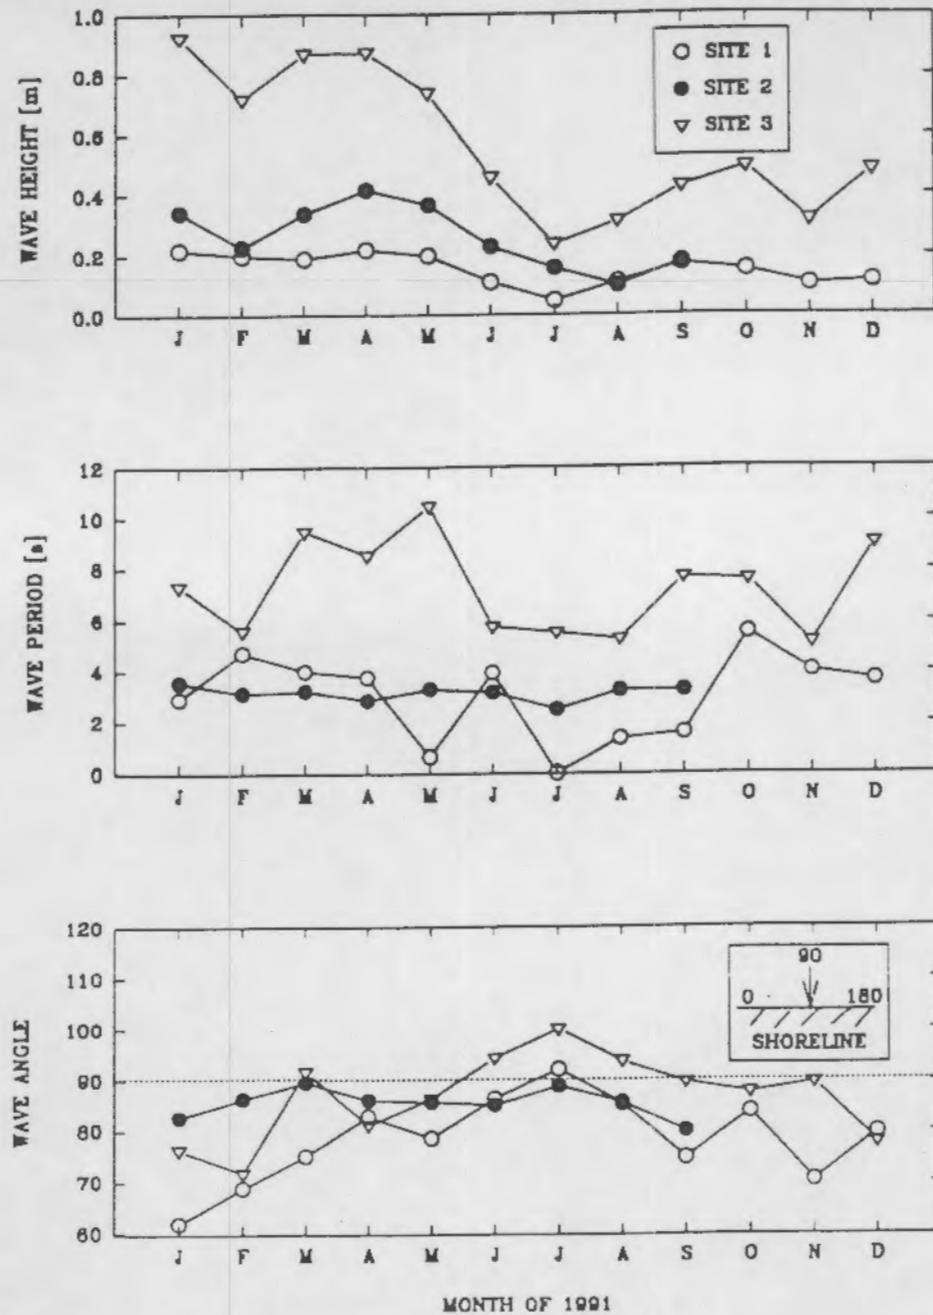
Figure 4. Average monthly wave height, period and angle from visual observations for 1991.

Average monthly wave height, period, and angle at breaking are shown in Figure 4. The daily observations are tabulated in DOUGLAS and HAUBNER (1992). Site 3, the only open Gulf site, clearly had much higher wave heights with longer periods. The other two sites are sheltered by the Sand Island shoals. Site 1 had smaller waves than Site 2 because it was located immediately in the lee of some offshore rubble structures and a sand bar which are discussed below. Most often, waves were approaching from east of south. This trend is fairly constant at the eastern end of the island. The trend reversed for the summer months at Site 3 where the average wave angle to the shoreline was from the west. Thus, the calmer summer months were apparently periods of wave angle reversal on the open Gulf beaches.

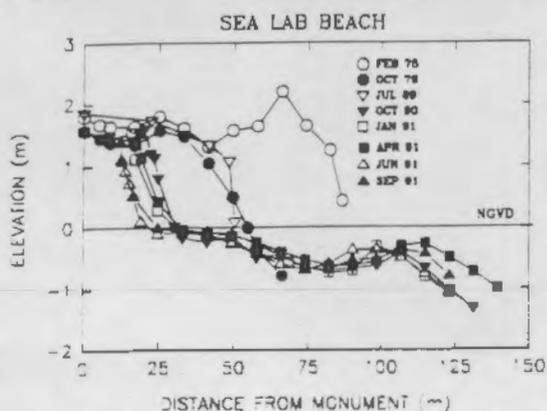
Figure 5. Sea Lab beach profiles.

The Sea Lab Beach profile line (Figure 5) shows significant, recent shoreline recession. From July 1989 to October 1990, the shoreline receded about 20 m. During the year of this study, October 1990 to September 1991, the shoreline receded about another 13 m. The erosion extends from the top of the bluff to the waterline. However, below the waterline, the profile shows little change. There is a flat, planar surface from the base of the bluff out 50 m from the monument.

During the year of this study, the easternmost 2 km of the island, Reach A, experienced shoreline recession of an average of 10 m with maximums of about 15 m. Two surveyed profiles, Sea Lab Beach and Coast Guard Beach, fall within this reach (Figures 5 and 6).

The alignment of the Sea Lab Beach profile line passed midway between the third and fourth westernmost groins. The probable explanation for the absence of vertical erosion farther out on the profile is the presence of the groin field. The flanked groin field still traps some sand immediately between the piles of rock in a sand bar. The sand bar and the rocks are providing wave sheltering to the beaches. At the Coast Guard Beach profile, which is about 200 m west of the flanked groin field, the vertical erosion extended out across the entire measured profile.

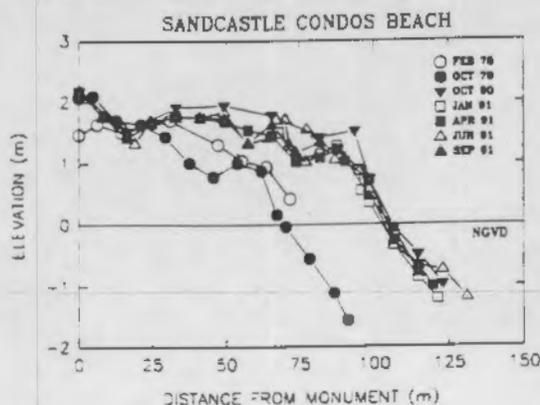
Figure 7. Sandcastle Condos beach profiles.

The Sandcastle Condos Beach (Figure 7) has experienced substantial accretion and deposition since 1979. The shoreline has accreted over 30 m. The entire profile has gained sand with a maximum vertical deposition of 3 m. This build-up of sand has caused the formation of a low dune field at an elevation between +1 and -2 m NGVD.

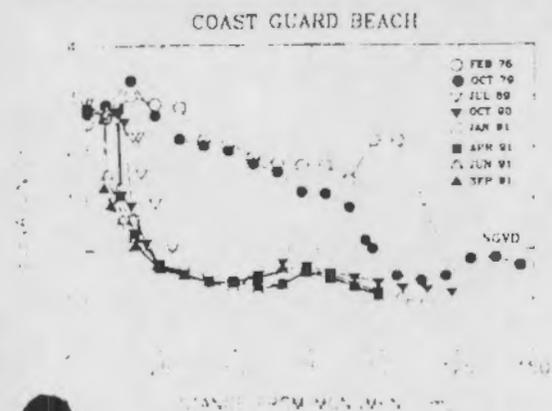
Figure 6. Coast Guard beach profiles.

The Coast Guard Beach profile (Figure 6) also shows significant recent shoreline recession and

erosion. The bluff receded 6.3 m/yr since 1975. During the year of this study, the bluff crest receded 7 m. The bluff recession rate was not constant through this study year. The greatest bluff

recession, 3.6 m, occurred from April to June 1991. This time period coincides with several strong storms with seas from the east. Unlike the Sea Lab Beach Profile, this beach profile has experi-

enced elevation losses along the entire measured profile.

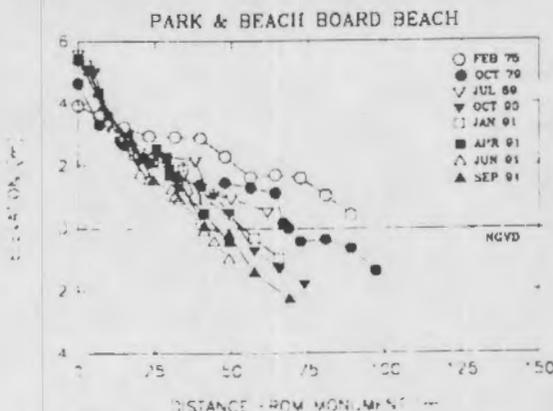
Figure 8. Park & Beach Board beach profiles.

The shoreline at the Park and Beach Board beach receded about 13 m during the year of this study (Figure 8). The recession rate was similar for the previous year. The entire beach profile is vertically eroding. A portion of the profile has eroded 2 m while going from dry foredunes to

submerged bottom. The erosion has exposed previously sand-covered tree stumps in the surf zone.

Reach C (Figure 13) is the 1 km recessionary shoreline around the fishing pier. The shoreline recession during the year varied from 3 m on the east side of the pier to almost 17 m. The Park and Beach Board Beach profile (Figure 8), which has eroded up to 2 m vertically, is 228 m west of the fishing pier. This erosion is probably being caused by the northerly migration of Sand Island. The marginal tidal channel, Pelican Passage, is being diverted farther north into Dauphin Island than at any time in the past century. In 1850, Sand Island was as far north but at a location about 1 km east of its present location (U.S. ARMY ENGINEER DISTRICT, MOBILE, 1978). The westerly migration of Sand Island may have been due to a westerly migration of this portion of the ebb-tidal delta. The beach around the fishing pier will probably continue to experience high rates of recession and erosion for the next few years. The erosion will probably continue until the position of Sand Island and Pelican Passage changes dramatically. The most likely scenario for the change is a relocation of Pelican Passage through a new, more southerly, breach in Sand Island. There is no clear evidence that such a breach occurred in the 1850's or 1860's, but it is probable. If this breach and relocation of Pelican Passage occurs, a very large volume of sand presently in Sand Island will be driven onto the beaches of Dauphin Island in the vicinity of the fishing pier.

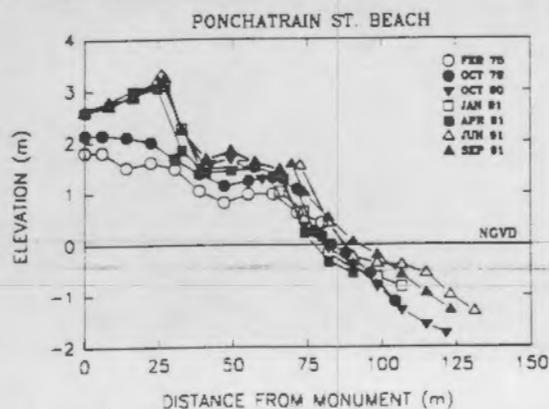
Figure 9. Ponchatrain St. beach profiles.

The Ponchatrain Street beach profile (Figure 9) shows little trend over the past decade yet the shoreline accreted 10 m during the year of this study. Most of the deposition occurred during the spring and summer from April 1991 to September 1991. A nearshore sand bar was present in June. Between June and September, the shoreline accreted while the offshore portion of the profile eroded. These changes are discussed below in terms of the onshore welding of sand bars which originated near the tip of Sand Island.

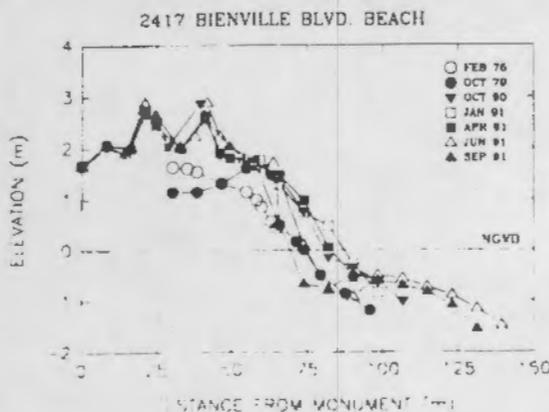
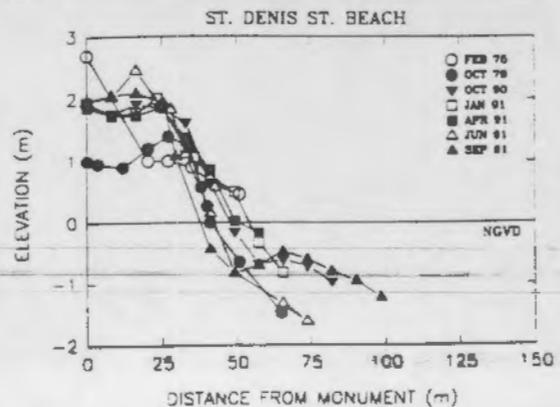
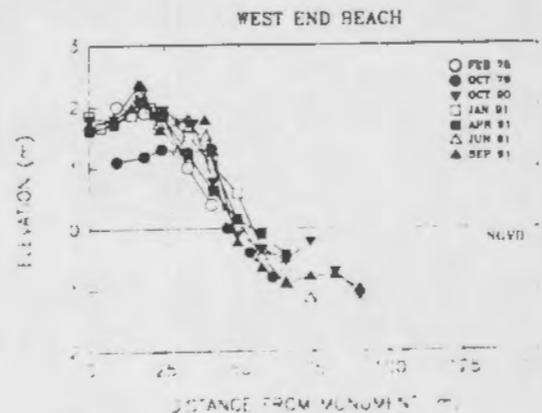
(Figures 10–12) show relatively little change over the past decade. During the year of this study, two of them show shoreline recession but sand deposition in a nearshore sand bar.

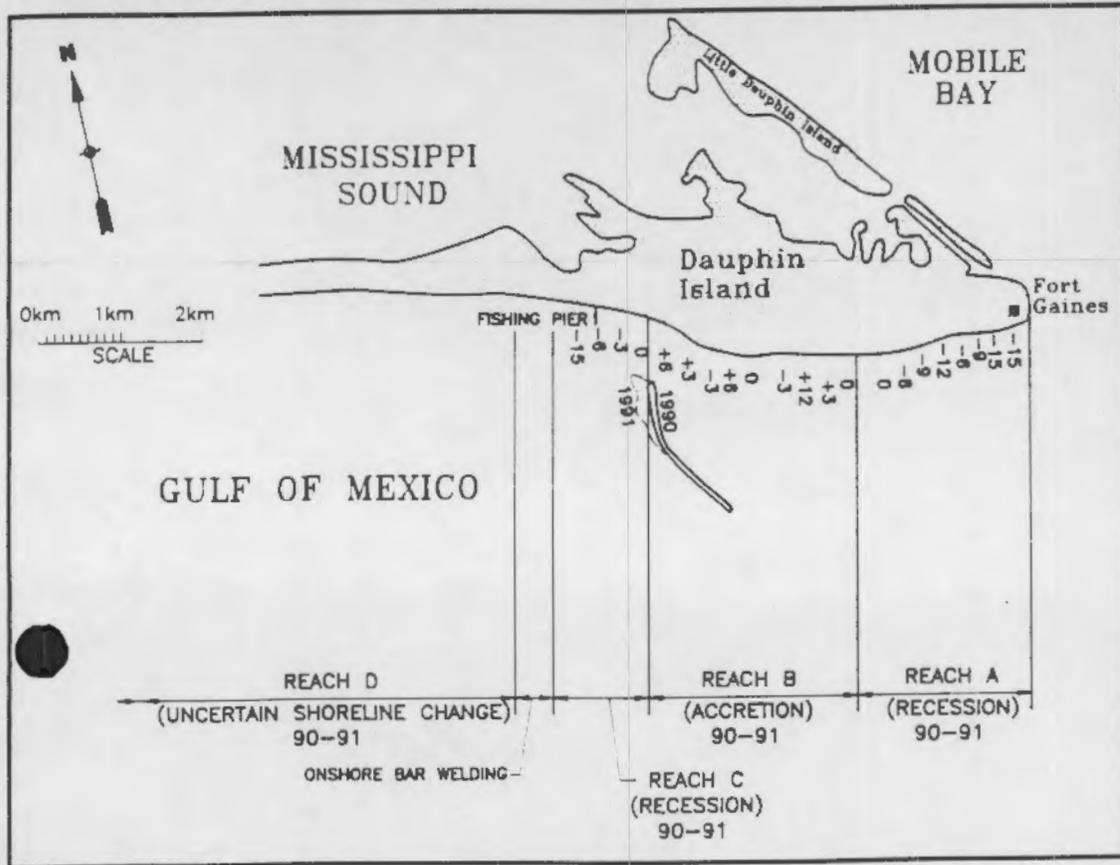
Figure 13. Dauphin Island shoreline changes from Sept. 1990 to Sept. 1991.

Shoreline changes during the year based on the analysis of the air photos are shown and summarized on Figure 13. For discussion purposes, a total of four reaches of beach are considered. There are alternating reaches of recession/accretion/recession along the eastern 6 km of the island.

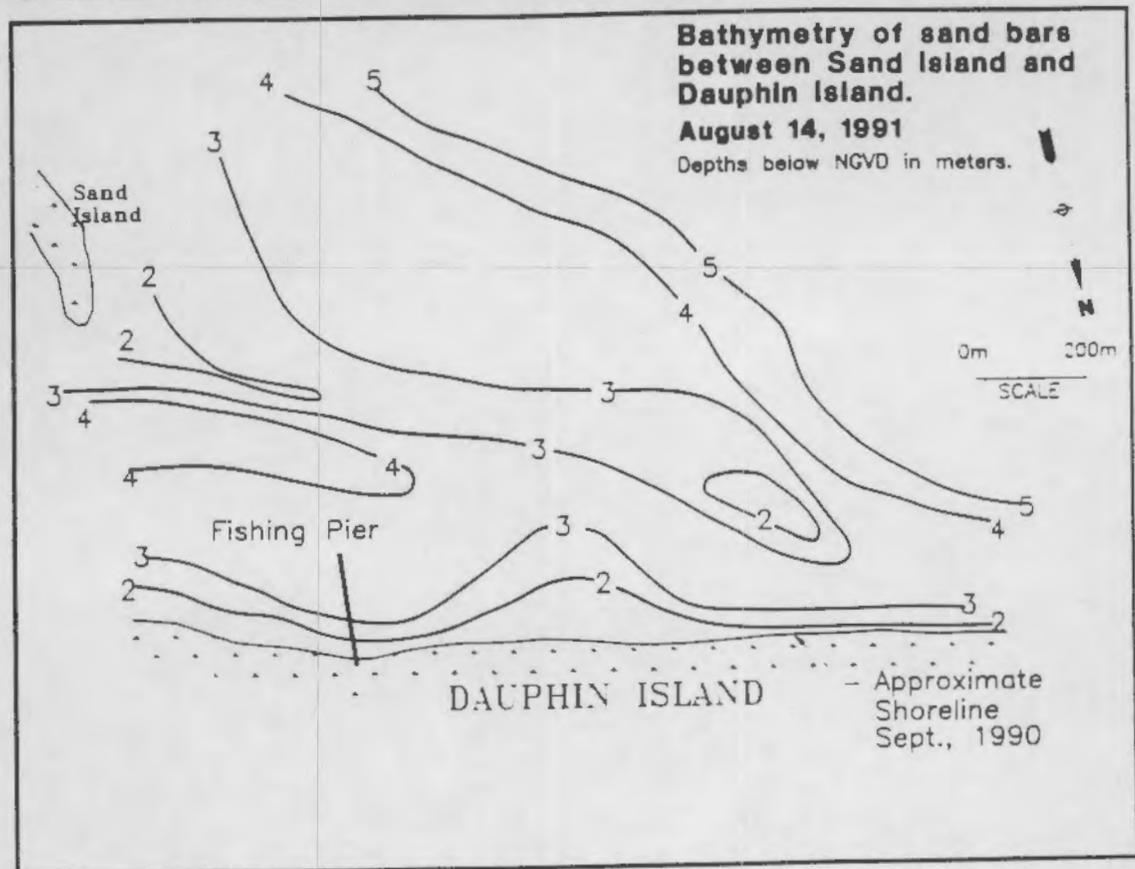
Figure 14. Bathymetry of sand bars between Sand Island and Dauphin Island (Aug. 14, 1991).

A bathymetric survey of an offshore sand bar is shown in Figure 14. A large, distinct sand bar begins at the northwestern end of Sand Island and extends westward roughly parallel to the Dauphin Island shoreline for about 1 km where

its alignment turns northward towards Dauphin Island. Just north of the sand bar the water depth increases to almost 5 m deep. The bar has an average depth of about 3 m (relative to NGVD). At its western end, where it is probably migrating toward shore, the bar becomes as shallow as 1.5 m deep. The bar is apparently a fairly consistent feature because during the pre-trip planning for the bathymetric survey, the boat operator, who is also a local commercial fisherman, correctly sketched the location and shape of the bar from his memory.

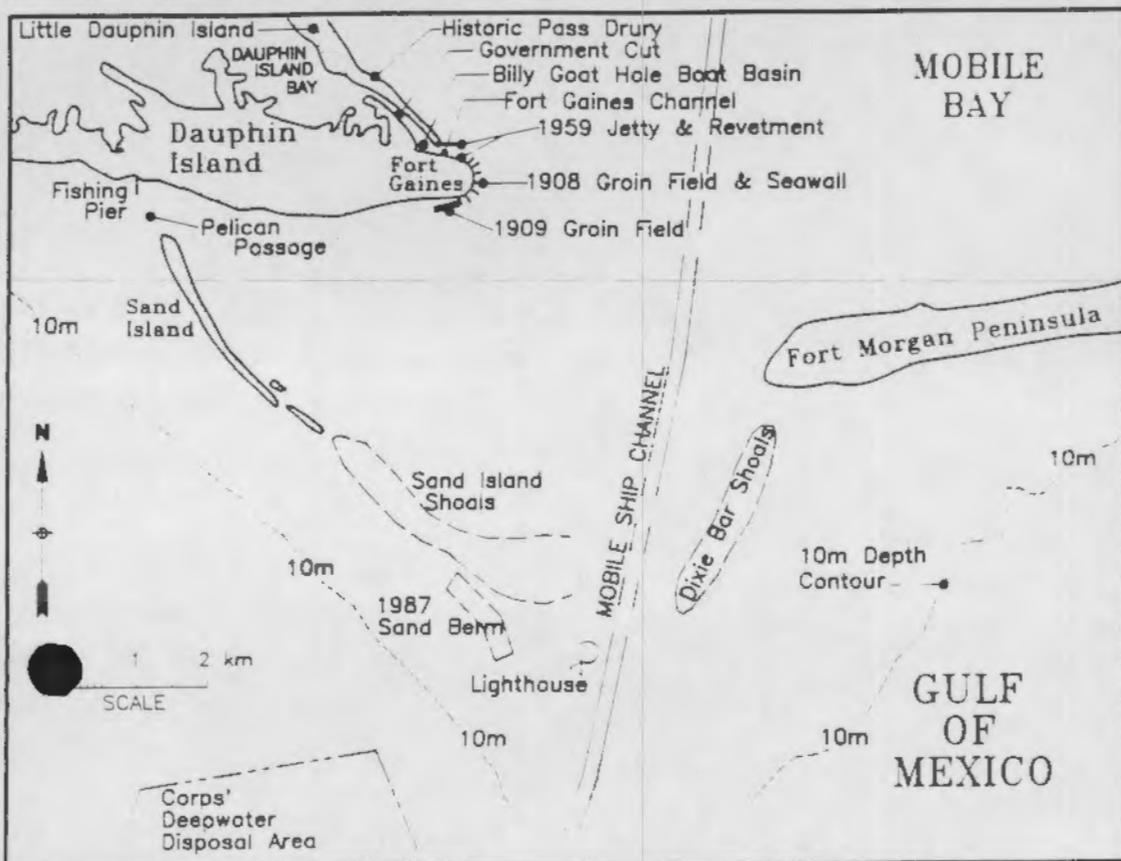
Figure 17. Coastal engineering around Dauphin Island.

Coastal engineering of the beaches and waterways of Dauphin Island probably began over three centuries ago. However, coastal processes are presently being affected by engineering projects completed within the last century. These coastal engineering projects (Figure 15) include rubble-

mound coastal structures around the east end of the island; a 1980 beachfill project which affected shoreline position at the east end during the 1980's; dredging of Dauphin Island's waterway system; and dredging of the Mobile Ship Channel.

In the late 1950's, a waterway system was constructed around the eastern end of the island. Fort Gaines Channel (Figure 15) was dredged through the northeastern shore of Dauphin Island. Prior to the dredging of this channel, the shoreline of Dauphin Island was continuous from the port to the northeast about 2 km to Pass Drury. An 000-

In 1987, 350,000 m³ of sand dredged from the Mobile Ship Channel were placed on the edge of the ebb-tidal delta south of the Sand Island shoals (Figure 15) as a continuous underwater mound or berm roughly 2 m high and over 1.5 km long (HANDS and BRADLEY, 1990). By 1988, the berm's upper surface had been planed off by wave activity. By 1990, a portion of the berm had migrated northward about 100 m (HANDS, 1991).

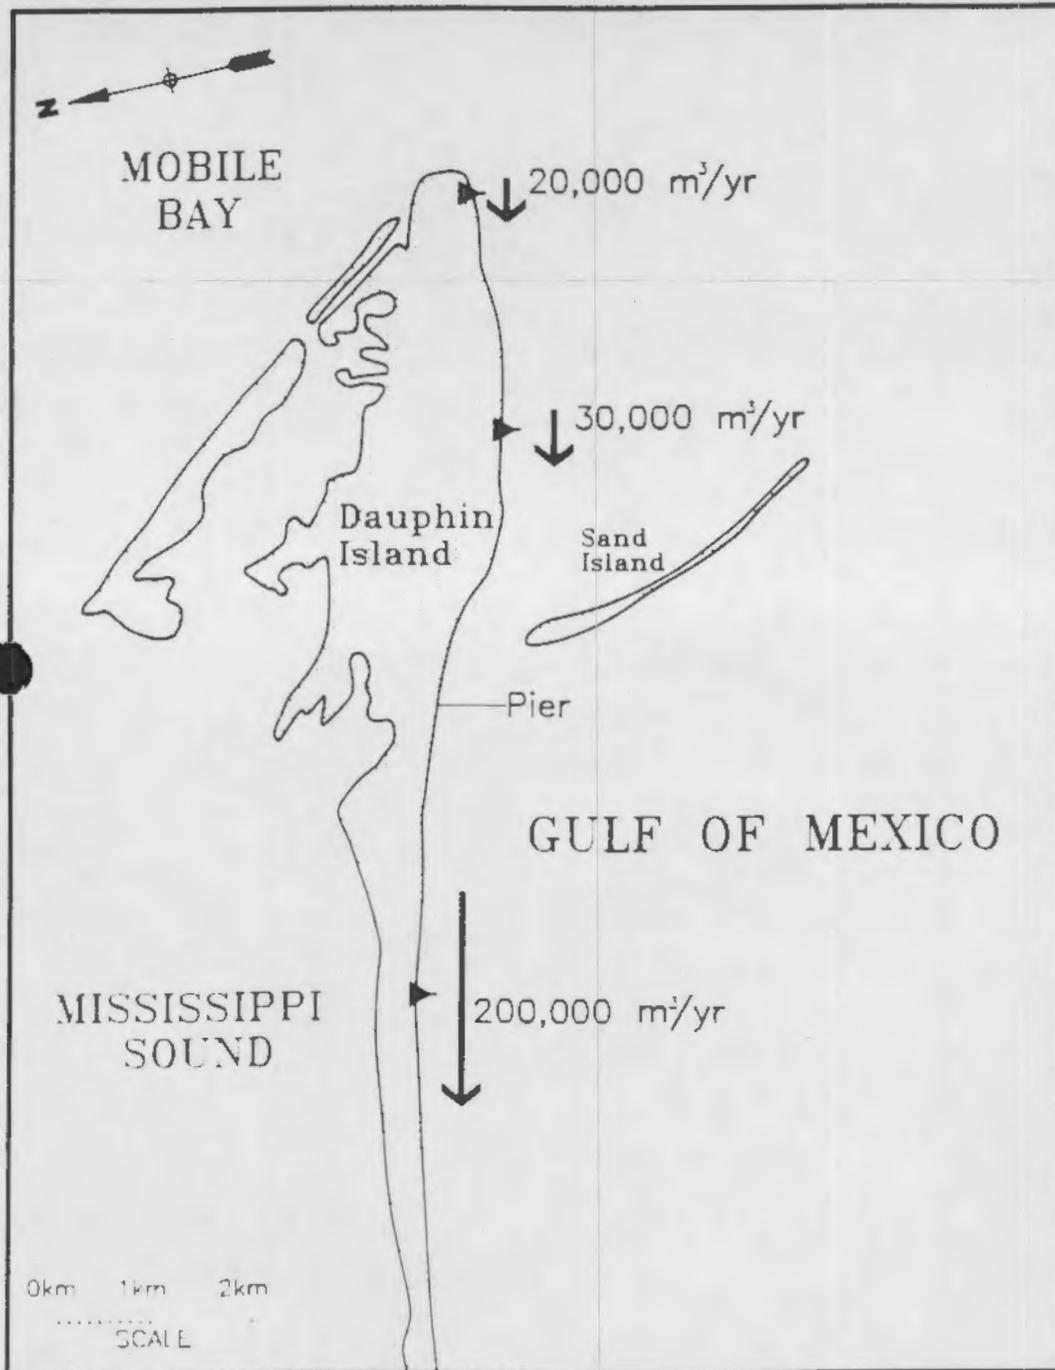
Figure 17. Longshore sand transport estimates from video wave data (1991).

Longshore sand transport rates were estimated from the visually observed breaker height and angle using the empirical relationship of the U.S. ARMY (1984). The longshore component of wave energy flux was calculated for each individual wave observation and the resulting transport rate estimated. The average annual net sand transport rates and directions are shown on Figure 17. At all three sites, net sand transport for the year was to the west. The estimated rates are 20,000; 30,000; and 200,000 m³/yr to the west at Sites 1, 2, and 3, respectively. At Site 3, the rate of westerly net transport of sand was an order of magnitude greater than at the other two sites. The actual numerical longshore sand transport rate estimates should not be considered very precise because of the inherent imprecision in the methodology. However, Figure 17 probably represents the qualitative and relative sand transport along Dauphin Island for the year.

There was proportionally less eastward, or reversal, transport at the sites in the lee of the Sand Island shoals. The ratio of net transport to gross transport was about 95% at Site 1 and 60% at Site 3. For example at Site 3, eastward transport was about 60,000 m³/yr, westward transport was 260,000 m³/yr and thus, gross transport, westward plus eastward, was about 320,000 m³/yr.

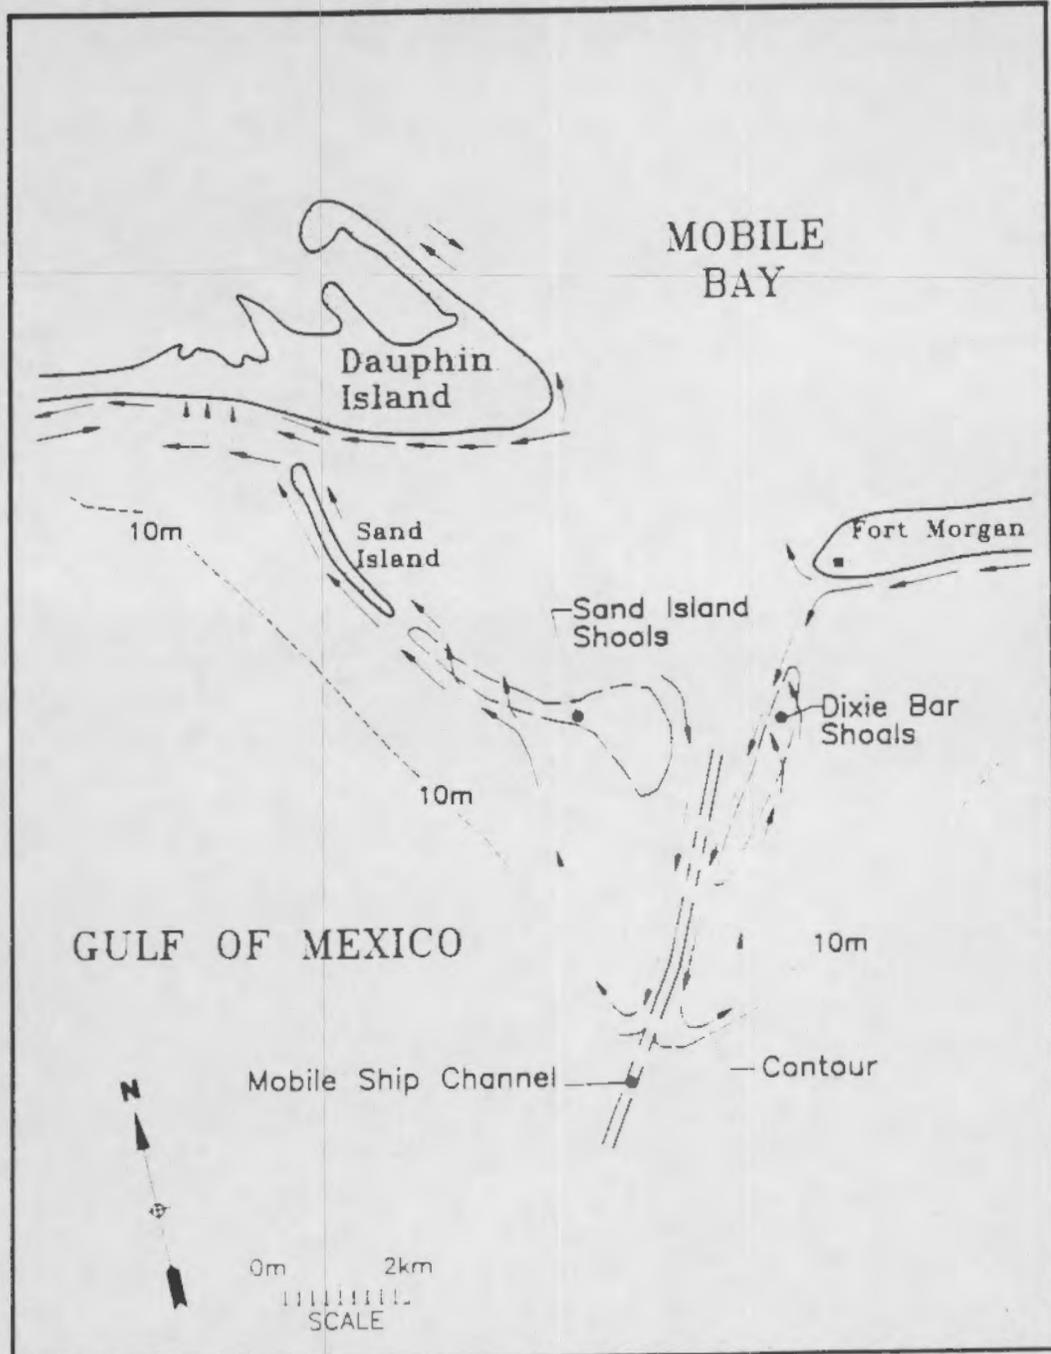
Figure 18. Summary of sand transport paths in the vicinity of Dauphin Island.

land, significant amounts of sand can only move one-way, westward, along the eastern beaches. Changes in the ebb-shoals have probably contributed to the recession and accretion pattern at the east end of the island. Sand has moved from the eastern eroding end to the accreting reach as discussed below. The probable sand transport paths are summarized schematically on Figure 18.

The beach changes, including both erosion and deposition, presently occurring on Dauphin Island can be explained by the sand transport paths related to the dynamics of Mobile Pass. The following discussion refers to shoreline reaches indicated on Figure 18.
