Munitions and Explosives of Concern Remediation After Action Report Munitions Response Site 6

STATEMENT OF REMOVAL OF MUNITIONS AND EXPLOSIVES OF CONCERN

EXECUTIVE SUMMARY

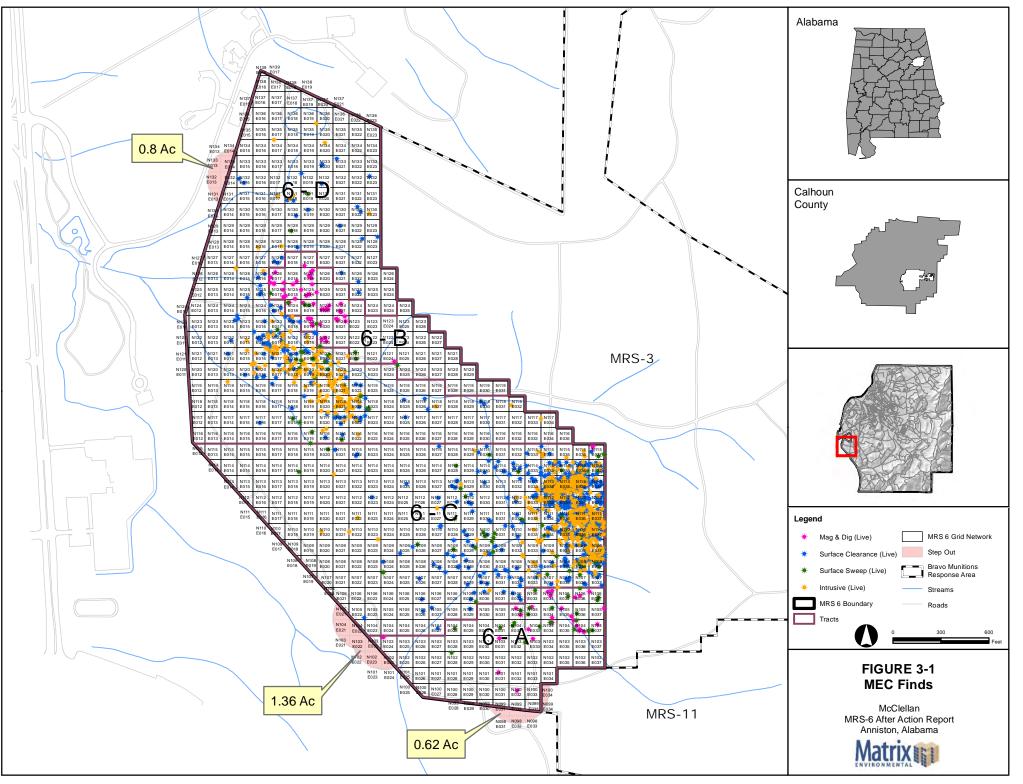
A total of 1,438 MEC items were recovered from MRS-6 as itemized in Table 2-2. The locations of all MEC found are shown in Figure 3-1. The MEC found consisted primarily of 1,355 (94.2%) of 60mm mortars (various). The remaining MEC consisted of 2.36 Inch Rockets (3.3%), and a variety of miscellaneous projectiles, grenades mortars, and fuzes. The largest MEC item found was the 105mm (HE) projectile.
