Munitions and Explosives of Concern After Action Report

Munitions Response Site 7

**Alpha and Bravo Munitions Response Areas of McClellan,
Anniston, Alabama**

June 2015

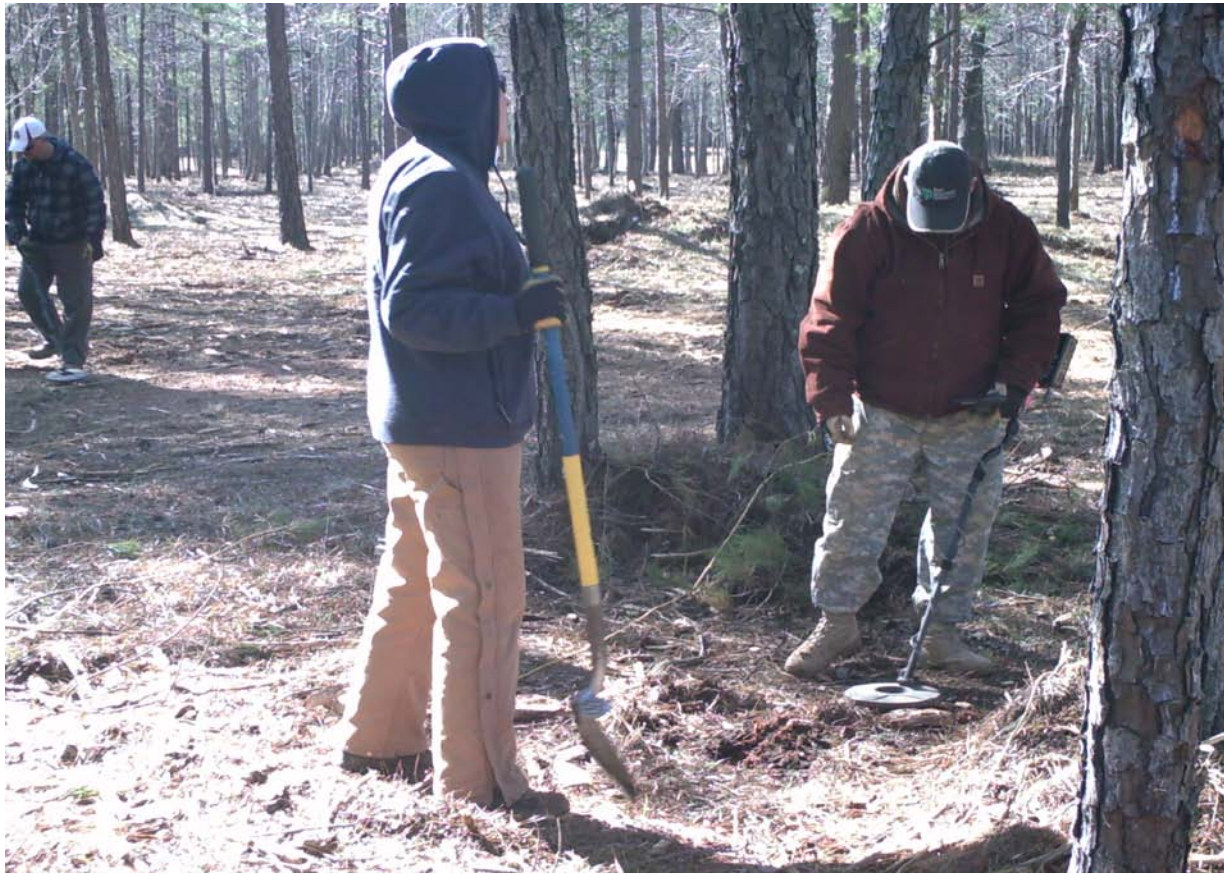
This operation was conducted utilizing the industry standard mag/dig procedures. Teams would delineate five-foot lanes using ropes and search the area using hand-held magnetometers. This

proved to be effective in reducing the overall number of DGM anomalies, which improved production rates and directed focus on clearance of subsurface items.

Aggressive Near-Surface Clearance Operations
