SUBJECT: Well Abandonment at the *Former Mock Village at Yahou Lake, Parcel 130Q-X*,
McClellan, Calhoun County, Alabama
Facility I.D. No. AL4 210 020 562

MONITORING WELL ABANDONMENT

Yahou Lake Well Abandonment Photo Log

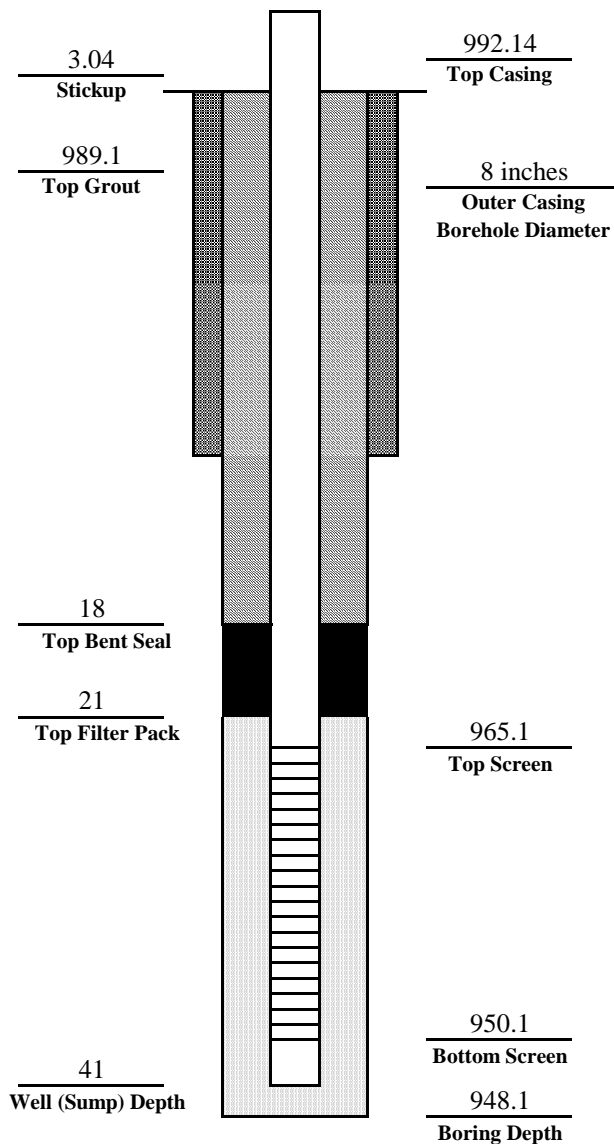
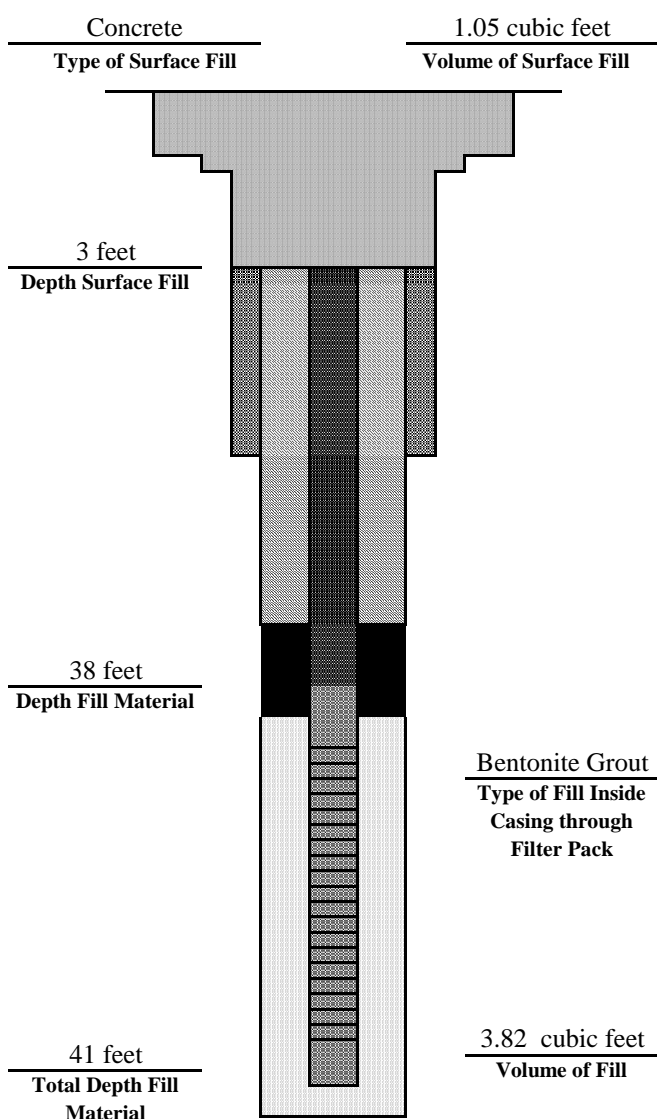
Well Summary Prior to Abandonment

Well Summary After to Abandonment

Approximately 20 feet of PVC casing from HR-130Q-MW01 was removed before the casing broke. An attempt to overdrill the well was made and the drill hit refusal around 9 feet below ground surface. The remaining well casing was grouted in place.

Length of Inner Casing Removed 20 feet

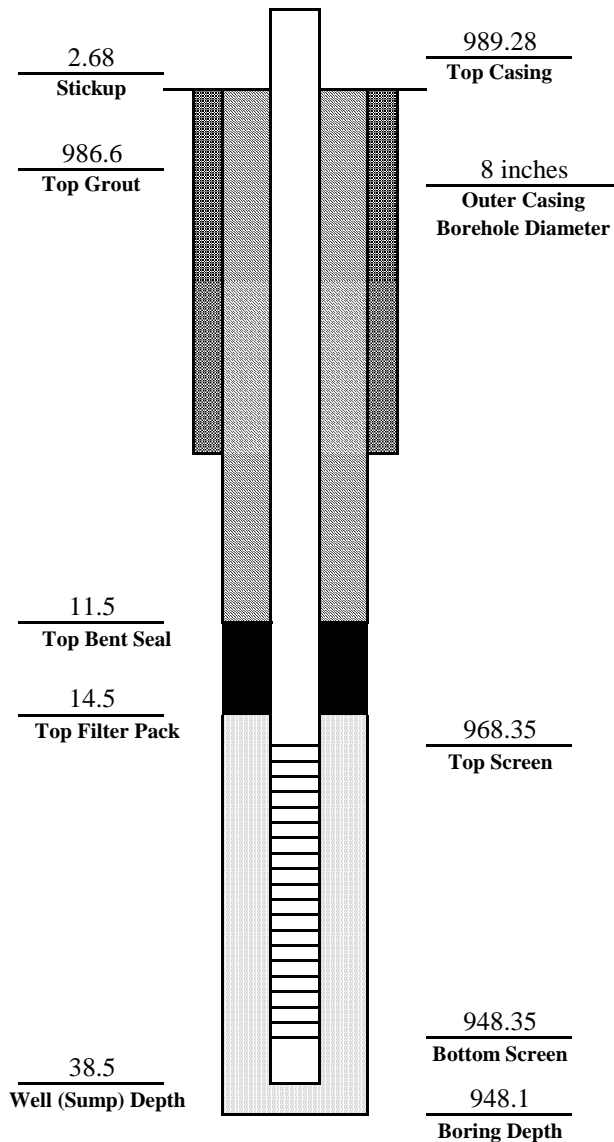
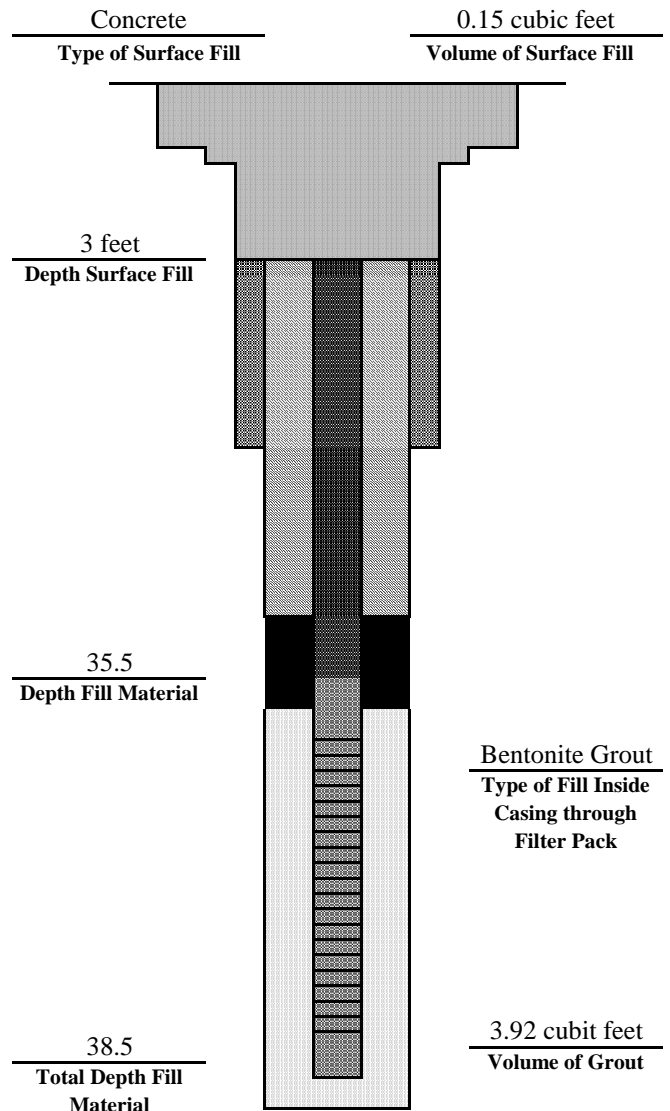
HR-130Q-MW02

Well Summary Prior to Abandonment

Well Summary After to Abandonment

During the removal of the PVC casing, the casing broke. The well was overdrilled with a hollow stem auger and a 4 1/4 inch bit to remove remaining casing and screen. The entire casing was removed.

Length of Inner Casing Removed 40 feet

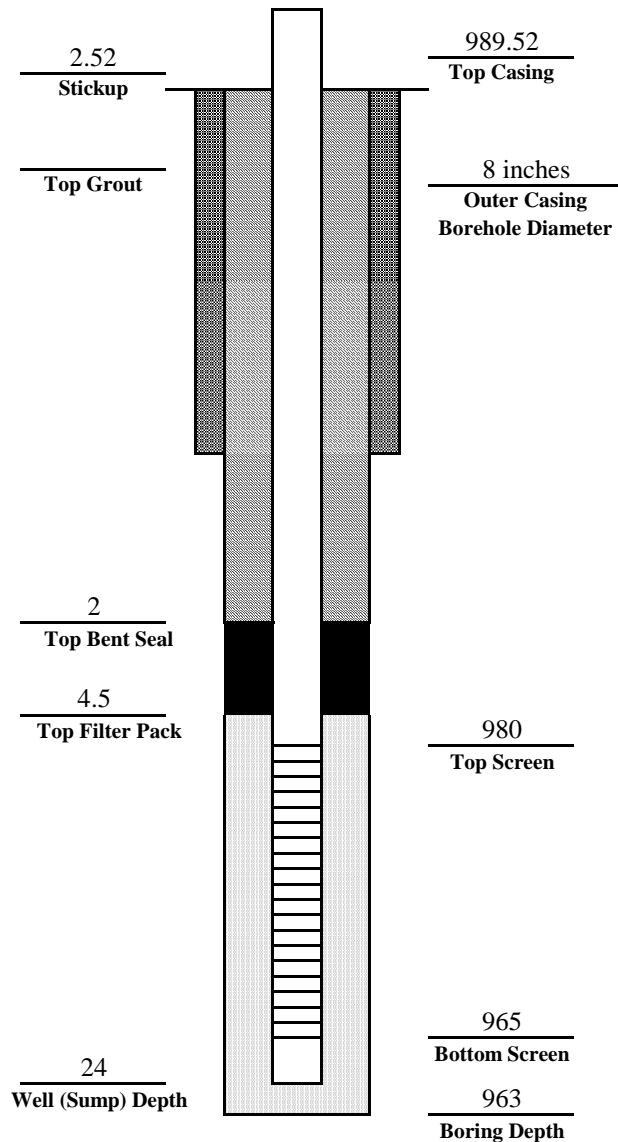
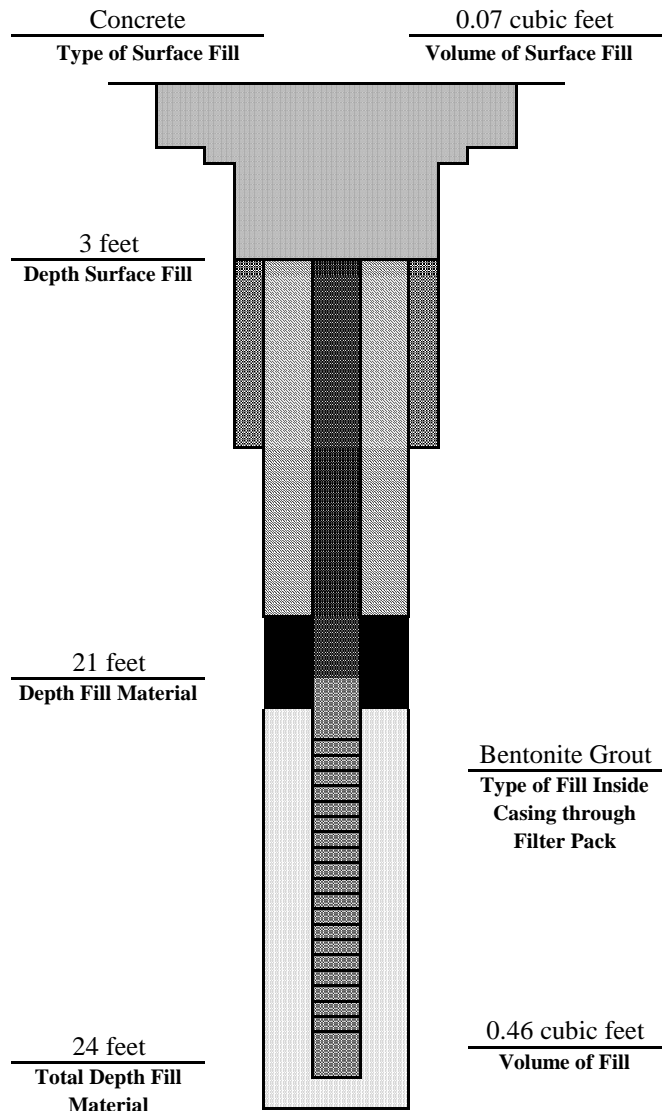
HR-130Q-MW03

Well Summary Prior to Abandonment*data presented in feet bgs*

**Well Summary After to Abandonment**

Entire casing and screen was removed from this well.

Length of Inner Casing Removed 26 feet

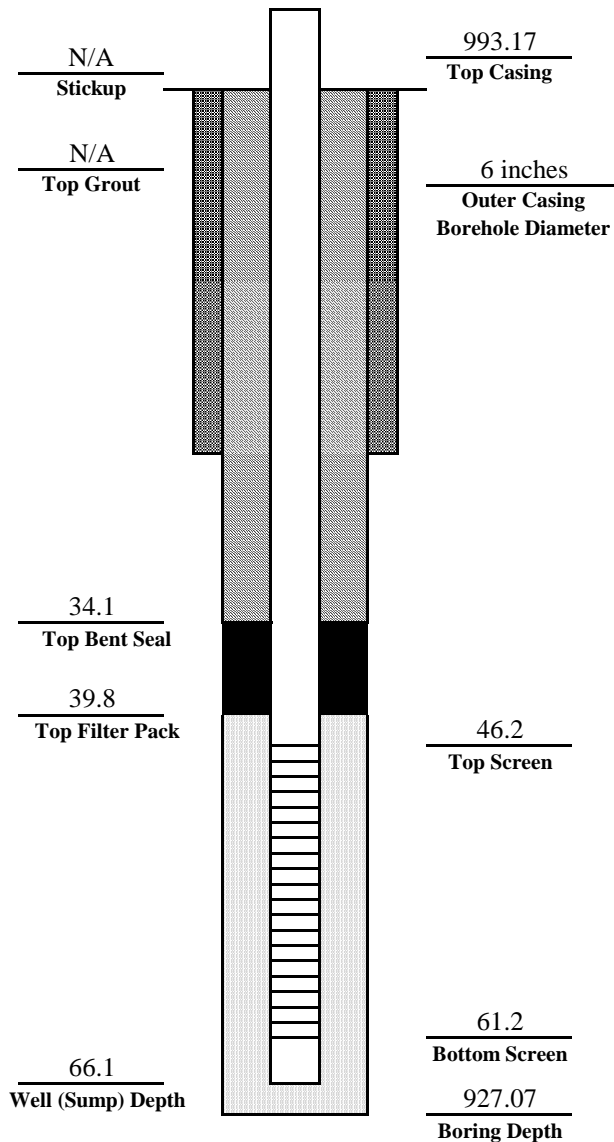
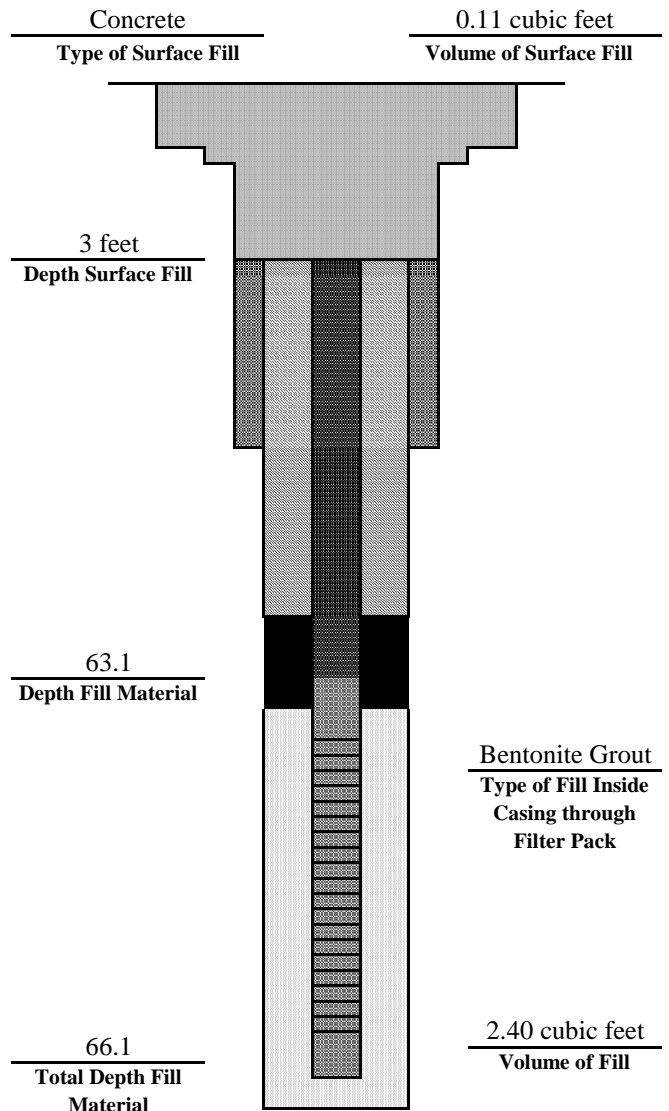
HR-130Q-MW14

Well Summary Prior to Abandonment

Well Summary After to Abandonment

Well was overdrilled with a solid stem auger and 3 1/2 inch bit. The entire casing was removed.

Length of Inner Casing Removed 66.1 feet

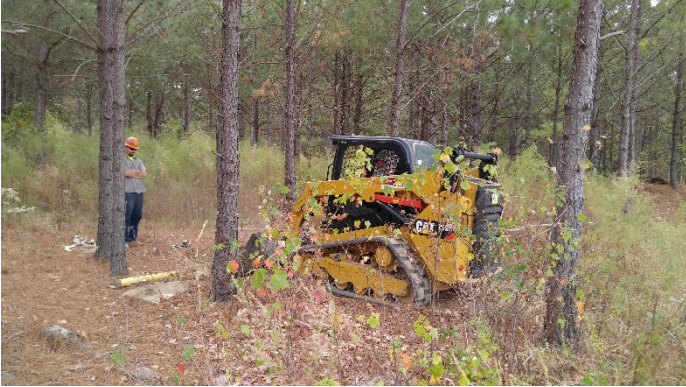
11-08-2016-001: A skid steer was used by the GeoLab to break up the concrete pads and pull the PVC well casing.

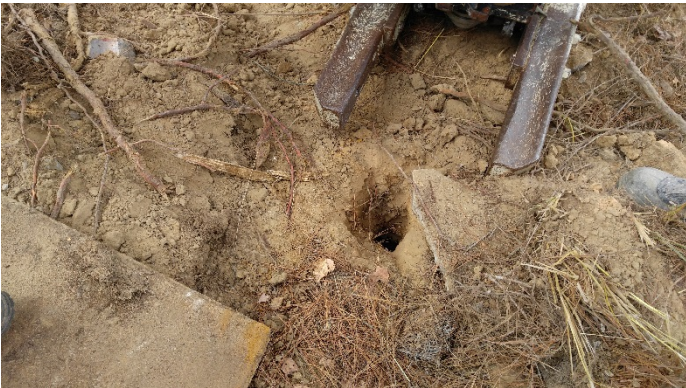
11-08-2016-002: The entire casing was removed from HR-130Q-MW03.

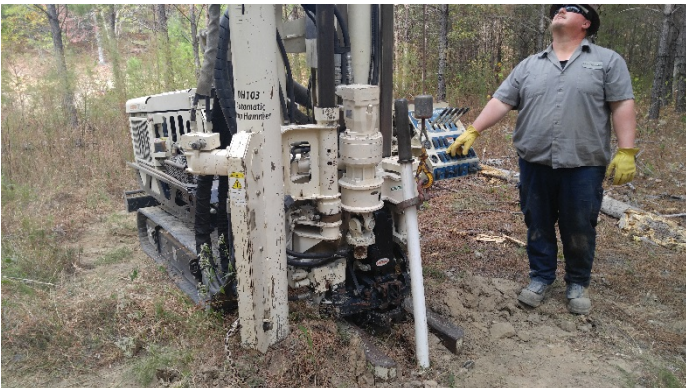
11-08-2016-003: The geoprobe was used to help remove the casings and over drill the well if the casing broke during removal.

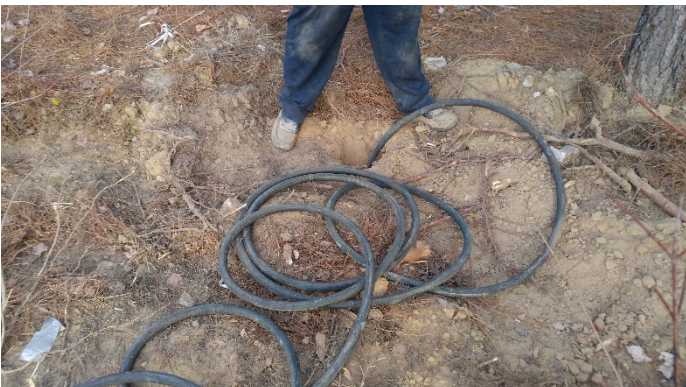
11-08-2016-004: When the entire casing was removed, MW-02 and MW-03 were filled with grout and allowed to settle overnight prior to pouring the cement cap.

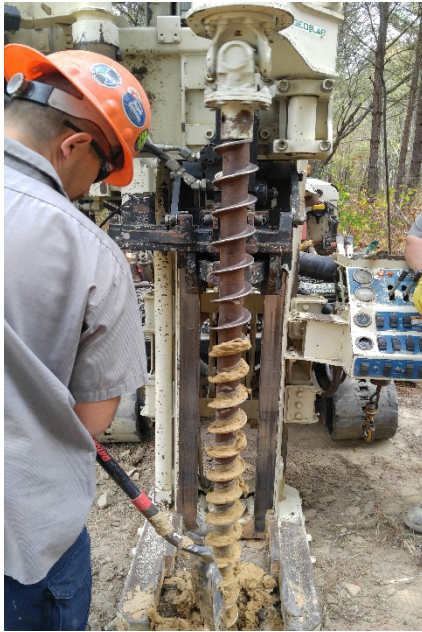
11-09-2016-001: GeoLab used the geoprobe to over drill wells to remove the casings that broke or were not able to be completely removed.

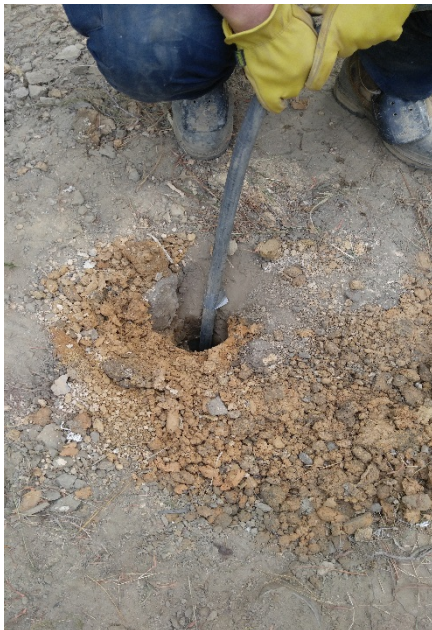
11-09-2016-002: Bentonite grout was applied to the wells after removing the well casing and screen and was allowed to sit overnight to account for settlement.

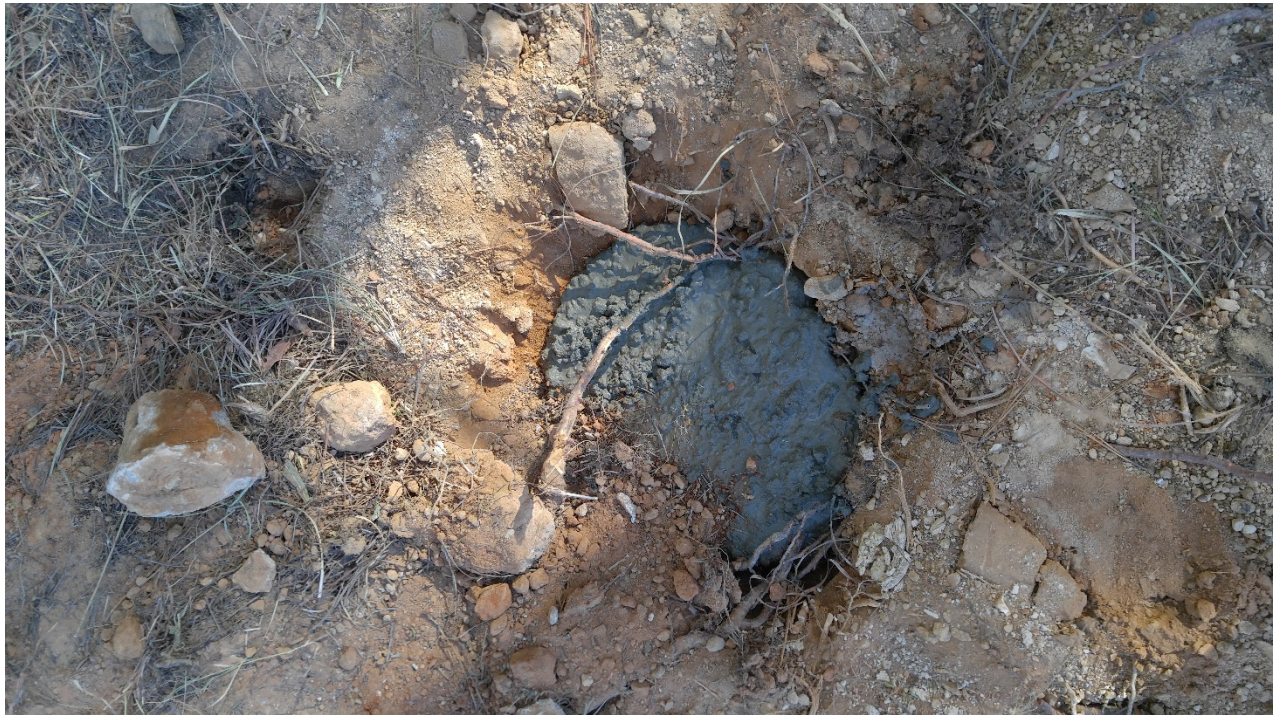
11-10-2016-001: A concrete cap seal was poured on top of the bentonite grout after allowing the grout to settle.
