# BLACK WARRIOR/TOMBIGBEE RIVER: DEMOPOLIS LOCK – UPPER MITER SILL FAILURE – 3 APRIL 2024

3 April 2024 condition update:

# BLACK WARRIOR/TOMBIGBEE RIVER: DEMOPOLIS LOCK – UPPER MITER SILL FAILURE - 16 JAN 2024

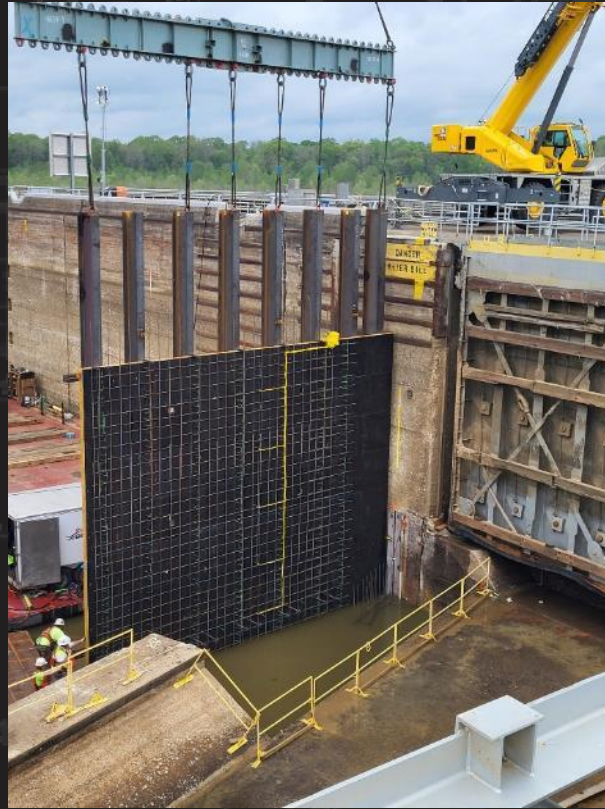
Installing Riverside Formwork

The river side concrete form has been installed into the chamber and secured in place. The stainless-steel bulkhead that separates the river monolith from the center monolith has also been installed. Work is underway to install the center and landside concrete formwork and the separating stainless-steel bulkhead.

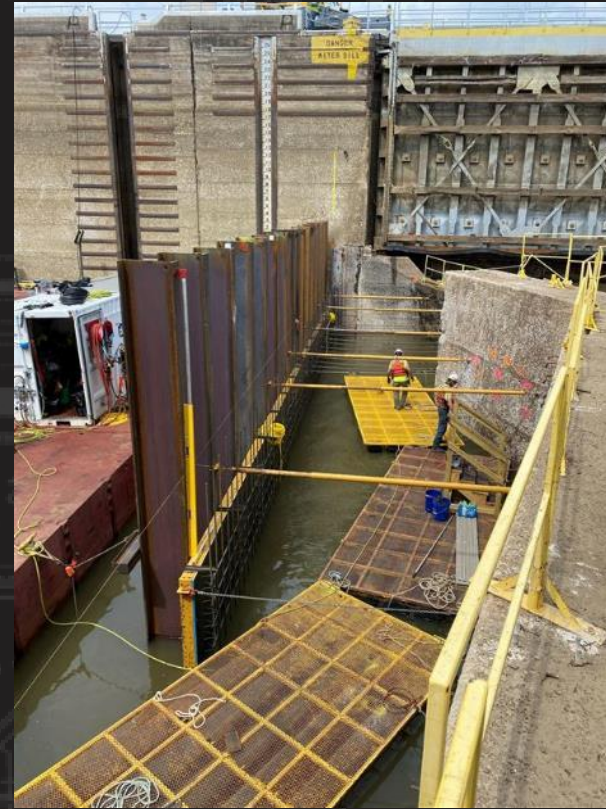
Attaching Dowels to Formwork

Work has been completed on the dowels and anchors to tie the new concrete monoliths into the existing structure.

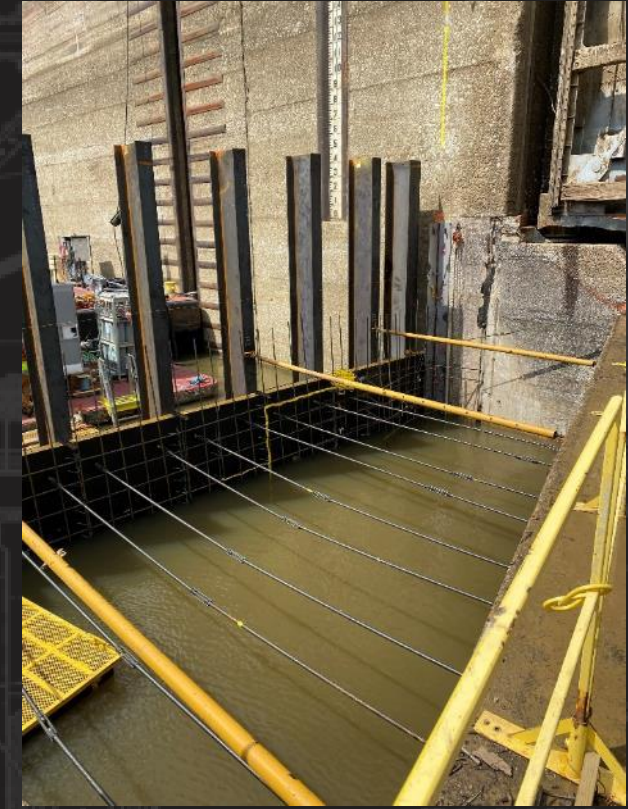
Installed Riverside Formwork

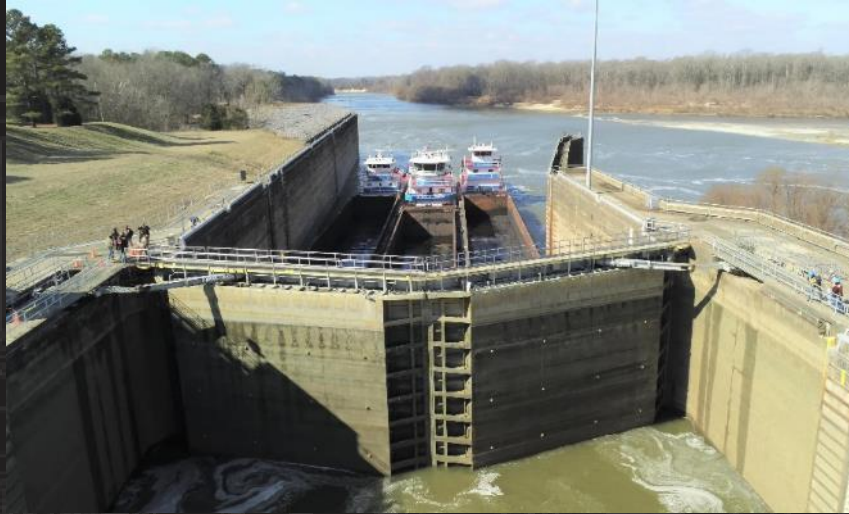
Parker Towing Barges & Towboats

- Parker Towing – assistance with closing lower miter gates
- TVA – assistance with originally setting upper stoplogs
- McKinney Salvage & Heavy Lift, Inc. – assistance with removal of large debris
- Cemex/ReadyMix – providing concrete from local batch plants in Demopolis
- ITWW Project – providing fleet assets to assist with repairs and construction

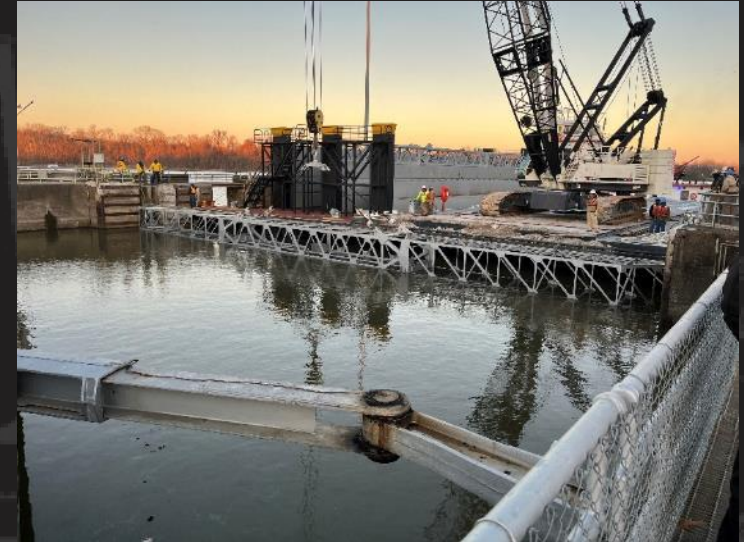
TVA Setting Upper Stoplogs

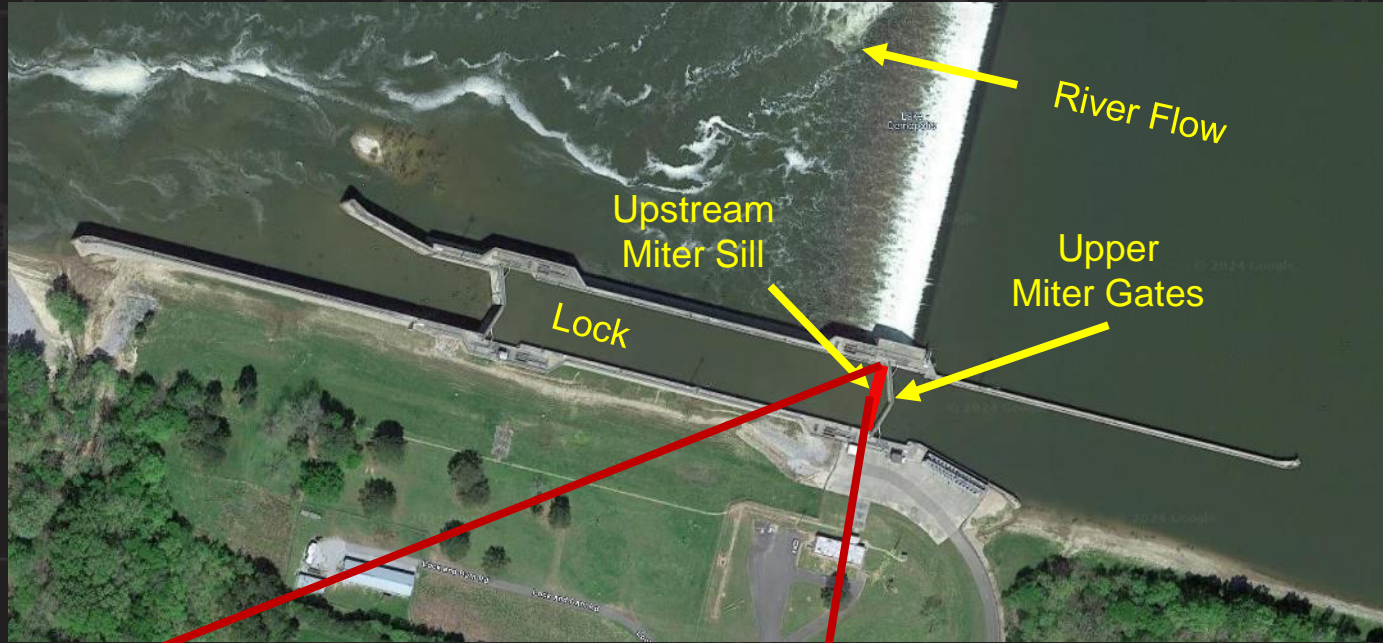
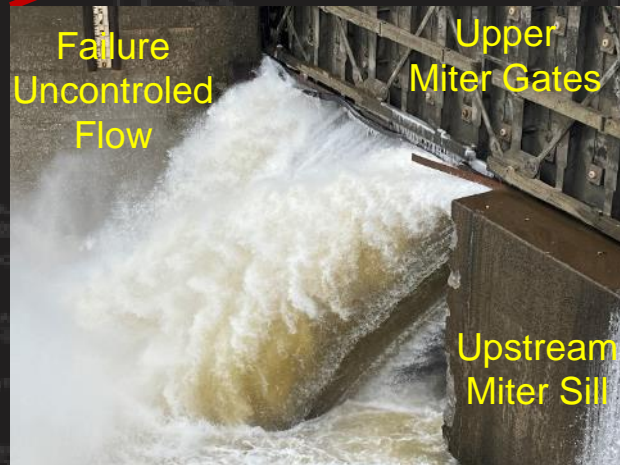
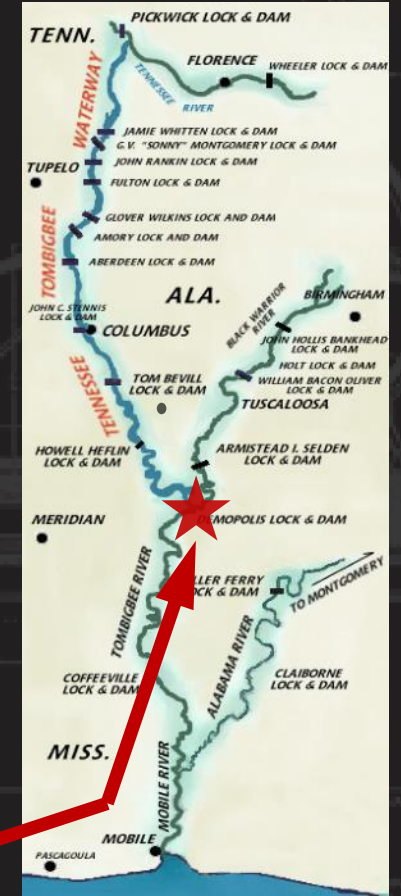
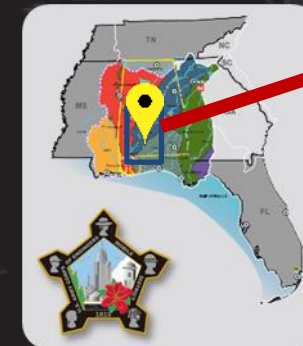
**16 January 2024 Incident:**  
At 0600 the on-duty lock operator heard a loud noise and while investigating noticed water flowing under the upper miter gate. The concrete that comprises the upper miter sill fractured, allowing water to pass under the gate. The lower lock gates were open at time of the incident.

Current operations are to close the lower miter gates to allow the pool to equalize and set the upper stoplogs to get the lock chamber under control. Operation will take place 19-21 January. Engineering and Operations are continuing to analyze the extent of damages and are working other courses of action to stop the flow and get the lock under control.

At this time, the extent of damages have not been determined. Once the lock is dewatered damage assessment and repair plans can be developed. No accurate estimate for closure duration is available at this time. This schedule will be refined once a full assessment of the damages can be performed.
