## BLACK WARRIOR/TOMBIGBEE RIVER: HOLT LOCK – RIVER WALL MONOLITH CRACKS – 28 AUGUST 2024

## BLACK WARRIOR/TOMBIGBEE RIVER: HOLT LOCK — RIVER WALL MONOLITH CRACKS — 21 JUNE 2024

## BLACK WARRIOR/TOMBIGBEE RIVER: HOLT LOCK — RIVER WALL MONOLITH CRACKS — 29 MAY 2024

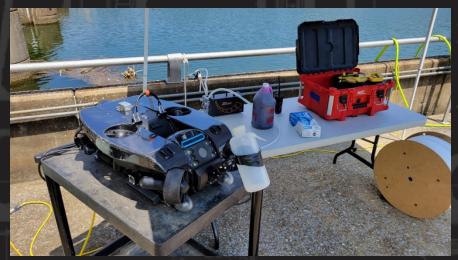
Remote Operated Vehicle w/ dye bottle

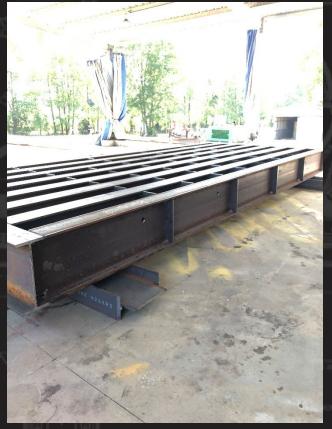
Bulkhead Section 1 Fit Up

Section 1 of 3 of the bulkhead has been fit up at the Contractor facility and USACE performed an inspection 27 August. A final fit up inspection will occur 30 August for all 3 sections of the bulkhead. Welding will begin after the inspection. Installation of the bulkhead is still scheduled for 30 September.

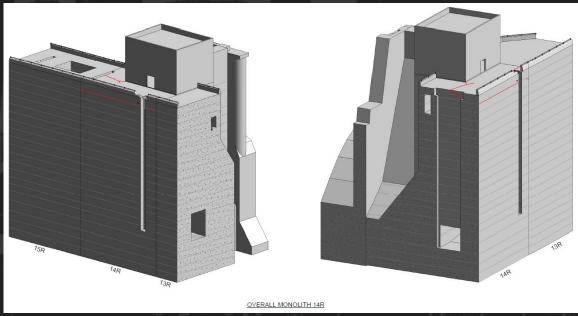
3D Model of Monolith and Assumed Crack Path

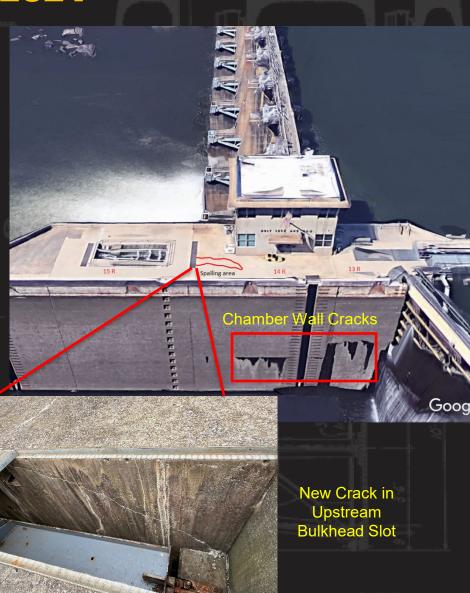
Concerns raised were increased water flows through existing cracks in the machinery spaces and galleries of the lock wall, new cracks and spalling discovered in the river side filling valve upstream bulkhead slot, and the failure of the gallery sump pumps.

Water Coming In Machinery Room

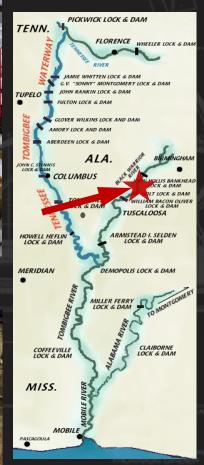
Staff at the BWT Project Management Office notified Mobile District Operations of recent changes in the observed cracks in river wall monolith 14R of the Holt Lock chamber.

Crack in Machinery Room Floor
