Corrective Measures Effectiveness Report
Eleventh Year Long-Term Monitoring
Former Small Weapons Repair Shop, Parcel 66(7)
McClellan, Anniston, Alabama

January 2022
Revised October 2022

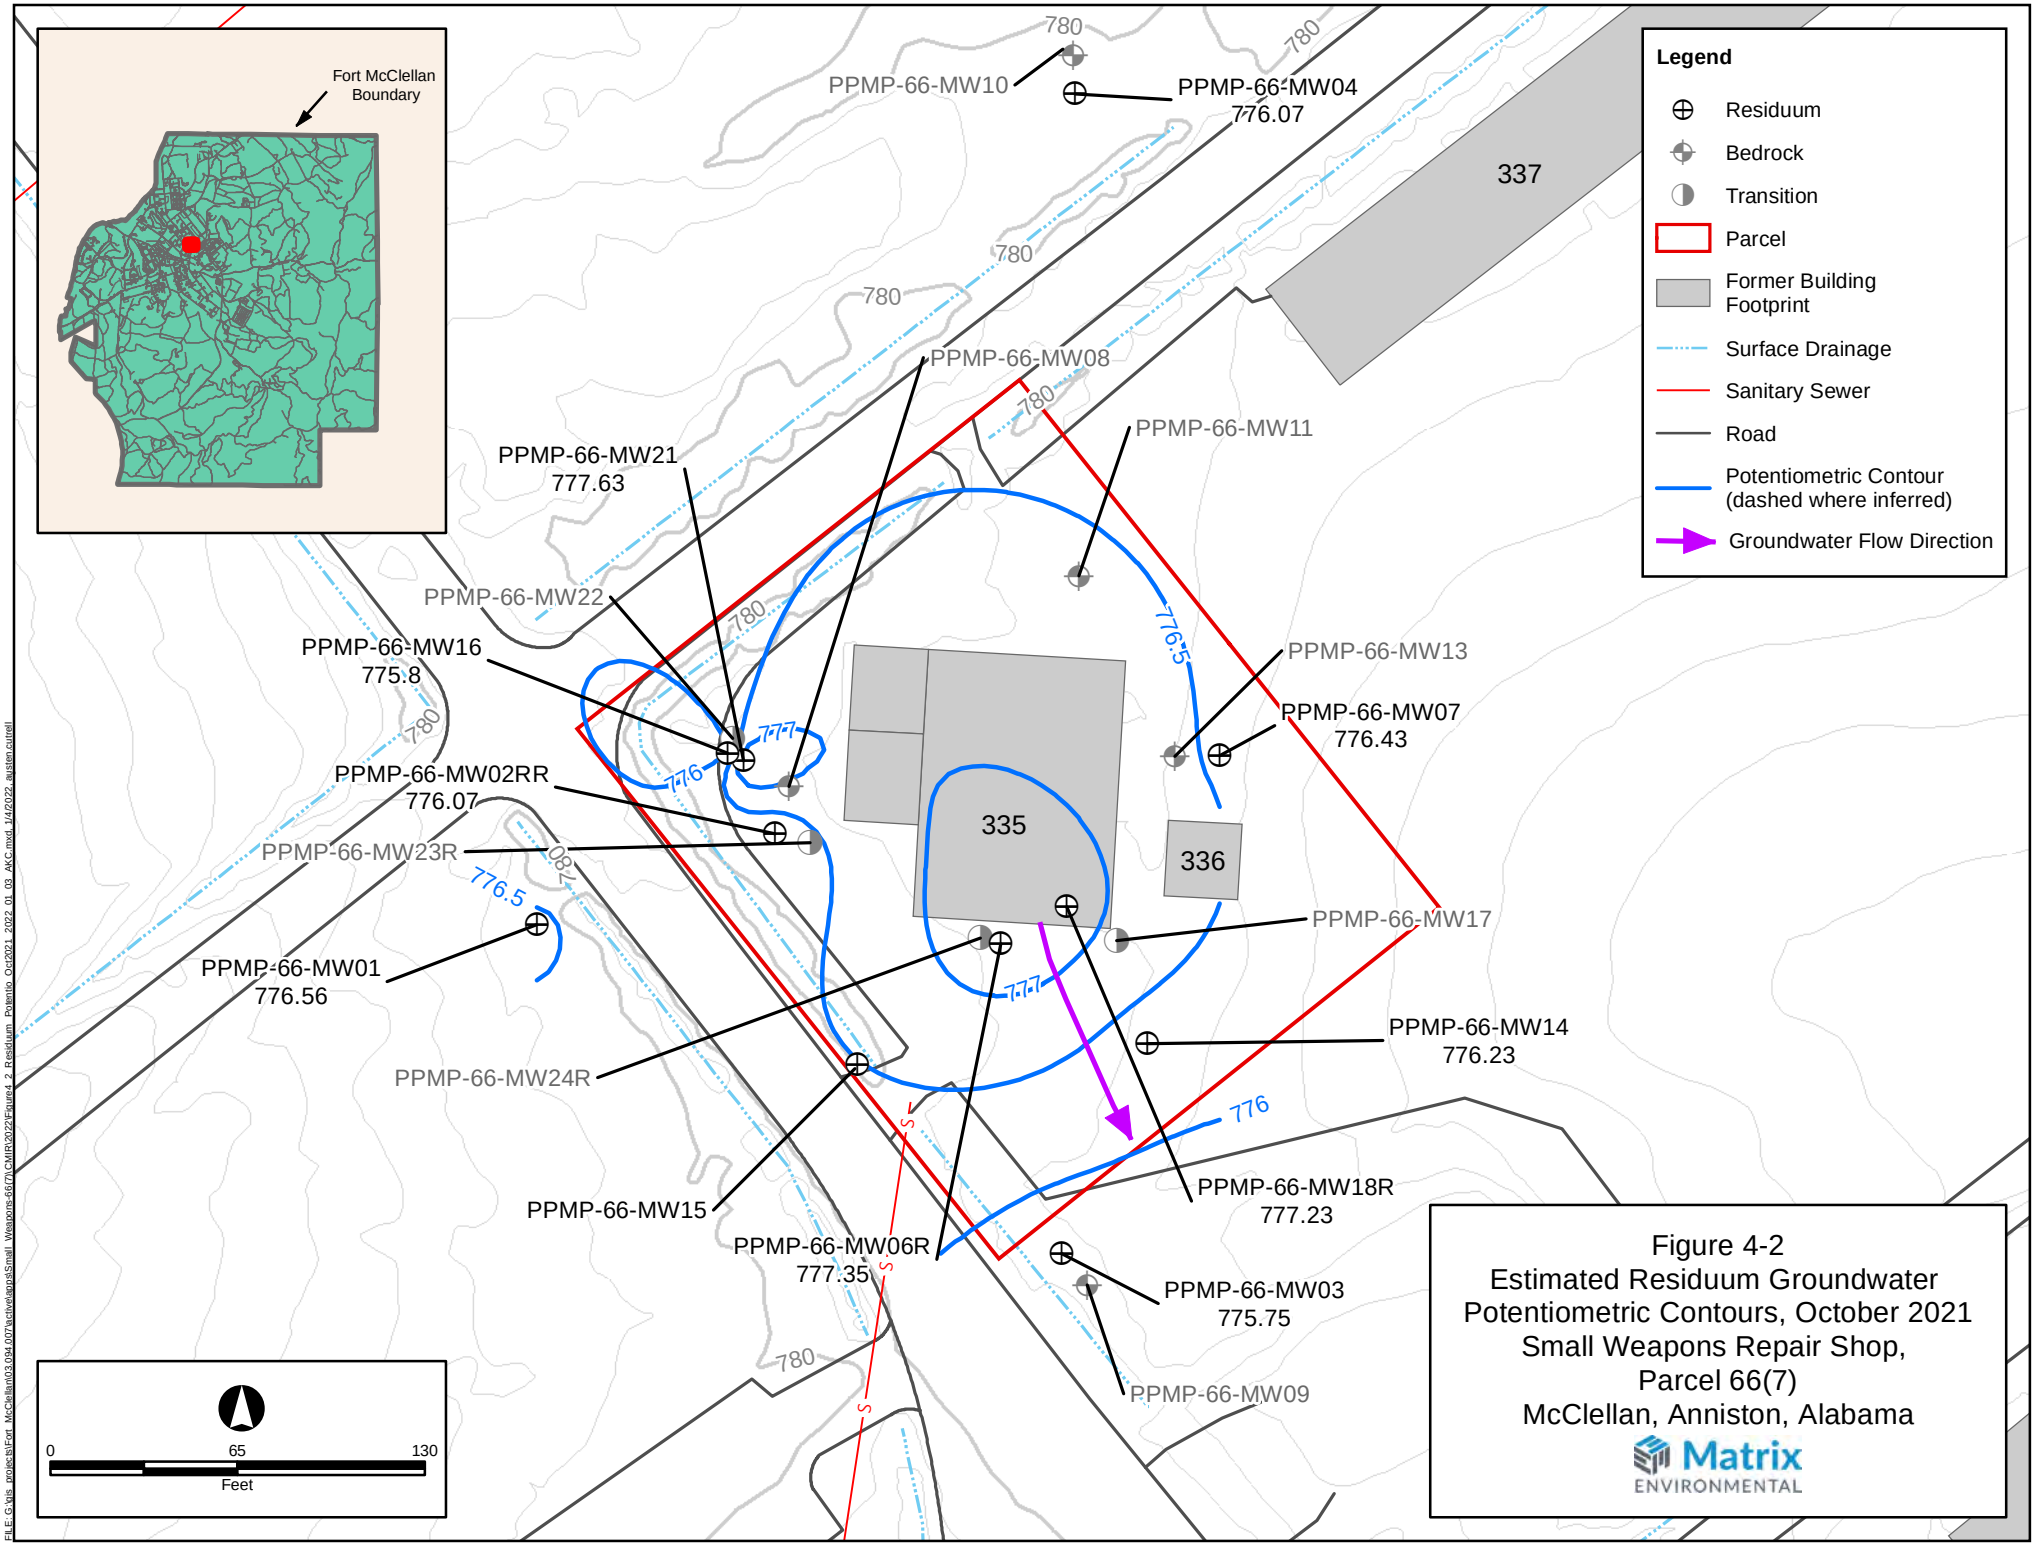
Figure 4-2
Estimated Residuum Groundwater Potentiometric Contours, October 2021
Small Weapons Repair Shop, Parcel 66(7)
McClellan, Anniston, Alabama

Groundwater was encountered at the Site at shallow depths for both semi-annual monitoring events during the eleventh year of LTM. During the eleventh year of LTM, groundwater in the residuum and transition zones appeared to flow radially from the site (Figures 4-1 and 4-2) and is consistent with past data.

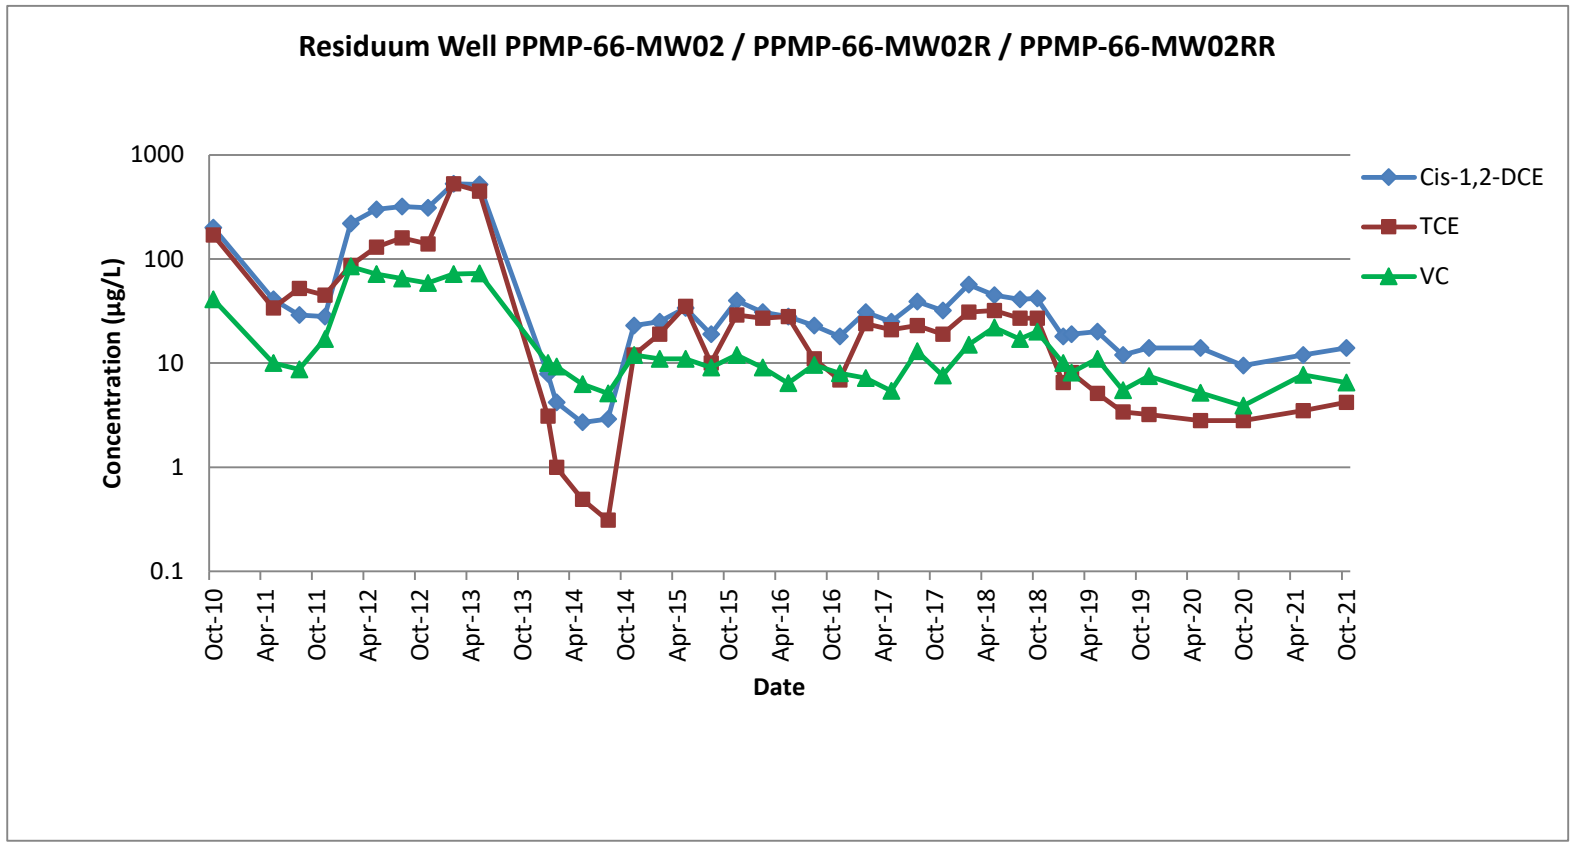
Figure 4-3: Volatile Concentrations in Residuum Well
PPMP-66-MW02 / PPMP-66-MW02R/ PPMP-66-MW02RR
Small Weapons, Parcel 66(7)
McClellan, Anniston, Alabama

Only vinyl chloride exceeded the groundskeeper RBTLs during the eleventh year of LTM, in residuum wells PPMP-66-MW02RR and in transition well PPMP-66-MW23R. Both of these wells are located in the vicinity of the estimated source area, south and southwest of the former Building 335. The lateral extent of vinyl chloride remained static in both the residuum and transition groundwater zones, compared to the baseline sampling event.

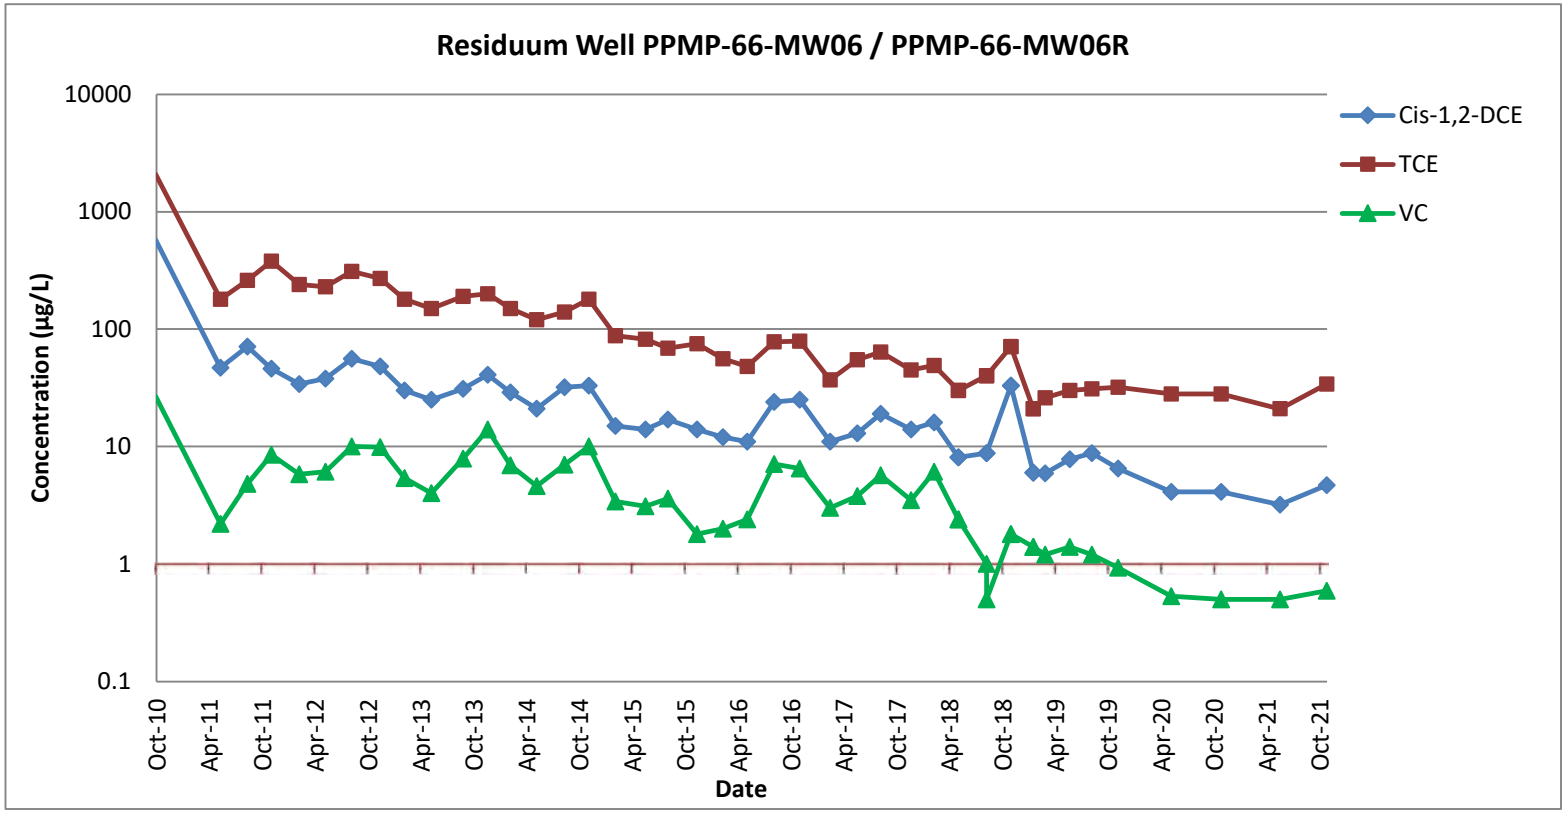
Figure 4-4: Volatile Concentrations in Residuum Well
PPMP-66-MW06 / PPMP-66-MW06R
Small Weapons, Parcel 66(7)
McClellan, Anniston, Alabama

Figures 4-3 to 4-6 show the trends in concentrations over time for the COCs. As indicated in the trend figures and Table 4-5a, wells PPMP-66-MW02RR and PPMP-66-MW23R showed small decreasing fluctuations during the eleventh year of monitoring compared to the prior years.

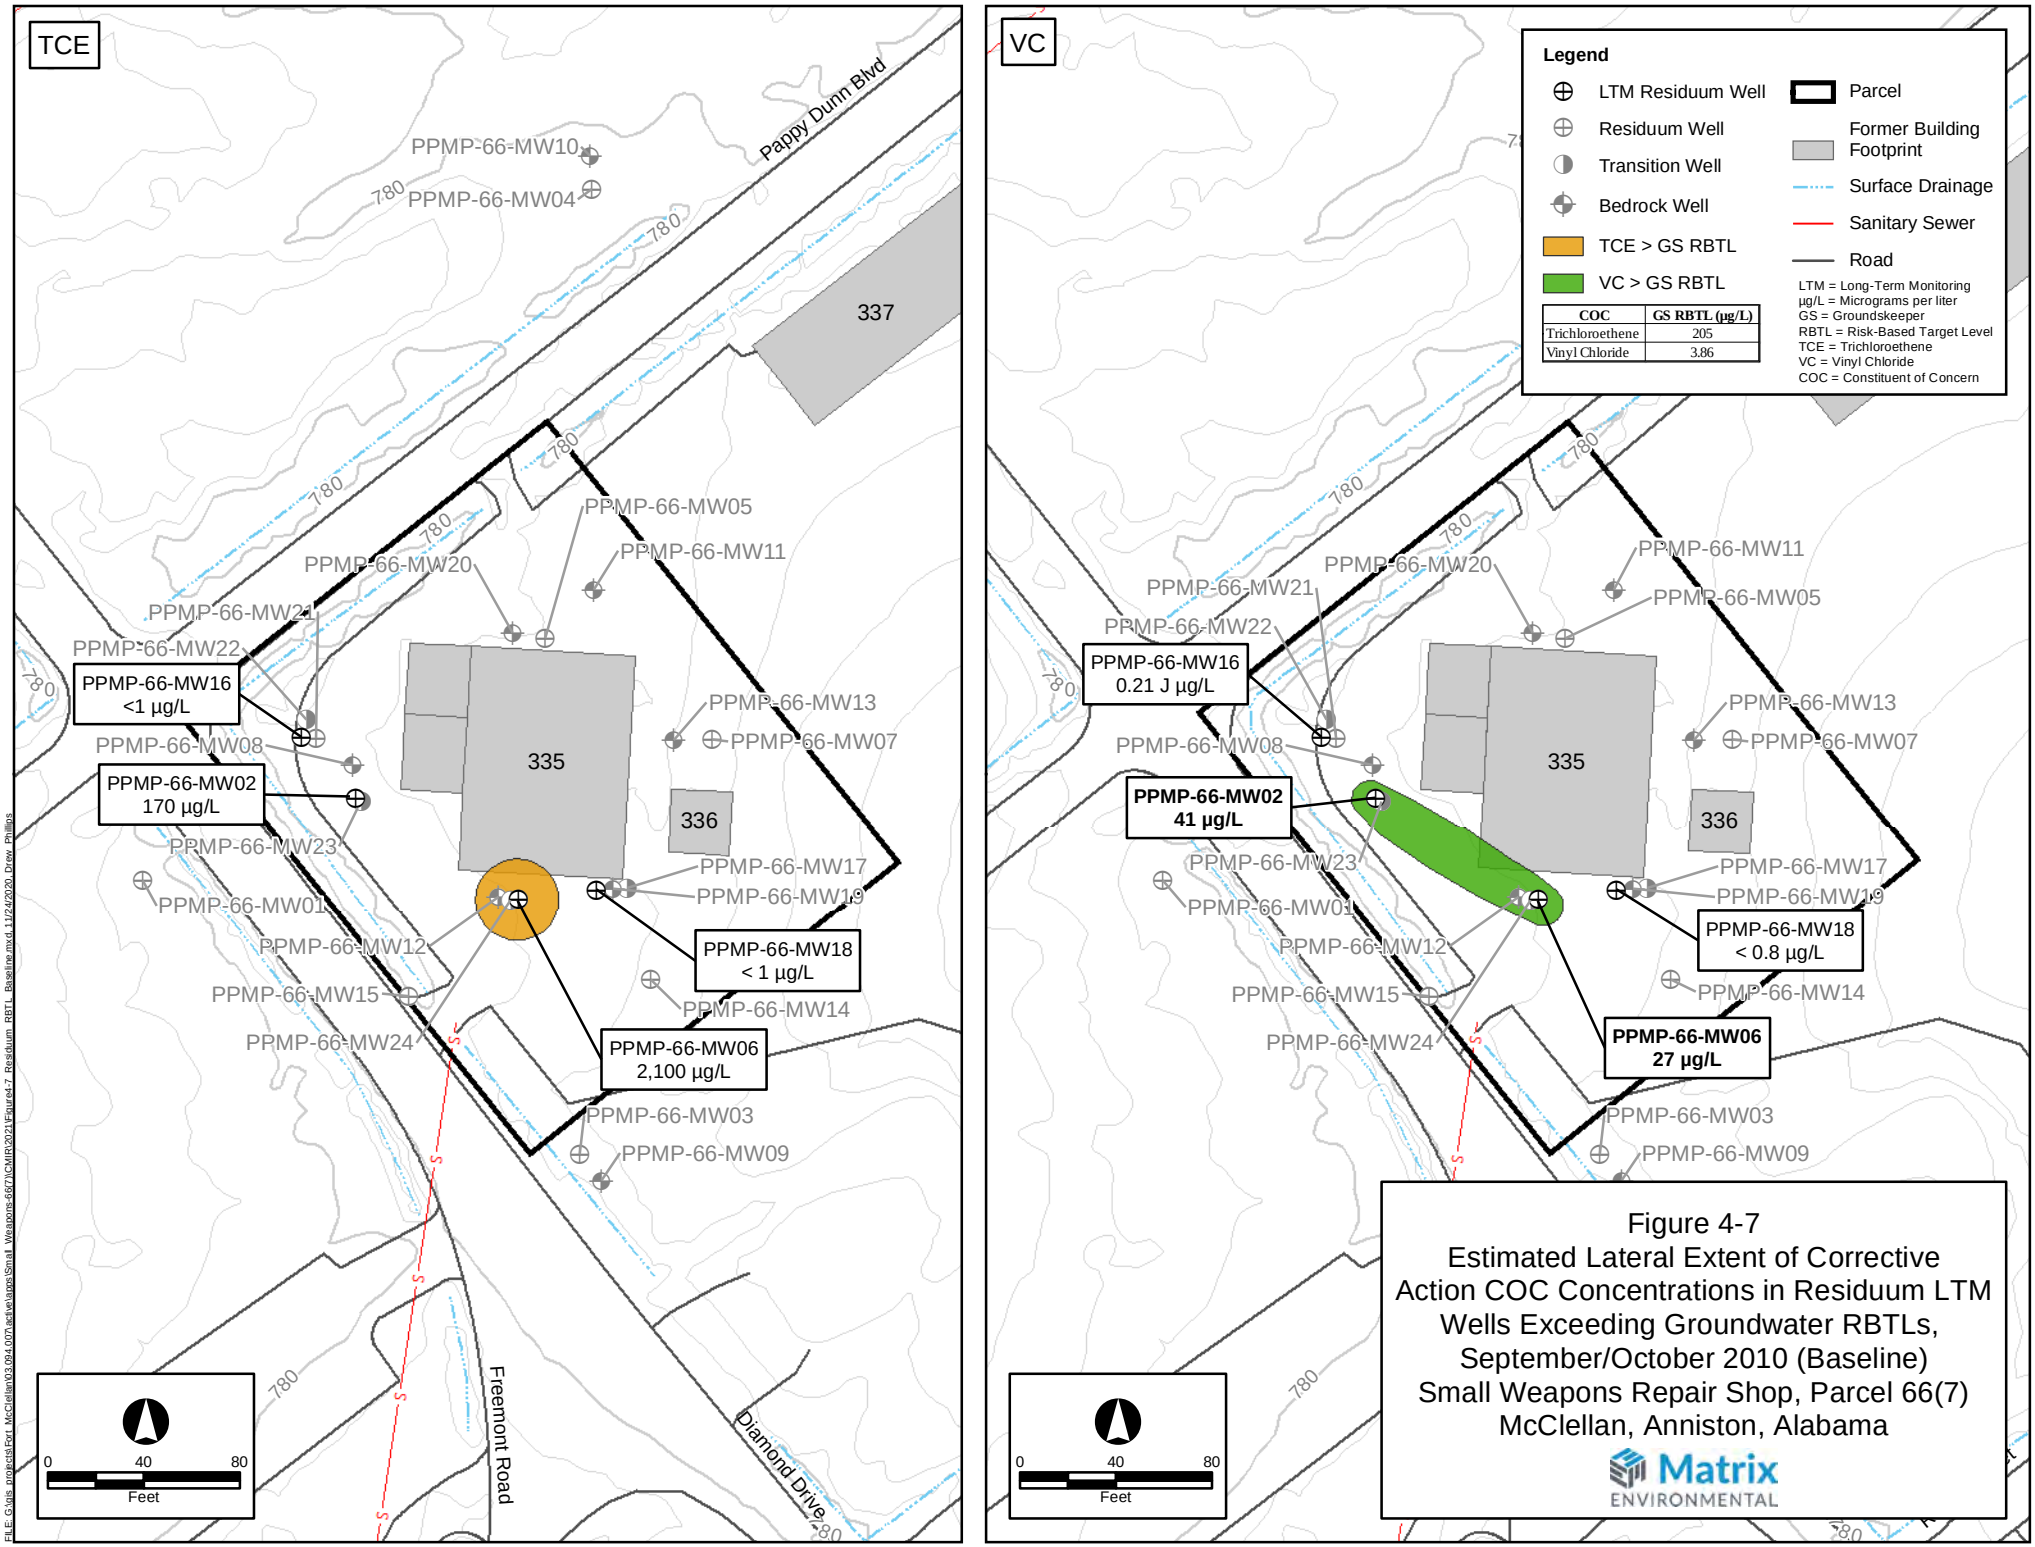
Figure 4-7
Estimated Lateral Extent of Corrective Action COC Concentrations in Residuum LTM Wells Exceeding Groundwater RBTLs, September/October 2010 (Baseline)
Small Weapons Repair Shop, Parcel 66(7)
McClellan, Anniston, Alabama

Figures 4-7 and 4-8 present the estimated lateral extent of TCE and vinyl chloride concentrations exceeding the groundskeeper RBTLs for the residuum and transition groundwater zones at the Site for the baseline September/October 2010 sampling event. Figures 4-9 to 4-12 present the estimated lateral extent of TCE and vinyl chloride concentrations for the residuum and transition groundwater zones at the Site for the eleventh year of LTM. The concentrations of vinyl chloride exceeding the groundskeeper RBTL in groundwater during this reporting period were located south and southwest of former Building 335.
