Appendix F

Daily Reports

SUXOS DAILY REPORT

Removal Action
Fort McClellan Tract 7B

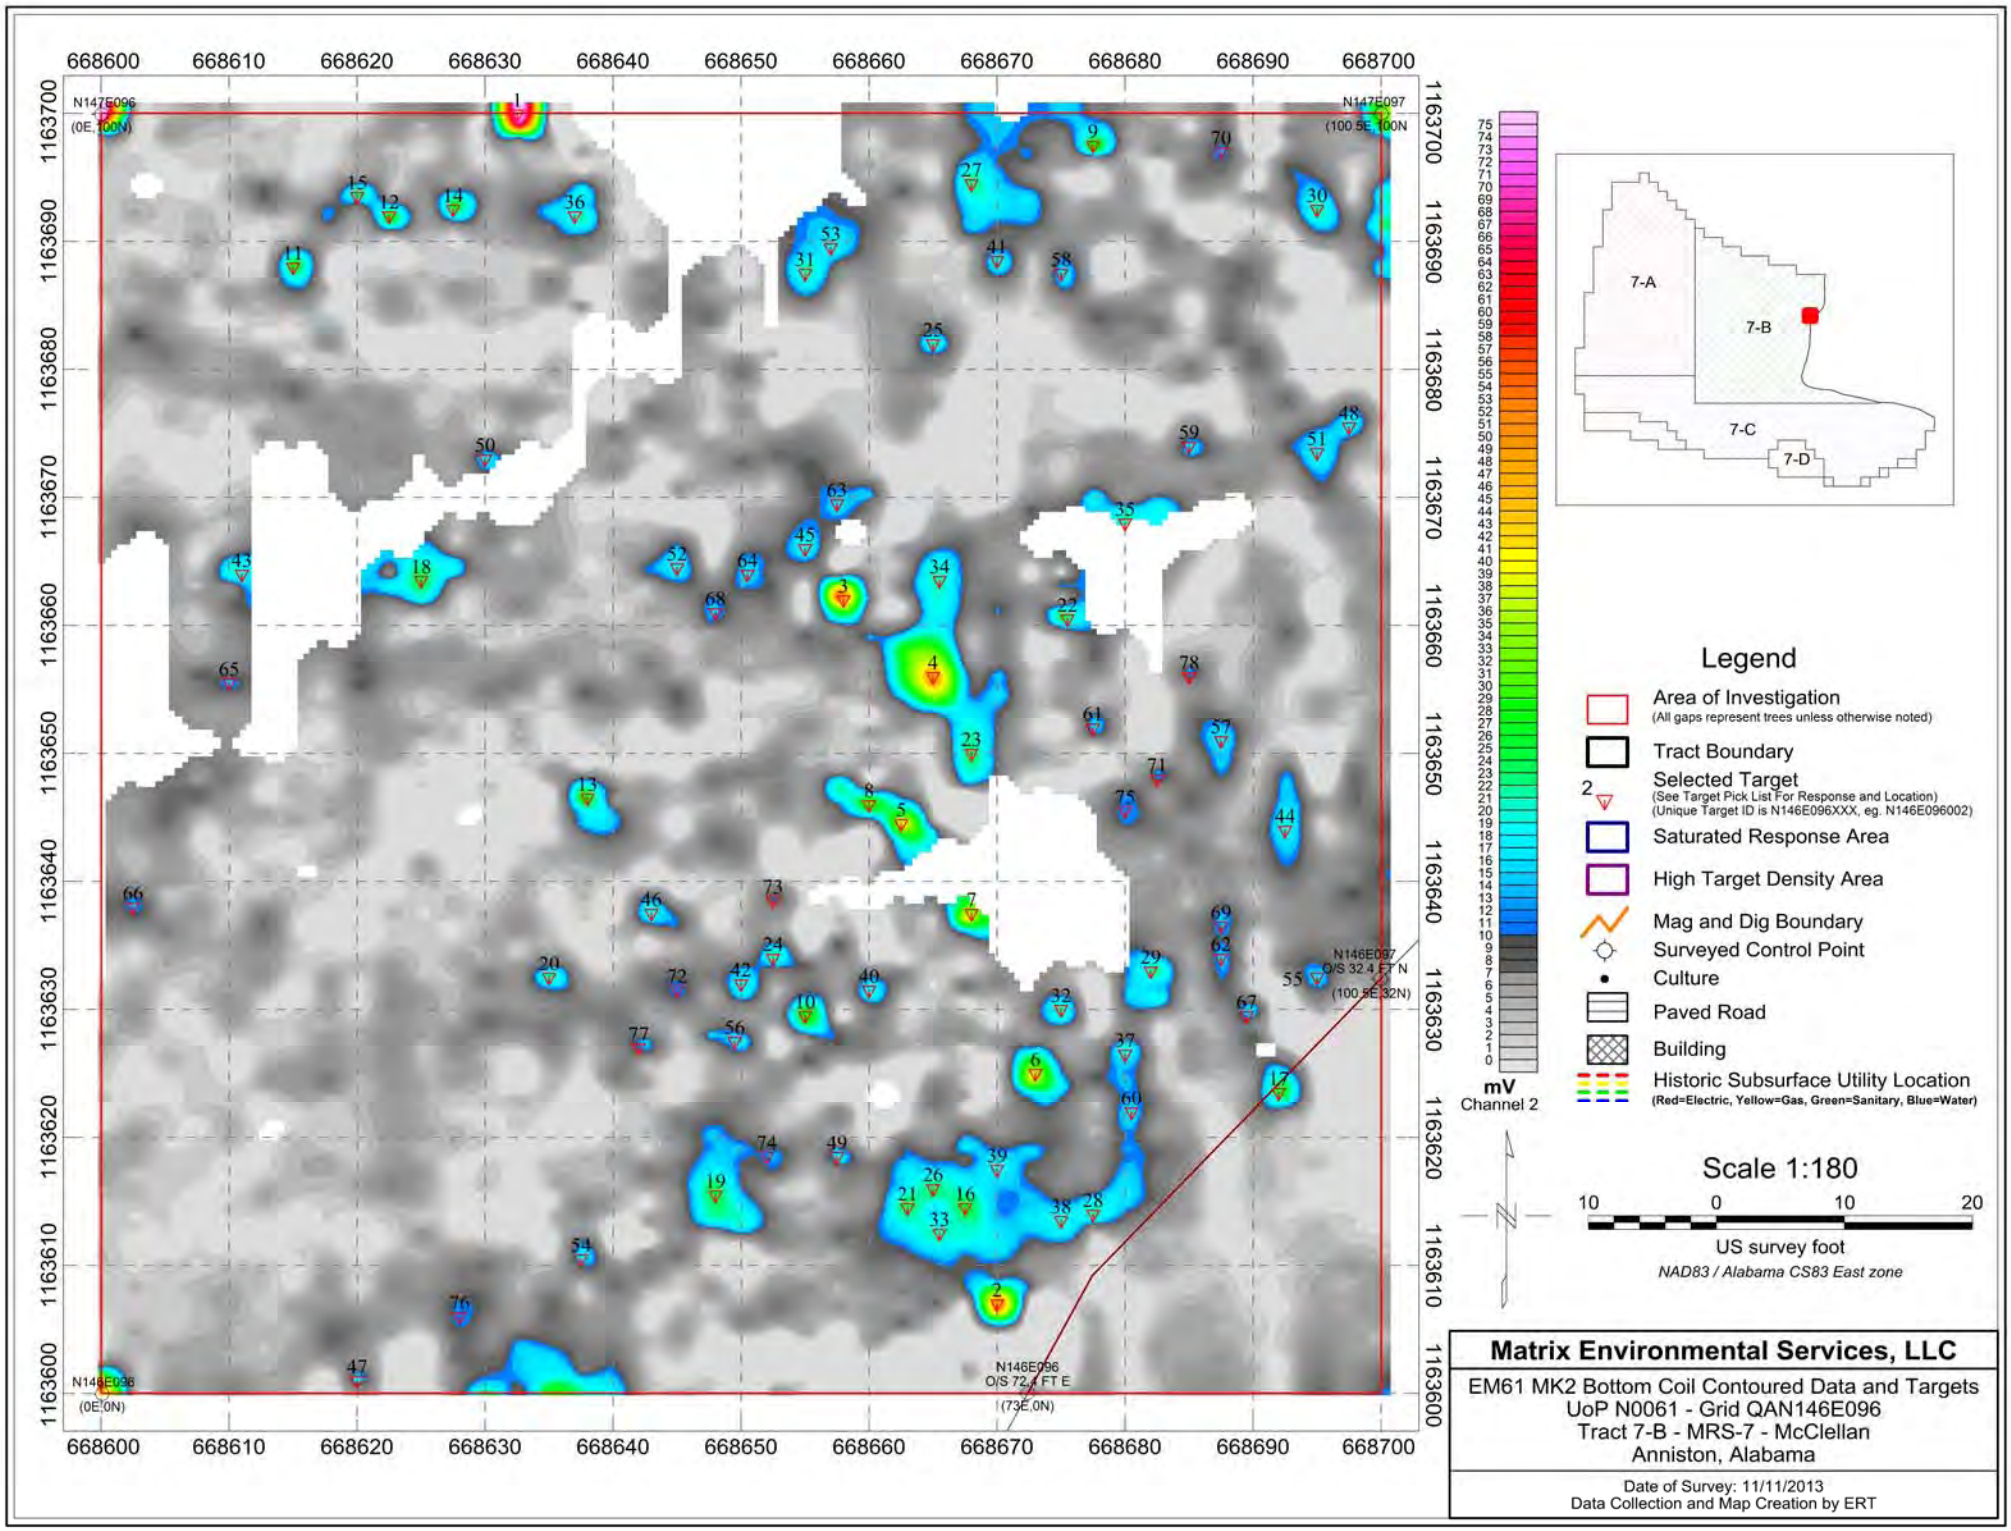
EM61 MK2 Bottom Coil Contoured Data and Targets
UoP N0105 - Grid QAN129E102
Tract 7-C - MRS-7 - McClellan
Anniston, Alabama

Grid N129E102 is located in a wooded area with steep slope. The data gaps on the map were caused by trees. One target anomaly of 10.3 mV was identified, which was located at a spoil pile.
