# THE MEMPHIS DEPOT TENNESSEE

## ADMINISTRATIVE RECORD COVER SHEET

RE: RCRA Facility Assessment (RFA) Findings  
DOD Defense Depot Memphis  
EPA I.D. No. TN4 210 020 570

APPENDIX B  
VSI Log Book

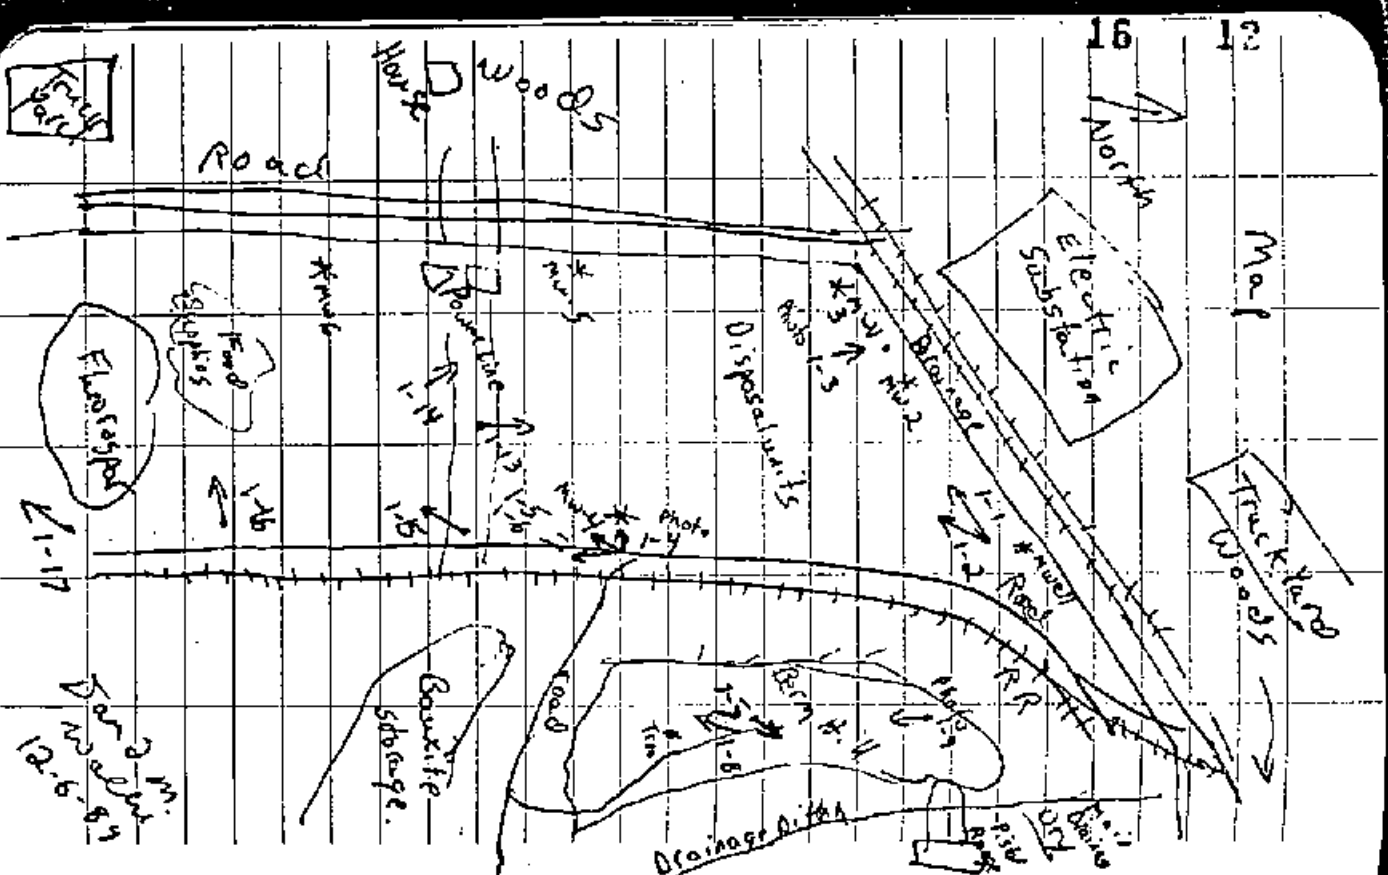
Memphis Sands and  
 Fort Pillow Sands  
 is Main Water Bearing  
 Sands.  
 photo's Number  
 0945  
 1-1 Southwest  
 1-2 South  
 photo's show surface of  
 old Disposal Areas  
 Area is grassed  
 Lots of the grass is still green  
 even in December  
 Two large pines on the  
 North boundary approx 25' tall  
 Do not look stressed

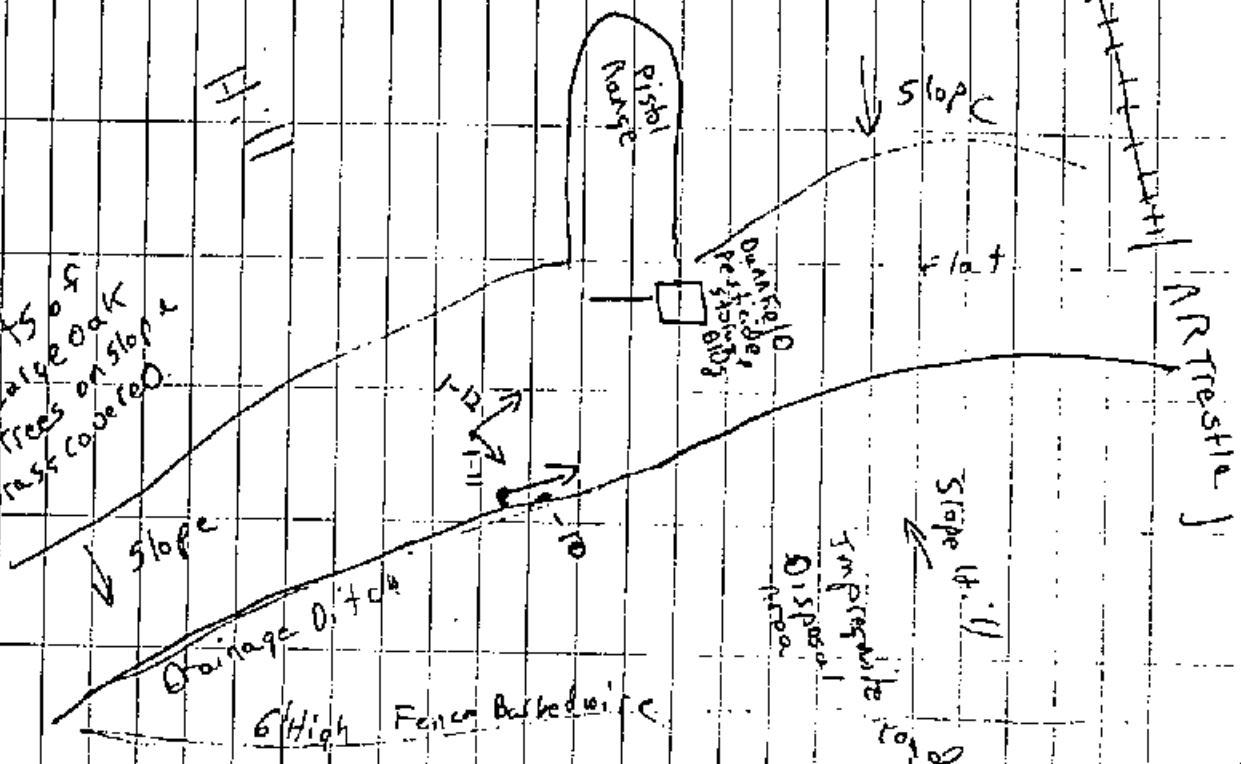
10:15 Photo 1-10  
Looking North along  
Dunn Field Drainage  
Ditches possible AOC  
To the left is pistol  
Range  
on the top of the hill  
to the left North ground  
or west is asphalt disposal  
and CN disposal  
possible Run off or  
leachate that was affected  
by the CN or asphalt  
area or pesticide storage  
would drain to this  
drainage ditch

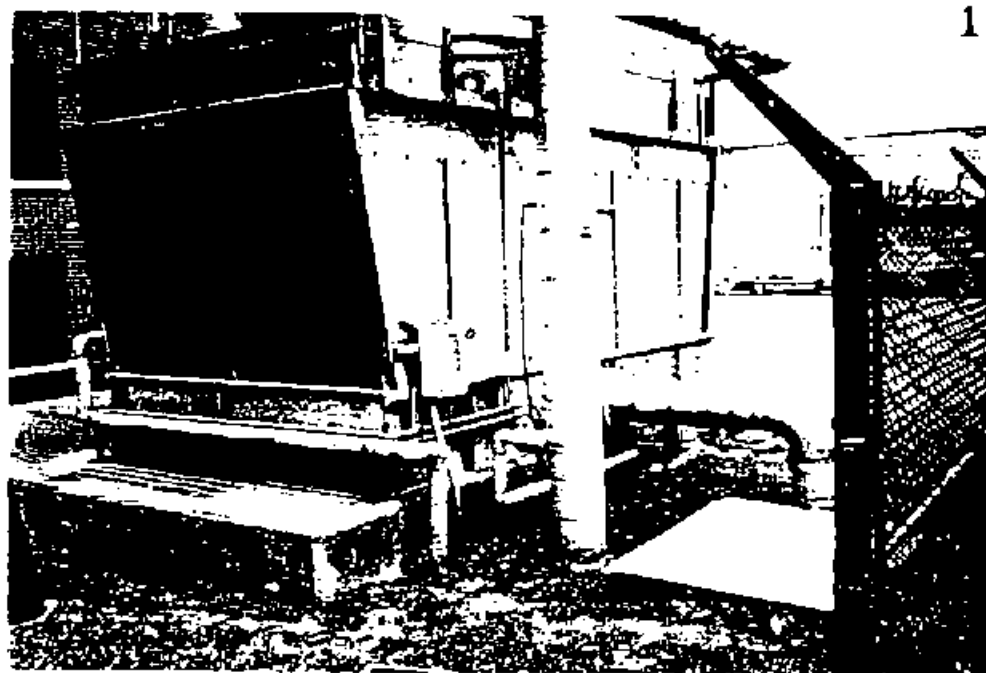
Photograph No. 3-1 Looking southwest at NPDES discharge point No. 002, which is for the Building 144 (Administration) Cooling Tower. (Photograph taken December 7, 1989, by Jack Slechta of A.T. Kearney.)

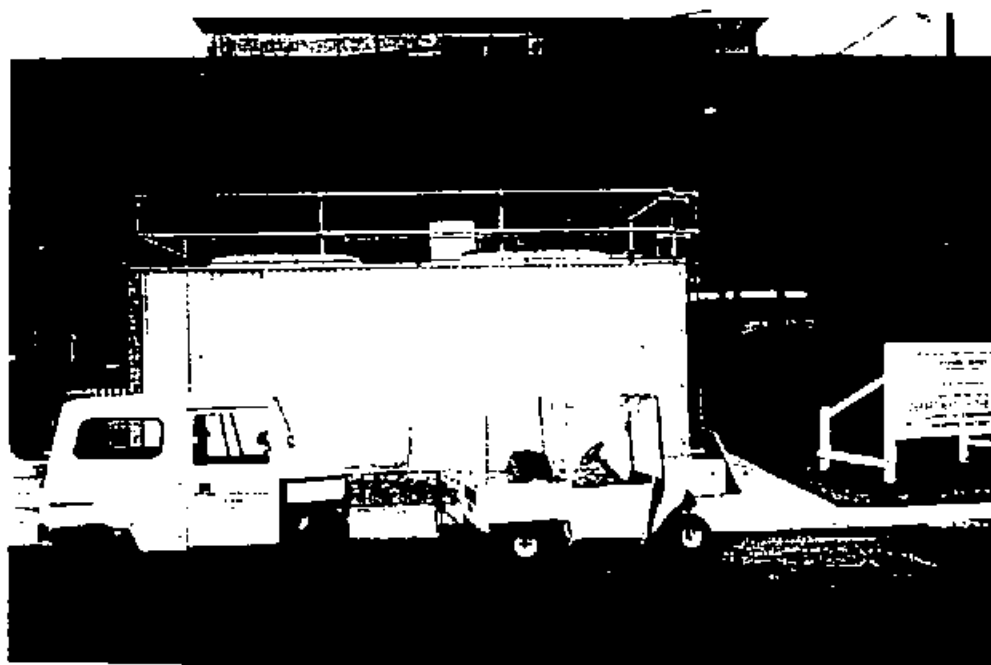
Photograph No. 3-2 Looking north at the Building 210 Cooling Tower. This is the source for NPDES discharge point No. 001. (Photograph taken December 7, 1989, by Jack Slechta of A.T. Kearney.)

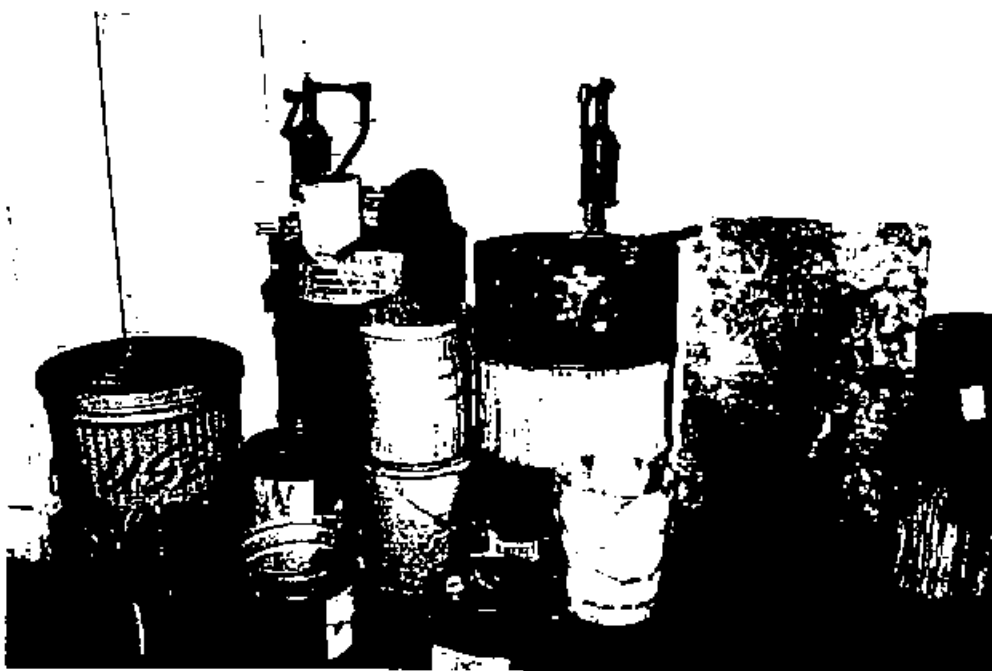
Photograph No. 3-4    Looking west at the Satellite Drum Accumulation Area (SWMU No. 41) located in the Building 260 Sign Shop. The drums and containers show evidence of spills which have occurred during filling. (Photograph taken December 7, 1989, by Jack Slechta of A.T. Kearney.)

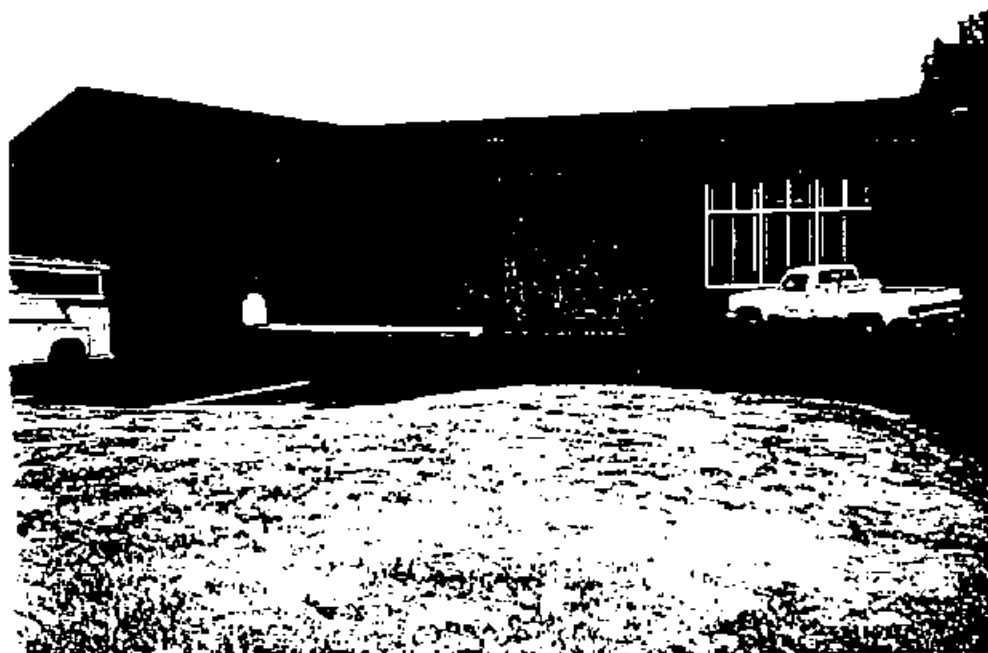
Photograph No. 3-6 Looking east at the Former PCB Transformer Storage Area (SWMU No. 48). The unit is located beneath the new cafeteria which is shown in the photograph. (Photograph taken December 7, 1989, by Jack Slechta of A.T. Kearney.)

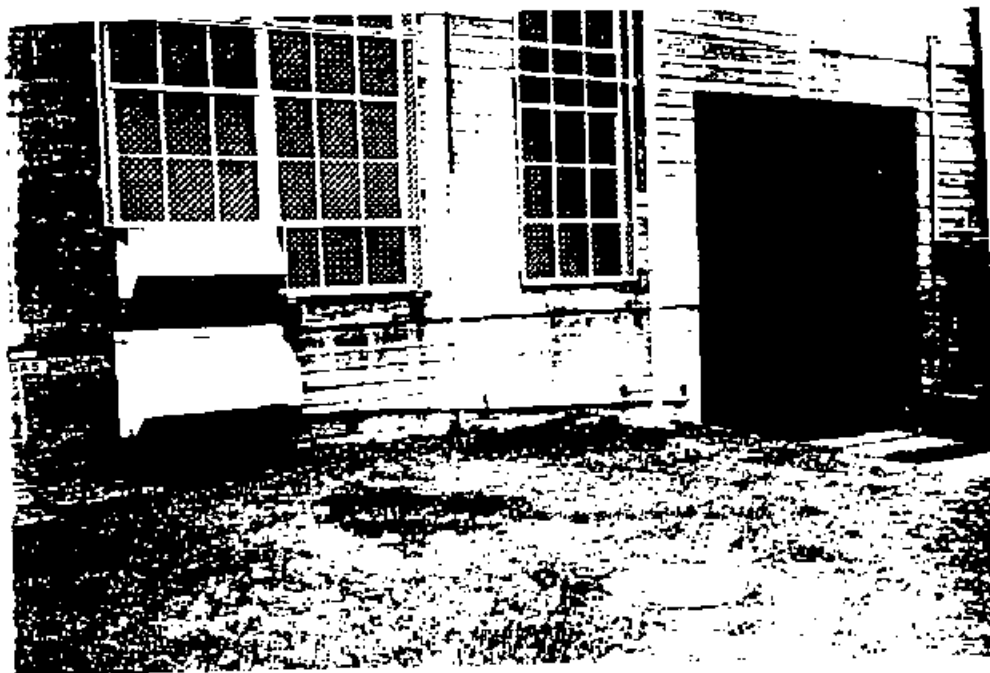
Photograph No. 3-7 Looking southwest at the exterior of the Medical Waste Storage Area (SWMU No. 49). (Photograph taken December 7, 1989, by Jack Slechta of A.T. Kearney.)
