Appendix B

Landfill Cap Inspection Checklist Items for Landfill 1, Landfill 2, Landfill 4, and Garbage Dump and Fill Area East of Reilly

Specific Site Identification: Ft McClellan Landfill 1 Date: October 21, 2010

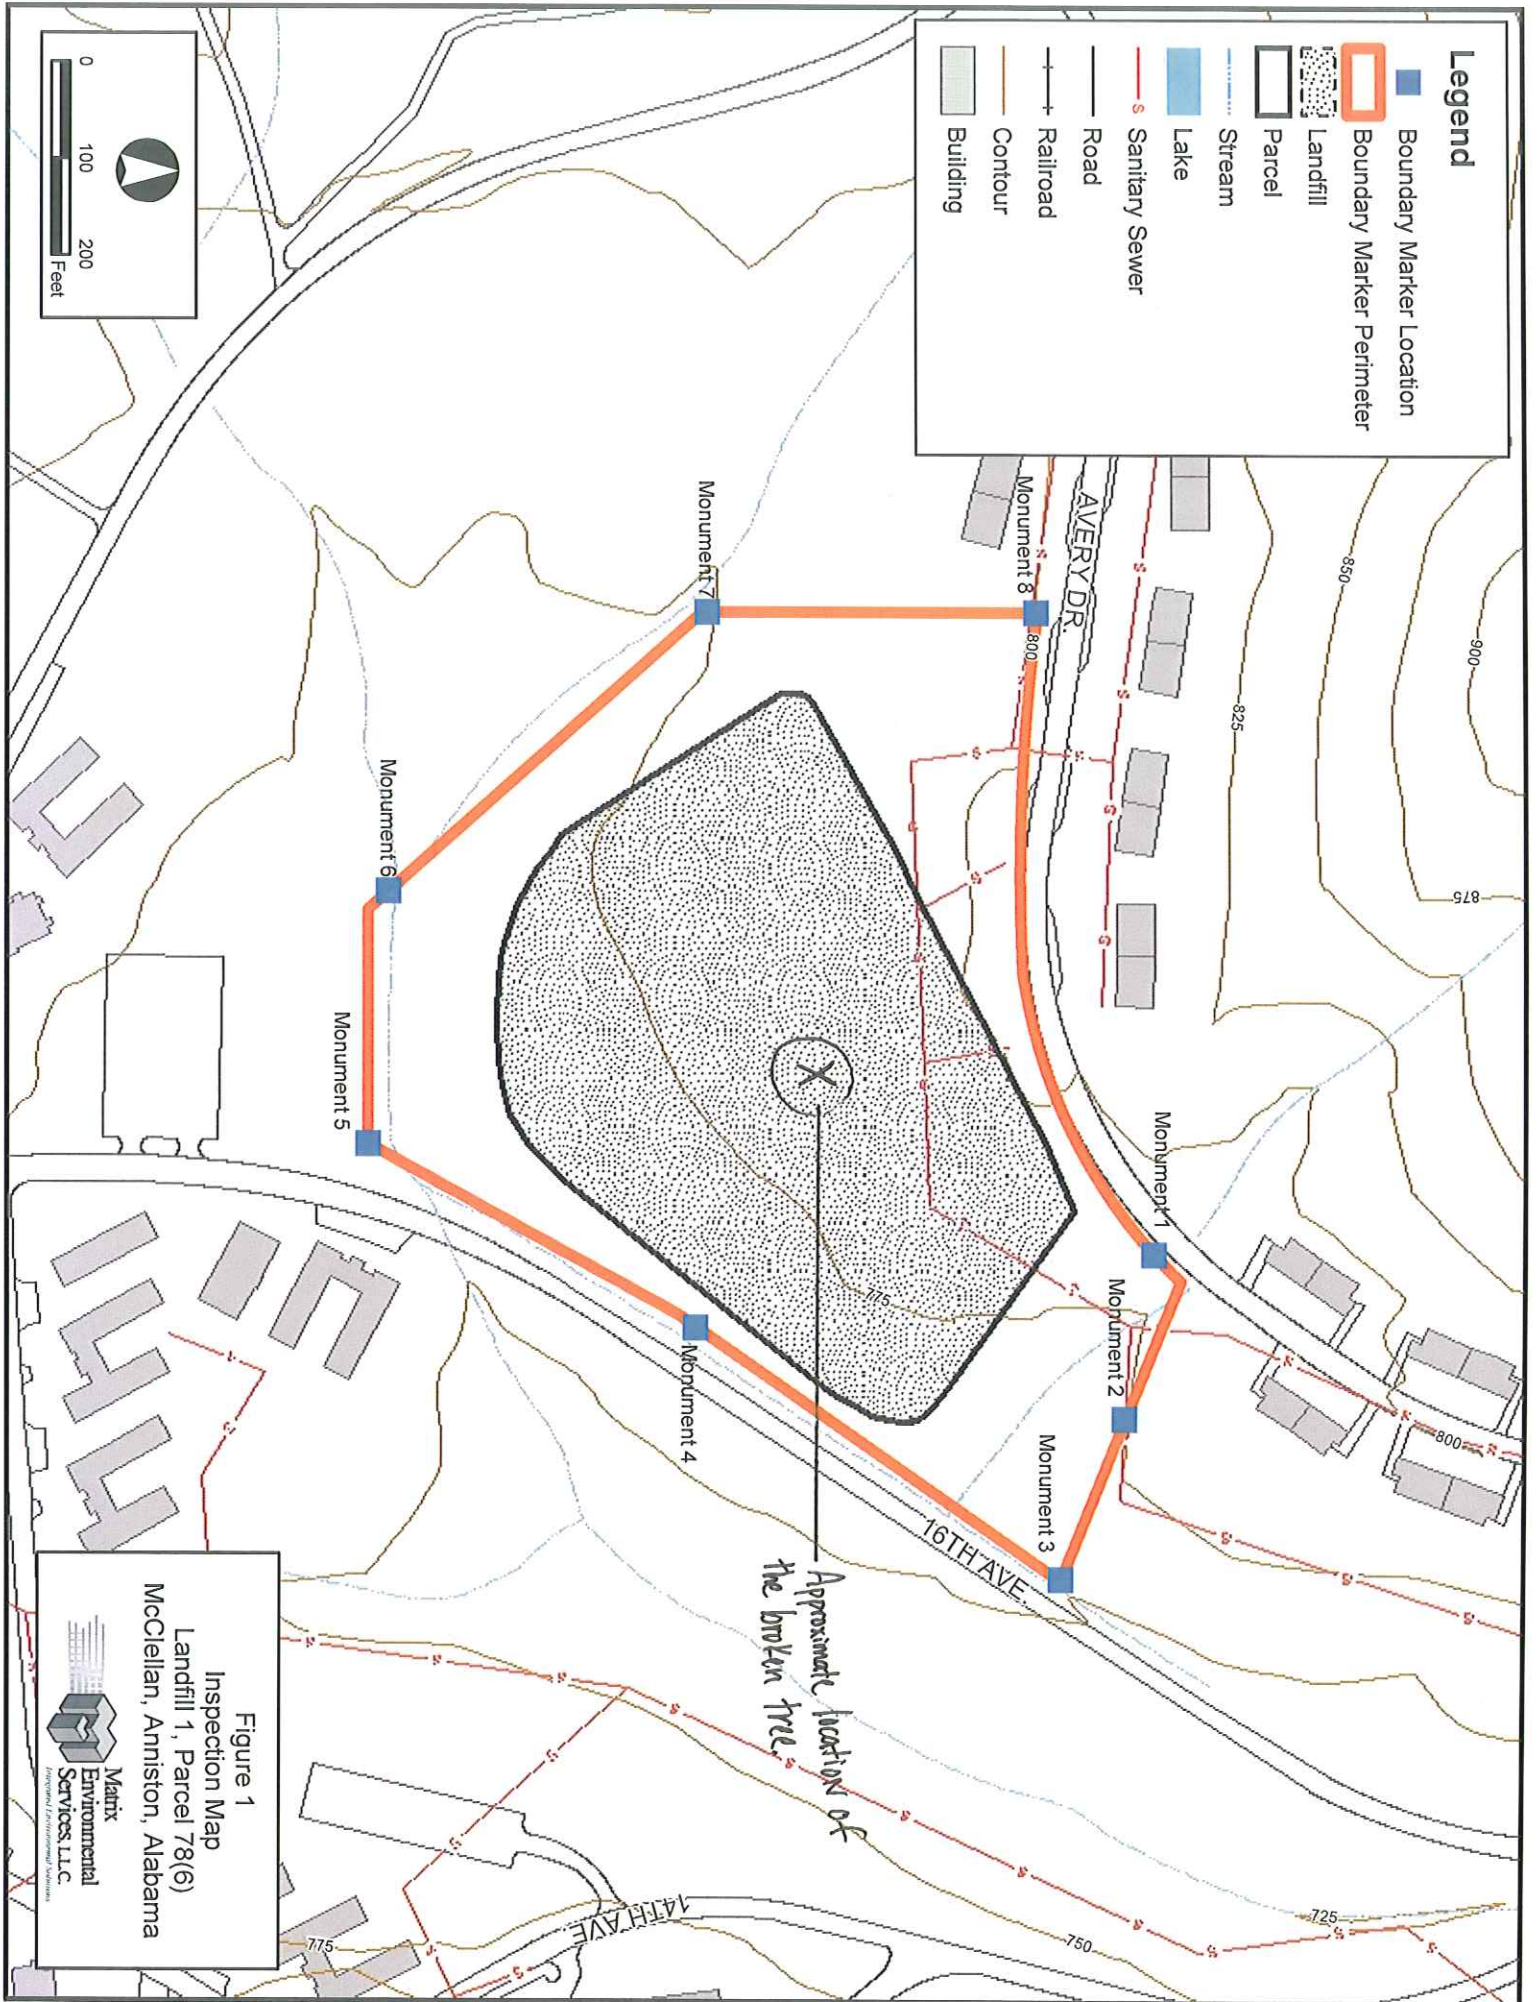
No visible signs of erosion or exposed debris were observed during the cap inspection. An oak tree in the center of the landfill had died and had been topped by the wind. (See photo log). The rootball was not exposed and the fallen branches did not penetrate the cap surface.

An old oak tree in the center of Landfill 1 died and broke in half; root ball was not exposed and cap surface not damaged.

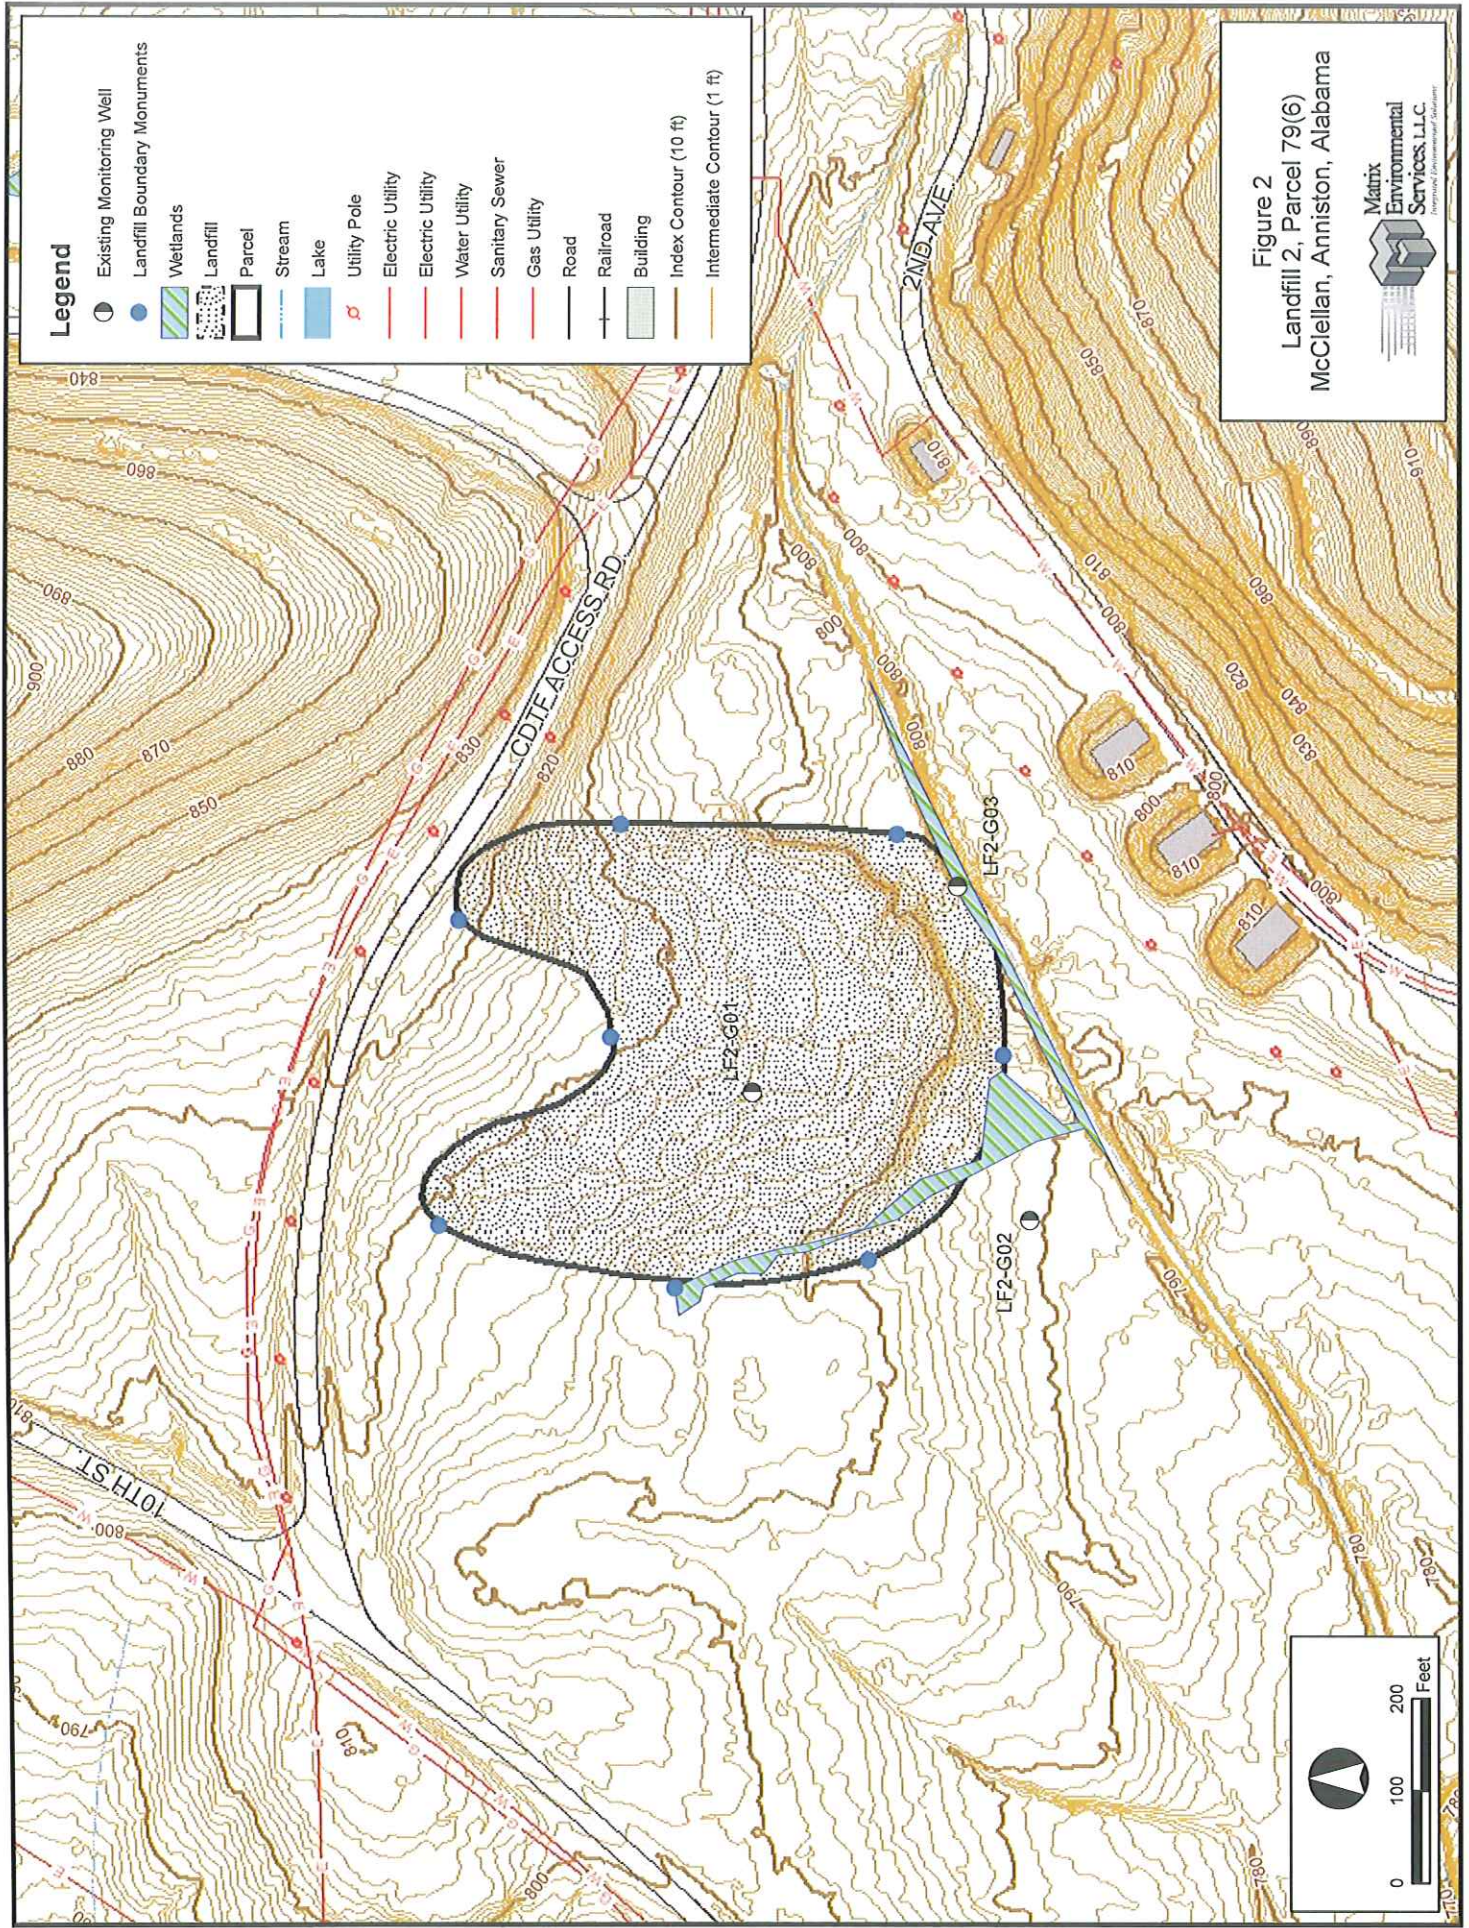
The boundary markers were in good condition.

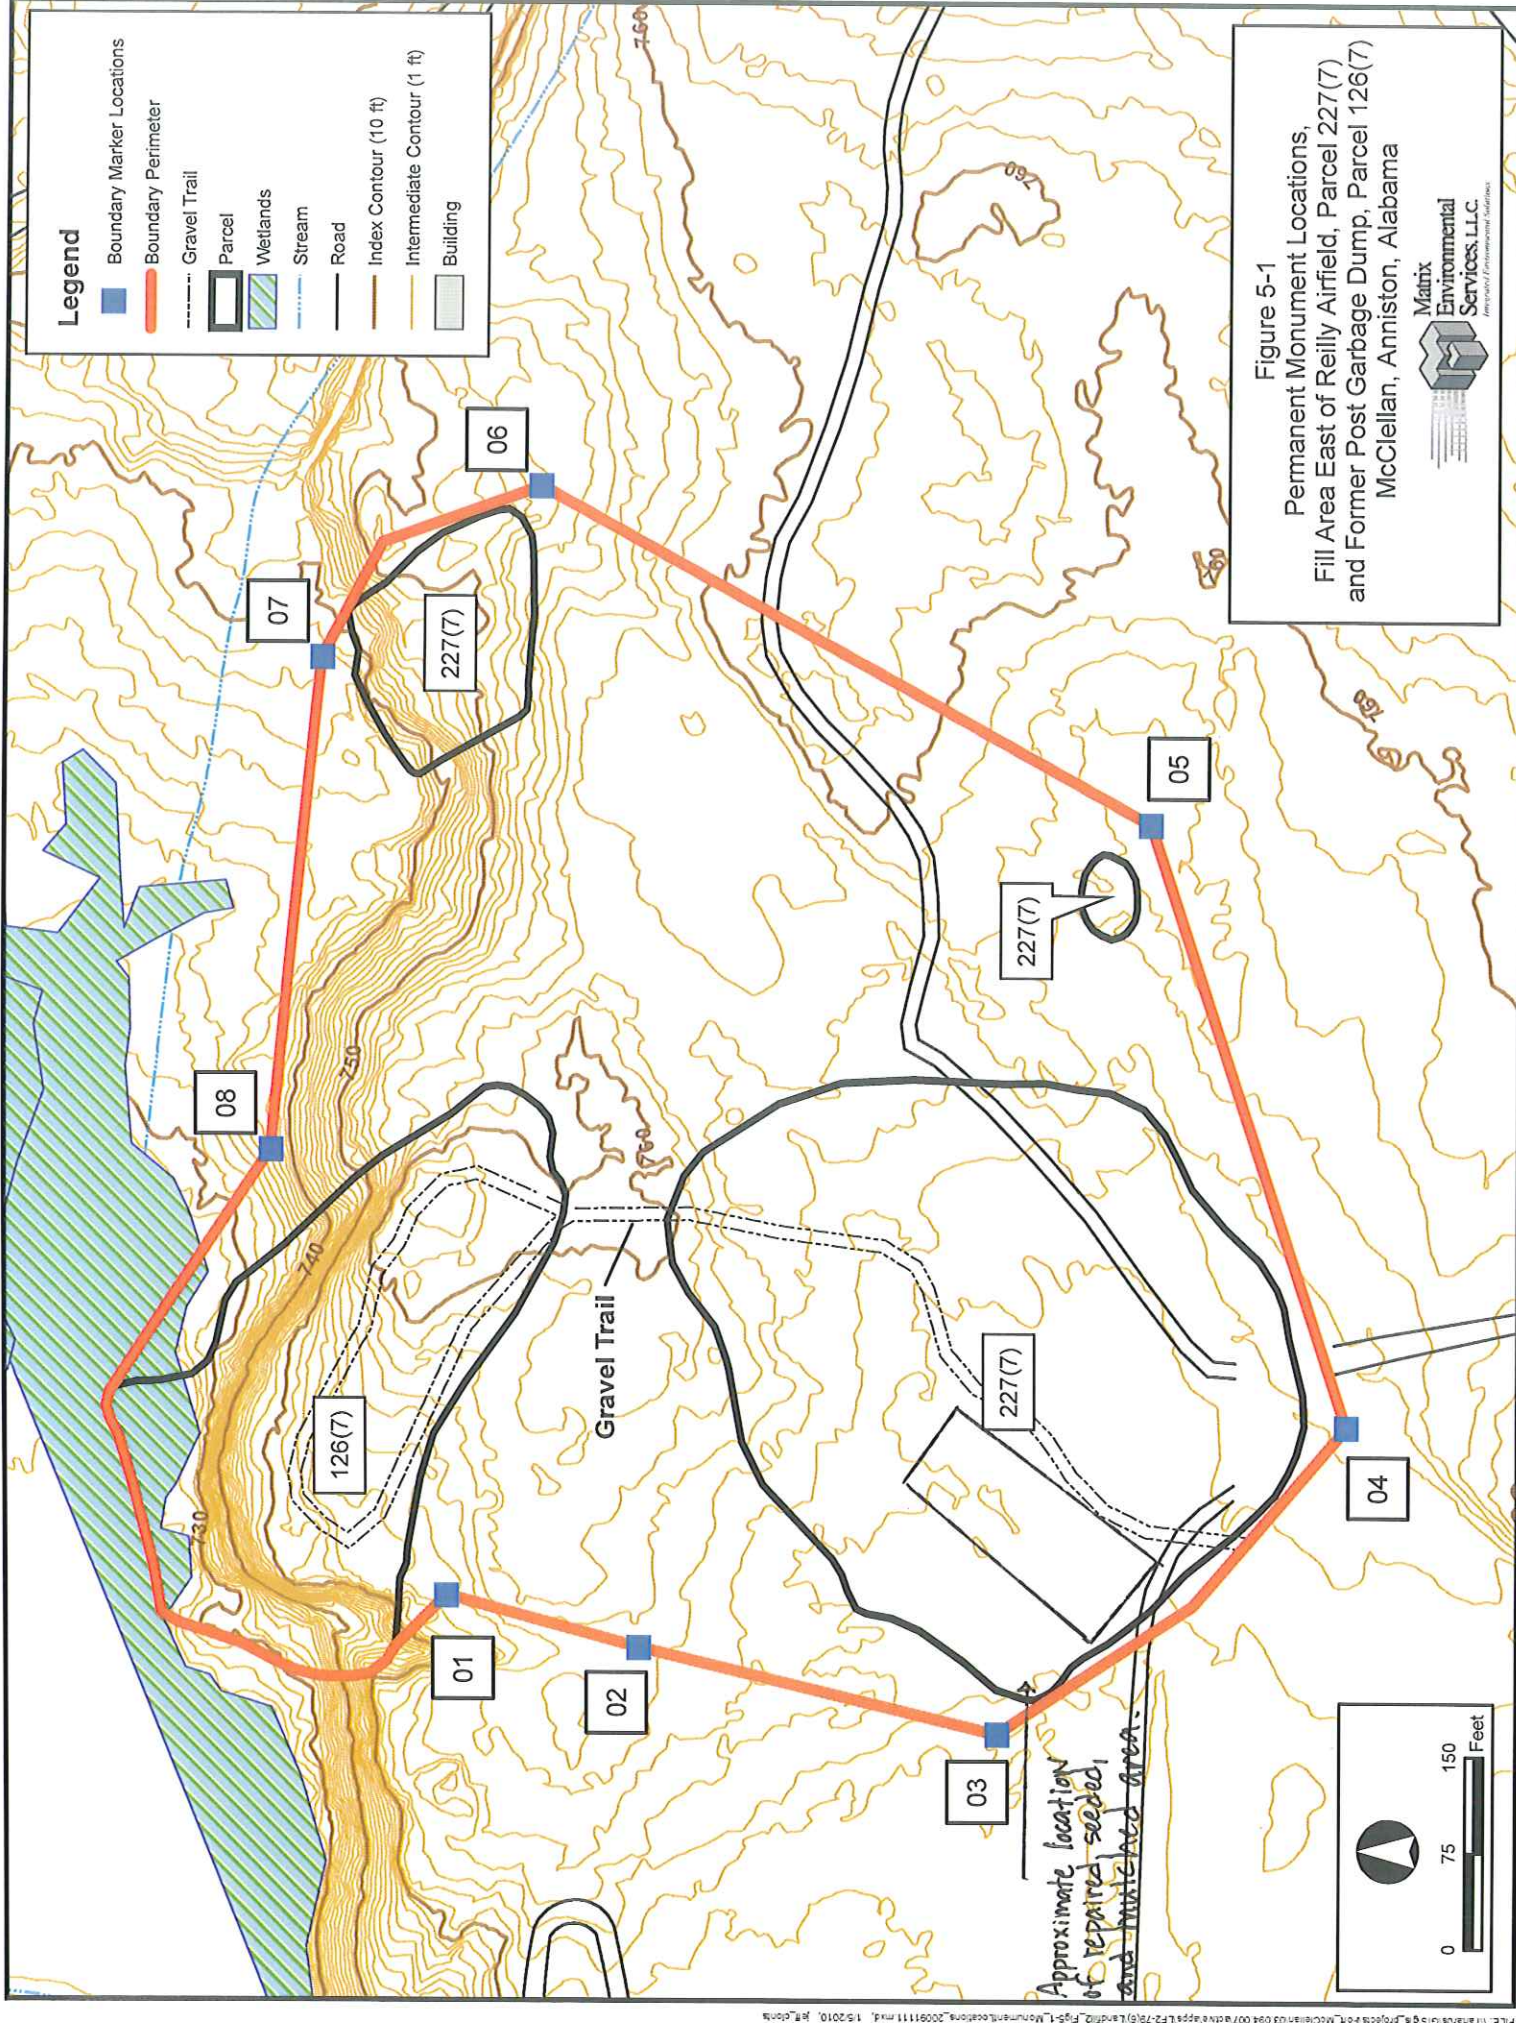
The boundary markers were all in good condition.
