**FINAL
MAINTENANCE OF EROSION CONTROL FEATURES AND
VEGETATION LETTER REPORT OF ACTIVITIES,
YEAR 4, EVENT 1**

**FORMER 81MM MORTAR RANGE, BAINS GAP ROAD
RANGES, FORMER CHOCCOLOCCO CORRIDOR
RANGES, AND RANGES NEAR TRAINING AREA T-24A**

**ENVIRONMENTAL REMEDIATION SERVICES AT FOUR
SITES, FORT MCCLELLAN, ANNISTON, ALABAMA**

February 2019

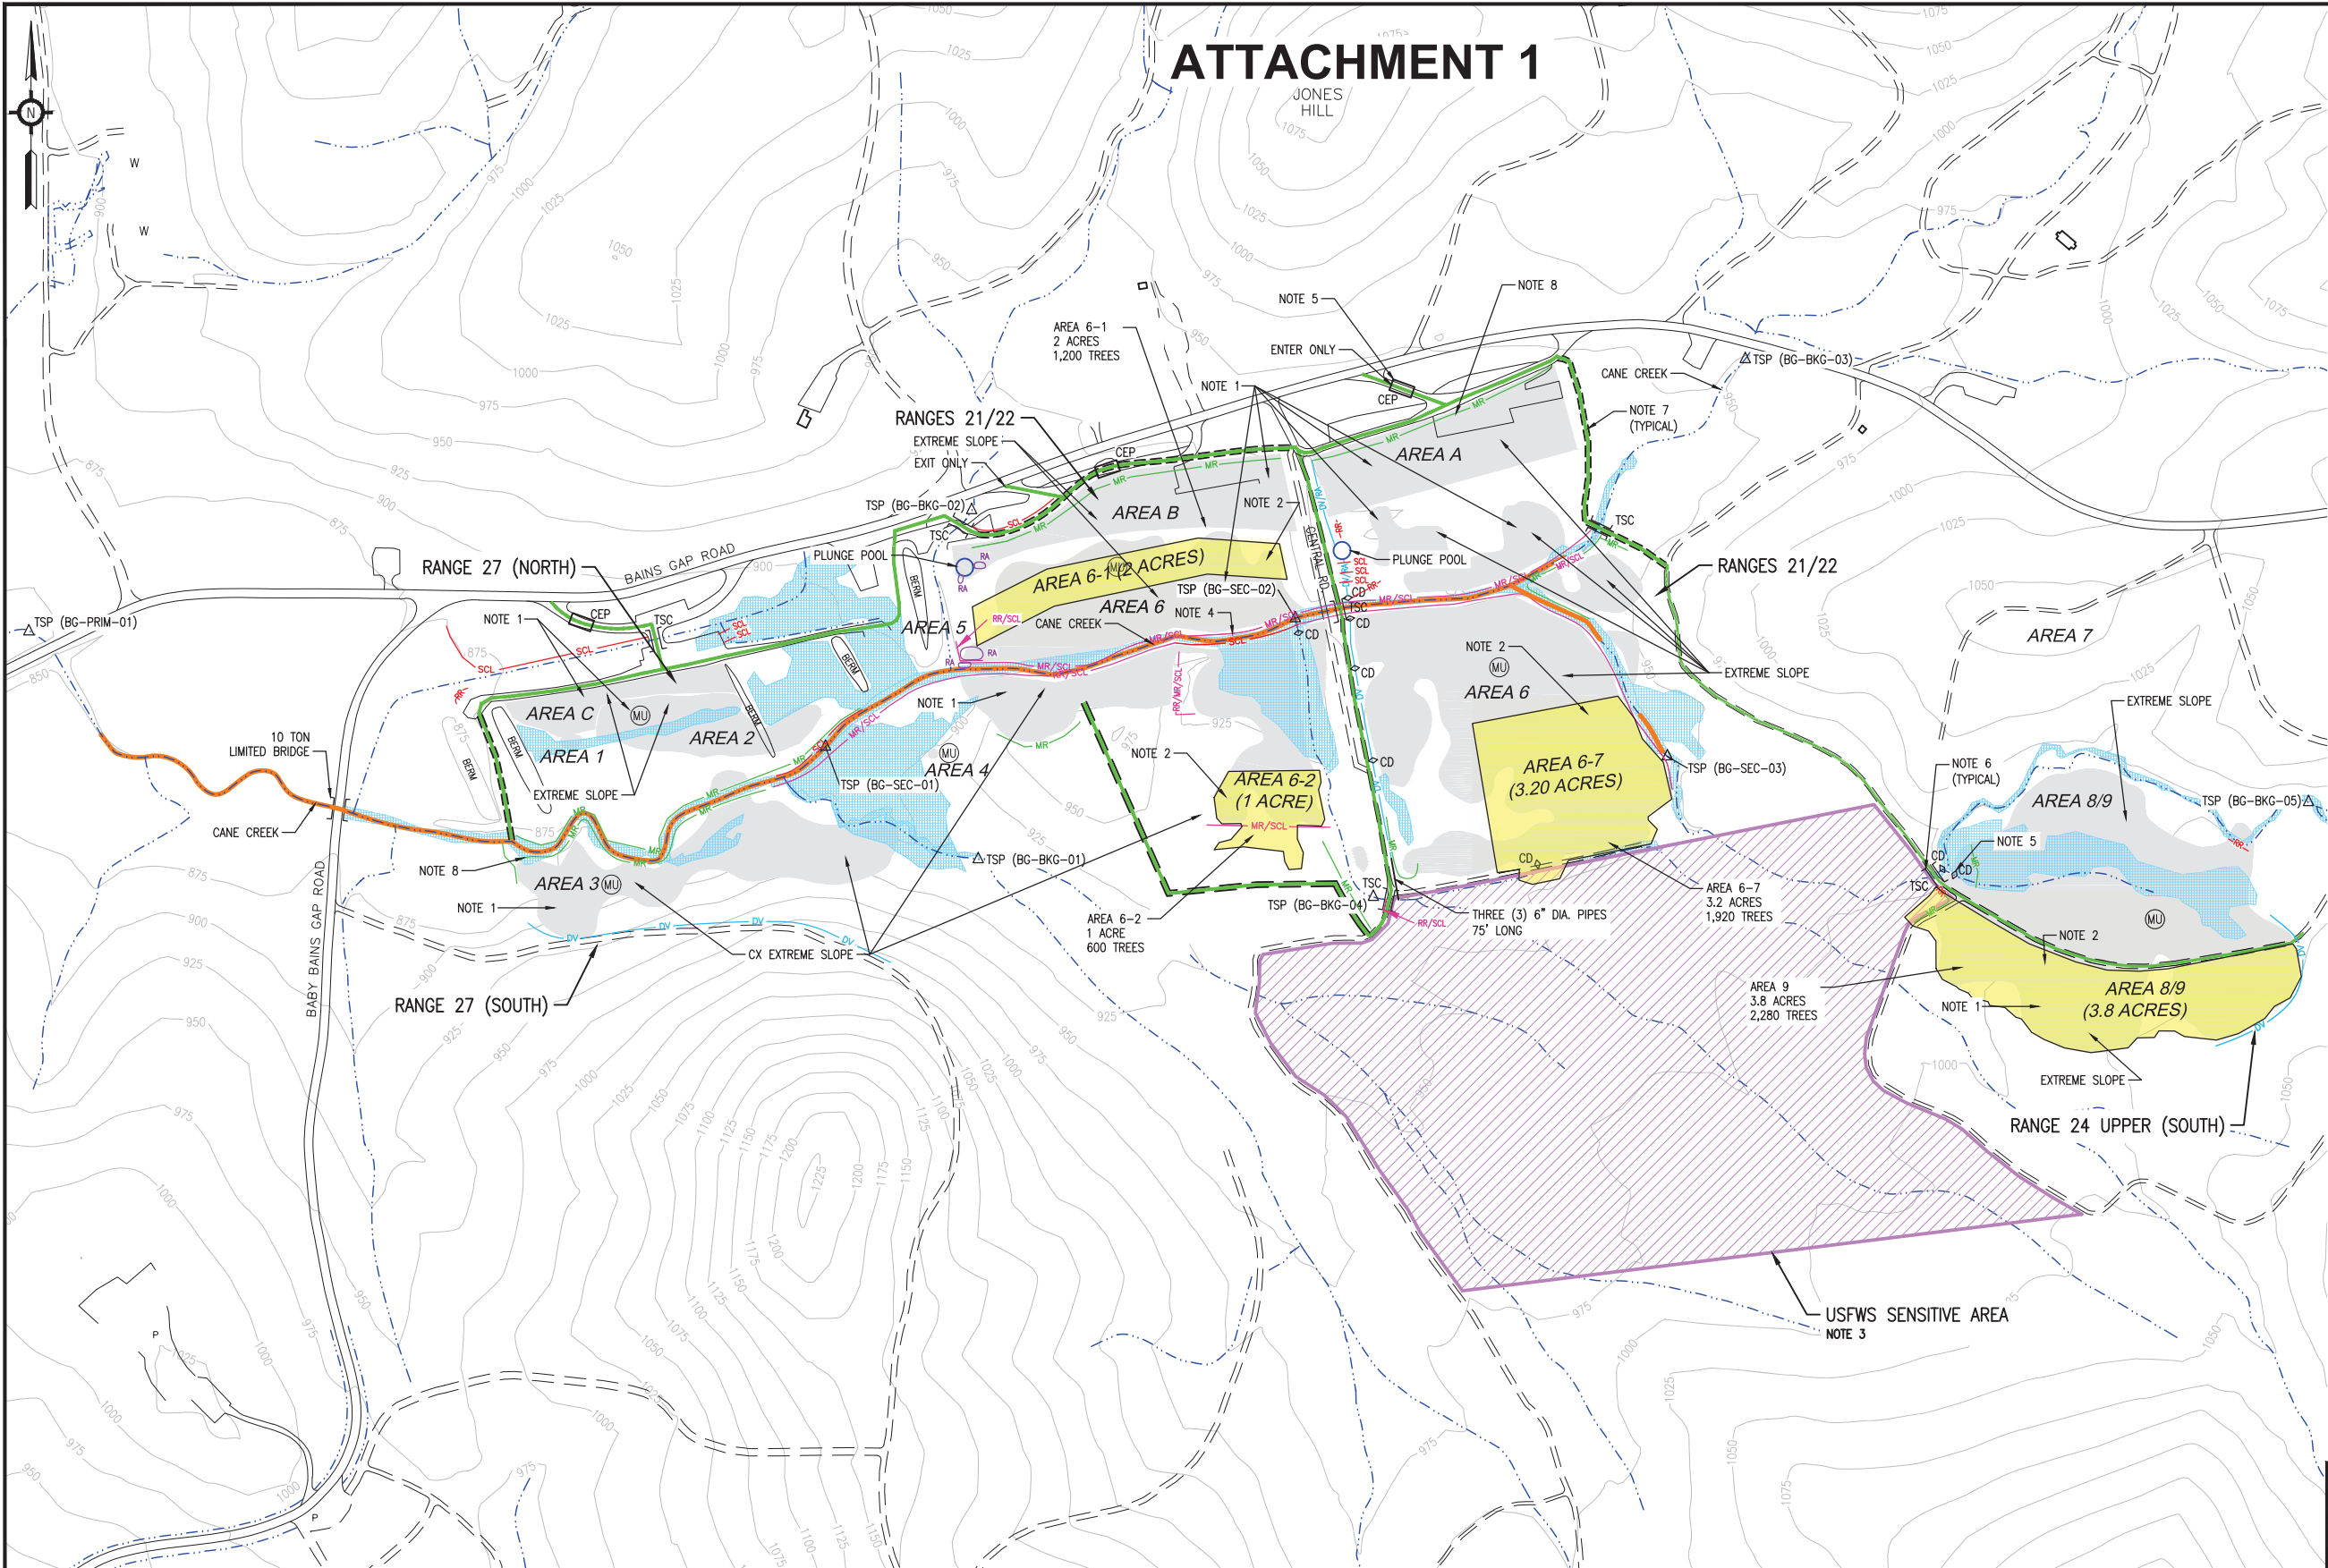
ATTACHMENT 1

Attachment 1 shows the configuration of erosion controls remaining at the site. Each of the remaining controls was inspected during Year 4, Event 1 on 12 September 2018 and found to be in good working order, except for the following maintenance activities performed by APTIM during the maintenance cycle in November 2018 (photographs in Attachment 5):

- Repaired typical road erosion along the Upper Road adjacent to Areas 1/3 and 4/5 by reworking and track compacting the roads to provide a smooth surface and knocking down the berms along the east side of the Upper Road to allow down slope drainage off the roadway. The repairs extend approximately 1,200 feet along the Upper Road from Area 7 past the forebay/plunge pool adjacent to Area 1/3. Revitalization included the use of stone and riprap.

- Repaired two areas of surface erosion along two abandoned temporary roads cut into Area 1/3 by rock armoring the existing gully, providing rock rows perpendicular to the flow at approximately 25-foot intervals, constructing a small rock wall at the bottom of the gully to trap sediment, and knocking down the existing berms to allow water kickout.

- Repaired an approximate 450-foot section of Central Road starting from Area 18 and extending eastward by compacting the road and revitalizing the road with riprap and stone.
