**Land Use Control Effectiveness Report - 2019**  
**McClellan, Anniston, Alabama**

**McClellan Development Authority**  
**McClellan, Anniston, Alabama**

**Matrix Environmental Services, LLC**  
**283 Rucker Street**  
**Anniston, Alabama 36205**

**January 2020**

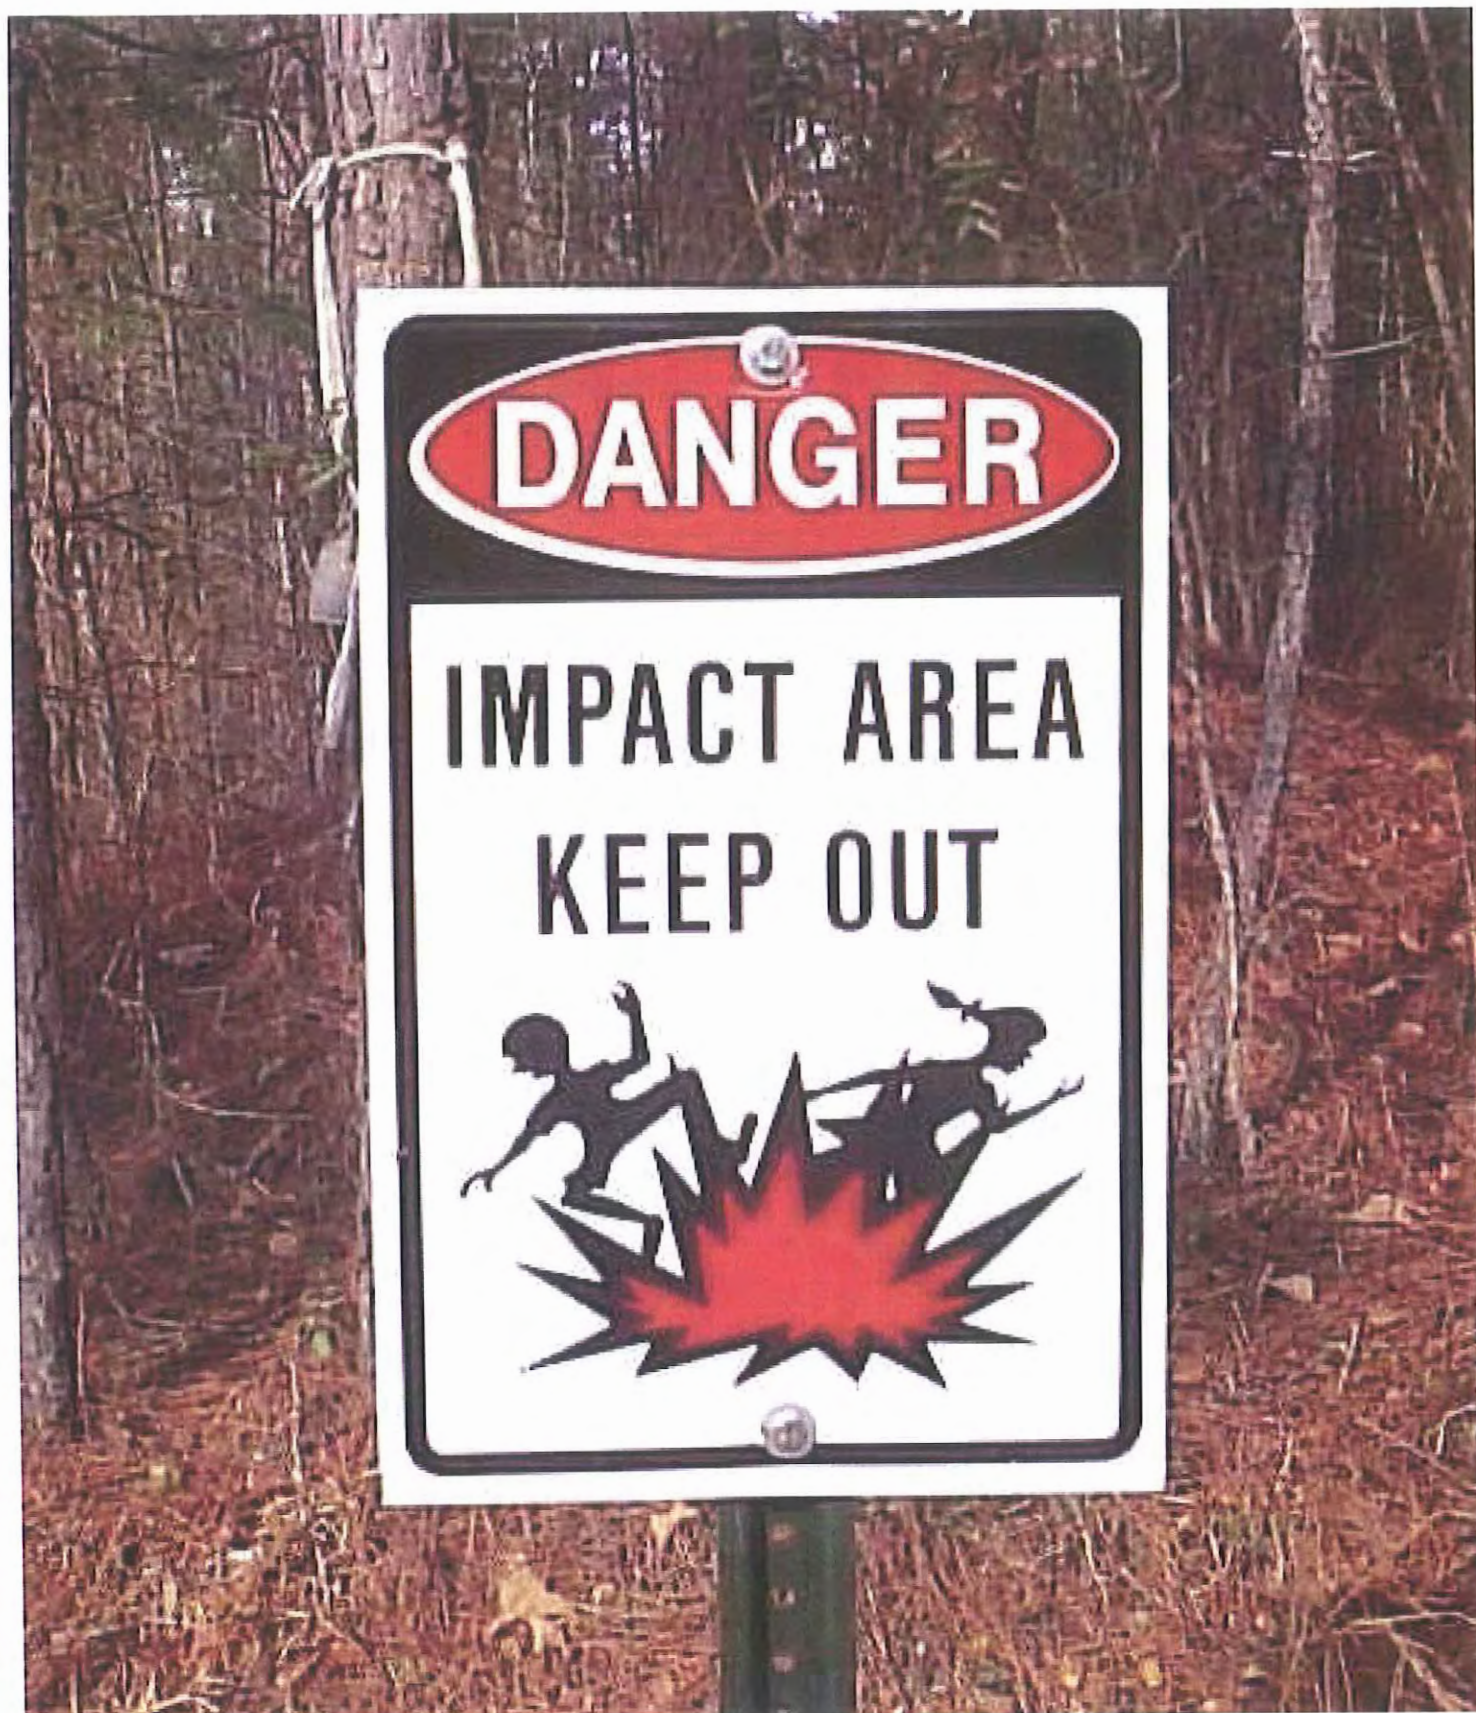
Figure 2

MEC warning signs (Figure 2) are installed around the perimeter of the Alpha MRA and Bravo MRA, and are inspected by Matrix on a semi-weekly basis. Missing or damaged signs are replaced as necessary. The MDA coordinates the community outreach program with the Army. A training video explaining the dangers of MEC is mandatory for anyone performing work on McClellan. The MDA and Matrix brief all contractors conducting work in these areas at McClellan on the possibility of encountering MEC, and describe procedures to implement should MEC happen to be encountered.
