Land Use Control Effectiveness Report - 2022
McClellan, Anniston, Alabama

MCCLELLAN
DEVELOPMENT AUTHORITY

Matrix Environmental Services, LLC
283 Rucker Street
Anniston, Alabama 36205

January 2023
Revised August 2023

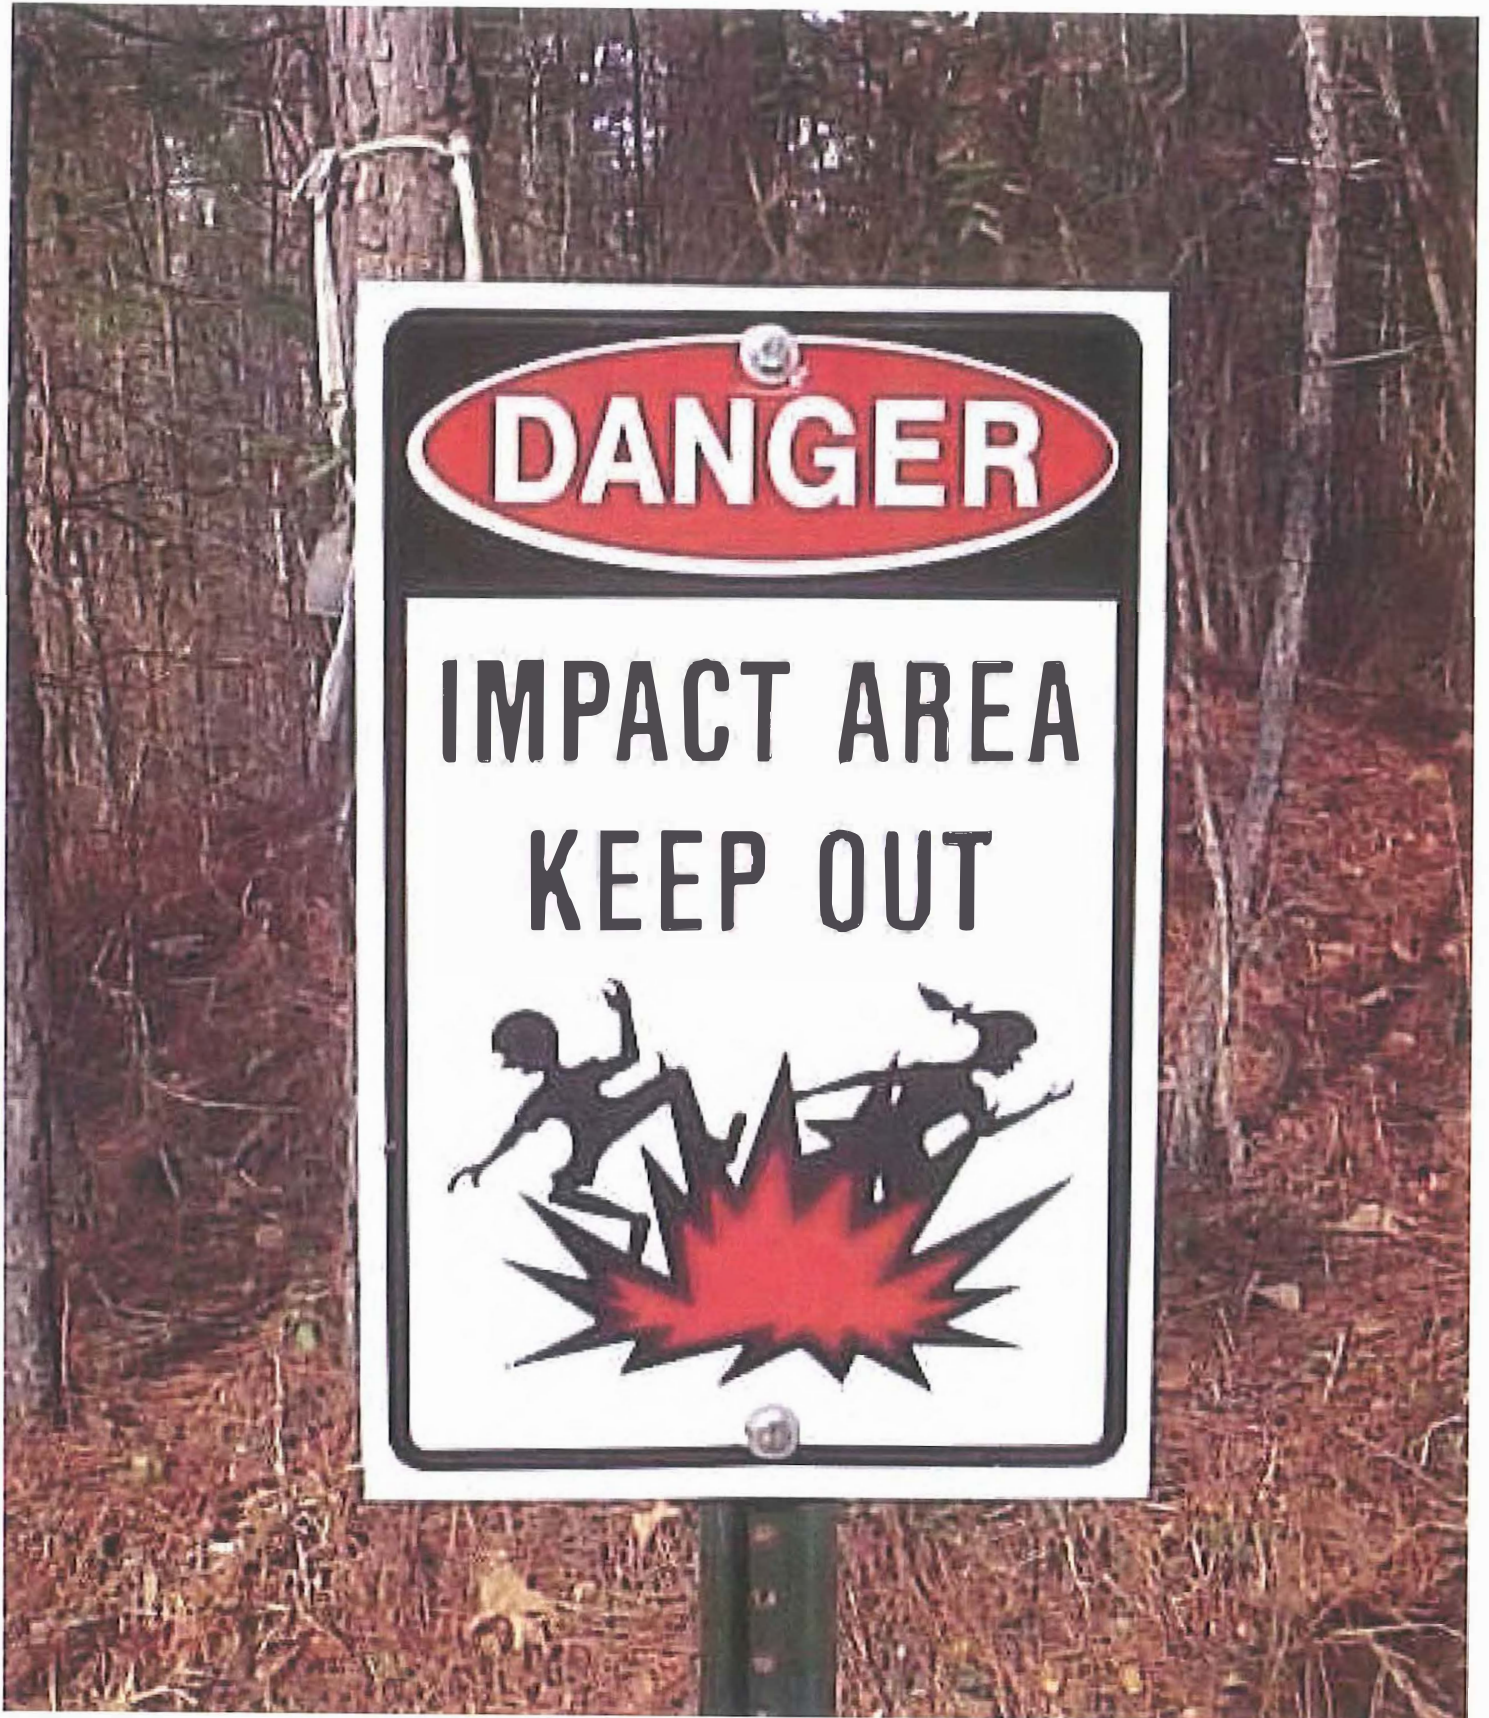
Figure 2

MEC warning signs (Figure 2) are installed around the perimeter of the Alpha MRA and Bravo MRA, and are inspected by Matrix on a semi-weekly basis. Missing or damaged signs are replaced as necessary. The MDA coordinates the community outreach program with the Army. A training video explaining the dangers of MEC is mandatory for anyone performing work on McClellan. The MDA and Matrix brief all contractors conducting work in these areas at McClellan on the possibility of encountering MEC, and describe procedures to implement should MEC happen to be encountered.
