July 13, 2016

**Re: MEC Safety Support Letter Report, Response Event 3, Choccolocco Corridor Ranges, Environmental Remediation Services at Four Sites, Fort McClellan, Anniston, AL
Contract: W912DY-10-D-0023, Task Order No. CK01
HGL Project Number: H10501**

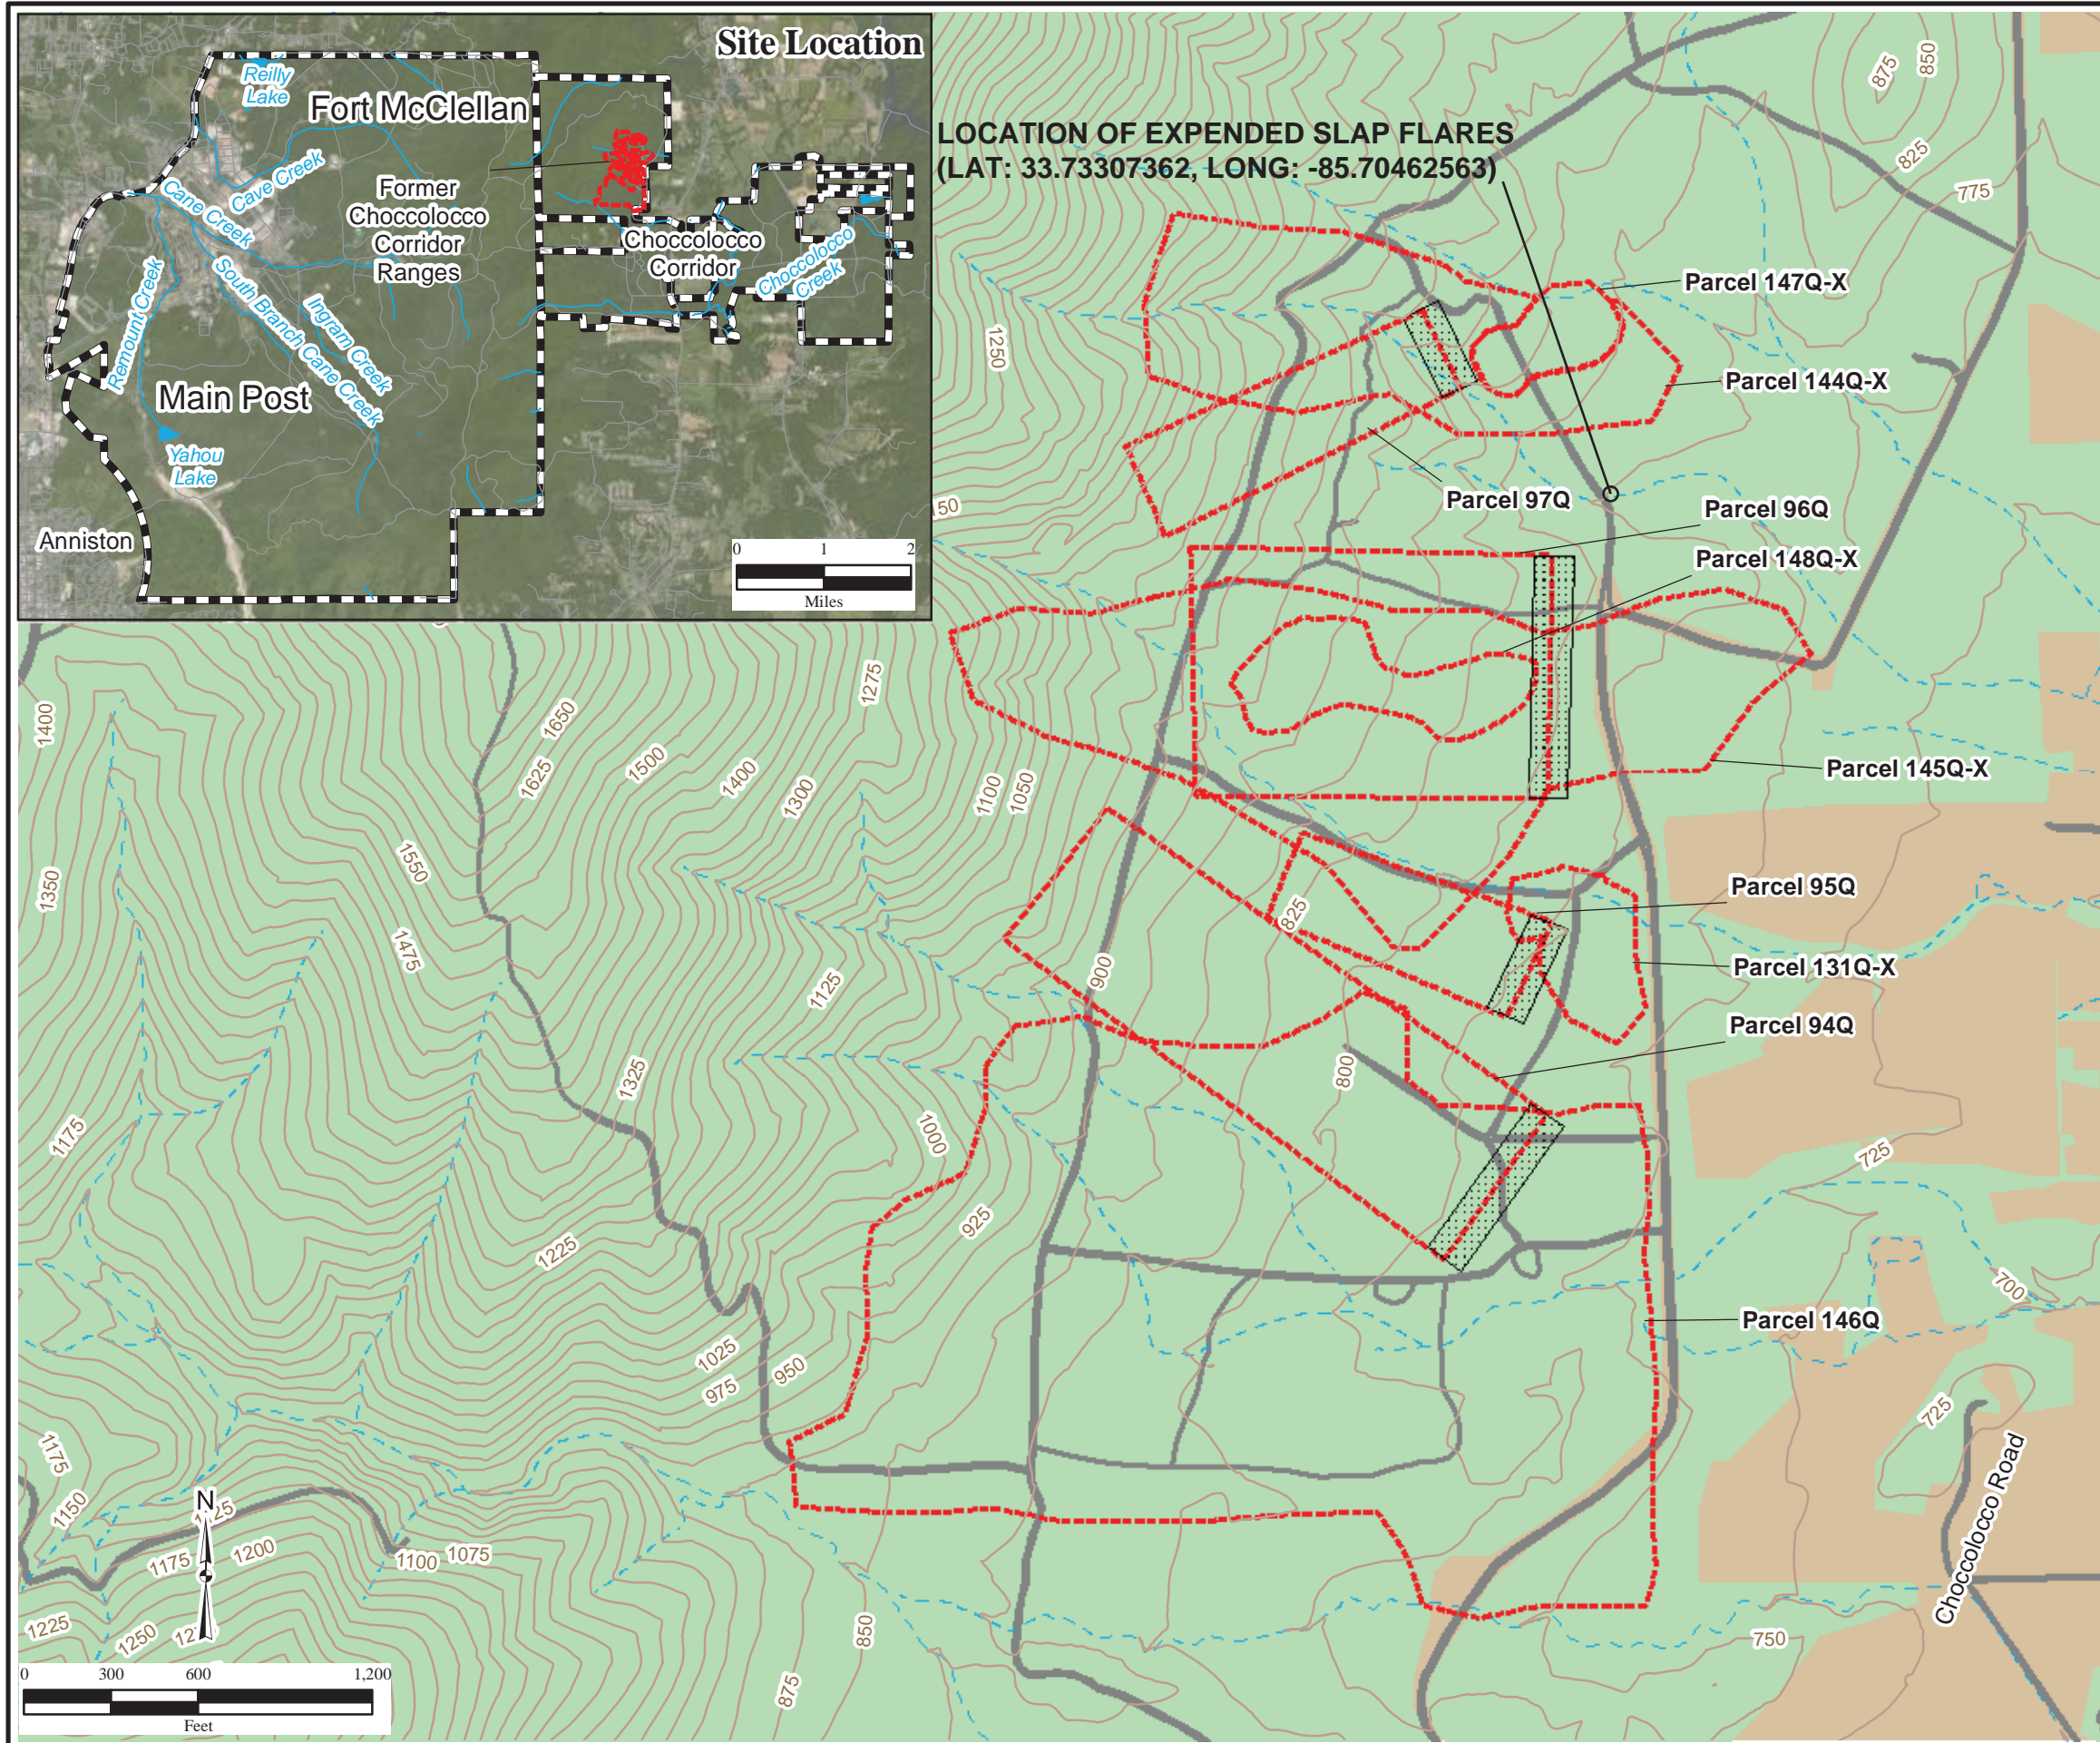
Figure 1
Location of Expended Signal, Illumination, Ground (Slap) Flares Choccolocco Corridor Ranges Fort McClellan, AL

During the conduct of the remedial activities at the subject project site, HGL's construction subcontractor identified what appeared to be an expended Signal, Illumination, Ground, commonly referred to as a slap flare during excavation of a plunge pool at the Choccolocco Corridor Ranges site (see attached Figure). A photo was provided to the unexploded ordnance (UXO) staff assigned to respond to the project location for MEC Safety Support who confirmed that the item was likely an expended flare.

The SUXOS returned on June 24, 2016, as an additional expended flare was observed in the same location. The SSHO and SUXOS determined that a UXO team should be on site during the excavation of the remaining plunge pools.
