# BLACK WARRIOR/TOMBIGBEE RIVER: DEMOPOLIS LOCK – UPPER MITER SILL FAILURE – 29 JAN 2024

# BLACK WARRIOR/TOMBIGBEE RIVER: DEMOPOLIS LOCK – UPPER MITER SILL FAILURE – 20 JAN 2024

# BLACK WARRIOR/TOMBIGBEE RIVER: DEMOPOLIS LOCK – UPPER MITER SILL FAILURE - 19 JAN 2024

# BLACK WARRIOR/TOMBIGBEE RIVER: DEMOPOLIS LOCK – UPPER MITER SILL FAILURE - 16 JAN 2024

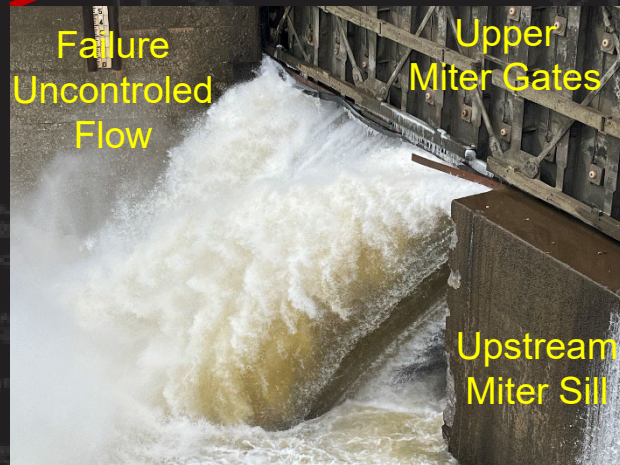
16 January 2024 Incident:  
At 0600 the on-duty lock operator heard a loud noise and while investigating noticed water flowing under the upper miter gate. The concrete that comprises the upper miter sill fractured, allowing water to pass under the gate. The lower lock gates were open at time of the incident.

Current operations are to close the lower miter gates to allow the pool to equalize and set the upper stoplogs to get the lock chamber under control. Operation will take place 19-21 January. Engineering and Operations are continuing to analyze the extent of damages and are working other courses of action to stop the flow and get the lock under control.
